Failure mechanism of anchored retaining wall due to the anchor head itself being broken

ABSTRACT: In this research, a case history of temporary earth support collapse is first illustrated briefly and the mechanisms of accident occurrences are introduced, with the results showing that the shallow penetration of piles mainly caused the sequences of collapse. In order to understand these failure characteristics and mechanisms, centrifuge model tests using an in-flight excavator were carried out. The failure mechanism of the retaining wall in this labour accident was firstly demonstrated using centrifuge model tests by Toyosawa et al. (1998). In this paper, we added some viewpoints regarding the mechanism of the retaining wall and it was thus clarified that the active and passive earth pressures in the retaining wall increased during excavation and then the anchor head exceeded the capacity with respect to tensile stress. As a result, the retaining wall and ground behind the wall collapsed suddenly.

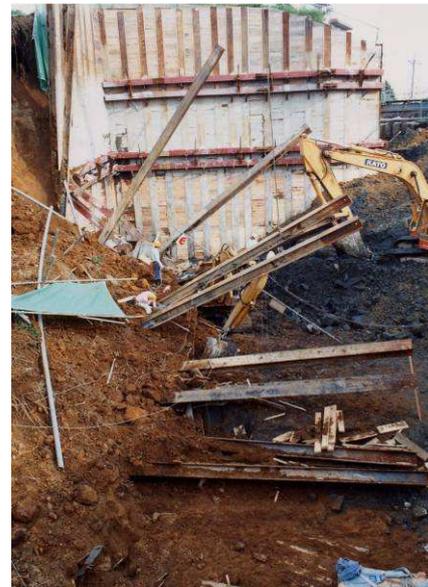
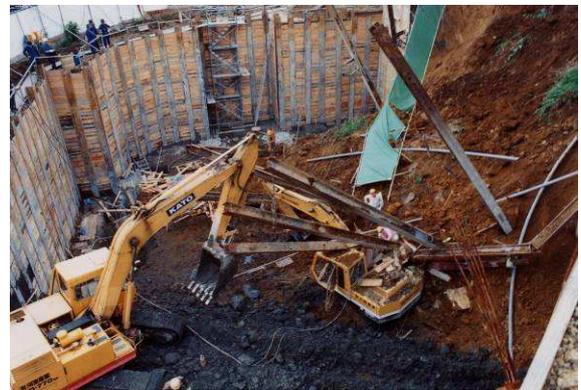
Fig. 3 The scene of the collapse accident

At around 1:15 p.m., with a loud noise, the central 15 m of the temporary earth support structure on the east side collapsed suddenly with the ground behind the support. The ground slid into the excavation area with a soil volume of approximately 200 m³ and a maximum thickness of approximately 4 m.

(a) The scene of the collapse accident (from south side)

(b) The scene of the collapse accident (from north side)

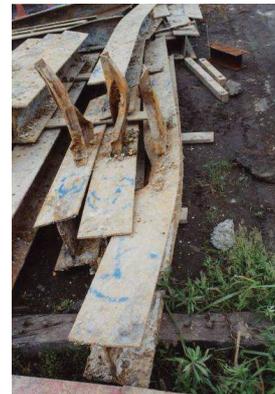
(c) Damaged H- steel for anchor head

Due to this collapse, eleven H- steel piles toppled. Four workers at the bottom of the excavation site were buried alive and three workers were struck by H- steel piles. As a result, five workers were killed and two others were injured.

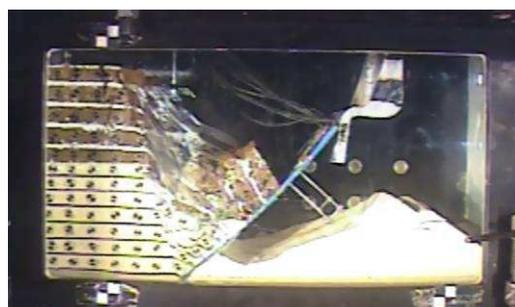
(b) Kanto loam and sand layer

The model consisting of Kanto loam and sand layers is shown after collapse in Fig. 11(b). The failure happened suddenly when the penetration depth reached about 60mm. The failure line's angle in the sand was about 65 degree.
