Kyoto. The restoration of the Imperial Gateway at Nijo Castle (2012-2013)

The restoration of Imperial Gateway (Kara-mon) at Nijo Castle

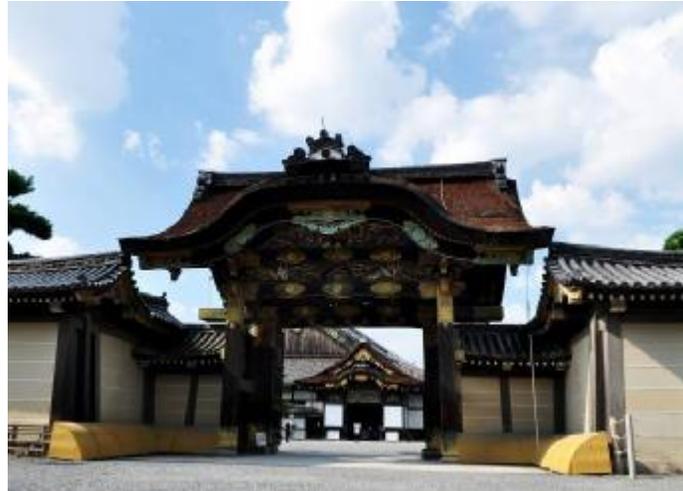
Fig. 1 Kyoto. The Imperial Gateway in Nijo Castle before the restoration (2008 © Olimpia Niglio)

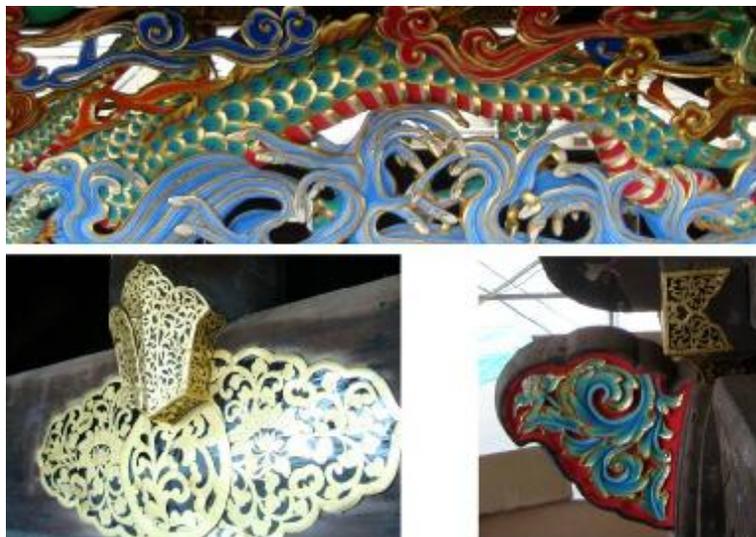
Fig. 2 Kyoto. The restoration site of the Imperial gateway in Nijo Castle. June 25, 2013
Details of the bas-reliefs in wood and of the decorations with typical colors, during restoration.
(2013 © Olimpia Niglio)

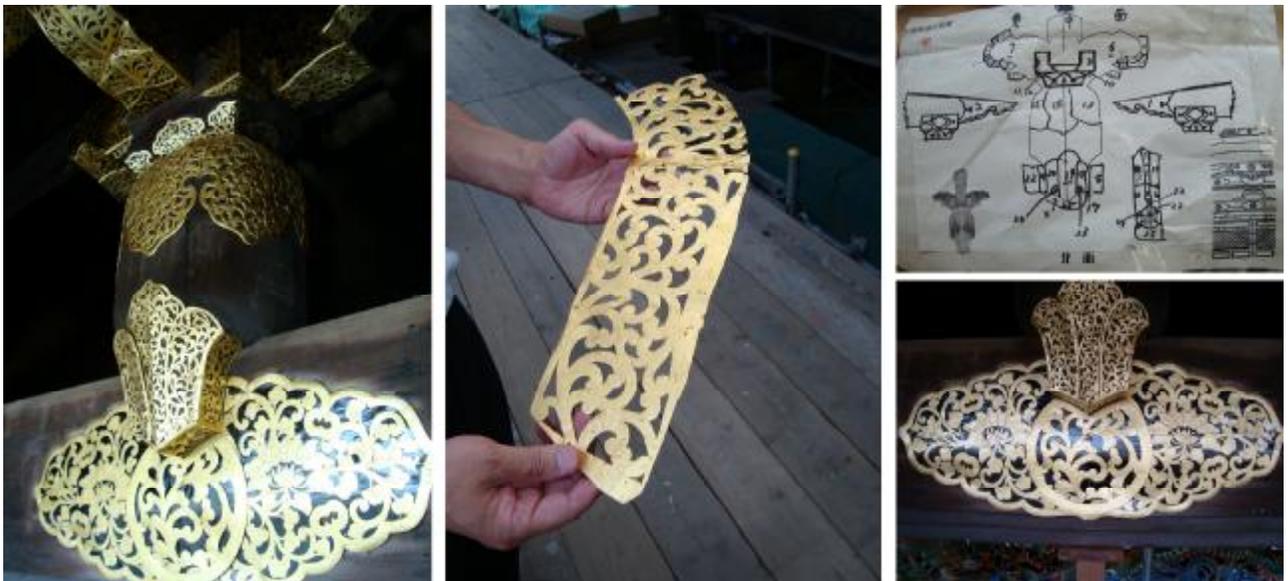
Fig. 3 Kyoto. The restoration site of the Imperial gateway in Nijo Castle. June 25, 2013
Details of the copper and gold decorations, during restoration. (2013 © Olimpia Niglio)

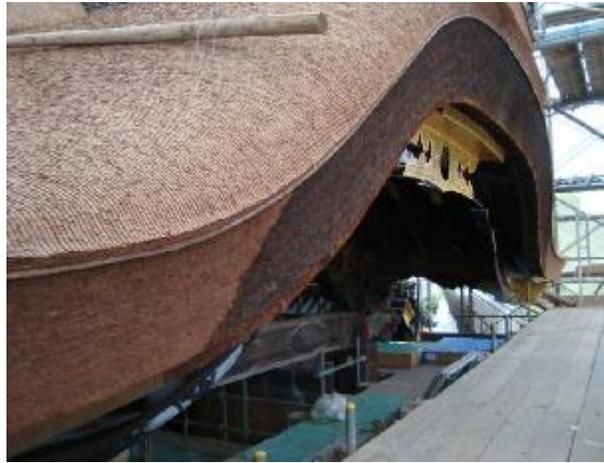
Fig. 4 Kyoto. The restoration site of the Imperial gateway in Nijo Castle. June 25, 2013
Detail of the *kara-hafu*. The dark area does not restored. (2013 © Olimpia Niglio)

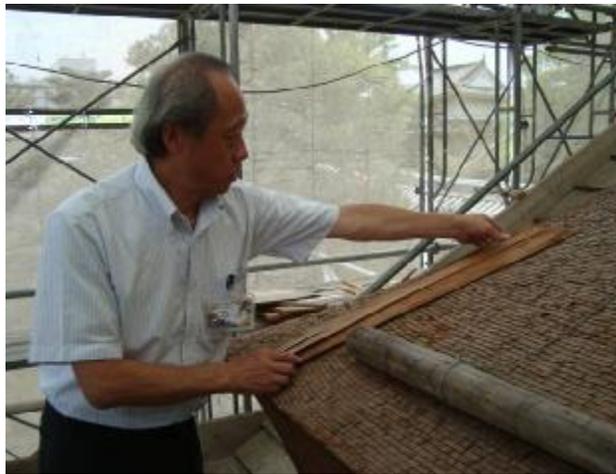
Fig. 5 Kyoto. The restoration site of the Imperial gateway in Nijo Castle. June 25, 2013
The Architect Goto describes the restoration of roof with bark of the cypress. (2013 © Olimpia Niglio)

The architect Goto explained the difficulties in finding the natural materials and the technique for extracting the bark from the cypress tree. Today in Japan there are only 10 companies working in the specific field of finding, removing and correctly working with the wood and bark of the cypress for the restoration of ancient architectures. Subsequently we have analyzed the technical execution of the restoration and we have observed the excellent state of conservation of wooden structures that are original to the seventeenth century. The decorative parts in copper and the wooden sculptures were disassembled and restored in the laboratory. On the restoration site it is possible to observe drawings showing the assembly stages of these works of art. The restoration work will be inaugurated September 30, 2013.

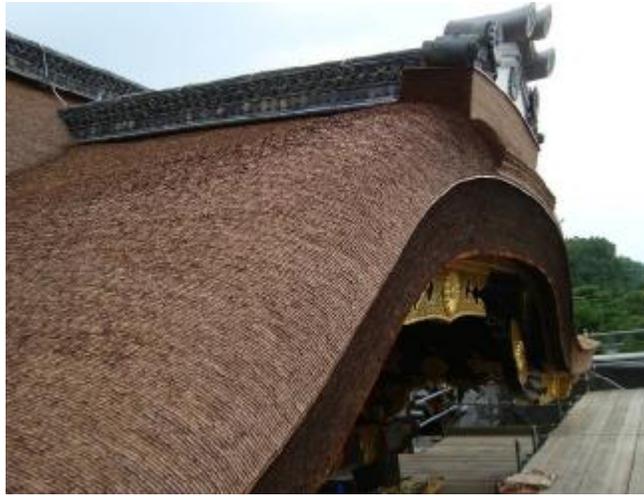
Fig. 6 Kyoto. The restoration site of the Imperial gateway in Nijo Castle. July 30, 2013
Detail of the *kara-hafu* after the restoration (2013 © Olimpia Niglio)

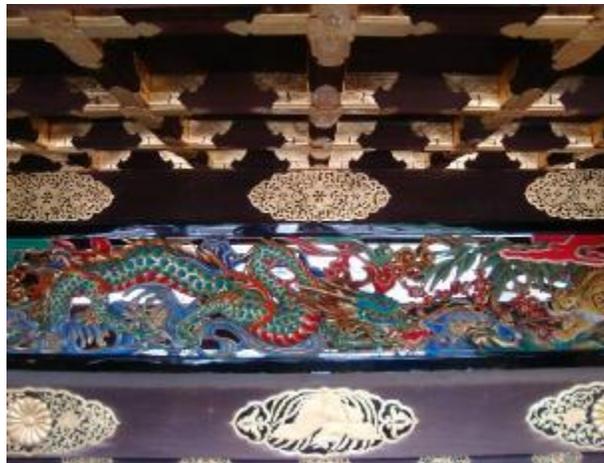
Fig. 7 Kyoto. The restoration site of the Imperial gateway in Nijo Castle. July 30, 2013
The copper decorations and the wooden sculptures (three-dimensional) after the restoration (2013 © Olimpia Niglio)

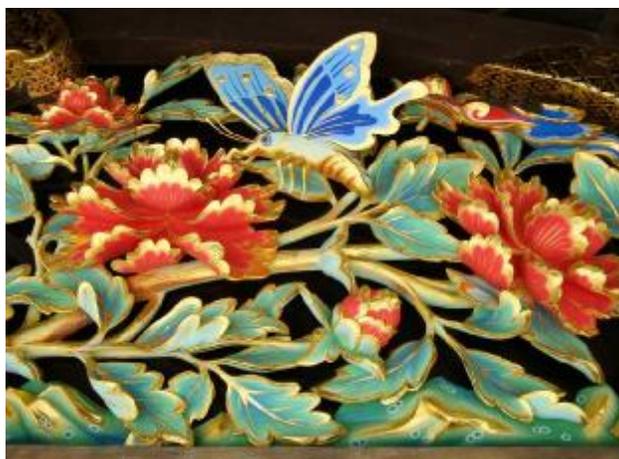
Fig. 8 Kyoto. The restoration site of the Imperial gateway in Nijo Castle. July 30, 2013
Detail of the wooden sculptures (three-dimensional) after the restoration (2013 © Olimpia Niglio)
