# Proposal of liquefaction countermeasure technique by log piling for residential houses

Masaho Yoshida (*Dept. of Civil Engineering, Fukui National Colledge of Technology, Japan*) Masakatsu Miyajima (*School of Environmental Design, Japan*) Atsunori Numata (*Research Institute of Technology, Tobishima Corporation, Japan*)

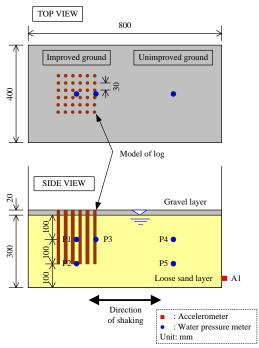
Fig. 4 General view of model ground and transducers

Fig. 4 illustrates cross sections of top and side view of a model ground with locations of transducers (Yoshida et al., 2008). The model ground was set up in a rigid acrylic container that measured 800 mm long, 400 mm wide and 540 mm high. The tests were conducted by using a composite ground which consists of two parts. One was improved area that model of logs made of Japanese cedar got by thinning in Fukui prefecture were installed in loose sand layer which was shown in left side of Fig. 4, the other was unimproved area. The loose liquefiable sand layer was made of silica sand No.7 and the relative density was about 35%. The physical properties of sand are listed in Table 1. The model of log made by scaling down 1/25 of the wood pile of Kida Bridge and measured 12 mm diameter and 220 mm length.

The shaking table tests were conducted as follows: 1) Pore water pressure transducers were installed at the locations as shown in Fig. 4. 2) The container was first filled with water to 300 mm high from the bottom. Then a sieve with a 2 mm mesh was moved back and forth below water surface, pouring wet sand through water to form a uniform sand layer with the thickness of 300 mm. 3) Excess water above the sand layer was soaked up so that the water surface was level with the surface of the sand layer. 4) Accelerometers were installed at the locations as shown in Fig. 4. 5) Thirty six logs were installed into the loose sand layer slowly with an interval 30mm, except the top of log with a length 20mm. 6) No. 5 gravels were laid over the loose sand layer with a thickness 20mm. 7) The model ground was shaken in the horizontal direction with the sinusoidal wave of 100 gal in peak amplitude, 5 Hz in frequency and 5 seconds in duration time as shown in Fig. 5. The pore water pressures and the response accelerations were recorded simultaneously on the data recorder. 8) After the excess pore water pressure had completely dissipated, the vertical displacements of logs and ground surface were measured by a point gauge. 9) The processes of 7) to 8) repeated five times with different amplitude which was from 100 gal to 180 gal at intervals of 20 gal.

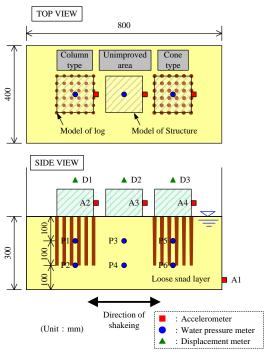
Fig. 9 General view of model ground and transducers

Fig. 9 illustrates cross sections of top and side view of a model ground with locations of transducers (Yoshida et al., 2009). The container and sand were same as Fig. 4. The tests were conducted by using a composite ground which consists of three parts. The left part was improved area installed by column type logs, the right part was also improved area installed by cone type logs and the center part was unimproved ground. The shape of cone type log was copied from real wood pile. The model of log in case of the column type measured 12mm diameter and 200 mm length. The diameter of top was 14mm and that of bottom was 10mm in case of the cone type. The volume of both models was same. The underside of structure model was 150mm square and the weight was 6000g.

The shaking table tests were conducted as follows: 1) Pore water pressure transducers were installed at the

locations as shown in Fig. 9. 2) The container was first filled with water to 300 mm high from the bottom. Then a sieve with a 2 mm mesh was moved back and forth below water surface, pouring wet sand through water to form a uniform sand layer with thickness 300 mm. 3) Excess water above the sand layer was soaked up so that the water surface was level with the surface of the sand layer. 4) Thirty six logs were gradually installed into the loose sand layer with an interval 30mm. 5) The models of structure were placed over the each area. 6) Accelerometers and displacement meters were installed at the locations as shown in Fig. 9. 7) The model ground was shaken in the horizontal direction with the sinusoidal wave of 80 gal in peak amplitude, 5 Hz in frequency and 5 seconds in duration time as shown in Fig. 10. The pore water pressures and the response accelerations were recorded simultaneously on the data recorder. A vertical displacement of structures was also measured by a laser displacement meter. 8) After the excess pore water pressure had completely dissipated, the vertical displacements of logs and ground surface were measured by a point gauge. 9) The processes of 7) to 8) repeated three times with different amplitude which was from 60 gal to 100 gal at intervals of 20 gal.

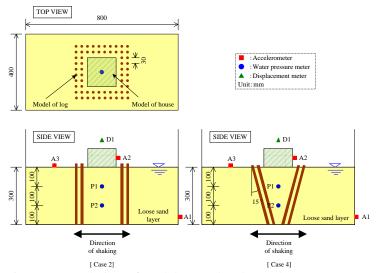
Fig. 15 General view of model ground and transducers

To propose how to apply the technique of log pilling for existing house, shaking table tests were conducted using the model ground. Fig. 15 illustrates cross sections of top and side view of a model ground with locations of transducers. The container, materials, model of house and way to make model ground were similar as shown in above chapter. A model of log measured 12 mm diameter and 300 mm long. Four types of way to install logs were adopted in this study. Case 1 was the ground without installing logs. In Case 2, the logs were installed around foundation of house. The top and bottom of log did not be fixed. In Case 3, the top of logs were fixed. In Case 4, the logs were installed into the ground with an inclination of 15 degree. The relative density of loose sand layer was about 40%. Input wave used in the tests was sinusoidal wave with a frequency of 5 Hz and a peak magnitude of 120 gal. The duration time of shaking was 20 second.
