1 **Submitted to: Engineering Geology**

3 Pore-pressure generation and fluidization in a loess landslide triggered by the 1920 Haiyuan  
4 earthquake, China: A case study

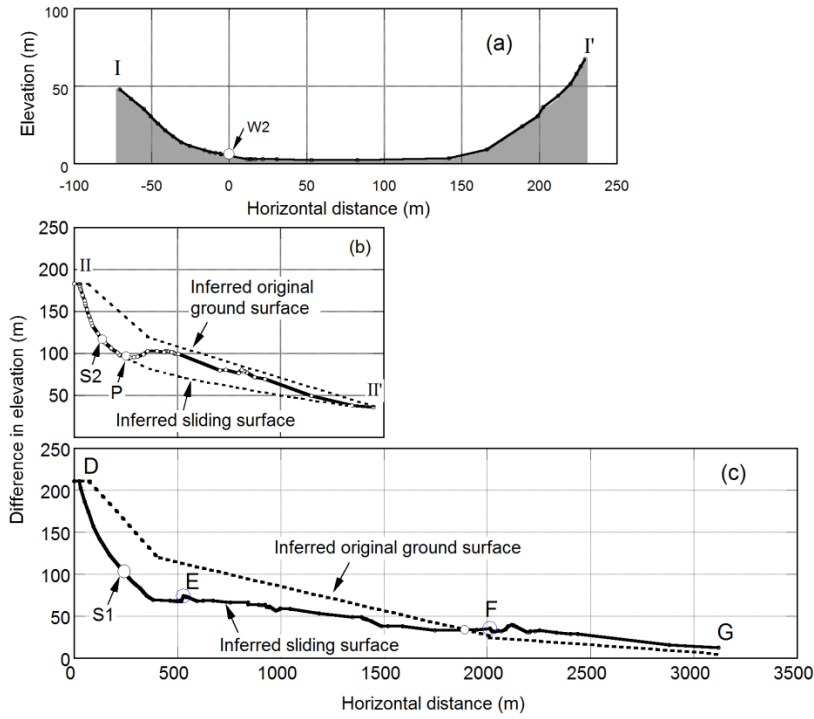
**Fig. 4.** Cross section along Line I-I' (a), longitude section along Line II-II' (b) and Line D-E-F-G (c) in Fig. 2,

respectively.

128 samples (two blocks, each sized 50 cm × 40 cm × 40 cm) at location S1 and disturbed samples (about 80 kg) at  
129 location S2 from the main scarps (see Figs. 2 and 4). These samples were taken from two pits that were dug  
130 approximately 1 m deep. We hypothesized that liquefaction failure of the water-saturated loess was the main  
131 reason for this long-runout landslide, and if the soil at location S1 was liquefiable, then all soil layers would be  
132 liquefiable as they had higher void ratios than at S1.

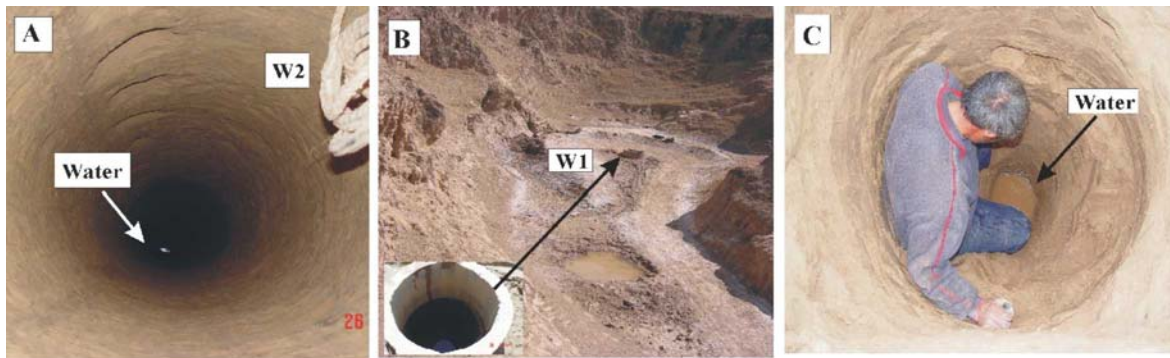
**Fig. 5.** Wells located in the right (a) and left (b) sliding blocks and the investigation pit (c) near the well W1

We observed standing water (Fig. 5) and shallow groundwater (Points W1 and W2 in Fig. 2) in the landslide source areas, even 80 years after the 1920 earthquake. Point W2 references a well that supplies water for several families, with a water table 22 m (measured on March 26, 2003) below the present ground surface. We were told that the groundwater table in W2 was usually higher during summer. Well W1 is very shallow. To examine the aquifer location, we dug a pit near W1 on March 20, 2005, and found groundwater at a depth of about 2 m (Fig. 5c).

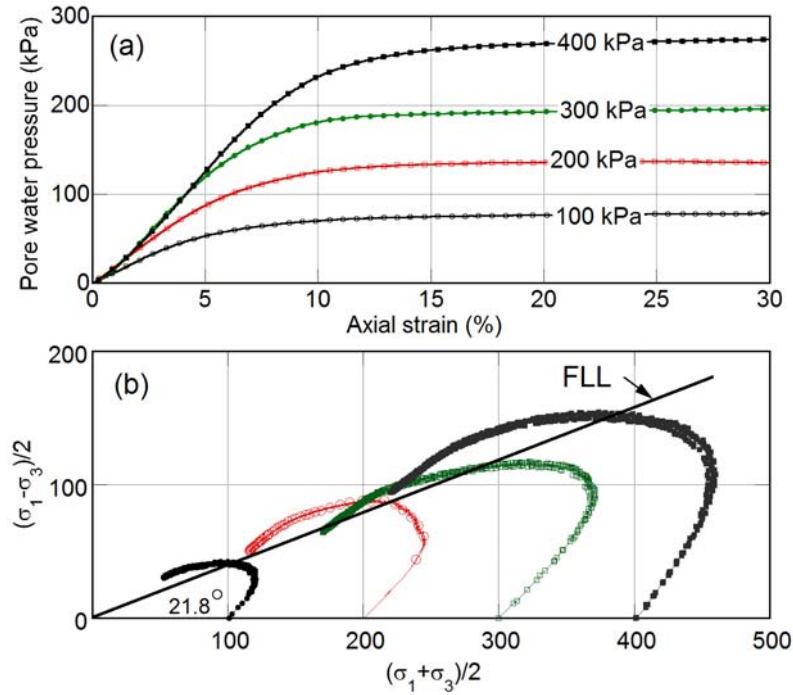
**Fig. 10.** Undrained triaxial compression test results on saturated undisturbed loess samples ( $e=0.79$ ). (a)

Pore-water pressure against axial strain; (b) Effective stress path. FLL: Flow Liquefaction Line.

161 terminated when the axial strain reached 30%. Fig. 10 presents the test results in the form of pore-water pressure  
162 against axial strain (Fig. 10a) and effective stress path (Fig. 10b). It can be seen that high pore pressure was  
163 generated, resulting in a remarkable decrease in effective stress. The final pore pressures in the tests were as  
164 great as 65% of the initial cell pressures. The locus of peak points in the effective stress paths can be well fitted  
165 by a straight line passing through the origin. This line is widely known as the flow liquefaction line (FLL) (Vaid  
166  
167

168 and Chern, 1983, 1985; Lade, 1993; Ishihara, 1993; Kramer, 1996; Yang, 2002), which indicates the initiation of  
169 flow deformation. The stress ratio, defined as the ratio of  $q$  ( $=(\sigma_1 - \sigma_3)/2$ ) to  $p'$  ( $=(\sigma_1 + \sigma_3)/2$ ), is approximately  
170 0.4, which corresponds to a mobilized friction angle of about 21.8 degrees. From these test results (Fig. 10b), we  
171 can conclude that the loess is susceptible to flow liquefaction failure.

285 If the stress path crosses the FLL during undrained shear, flow liquefaction will be initiated regardless of  
286 whether the loading is cyclic or monotonic (Void and Chern, 1983). Because the test results presented in Fig. 10  
287 were obtained from the densest undisturbed loess sample, it is reasonable to infer that once the stress condition in  
288 the loess layer reaches the FLL due to the introduction of seismic loading, flow liquefaction will be triggered and  
289 the shear resistance will rapidly drop to the steady-state strength.

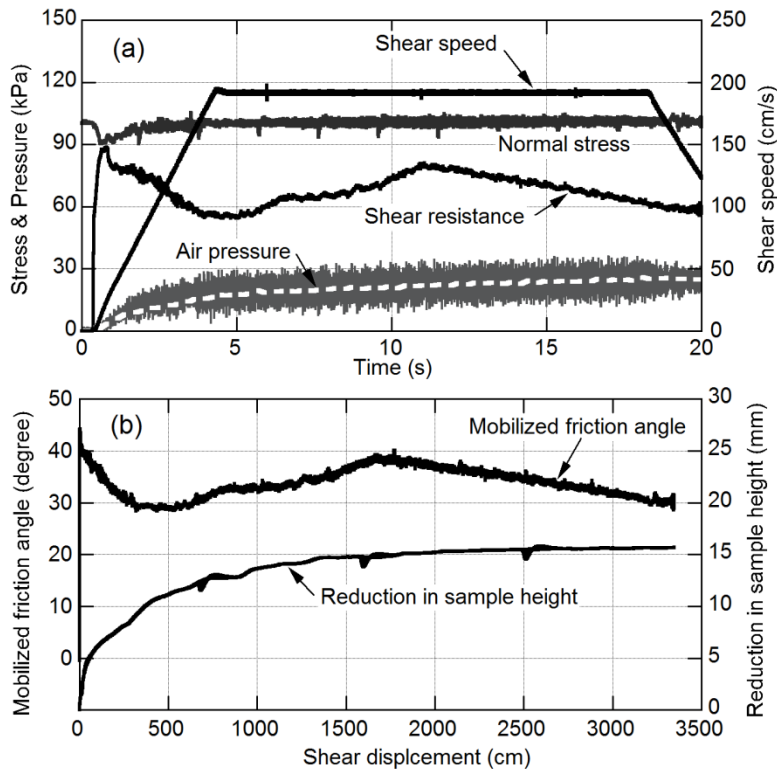
**Fig. 12.** Undrained response of water-saturated loess sample to cyclic loading in ring shear test. (a) Time series data of normal stress, shear resistance, pore-water pressure and shear displacement; (b) Effective stress path ( $e = 0.99$ )

214 Cyclic loading tests were also conducted on a water-saturated loess sample. After saturation, the sample was  
215 consolidated under a normal stress of 200 kPa while a shear stress of 80 kPa was applied. After consolidation, a  
216 cyclic shear loading was applied under undrained conditions with an amplitude of 60 kPa and frequency of 0.25  
217 Hz, while the normal stress was kept constant. Fig. 12 presents the test results in the form of time-series data of  
218 normal stress, shear resistance and pore-water pressure (Fig. 12a), and in the form of the effective stress path  
219 (Fig. 12b). Shear failure was triggered during the first cycle and pore-water pressure increased continuously  
220 thereafter, while shear resistance decreased until reaching a small, constant value (about 7.6 kPa). It is noted that  
221 the measured shear resistance before the occurrence of shear failure represented the applied shear loading, but

222 after failure shear loading greater than the shear resistance of soil could not be applied (Wang et al., 2007).  
223 Hence, the intended amplitude of the cyclic loading is not apparent in Fig.11, although the frequency of the  
224 applied cyclic loading is. From Figs. 11 and 12, it can be concluded that the water-saturated loess samples are  
225 highly liquefiable under undrained monotonic or cyclic shearing.

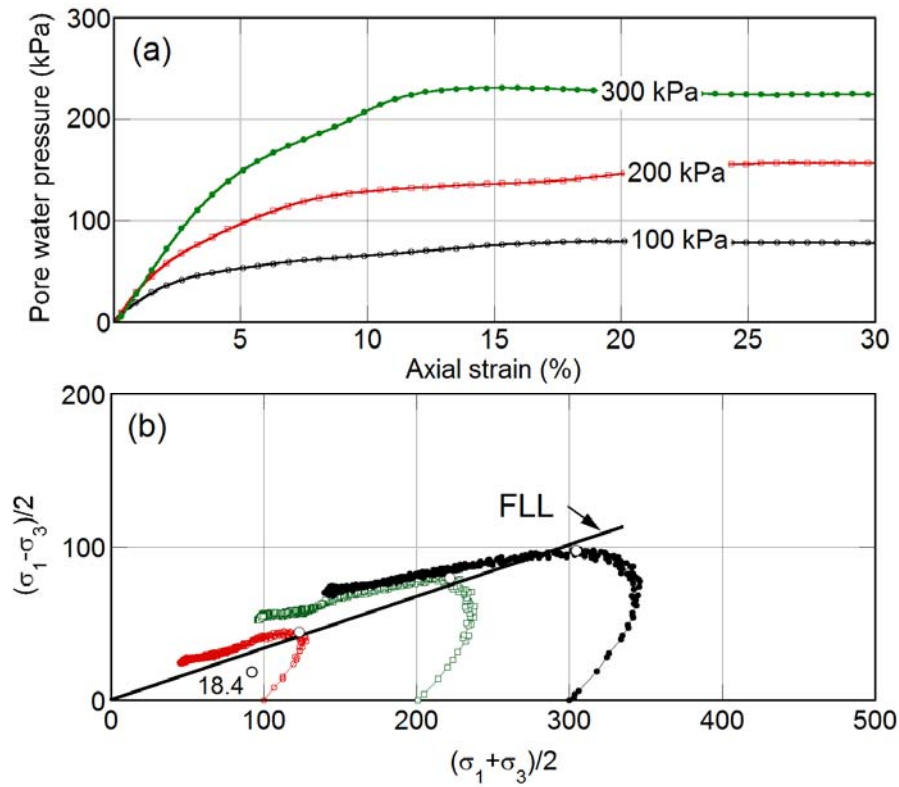
**Fig. 14.** Undrained triaxial compression tests on remolded sample ( $e=0.79$ ). (a) Pore-water pressure against axial strain; (b) Effective stress path. FLL: Flow Liquefaction Line.

270 As reported by Yang (2002), the slope of the flow liquefaction line varies with both the materials and the  
271 soil state. Wen and Yan (2014) examined the influence of structure on shear characteristics of unsaturated loess  
272 and found that peak shear strength and strength parameters (cohesion and friction angle) of the loess were  
273 significantly reduced once its structure was destroyed. Considering that some loess in the lower part might have  
274 been disturbed before the earthquake by human activities, we performed three undrained triaxial compression  
275 tests on remolded loess samples to examine the possible variation of the flow liquefaction line with the soil state.  
276 The remolded samples in these tests were prepared at the same density as that of the undisturbed samples, and  
277 testing procedures were unchanged from those used during the undisturbed tests. Fig. 14 presents the test results.

278 As can be seen, similar to results from tests on undisturbed samples, pore water pressure continuously increased  
279 with increasing axial strain, and all tests showed flow liquefaction behavior. However, the slope of the flow  
280 liquefaction line is approximately 18.4 degrees, gentler than that for the undisturbed samples shown in Fig. 11b.  
281 Therefore, we can conclude that the remolded loess is more prone to flow liquefaction than undisturbed loess

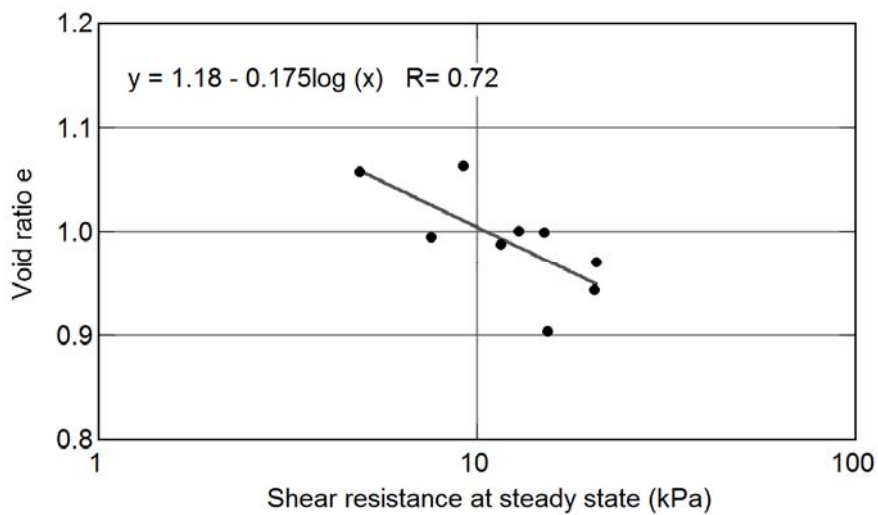
**Fig. 15.** Shear resistance at steady state versus void ratio for water-saturated loess samples

300 different initial void ratios. Probably due to the small value of the applied initial normal stress (200 kPa) and the  
301 specimen preparation method, the void ratios of tested specimens ranged from 0.9 to 1.1, showing no significant  
302 difference. Each specimen was sheared to steady state. The steady-state points for all the tests are shown on the  $e$   
303 versus  $\log(\tau_s)$  plot (Fig. 15). Based on these data, a steady-state line was obtained by regression. Using the  
304 measured in-situ unit weight ( $\gamma_d$ ) of 15.0 kN/m<sup>3</sup> (the largest value, which corresponds to a void ratio of 0.79) for  
305 the loess layer in the source area, a possible maximum thickness ( $H$ ) of about 50 m (from the cross section along  
306 I-I' shown in Fig. 4a), and the slope angle ( $\theta$ ) of 20 degrees, we estimate that the shear stress acting on the  
307 potential sliding surface ( $\tau = H\gamma_d \sin\theta \cos\theta$ ) before the sliding was about 180 kPa. This initial shear stress and

308 the in-situ void ratio will plot above the steady-state line shown on Fig. 15. Hence, once shear failure occurred  
309 during the earthquake, the shear resistance of the water saturated loess layer near the sliding surface would drop  
310 to a very small value due to liquefaction, and then the great difference between the driving shear stress and the  
311 lowered shear resistance would result in the accelerating movement of displaced landslide materials.

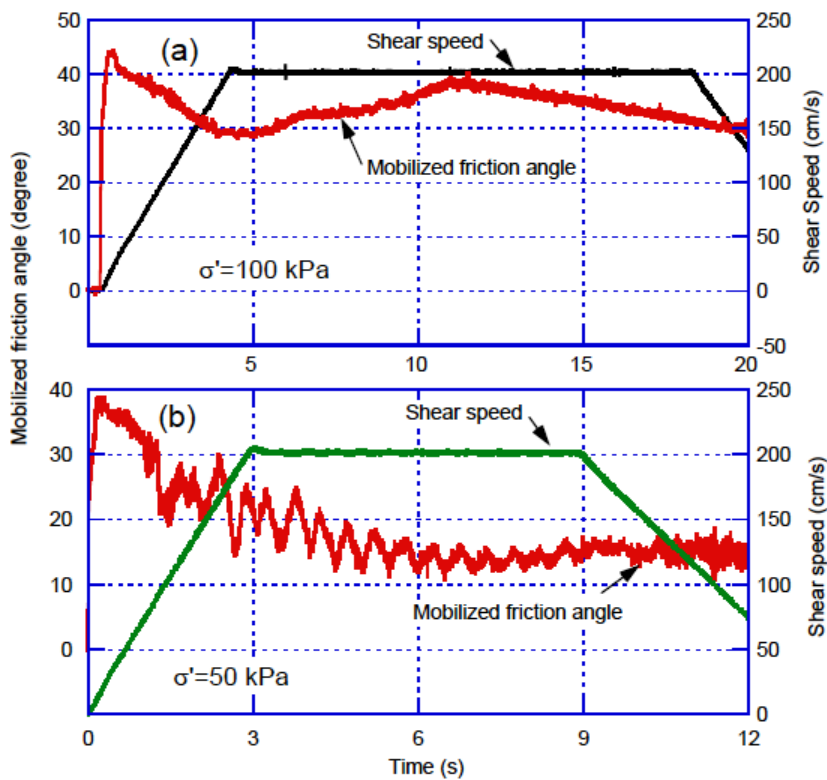
**Fig. 17.** Results of tests on air-dried loess samples that were consolidated under the initial stress of (a) 100

kPa ( $e = 1.42$ ), and (b) 50 kPa ( $e = 1.43$ ), respectively.

321 Based on the concept of the mobilized friction angle, the possible effect of entrained air on the landslide  
322 movement was examined by conducting a series of undrained fast shear tests on air-dried loess samples. The  
323 samples were normally consolidated under initial effective normal stresses ( $\sigma_i$ ) of 50 and 100 kPa. In these tests,  
324 the observed pore-air pressures were within a narrow range (20-27 kPa), but the mobilized friction angles were  
325 different (Fig. 17). The test under  $\sigma_i = 100$  kPa indicated a mobilized friction angle of 30 degrees during the  
326 shear process, whereas the test under  $\sigma_i = 50$  kPa showed a significantly lower value of  $\phi_m$  of about 13 degrees.

336 From Fig. 17, we can conclude that increased pore-air pressure would have less effect on the mobility of  
337 deep-seated landslides because the reduction of effective normal stress from elevated pore-air pressure is  
338 negligible when the normal stress is large (i.e., the landslide thickness is great). Moreover, it is worth nothing  
339 that the test shown in Fig. 17b was performed under an idealized undrained condition. In the field condition,  
340 high permeability of soil with large pore spaces and abundant cracks may enable the quick dissipation of  
341 generated air pressure. Hence, any shear-induced generation of air pressure in the field would be smaller than in  
342 the laboratory to the extent that its contribution to the high mobility of shallow landslides may be ignored.
