## **Reevaluation of the offset of the Great Wall caused by the ca. M**

### **8.0 Pingluo earthquake of 1739, Yinchuan graben, China**

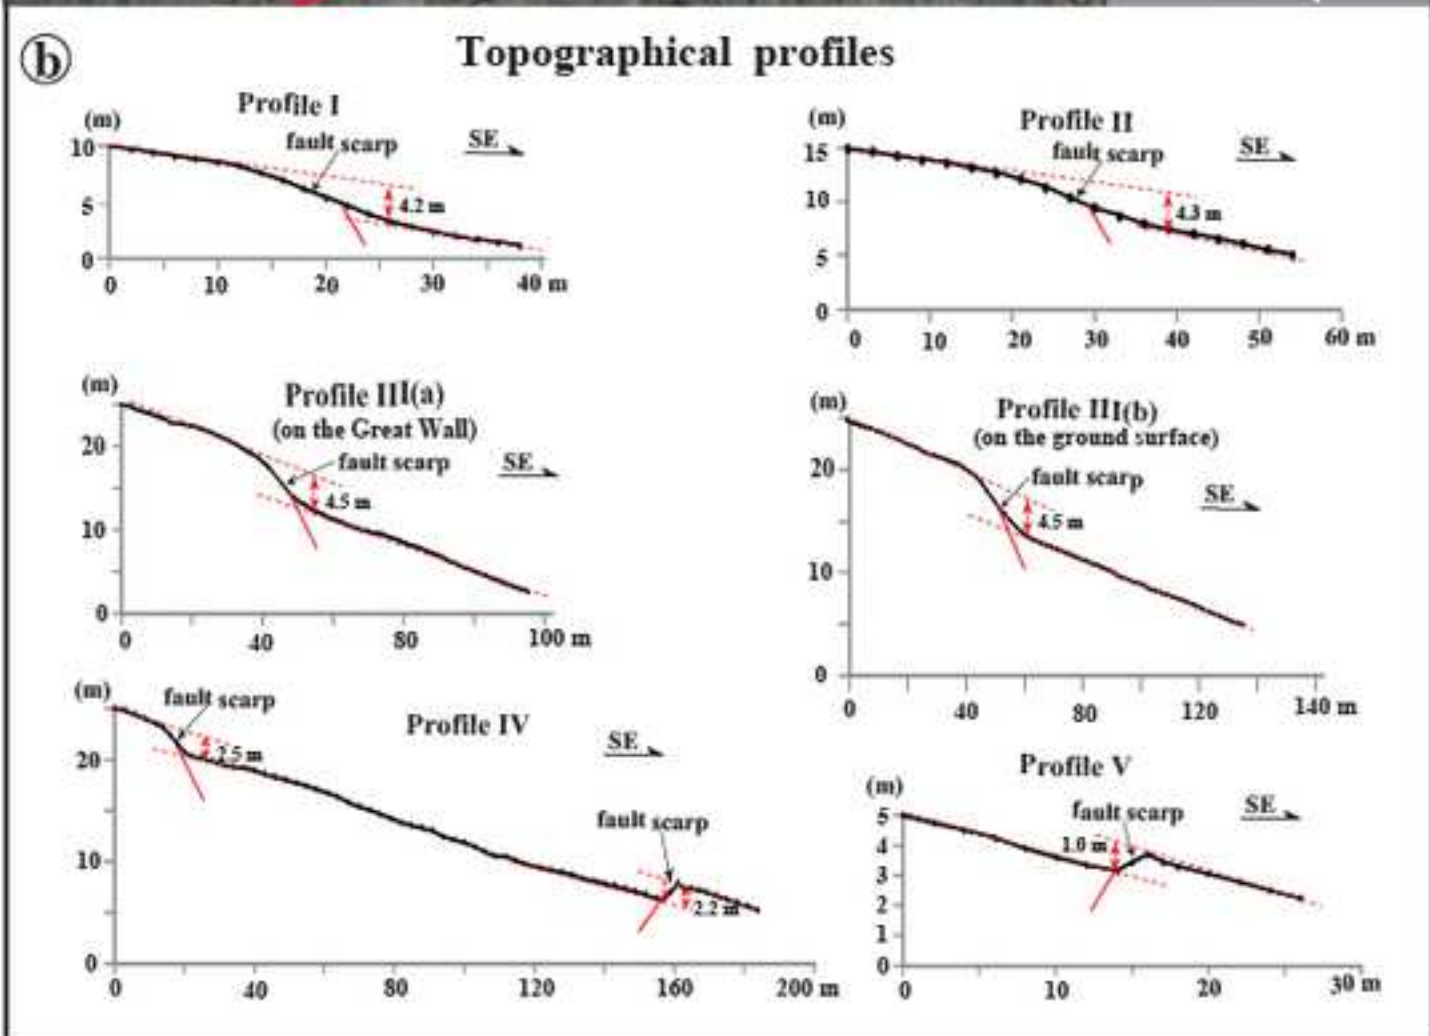
Figure2  
[Click here to download high resolution image](#)

Figure 2. Google Earth image (a) and the topographical profiles (b) showing the tectonic topography of the Helan-Shan Piedmont Fault and the line of the Great Wall in the study area. Loc. 1–3 denote the three field sites where the Great Wall crosses fault scarps.

In the study area, the Helan-Shan Piedmont Fault principally comprises three branch faults along which fault scarps, 2–6 m high (F1–F3), have developed (Figs 2 and 3; Zhang et al., 1986). The F1 and F2 fault scarps face southeast, while the F3 fault scarp faces northwest to form a small graben structure between the three scarps (Figs 2 and 3b). The Great Wall has collapsed where it crosses these three fault scarps, as described below.

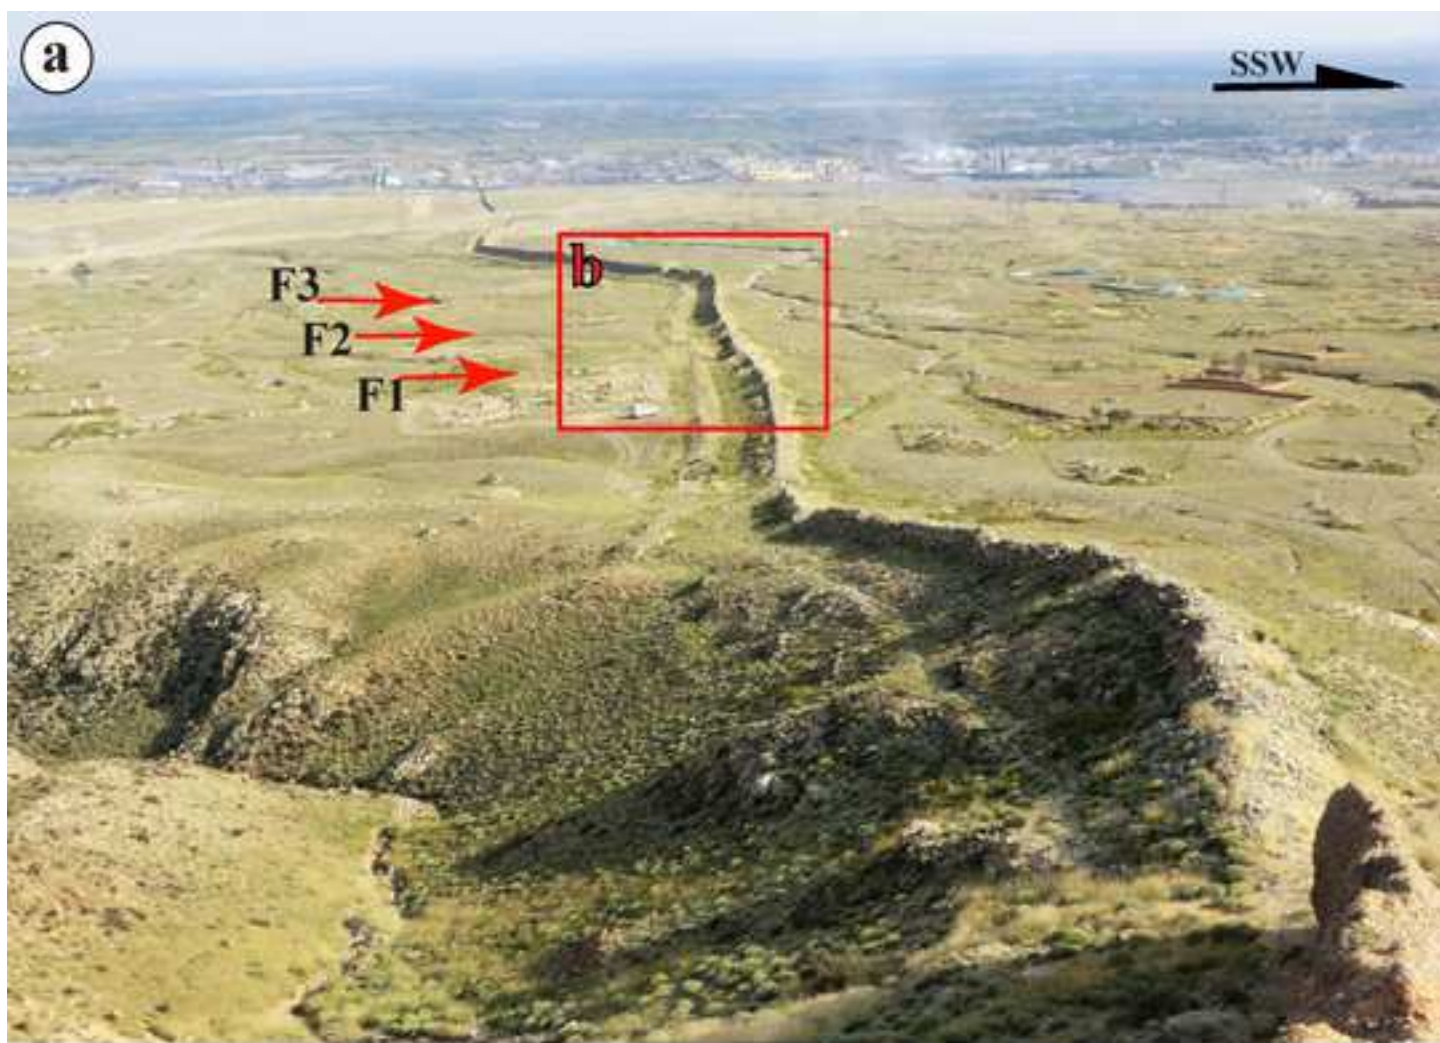
Figure3  
[Click here to download high resolution image](#)

Figure 3. The Great Wall in the study area. (a) General view. (b) Close-up of (a). F1–F3 denote the branch faults of the Helan-Shan Piedmont Fault, on which the Great Wall sits. See Fig. 2 for detailed locations of Loc. 1–3.

The section of the Great Wall in the study region was built in 1531 AD (Zhang et al., 1986) on the eastern side of the Helan-Shan Mountains, and is found mostly on alluvial fans that tilt E–SE. The wall generally strikes NW–SE (N40°W), and is around 3.5 km long in the study area (Figs 1–3). The wall is

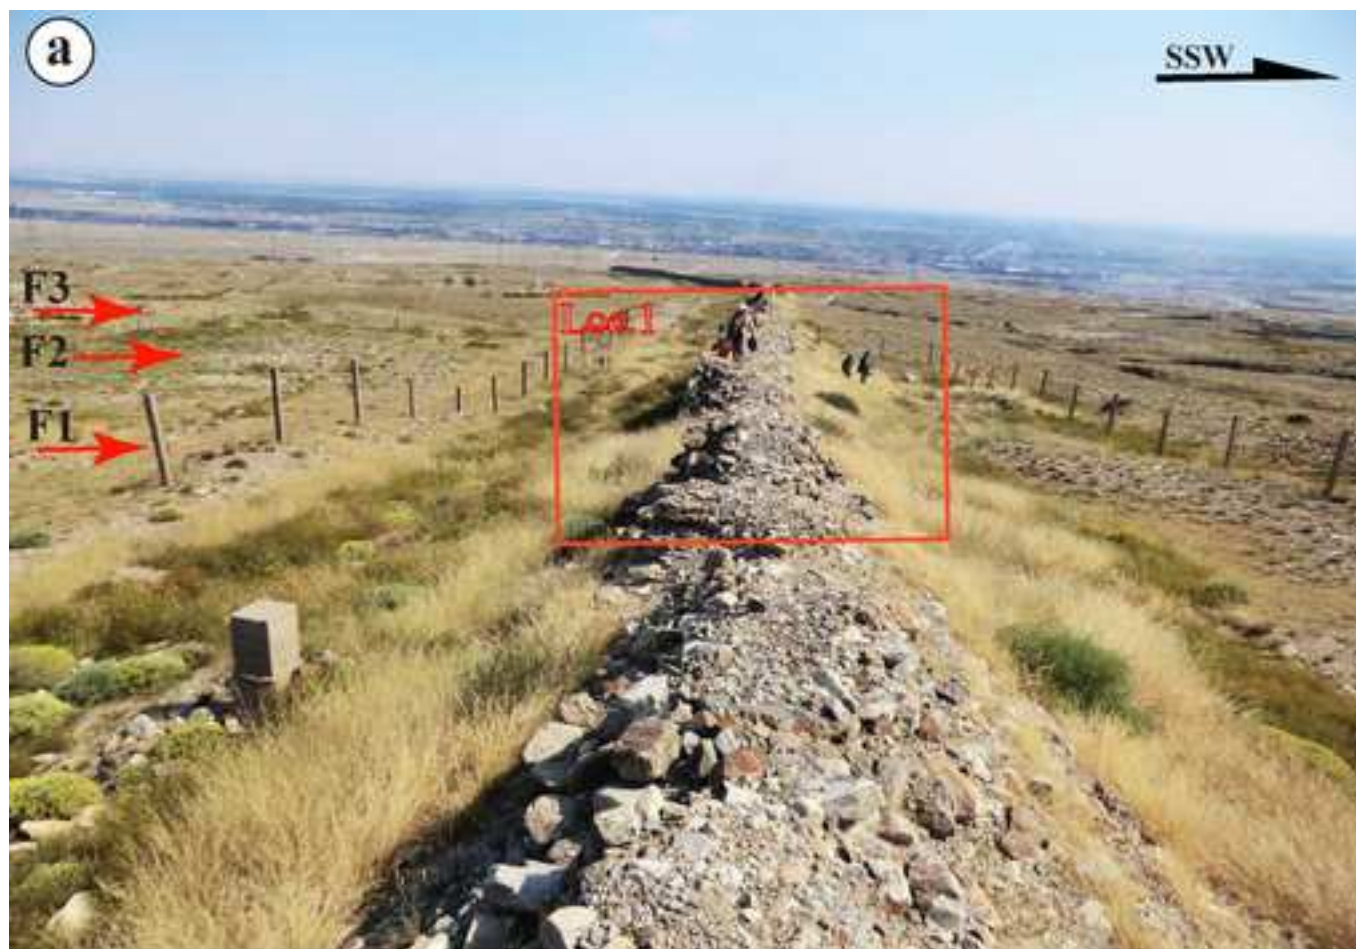
Figure4  
[Click here to download high resolution image](#)

Figure 4. The Great Wall at Loc. 1. (a) General view. (b) The collapsed state of the Great Wall cross the F1 fault scarp at Loc. 1. Note that the Great Wall is composed of faced dimension stone and boulders.

At Loc. 1, the Great Wall is composed mainly of stone, including faced dimension stone and boulders (Figs 4 and 5), and was reconstructed during the early 1980s based on the premise that the wall was displaced vertically and

At Loc. 1, previous studies reported that the wall was offset by 1.2–1.45 m right laterally and 0.35–0.9 m vertically (Liao and Pan, 1982; Zhang et al., 1986), based on measurements of the current state of the wall (Fig. 4b). As

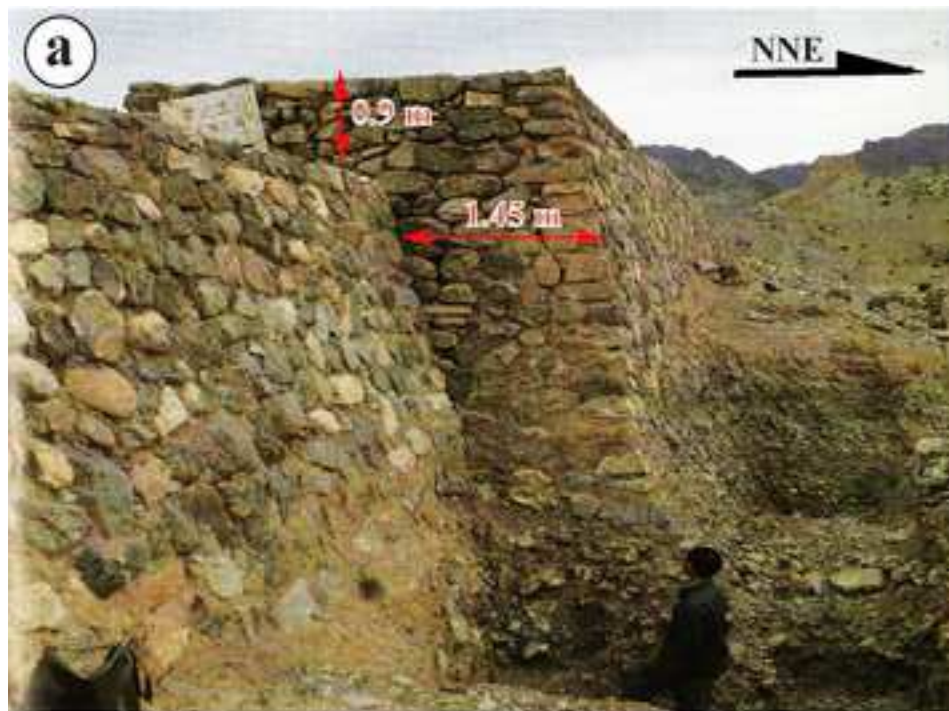
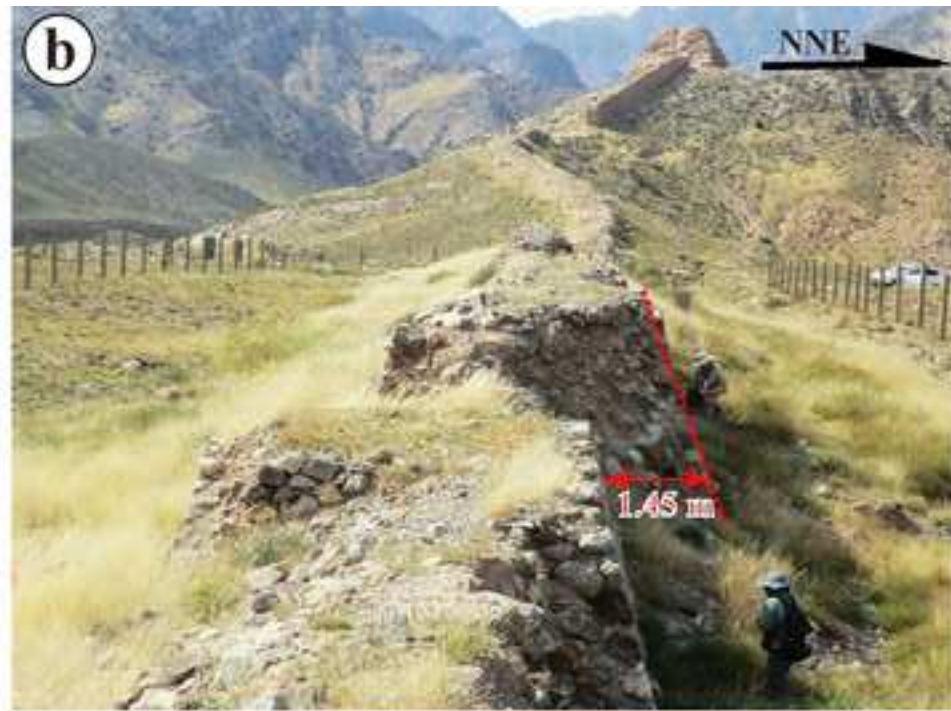
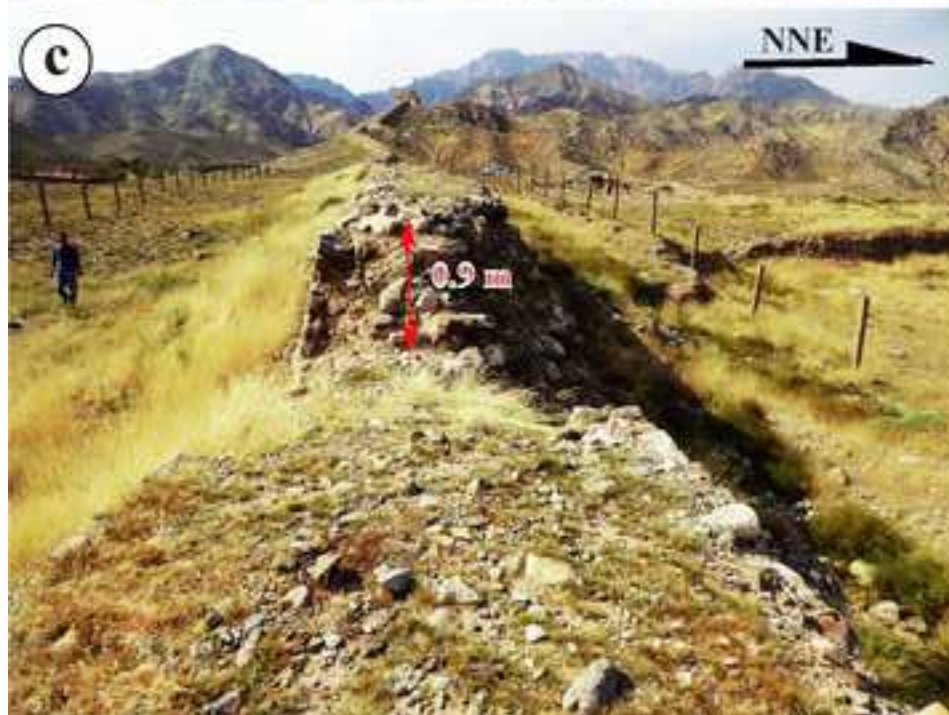
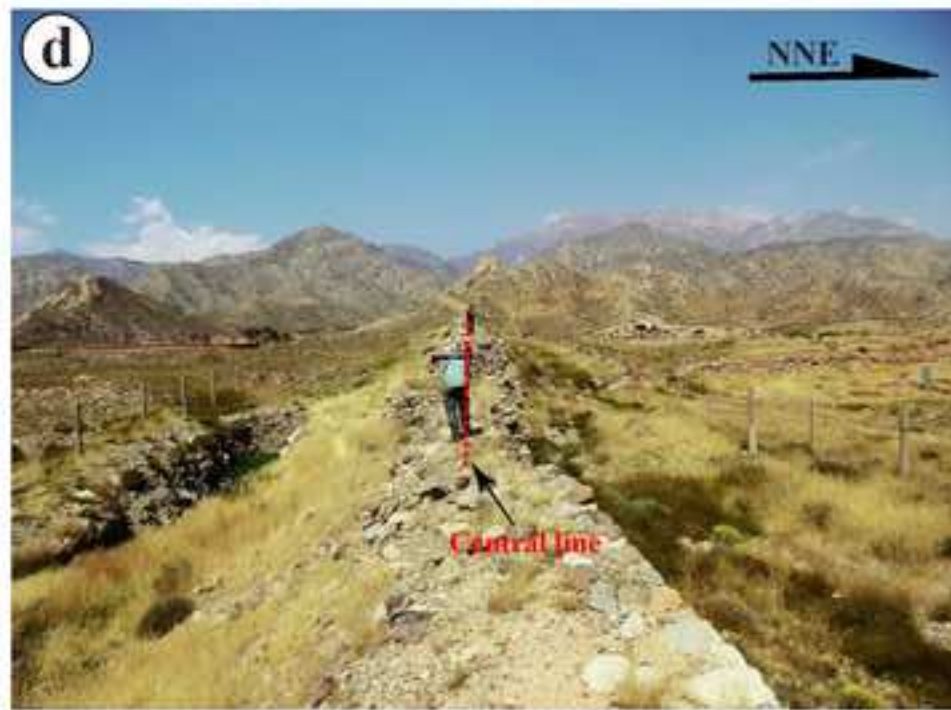
Figure 5  
[Click here to download high resolution image](#)

Figure 5. Apparent displacement of the Great Wall at Loc. 1. (a) Reconstructed Great Wall (reconstructed in 1981) showing apparent vertical and horizontal offsets (photograph from Huzita, 1984). (b, c) Apparent offsets of the Great Wall measured in situ: 1.45 m right laterally and 0.9 m vertically. (d) Longitudinal view of the Great Wall. Note that the central line of the top surface of the Great Wall is linear, with no distinct horizontal displacement.

horizontally (Fig. 5) (He, 1982; Liao and Pan, 1982; Hujita, 1984). Although the reconstructed wall on both sides of the fault scarp has partially collapsed, the location of the wall can be deduced from the remaining material. The wall has a rectangular trapezoidal shape and is 4 m wide at the base, 3.5 m wide at the top surface, 12 m long, and 2.4 m high on the northwestern side of the supposed fault, and is the same width but only 6.5 m long and 1.6 m high on the southeastern side of the supposed fault (Fig. 6a and b). The height difference of the top of the wall, and apparent right-lateral offset measured from the current remnants of the wall across the supposed fault are around 0.8 and 1.2 m, respectively (Fig. 6).

shown in the sketches (Figs 5 and 6), the Great Wall was reconstructed in a rectangular trapezoidal shape during the early 1980s based on the assumption that the wall was displaced by the ca. M 8 earthquake of 1739 (Figs 5 and 6). However, it is clear that the reconstructed parts of the wall have an unnatural shape and are around 1.0–1.2 m wider than the adjacent wall, and asymmetric in shape to both sides of the central line of the adjacent wall (Fig. 6a and b). The central line of the original wall, on both sides of the supposed fault, is continuous and linear. This indicates that at this site, the original wall followed a straight line, and had not been offset since its construction.

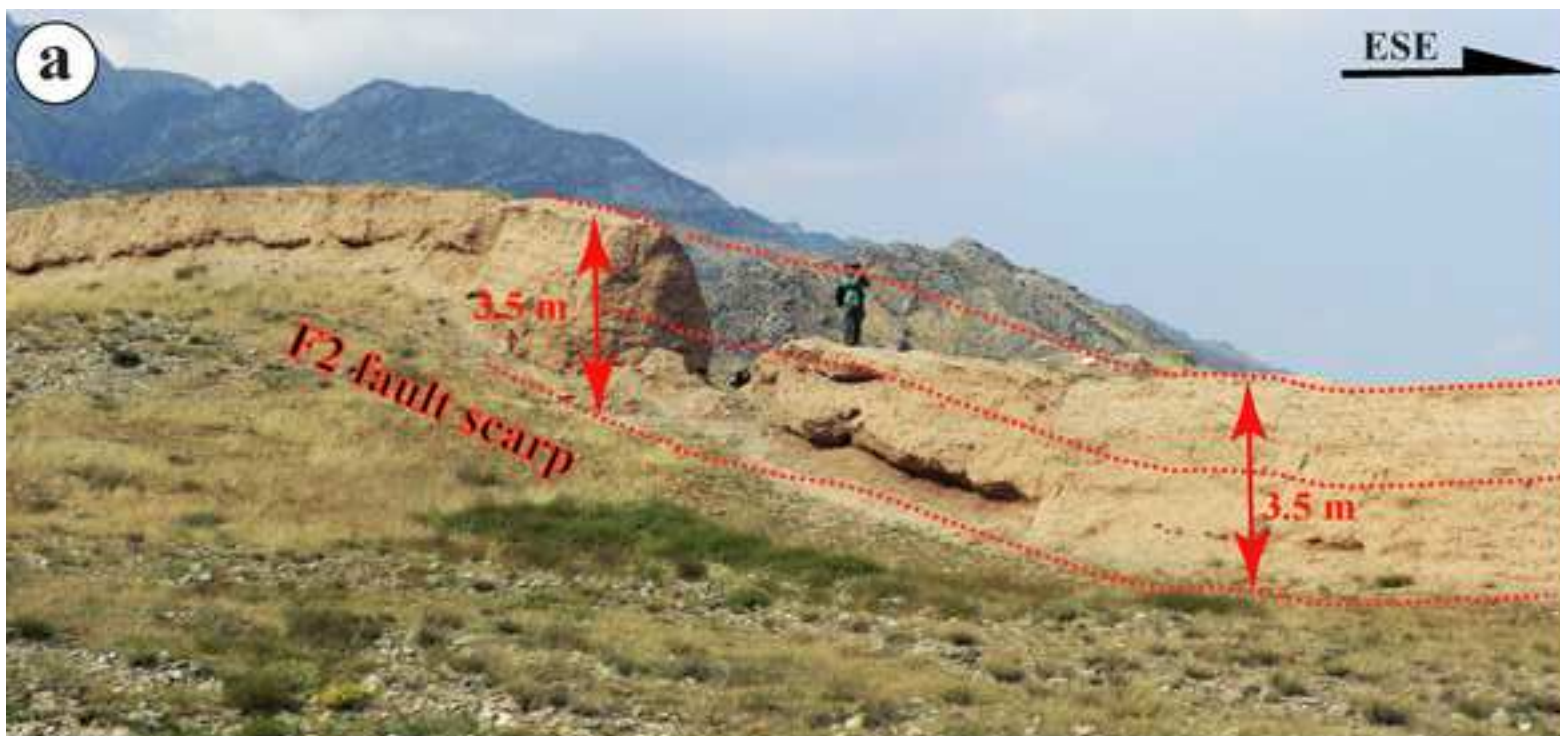
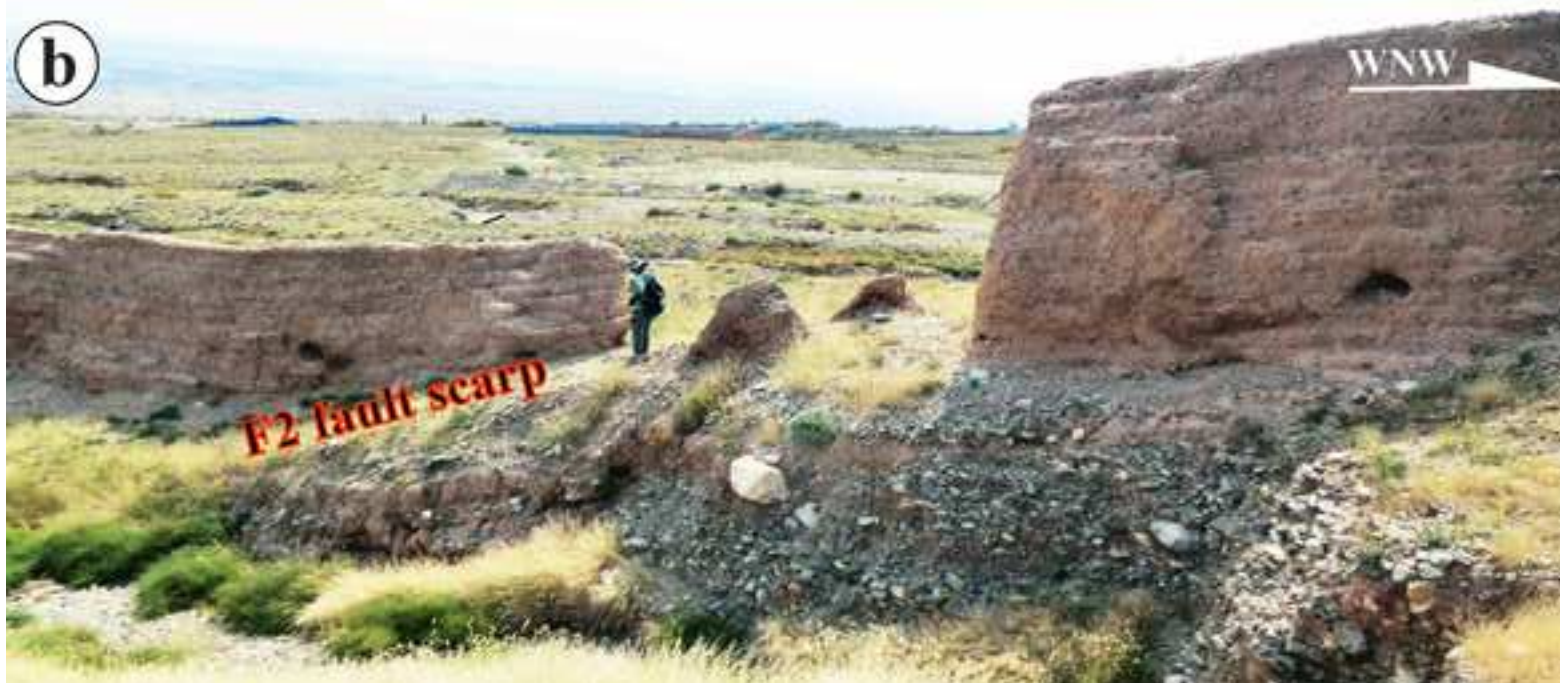
Figure7

Figure 7. Photographs showing the apparent vertical displacement of the Great Wall at Loc. 2. (a) The Great Wall sits on the F2 fault scarp, which has collapsed and been eroded. (b) A 4-m-wide gap of the wall forms on the F2 fault scarp. Note that the Great Wall is made of tamped earth with layered structures (red dotted lines) and the wall height is the same on both sides of the F2 fault scarp.

At Loc. 2, the Great Wall lies on the fault scarp, which is around 4 m high, and is made of tamped earth (layered adobe) containing pebbles and cobbles (Figs 7–9). On the fault scarp, the wall has collapsed, and a gap of around 4 m wide has formed. A sketch (Fig. 9) based on field measurements shows that the wall is 3.5 m high, 3.5 m wide at its base, and 1.5 m wide at the

top on the uplift (northwestern) side of the fault scarp, but 1.9 m high, and 2 and 1.35 m wide at the base and top surface of the wall, respectively. The height of the wall is almost the same on both sides of the fault scarp, but there is a height difference of 1.6 m between the top surfaces of the currently remaining parts of the wall on either side of the gap on the fault scarp (Figs 7 and 9). The layering structure of the tamped earth of the wall is tilted to the southeast, generally parallel to the topographic surface of the fault scarp (Fig. 7).

The maximum apparent right lateral and vertical displacement of the Great Wall at Loc. 2 were estimated to be around 0.95–2.0 m vertically (Liao and Pan, 1982; Deng et al., 1984; Zhang et al., 1986) and 1.67 m right laterally (Zhang et al., 1986). The vertical offset was measured directly by examining the top surface of the wall on each side of the fault scarp, as shown in Fig. 8a (from figure 11 in Zhang et al., 1986). It is clear that the top surface of the wall on the downthrown side of the fault scarp has been eroded and undermined, and is consequently lower than other sections farther from the fault scarp. As shown in Fig. 7, the layered structures in the tamped earth of the wall are generally parallel to the topographic surface along the wall. These layered structures formed as a result of the tamping of earth with rectangular wooden frames during construction (a method commonly used to construct earthen houses in China). If the layered structures are extended along their curved lines, the wall can be smoothly connected with continuous layering that runs parallel to the

topographic surface of the fault scarp and with no distinct vertical offset of the top surface of the wall (Figs 7a and 9a).

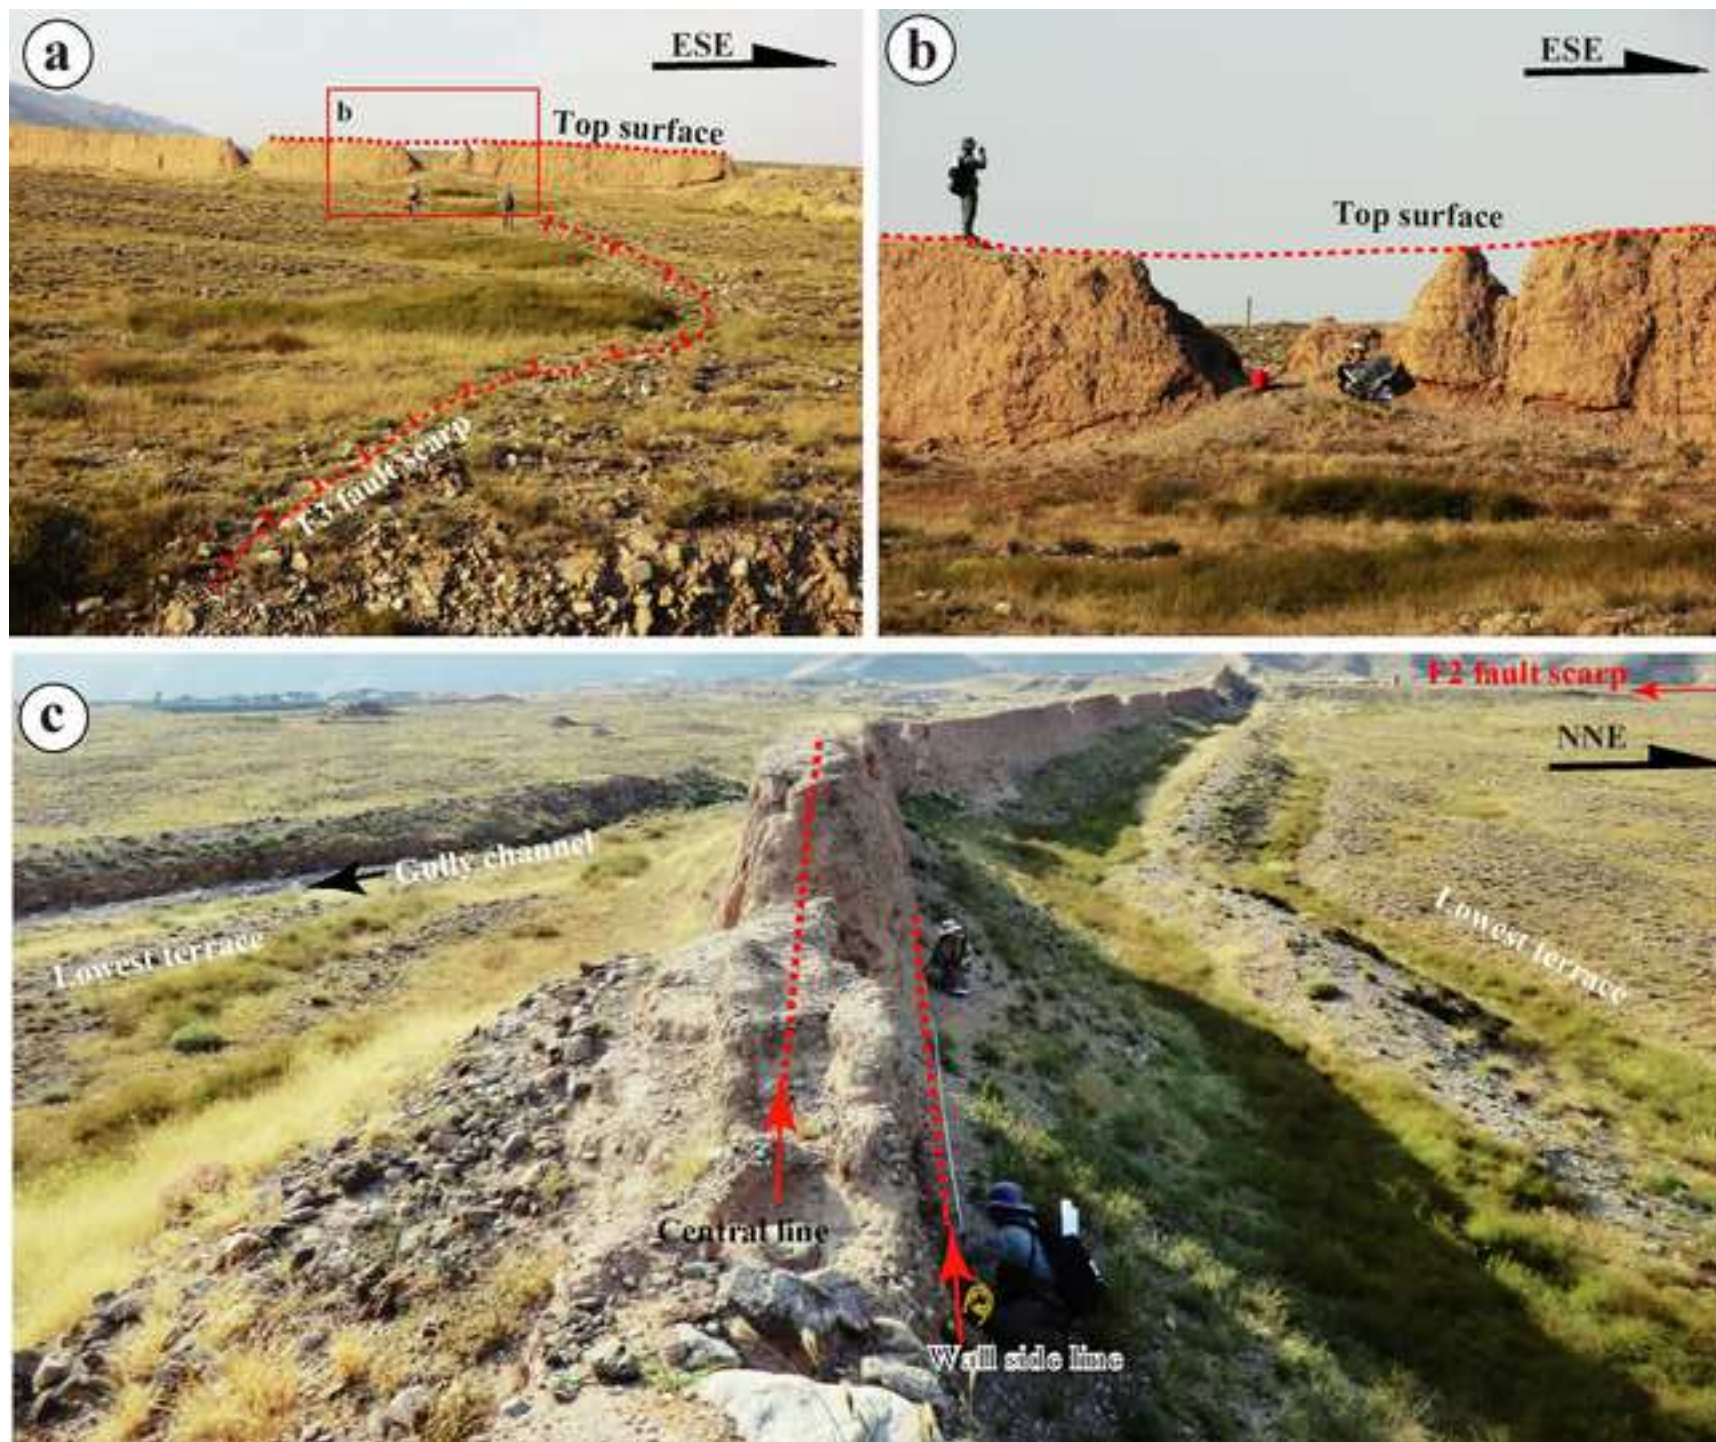
Figure 10  
[Click here to download high resolution image](#)

Figure 10. (a) General view of the Great Wall at Loc. 3. Note that the F3 fault scarp (facing northwest) is evident on both sides of the wall and is not vertically offset. (b) Close-up view of (a). (c) Longitudinal view of the Great Wall. Note that both the central line and sides of the Great Wall are not distinctly displaced in the horizontal.

At Loc. 3, the Great Wall is situated on an alluvial fan and was built along a gully that strikes NNW–SSE (Figs 2b and 10). The wall is made of tamped earth containing pebbles and cobbles, and has collapsed and been eroded, causing a gap 3–5 m wide to form (Fig. 10a and b). A distinct fault scarp, striking NNE–SSW, 0.5–2.0 m high, and facing northwest towards the Helan-Shan Mountains (antithetic to the fault scarps observed at Loc. 2 and 3), developed on both sides of the gully, but the lowest terrace bounded by the gully

channel where the wall is situated was not deformed. The top surface and base of the Great wall are continuous and linear, with no distinct vertical or horizontal displacement (Fig. 10a and b).

both vertically and right laterally at Loc. 3 (Liao and Pan, 1982; Zhang et al., 1986). In fact, these displacements are difficult to measure accurately due to the collapse and erosion of the wall. The new field measurements reported here show that both the central line and baseline of the wall on both sides of the supposed fault are linear and continuous, with no distinct offset either vertically or horizontally (Fig. 10c). As stated above, the wall at this site was constructed in a small gully, where no fault scarp is recognizable, on the lowest terraces bounded by the gully channel, although a 0.5–2.0 m high fault scarp is evident on both sides of the gully. This indicates that no faulting event occurred here after the formation of the lowest terraces. These observations confirm that the Great Wall was not offset at this location after its construction.
