# 地上設置型合成開口レーダー(GBSAR) を用いた観測事例と今後の課題

平成27年度 京都大学防災研究所 一般研究集会(課題番号:27K-08)  
新世代SARがもたらす災害・環境モニタリングの進展

日本工営株式会社  
倉岡 千郎 中島裕一

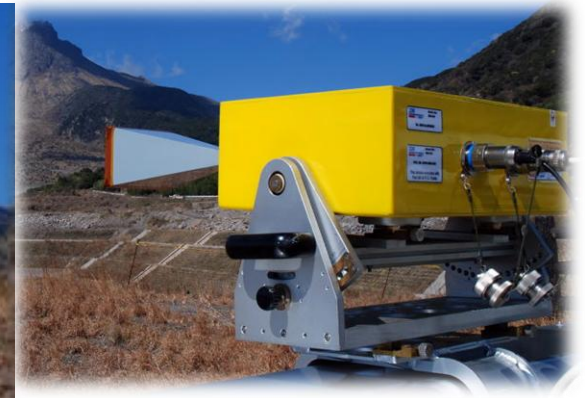
2mのレール上をアンテナが移動→合成開口

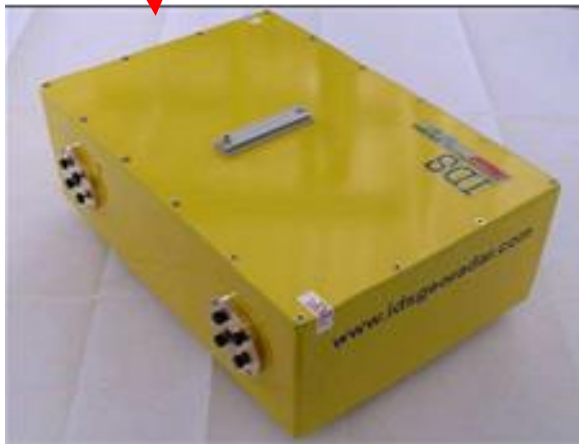
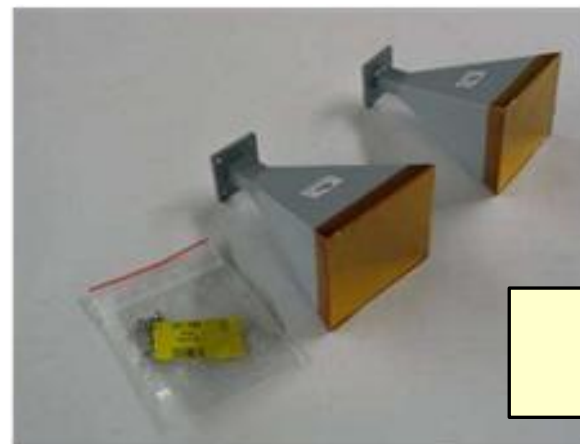
ホーン型  
アンテナ

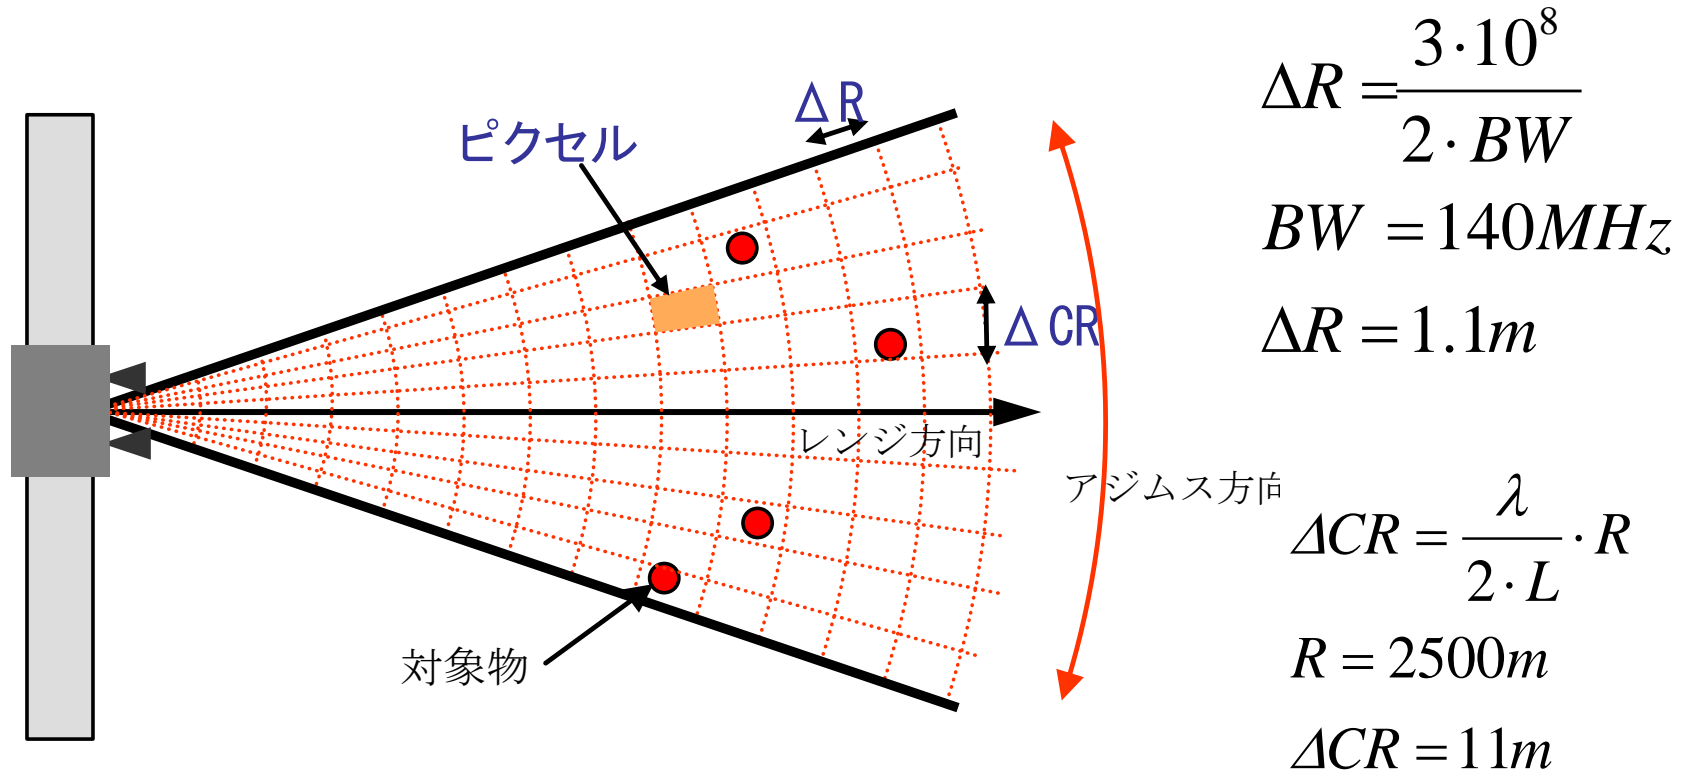
# 周波数及び分解能

- ・Ku バンド周波数: (中心周波数: 17.17GHz)
- ・バンド幅 140 MHz
- ・波長は約 17 mm
- ・アジムス方向のピクセル数: 401ピクセル
- ・観測間隔は5-7分程度(観測距離に基づくユーザー設定)

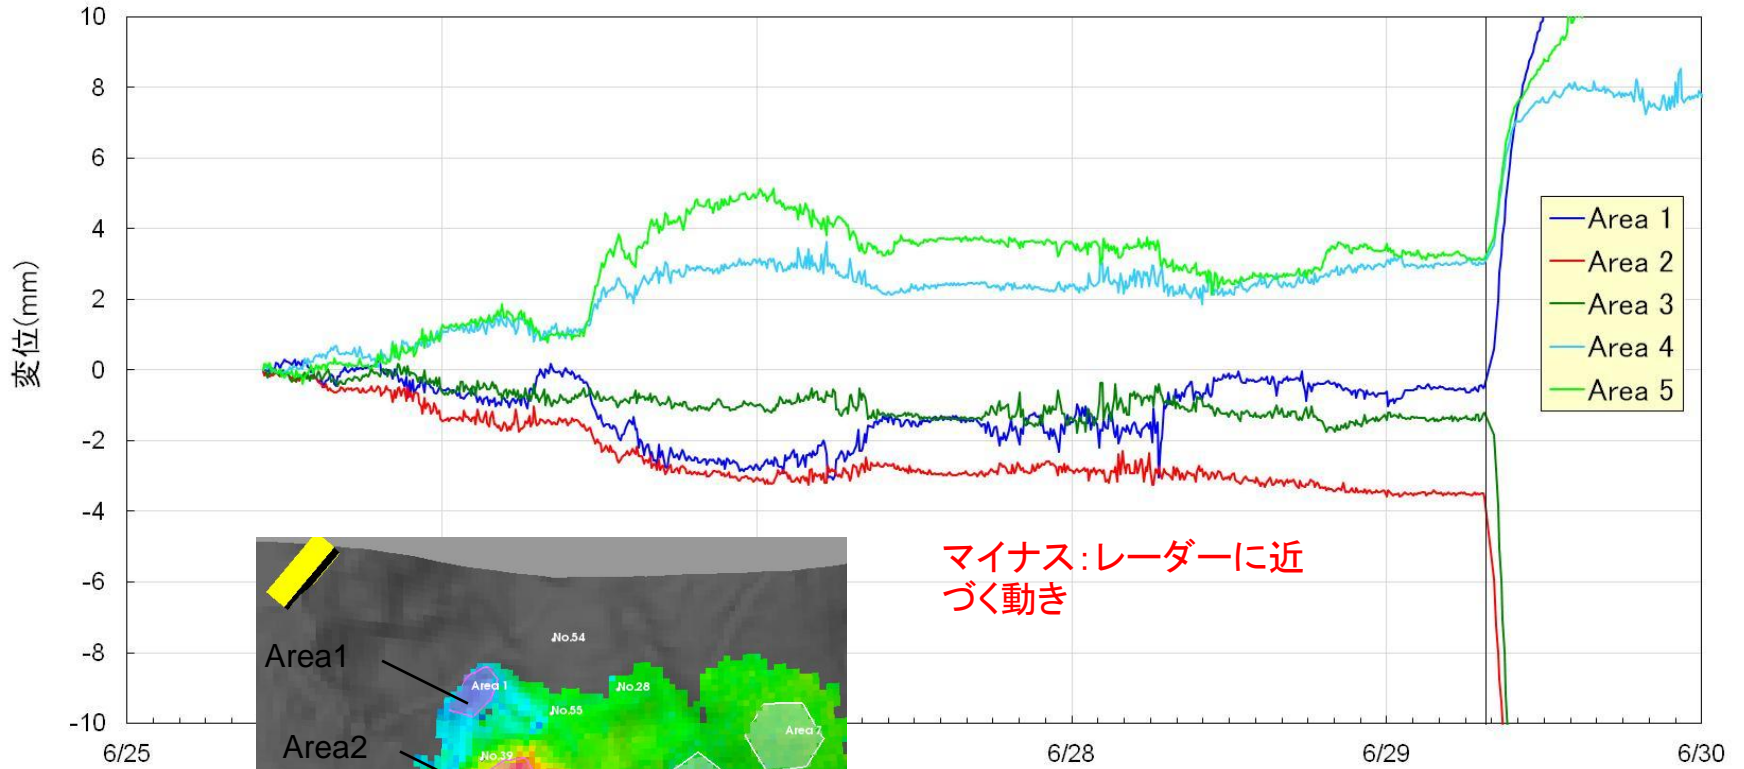
# 6/29 前の時間スケールを拡大

マイナス: レーダーに近づく動き

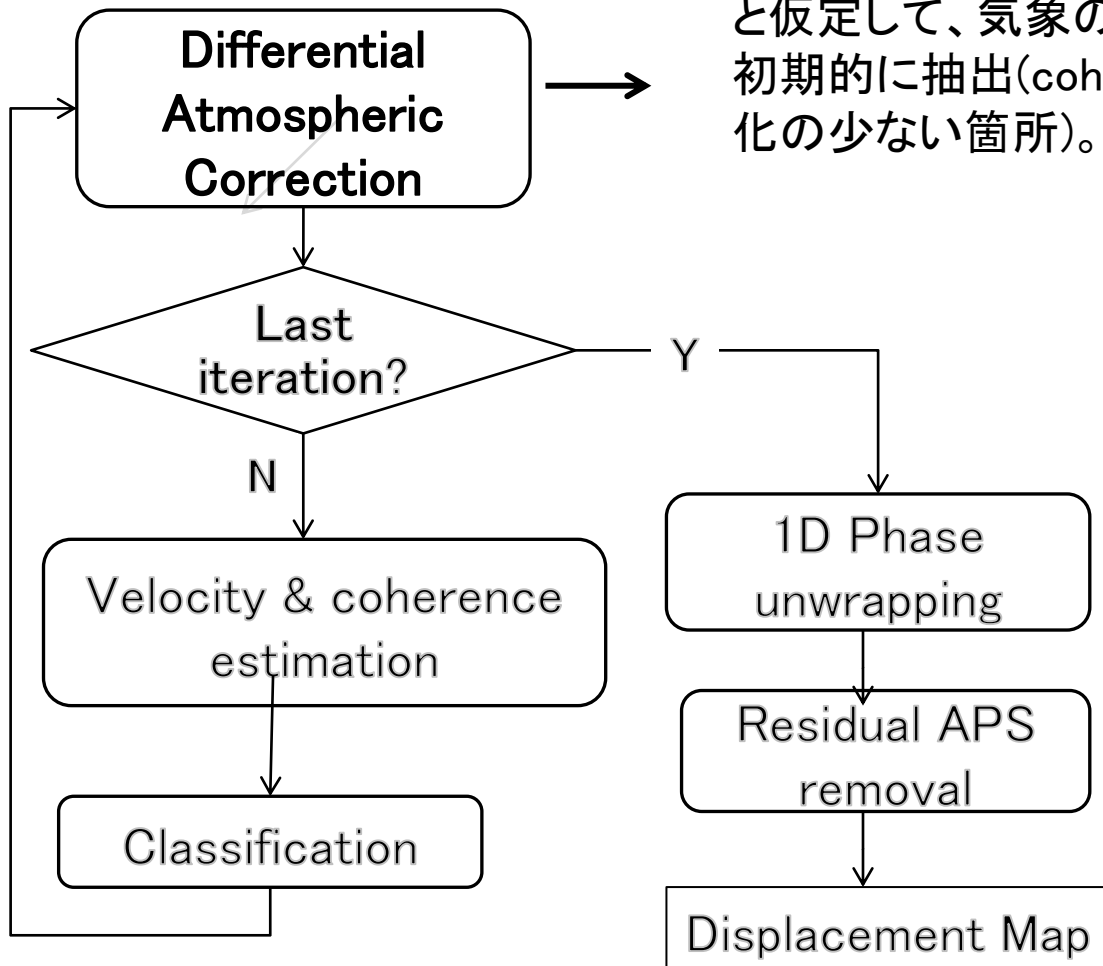
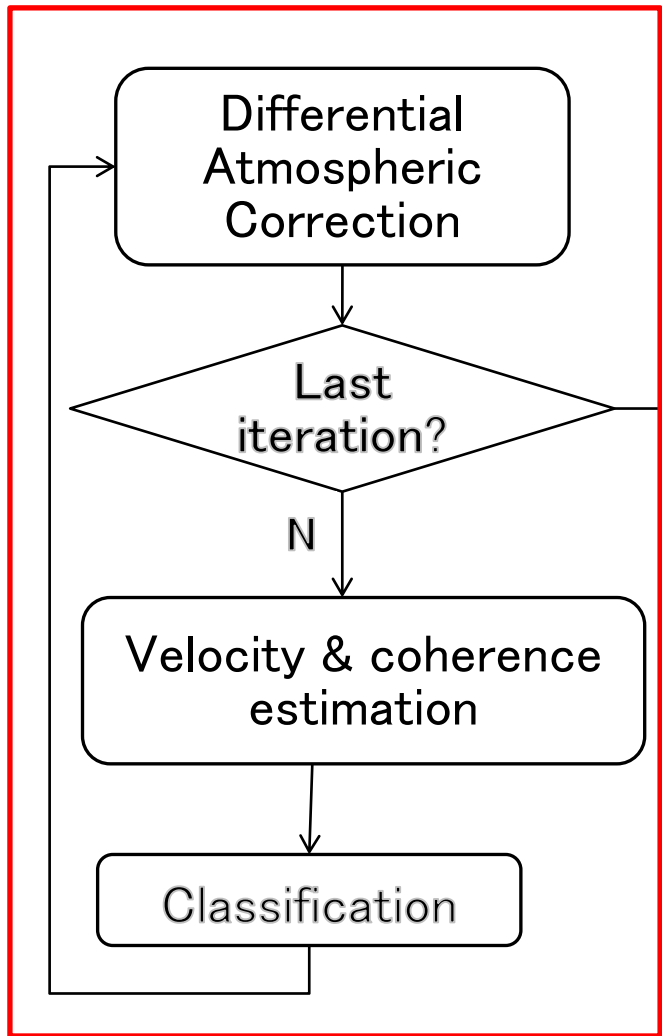
初回の計算

解析領域の約60%(ユーザー設定可能)が不動領域と仮定して、気象の影響補正に用いるPS点(仮定)を初期的に抽出(coherenceやSNRが良く、位相の変化の少ない箇所)。

- ・10程度のinterferogramを使って、繰り返し演算により不動とするPSと動いているとするPSを分類
- ・更新された不動と見なされるPSを使って補正を繰り返す
- ・この後、位相を変位に変換

問題: 解析領域の全体が動くと補正用のPS点が無い

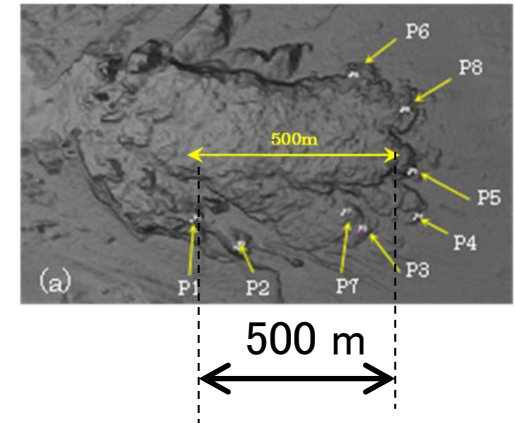
The change in the distances between the mirrors and the station are obtained with the two EDM stations set at two different locations since September 1<sup>st</sup> of 2007

Locations of the EDM stations and reflecting mirrors

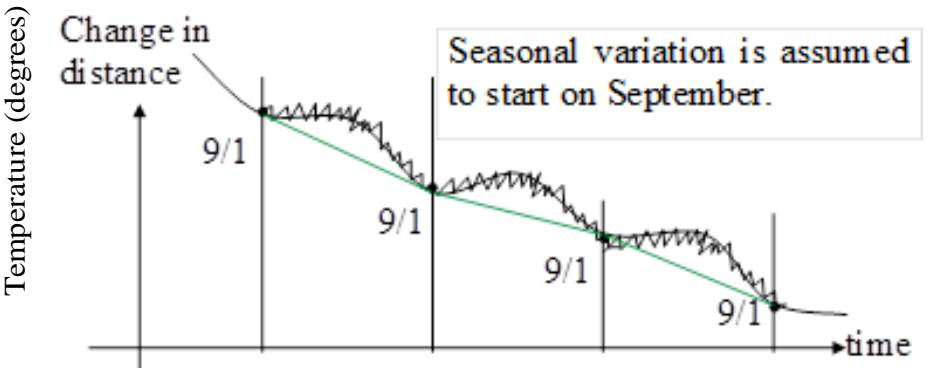
## Displacements of P3: Tenguyama EDM stations (2007/9/1 to 2014/3/1).

30 ~ 60mm/year (0.08 ~ 0.16mm/day)  
 Correlation with monthly mean temperature can be seen

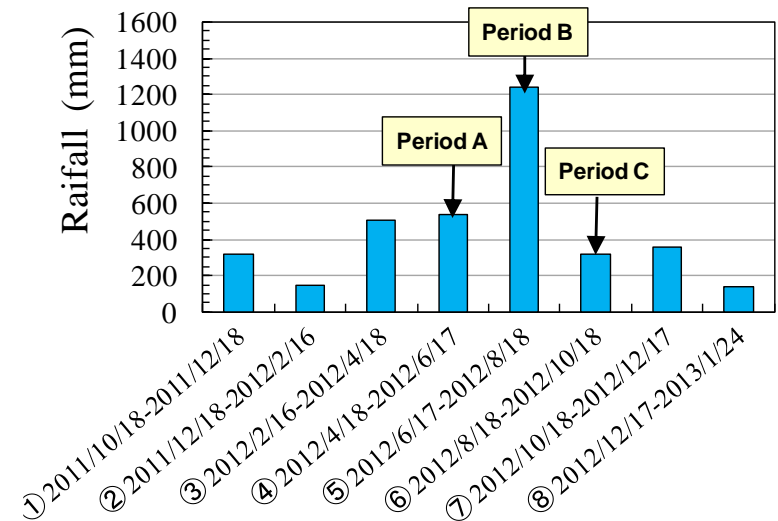
**Rainfall may be affecting  
the displacement**

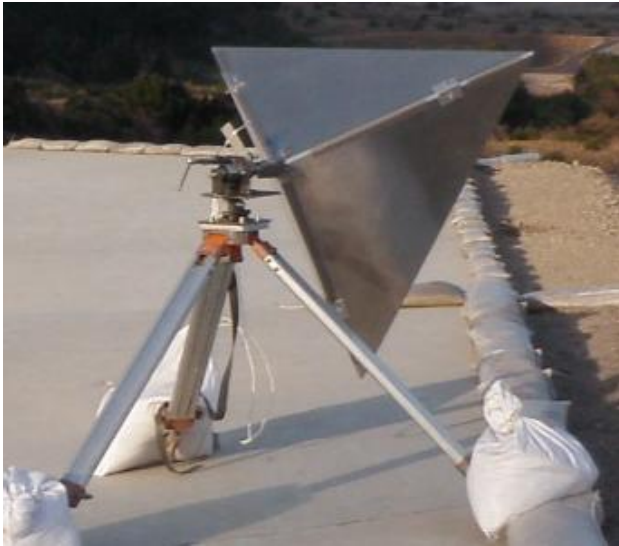
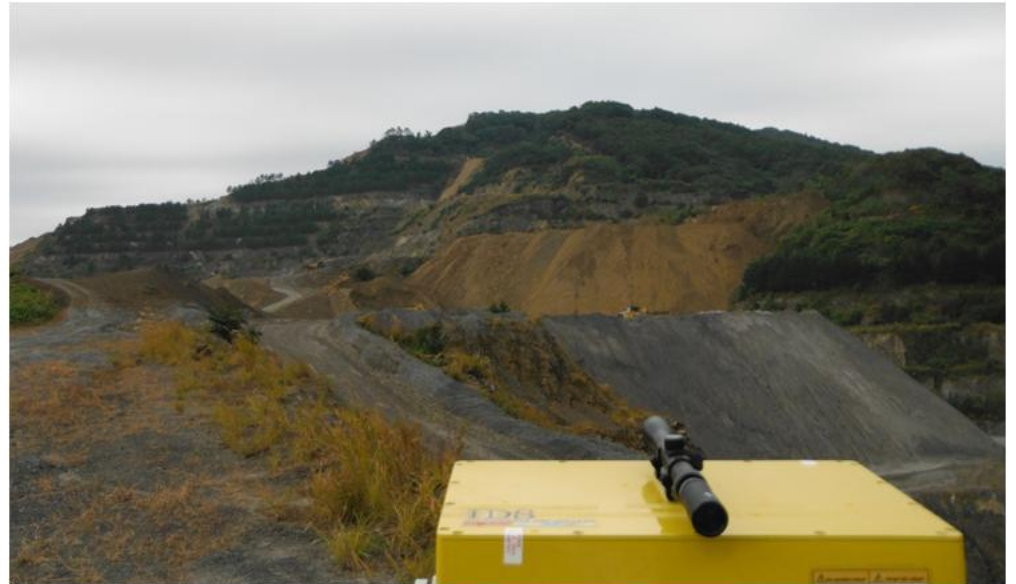
反射板(CR: Corner reflector)

辺の大きさの異なる3つのCRを用いた: 70 cm、45 cm、30 cm

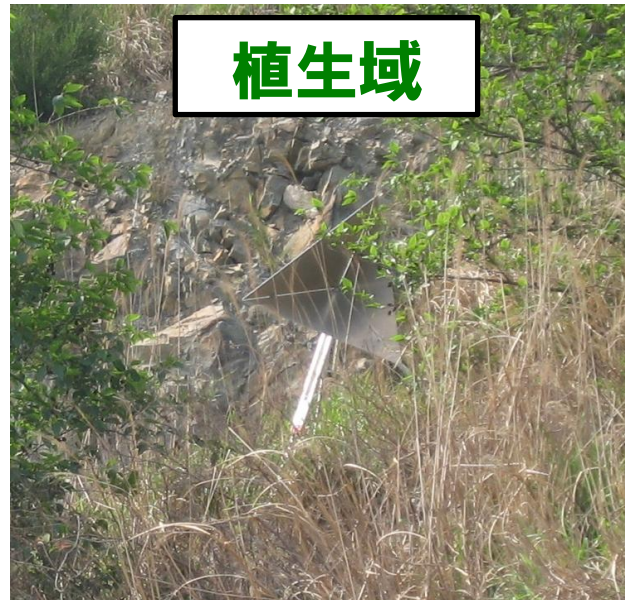
- ①反射板を設置しない状態で計測
- ②反射板を設置した状態で計測
- ③2mm毎の変位を与え計測

- ・辺の大きさの異なる3つのCR(70 cm、45 cm、30 cm)を使用
- ・CRの向きをLine of sight(LOS)から30度、水平方向に振る

岩盤近傍と植生域で①⇒②⇒③を実施

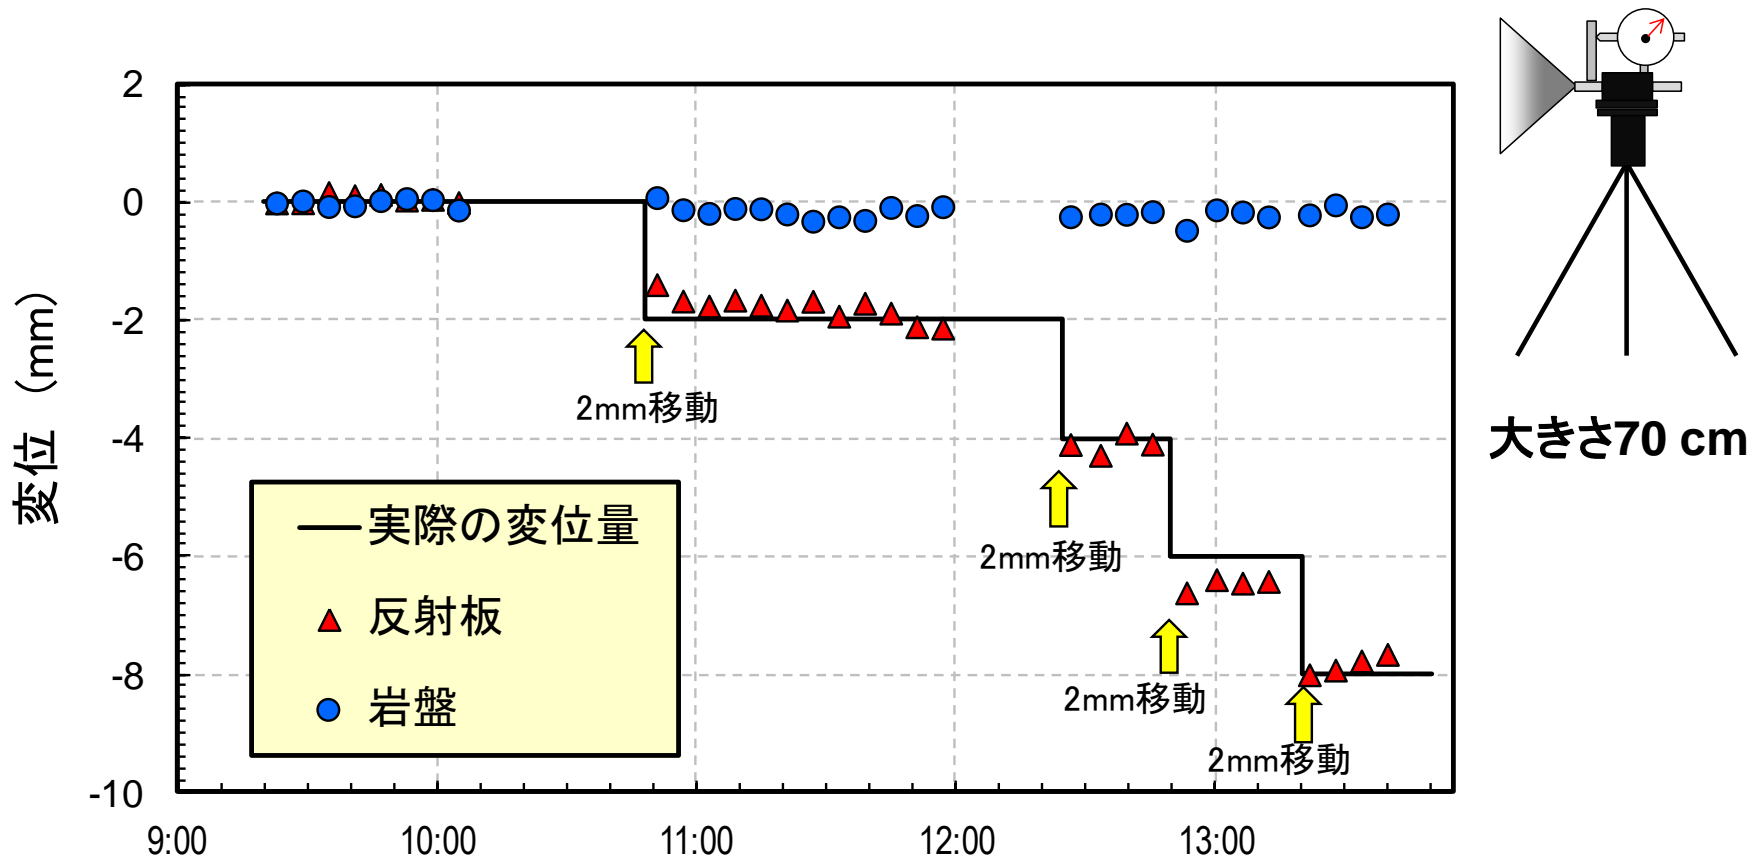
# 試験結果例 岩盤近傍(人為的に変位)

2乗平均平方根誤差(RMSE)=0.27mm

- 3つの大きさの異なるCRを使った結果の変位の精度は、2乗平均平方根誤差で0.1mm~0.35mmであり、1mm程度の精度は有すると考えられる。
- 本実験の条件ではCRを岩盤と植生から分離して検出できる
- 反射板の向きを30°程度振っても、475mの距離においては、2乗平均平方根誤差で0.1mmで変位を計測することができる。

70cm	45cm	30cm	30cm30° 回転
地点A (840m)	0.27mm	0.18mm	0.35mm	未実施
地点B (475m)	—	0.18mm	0.11mm	0.10mm
