**A Study of Living Conditions in Post-Tsunami Houses:
The Case of the Moklen Ethnic Minority
in Phang Nga Province, Southern Thailand**

Graduate School of Global Environmental Studies

Kyoto University

Doctoral Course in Environmental Management

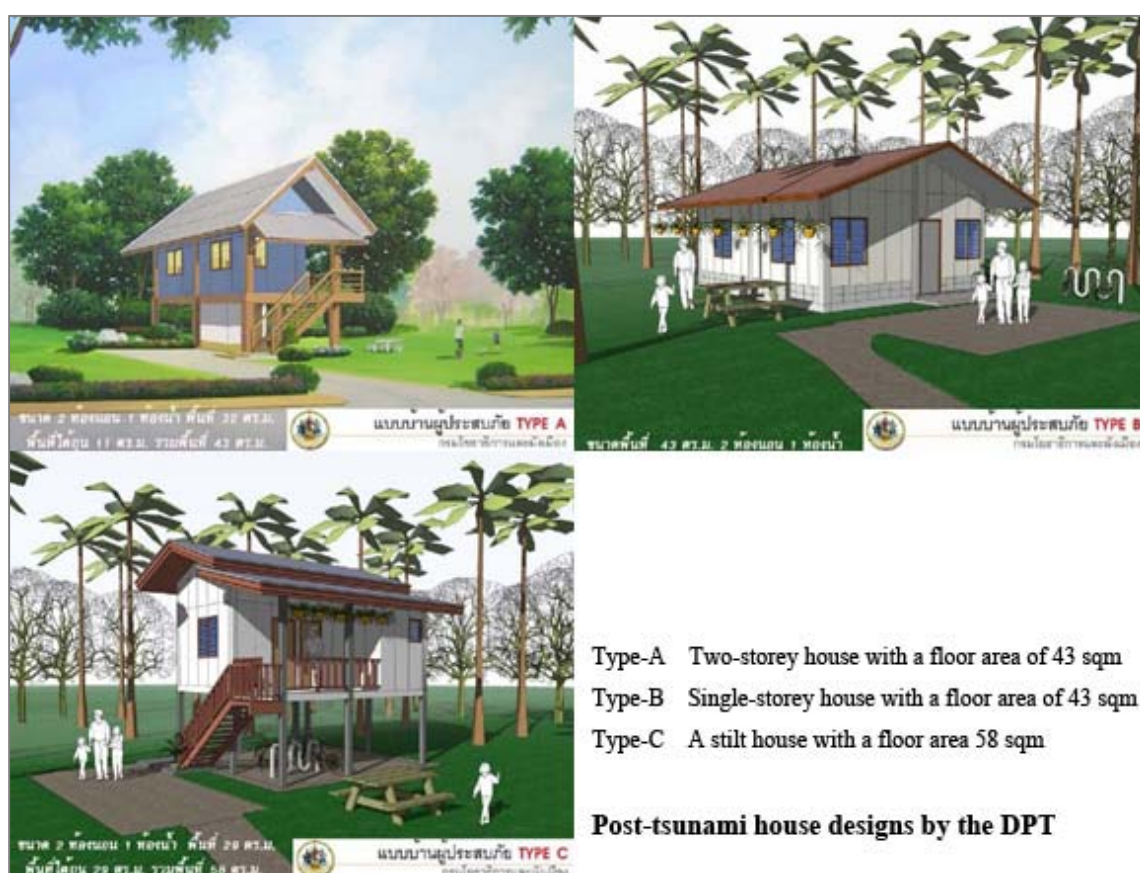
Figure 2.2 Post-tsunami house designs by the DPT

Three post-tsunami house designs were provided with different details and space arrangements. Type-A is two-storey house with a floor area of 32 sqm; Type-B is single-storey house with a floor area of 43 sqm; and Type-C is a stilt house with a floor area measuring 58 sqm (Figure 2.2). These house designs were applied by the government departments responsible for house construction in the affected provinces, while planning came under the responsibility of the DPT.

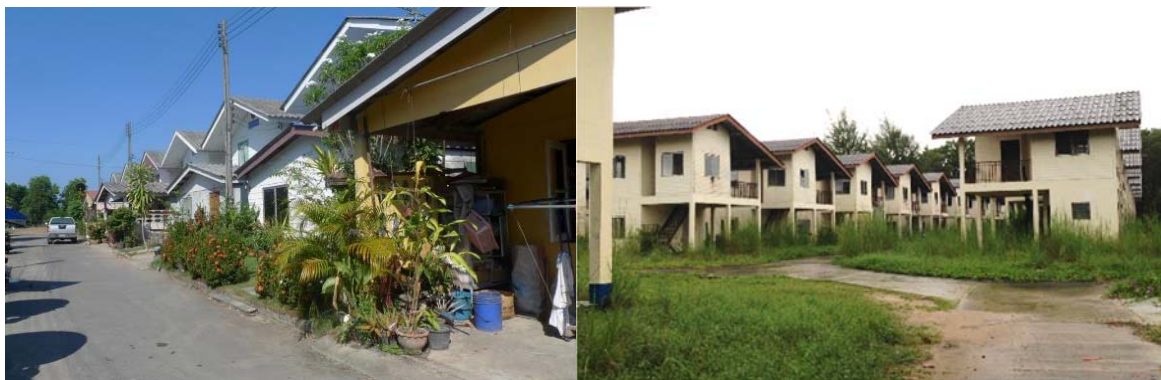
Figure 2.3 Provided houses support by NGO;
Pru Tiew village (left), and Baan Pak Jok in Koh Pra Thong (right)

In addition to the support from government departments, both domestic and international assistance was provided from the NGO, charity organization and private sector. The house designs differed, according to the organisation involved in the design process and construction. For example, many villages, including Nam Khem in the Bang Muang District of Phang Nga Province were assisted by various organisations (figure 2.3). Pru Tiew village was supported by the Rotary Club, Baan Pak Jok in Koh Pra Thong was supported by Lions Club International, Malteser International in the Bangsak area etc. However, there is no substantive record of the number of post-tsunami houses built by the various organisations, since the properties were offered to the villages directly without local government being informed.

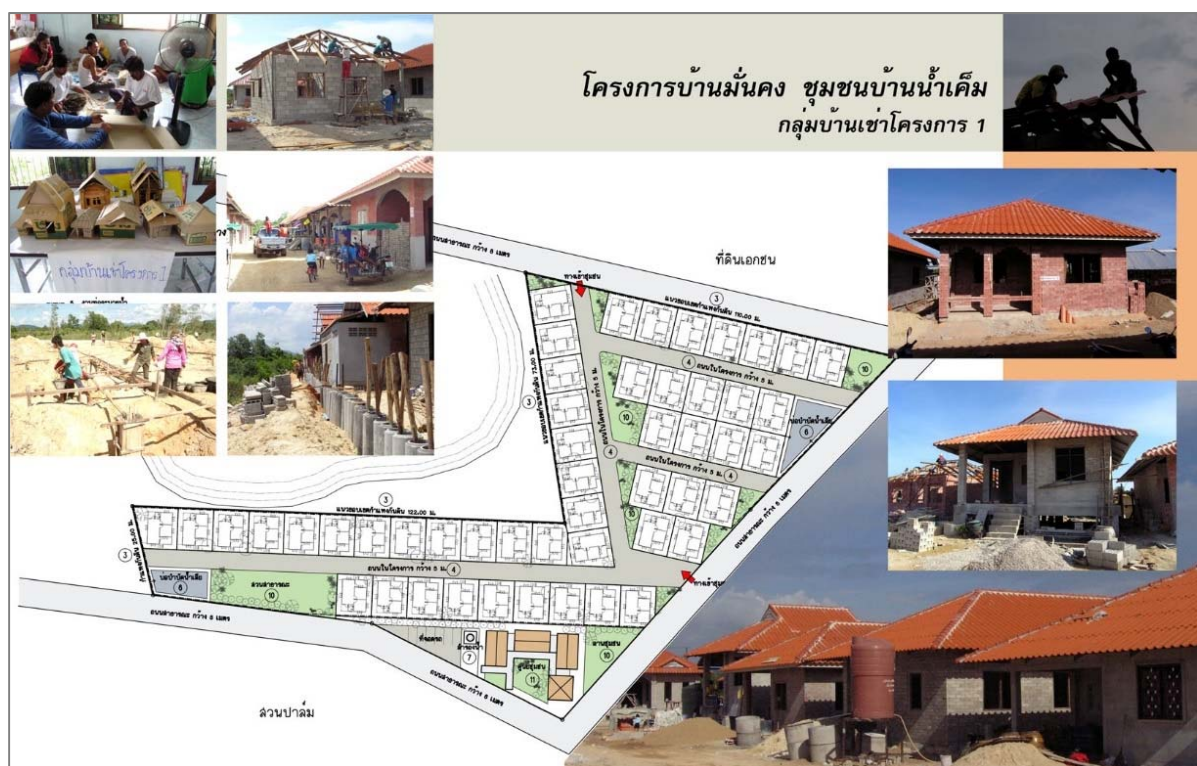
Figure 2.4 Baan Mankong project 1 in Nam Khem village by CODI

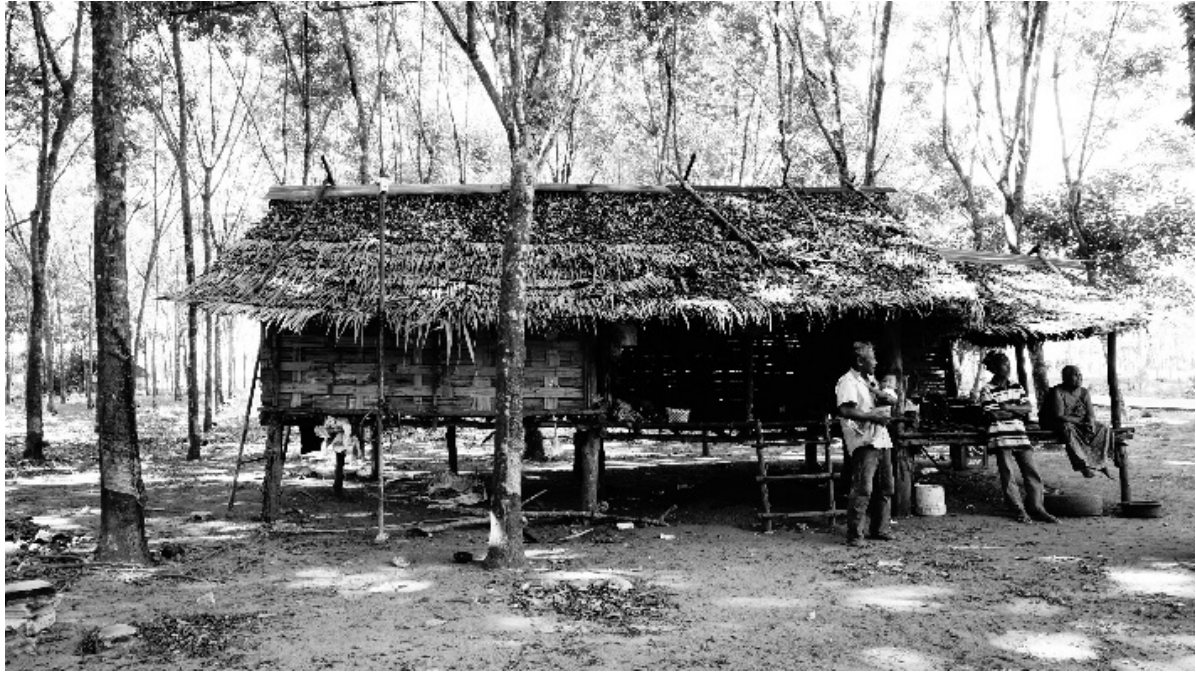
Figure 3.2 Moklen ethnic house

Traditionally, Moklen houses were built on stilts as this method offered protection from animals and wildlife. Nowadays, with environmental changes, it is not necessary to raise the floor as before, which was also less convenient. The stilt house also provides advantages because Southern Thailand has a long rainy season, which causes high moisture in the air. Creating a house on the ground gives poor ventilation, and the area under the stilt floor is also beneficial to animals (Figure 3.2). Moklen traditional housing used local, natural materials, depending on the area, such as tree trunks, mangrove forest trees, bamboo for the walls, and nipa palm leaves for the roof (Figure 3.3).

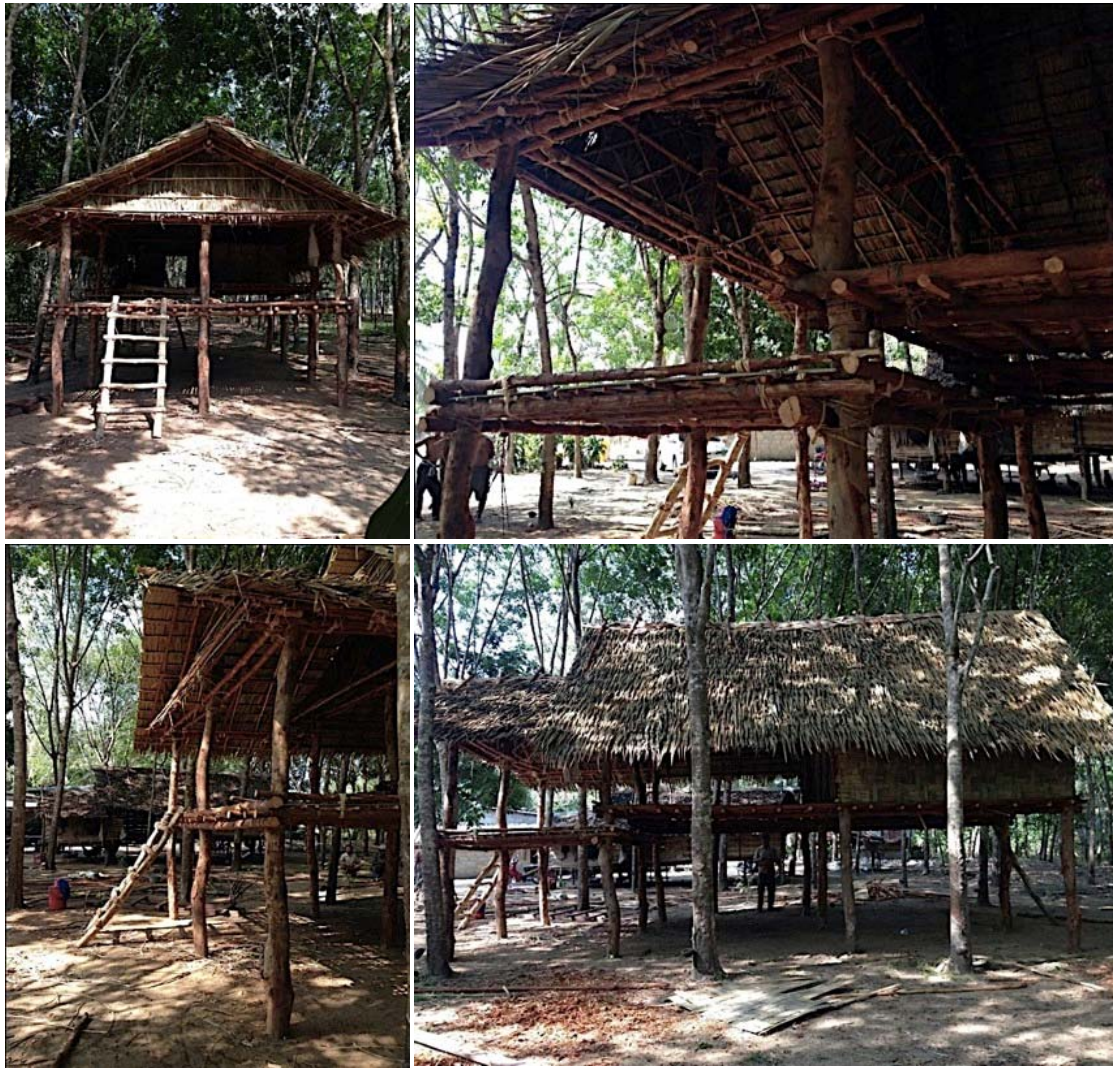
Figure 3.6 Construction project of Moklen ethnic house

In addition to the impact of the tsunami, urban development has also affected many Moklen communities due to their locations. A new access road is rapidly changing the village, bringing influences in the form of modern conveniences and readily available house building materials. This may be due to the fact that the Moklen ethnic houses made from natural materials are not durable and subject to a change in values of the Moklen people. Meanwhile, the application of knowledge and materials is also used in combination with modern house construction.

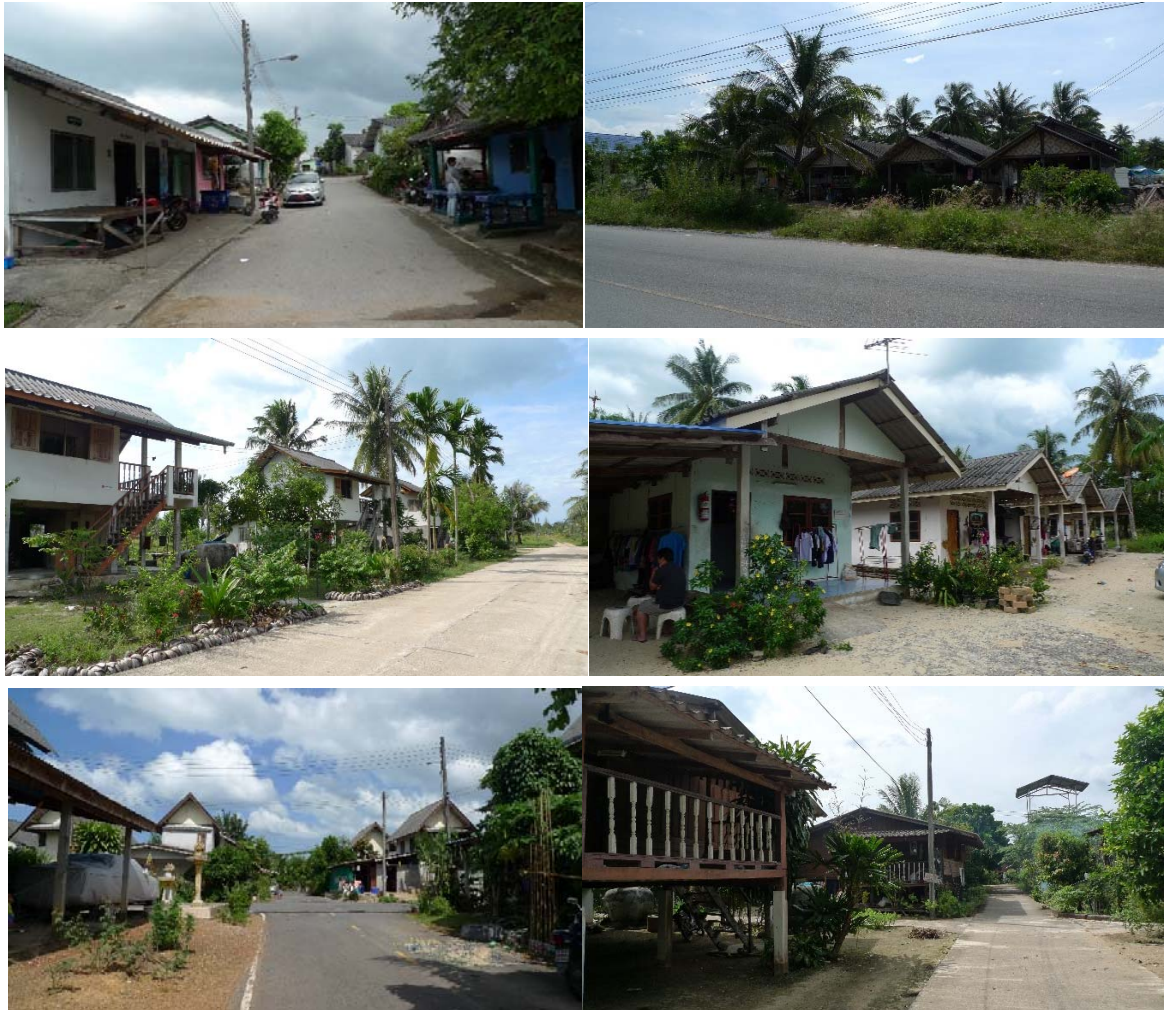
Figure 4.2 Post-tsunami housing for Moklen people; Soi Ongkarn (top-left), Tubtawan village (top-right), Soi Malteser (centre-left), Soi Willy (centre-right), Bangkaya village (bottom-left), and Tungwa village (bottom-right)

Tubpla village was not directly affected by the tsunami. It is located in a mangrove area, deep inside a colonnade of mangrove trees. However, eight villagers died working outside the village. In addition, the Moklen houses in the village looked temporary as they were built from natural materials. The French Rotary Club provided pre-fabricated housing to the village, for the construction of 34 houses with a budget of 150,000 baht.

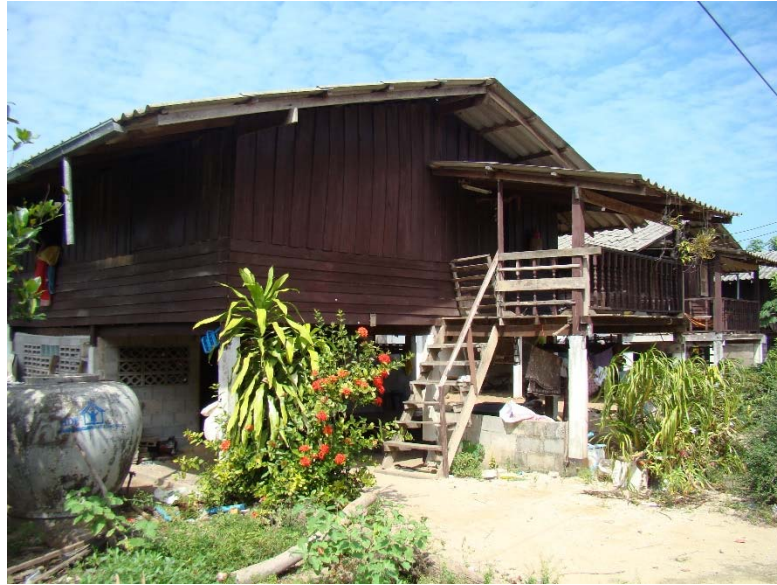
Figure 5.5 The post-tsunami standard housing design in the Tungwa community

The aerial photograph from 2009 shows the village five years after the tsunami. The community layout was drastically changed, the buildings had been neatly organised in rows, with each house sharing an equal area of land, but with considerably less space than in the pre-tsunami period. All houses display the same design with a high basement, gabled roof, and modern construction materials, resembling typically Thai rural houses in this coastal region (Figure 5.5).

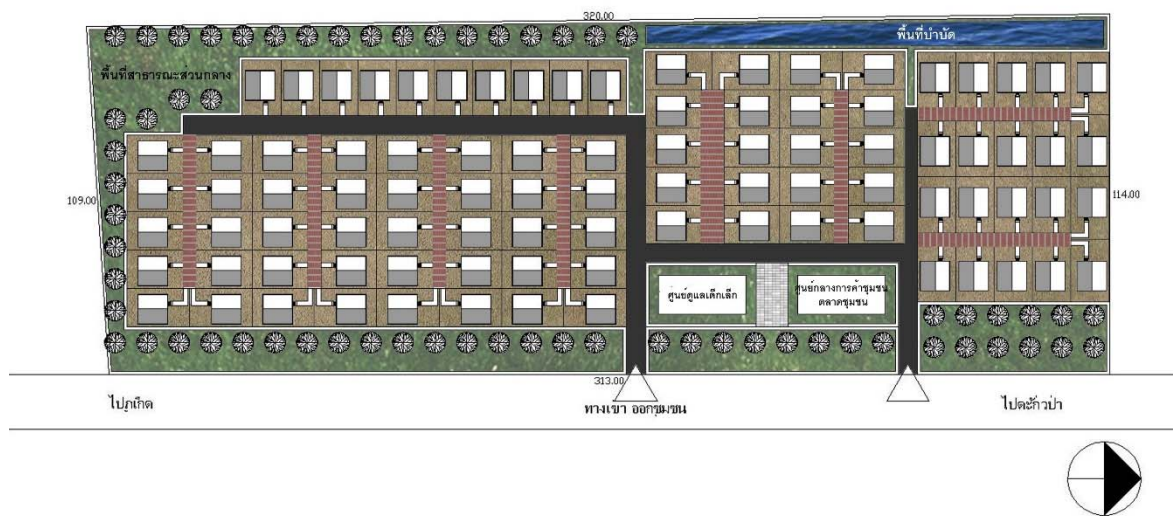
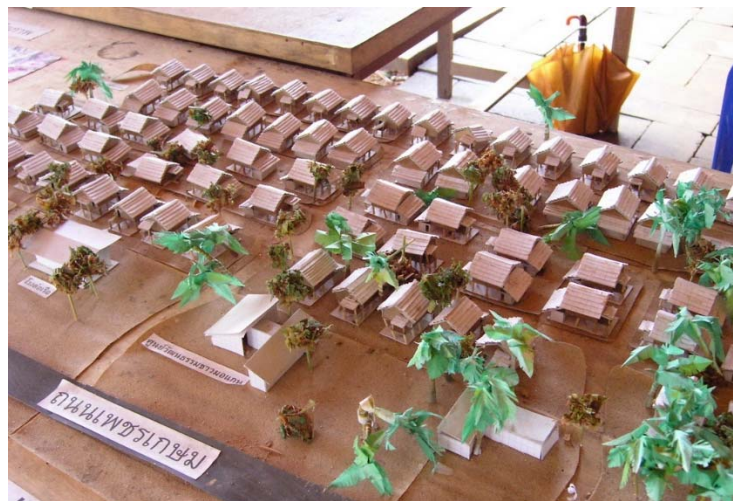
Figure 6.3 Design of layout plan of Tungwa village before and after the land compromise

The master plan for rebuilding was based on information obtained from the residents regarding pre-tsunami housing in the original village layout. The design process involved participation of the residents to determine the residential and common areas, including requests for facilities to support village activities. In addition, a design infrastructure was provided to improve living conditions (Fig. 6.3).

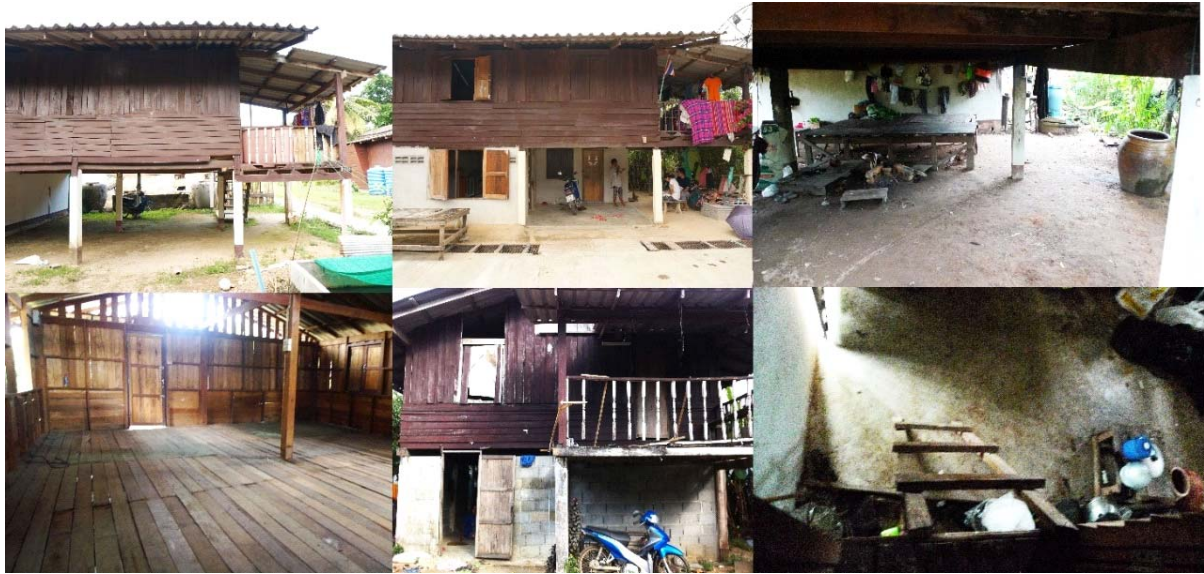
Figure 6.6 House and living conditions in Tungwa village (taken by the author)

The field survey collected data on current housing conditions concerning the changes after the tsunami, and satisfaction and dissatisfaction among the residents to understand the problems residents face as they live in the rebuilt houses. The conditions of the village as shown in Fig. 6.6. House with stilts floor space, extensions on ground floor space, living space of the ground floor, the stilt floor space was left unused, the deterioration of house and low quality of building elements.

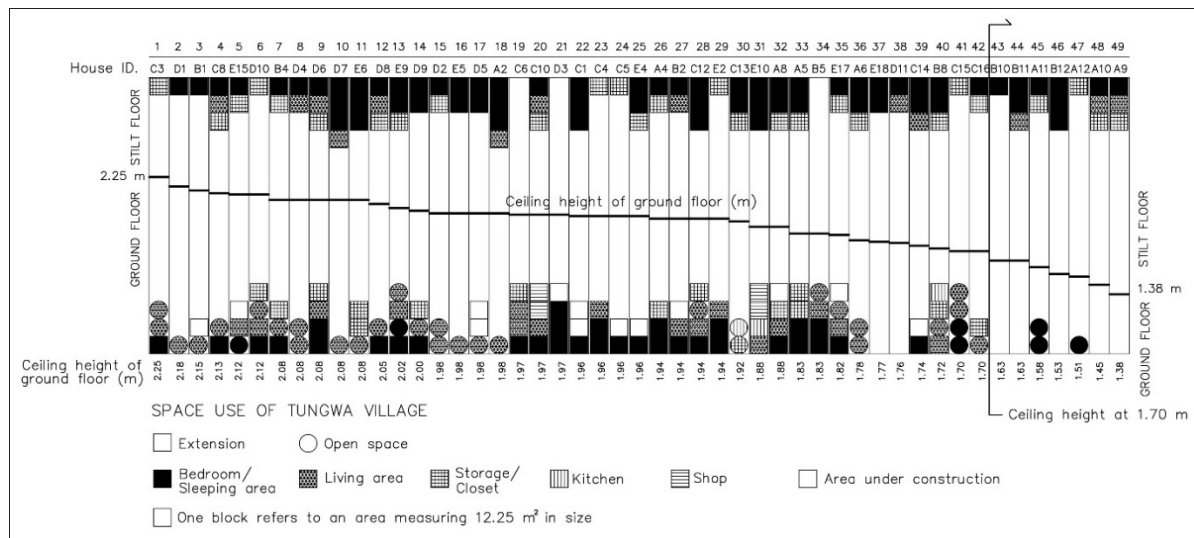
Figure 6.8 Relationship between the ceiling height of the ground floor and space use of rebuilt houses in Tungwa village

The study found that post-tsunami housing in Tungwa village shows many different patterns of space usage by the residents on the stilt floor as well as the ground floor (Fig. 6.8). Space usage refers to areas for daily functions, offered by partitions or an open plan design. Fig. 6.8 shows mainly sleeping space, living space, and storage space on the stilt floor, while multi-purpose activities are carried out in the kitchen, living room, sleeping area, storage, and shop spaces on the ground floor. It can be seen that the ground floor is flexible for accommodating a variety of functions as well as new family members. However, there are ten houses where the stilt floors have been left unused or used as storage, namely houses C3, D10, C6, D3, C4, C5, E2, B5, C15, and A12 as shown in Fig. 6.8. The study also found that among the 49 houses in the survey, seven have distinctive patterns of space usage (numbers 43–49 in Fig. 6.6) The ground floor is mostly non-functional in these houses, as they have ceiling heights below 1.70 m. However, the two houses where residents use the ground floor, even though the ceiling is very low, are A11 and A12 (Fig. 6.8). The residents in house A11 (Fig. 6.9, Fig 6.10), are an elderly couple aged 80, who have difficulties getting up to the stilt floor, as does the 50-year-old resident of A12. These residents lived in a Moklen house before the tsunami.

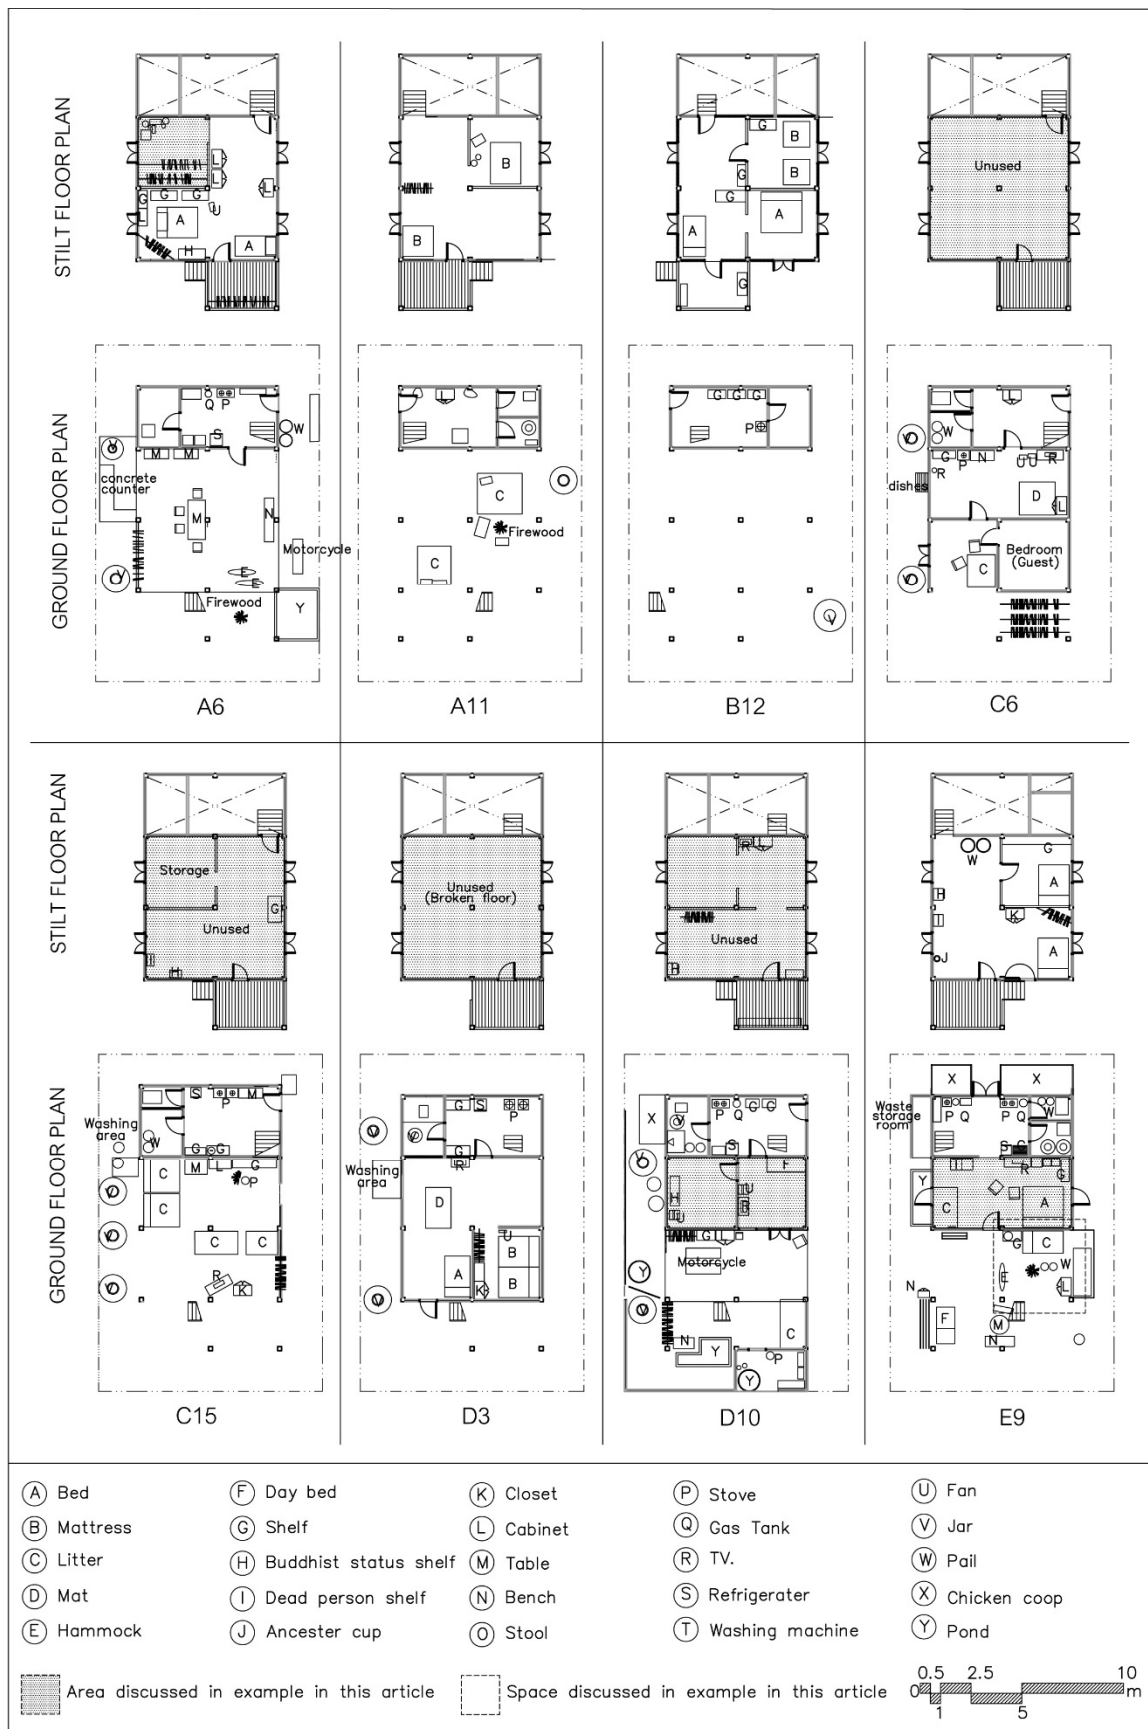
Figure 6.9 Examples of space usage for post-tsunami houses in Tungwa village

Components: the limited areas around the house and windows were reduced for the rebuilt house design, which has resulted in ventilation problems. Many residents moved windows to the front of the house during the construction process. The deterioration of some components has also led to changes in living space. For example, the stilt floor in house D3 (Fig. 6.13) collapsed as a result of damage by termites and insects. Owing to safety concerns, the resident decided to move down to live on the ground floor. Furthermore, damage by rainwater to the outside stairs, resulting in their subsequent removal, has made it inconvenient to use the stilt floor. Moreover, the low quality of stairs, most of which were built by the residents themselves, means that they are no longer safe to use.
