**REHABILITATION OF MAJOR STEEL BRIDGES
IN MYANMAR UNDER SEISMIC RISKS**

A Thesis submitted to the Faculty of Engineering of Kyoto University
in partial fulfillment of the requirements for
the Degree of Doctor of Engineering

Maubin Bridge was selected as a case study bridge, and preliminary analysis with FE bridge model showed higher overstresses in some diagonal members under design loads as well as increased seismic loads of 0.2 g and 0.4 g. Resistance of piles against the earthquake also cannot be assured anymore when the earthquake intensity is greater than 0.1g, and the earthquake resistance of the bridge in the longitudinal direction is relatively weaker than that in the transverse direction due to the arrangement of bearings and piles. Hence, static and dynamic loading tests were done on the bridge with two (60 ton) trucks in September 2016 to investigate the dynamic characteristics and current performance of the bridge, and measured results were used to compare and update the FE bridge model. After updating, the bridge model was analyzed under the time history dynamic analysis using modified Thabeikkyin Earthquake (2012) data for before and after retrofitting conditions u

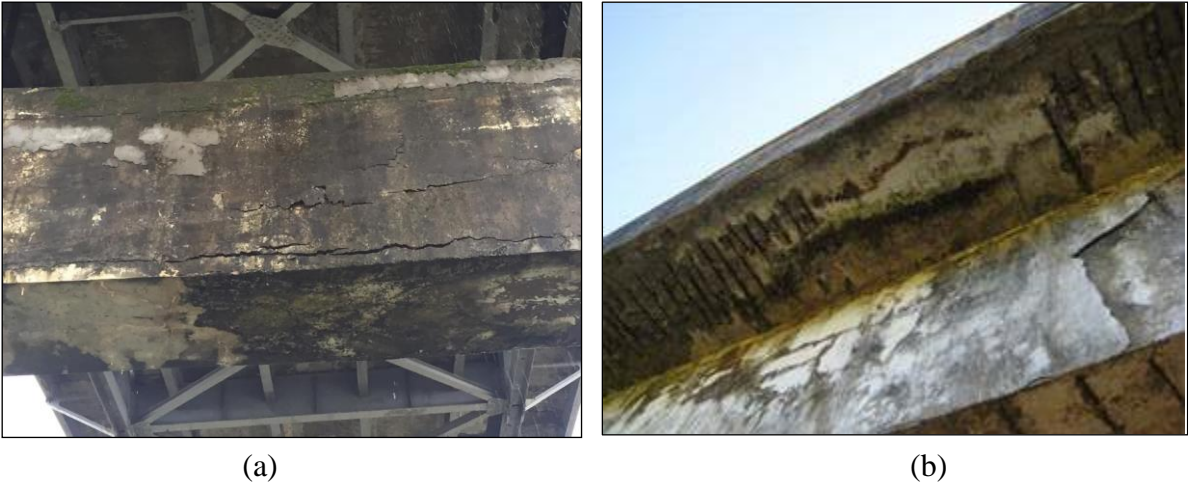
Figure 2.2: (a) Corrosion of bridge bent in Min Chaung Bridge; (b) Corrosion of bottom cover underneath the side walk in Lone Daw Pauk Bridge.

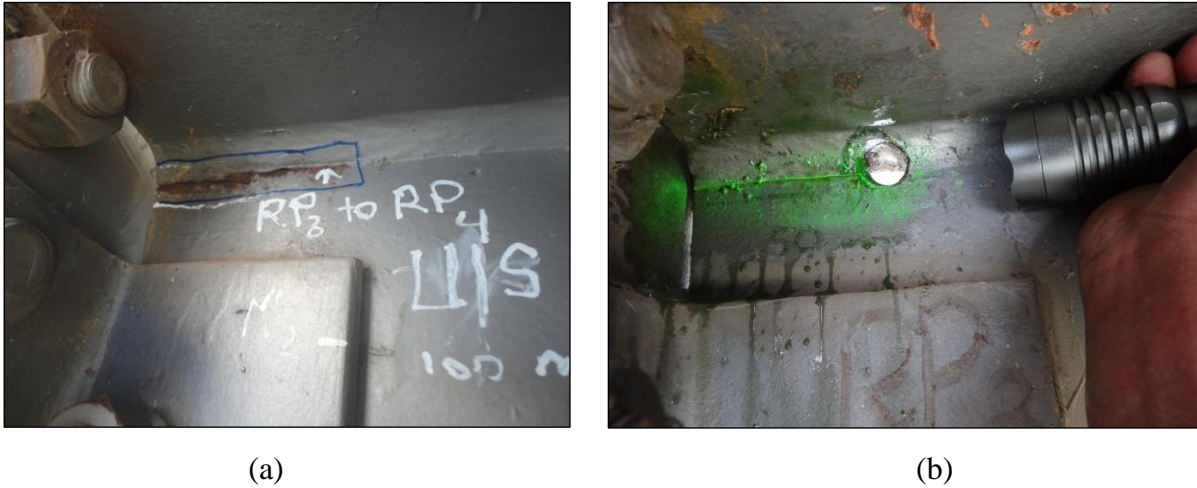
Figure 2.6: (a) Crack in the welded joint between the top flange and the web; (b) Stop hole drilled at the tip of crack.

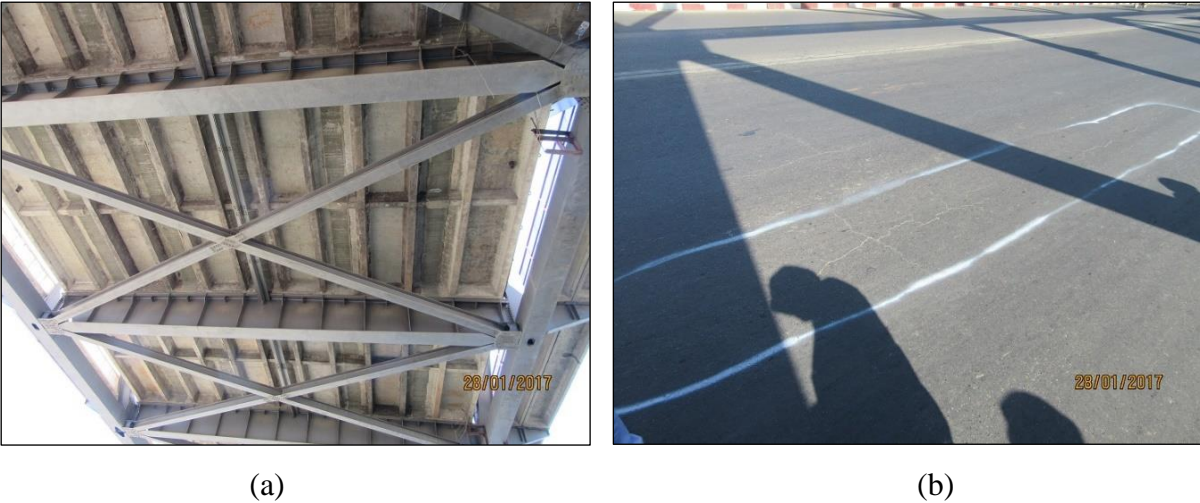
Figure 2.7: (a) Precast concrete deck slab seen from underneath the bridge; (b) Cracks in pavement on the bridge due to the deflection of precast concrete slab.

Yadanarpon Bridge over the Ayeyarwady River connecting Mandalay and Sagaing was constructed in October 2001 and opened to public in February 2008. However, in 2012, only 4 years after the opening, cracks were found at the end of some floor beams especially at the welded connection between top flange and web of the beams near the end [16, 17] as shown in Figure 2.6. CAME company, the Chinese company which designed and fabricated the bridge, inspected the bridge and suggested to drill the stop holes (10 mm to 25 mm diameter) at the crack tip in order to stop the proceeding of cracks after identifying the cracks with Magnetic Particle Test Machine. This method stopped the cracks up to 92% but more cracks were still occurring in some other beams over some time until now. This may be due to the requirements in structural design and joint detailing or due to over loading or due to the use of precast concrete ribbed decks only without the steel stringers (along the longitudinal direction of the bridge) as shown in Figure 2.7 (a).

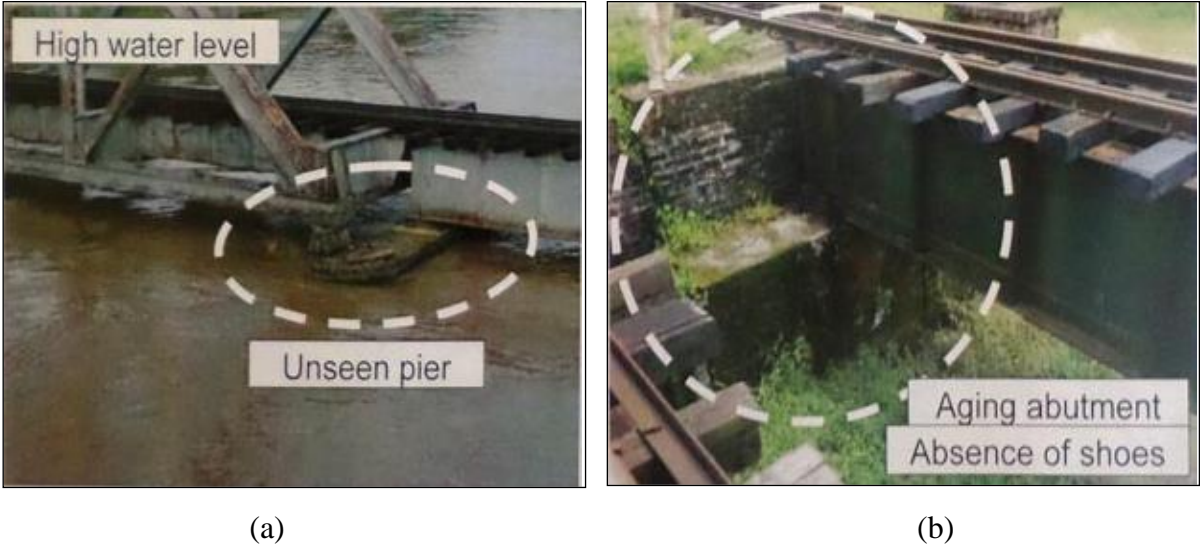
Figure 2.8: (a) Unseen bridge pier during high water level in bridge No. 111; (b) Aging abutment and absence of shoes in bridge No. 42.

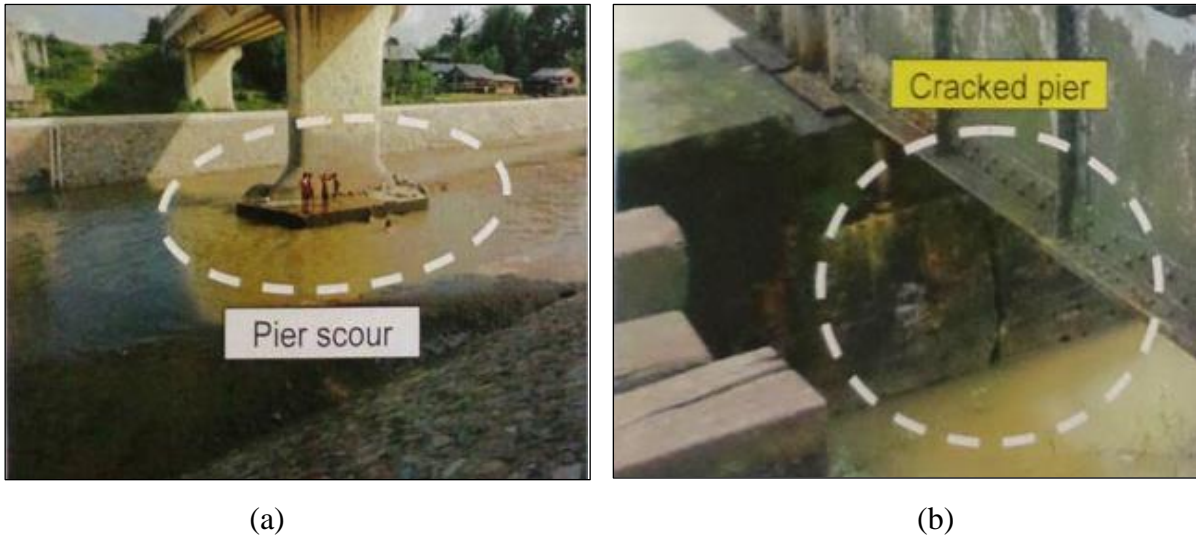
Figure 2.9: (a) Pier scouring in bridge No. 393; (b) Cracked pier in Bridge No. 21.

retaining walls, piers, and hence greatly reduced their service life. Therefore, the inspection team suggested to replace most bearings as well as to reconstruct most of the abutments and piers because they were the main reasons to reduce the speed of trains while crossing those bridges. Figure 2.8 shows the unseen bridge pier during high water level in bridge No. 111 and aging abutment and absence of shoes in bridge No. 42 along the Yangon – Mandalay rail track. Pier scouring at the base of pier in bridge No. 393 and the cracked pier in bridge No. 21 were also shown in Figure 2.9.

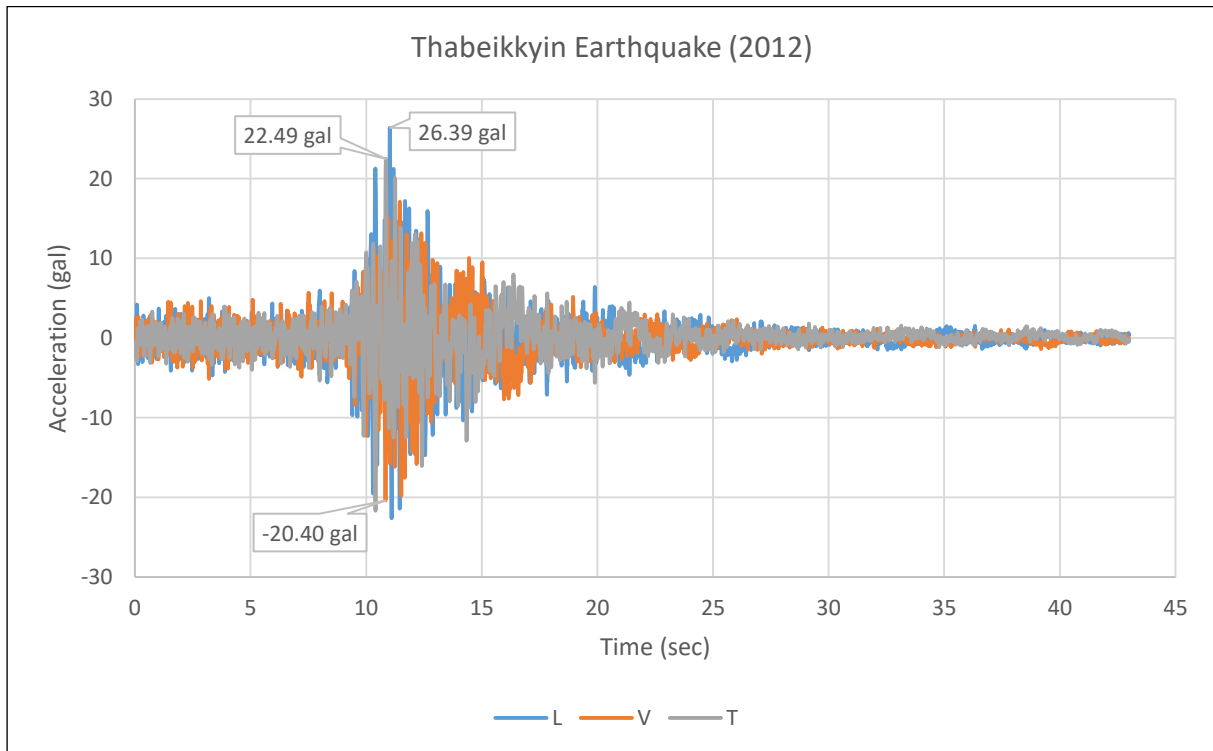
Figure 3.4: Acceleration record of Thabeikkyin Earthquake from Mandalay station.

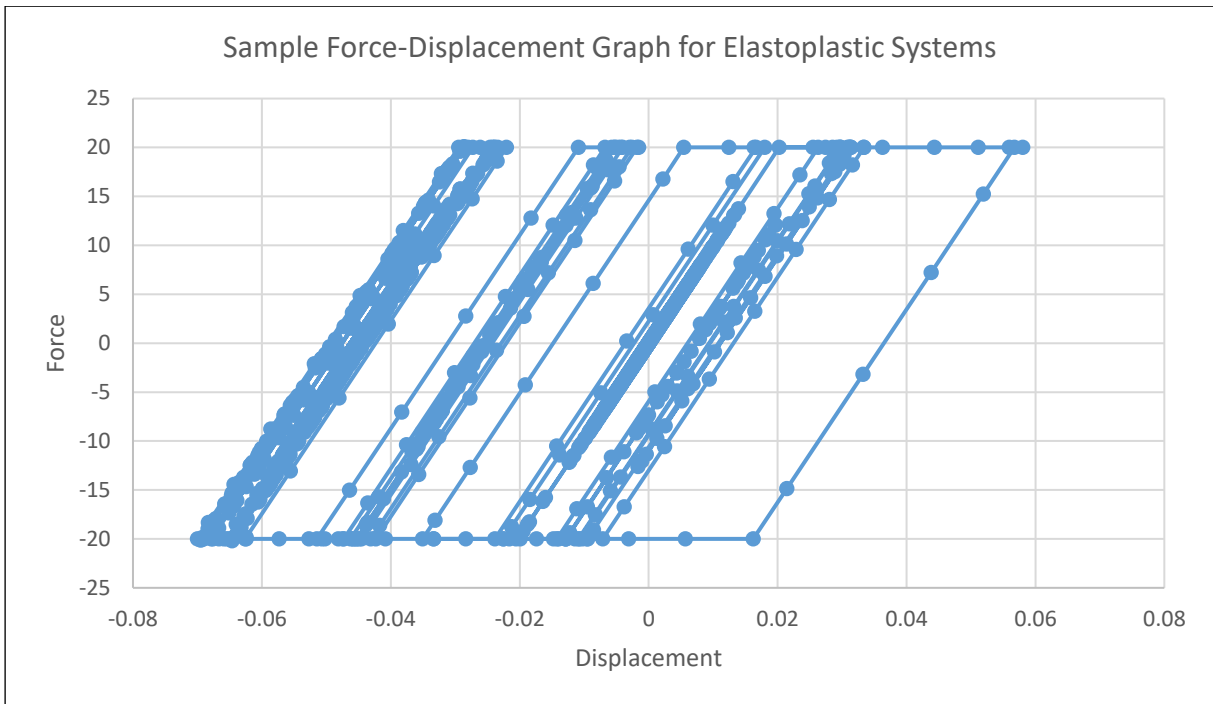
Figure 3.8: Sample of force-displacement graph for elastoplastic systems.

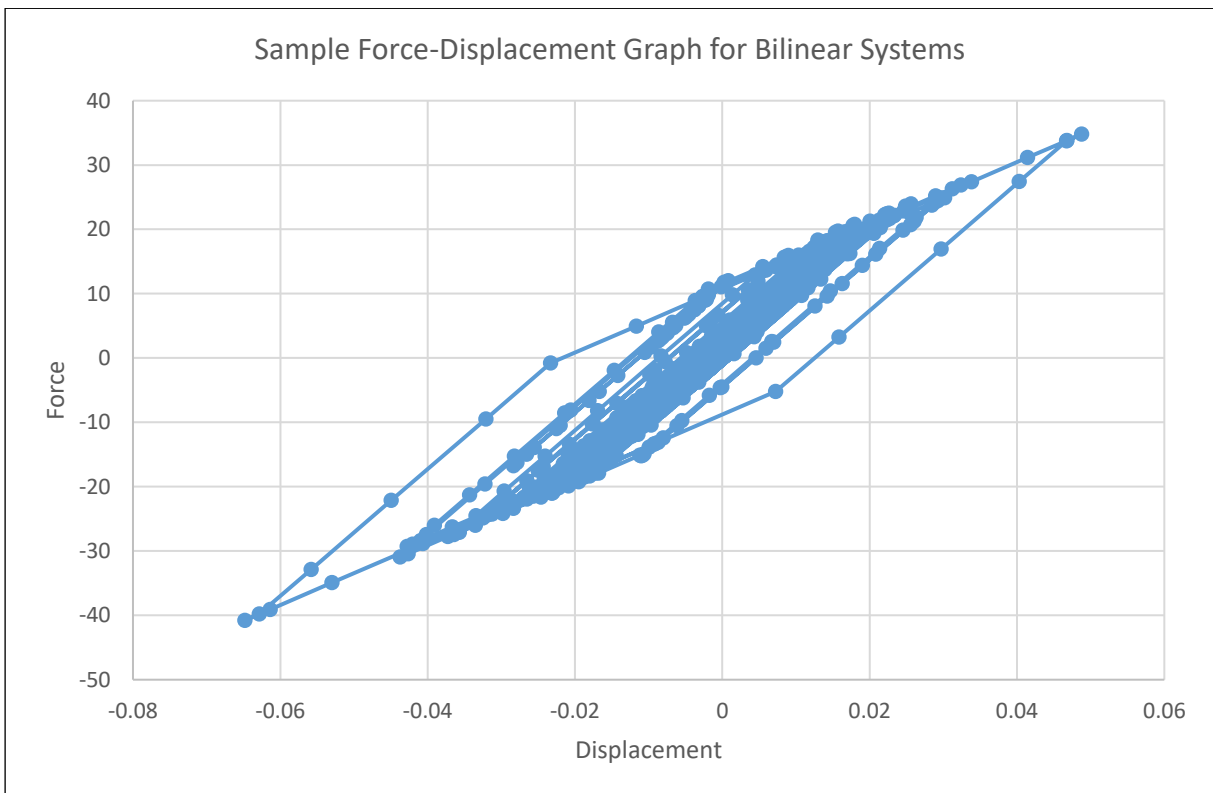
Figure 3.9: Sample of Force-displacement graph for bilinear systems.

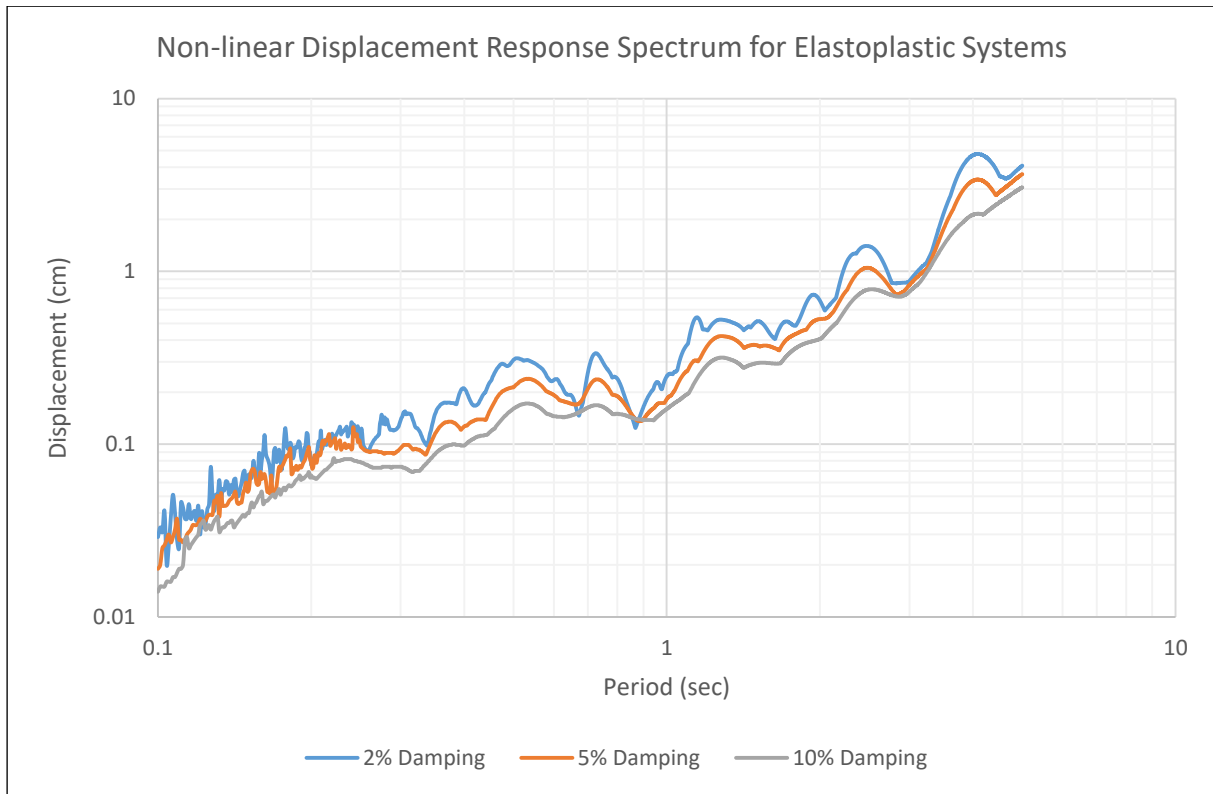
Figure 3.12: Non-linear displacement response spectrum for elastoplastic systems due to Thabeikkyin Earthquake.

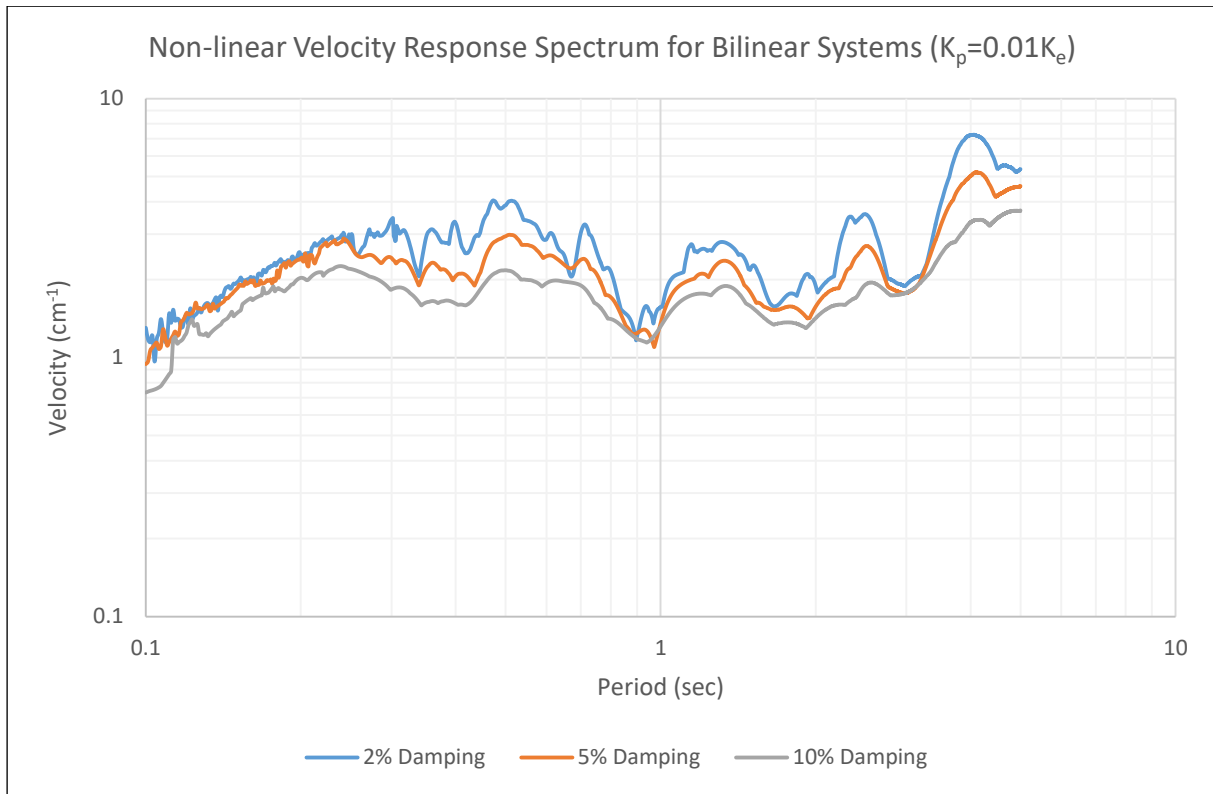
Figure 3.14: Non-linear velocity response spectrum for bilinear systems due to Thabeikkyin Earthquake.

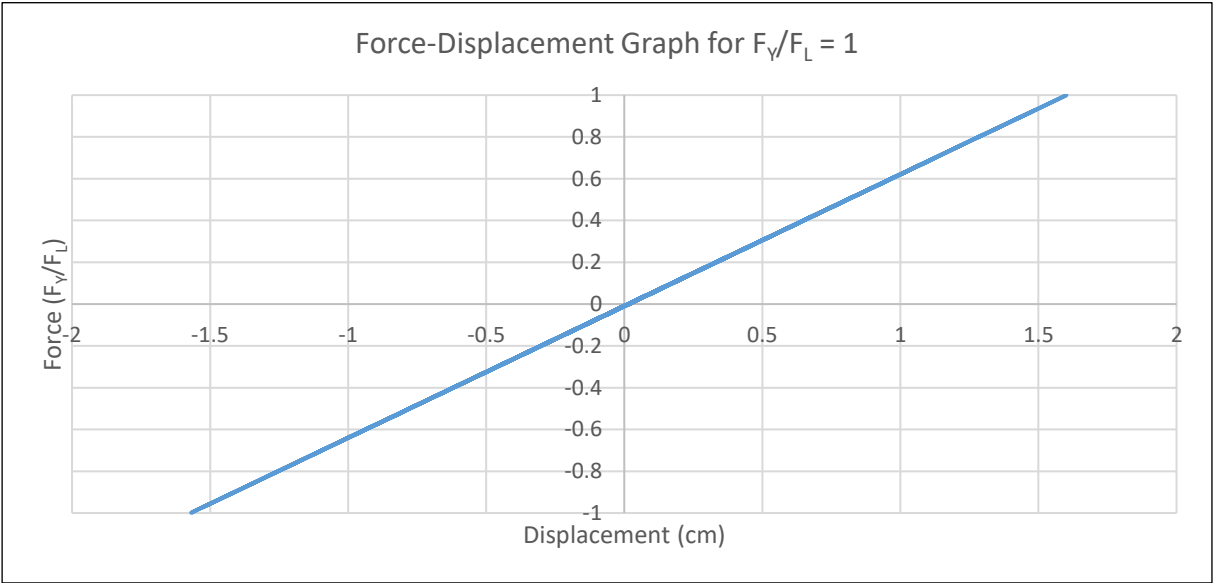
Figure 3.16: Force-displacement graph of a linear system with $T = 0.5 \text{ sec}$ and $\zeta = 5\%$ under Thabeikkyin Earthquake.

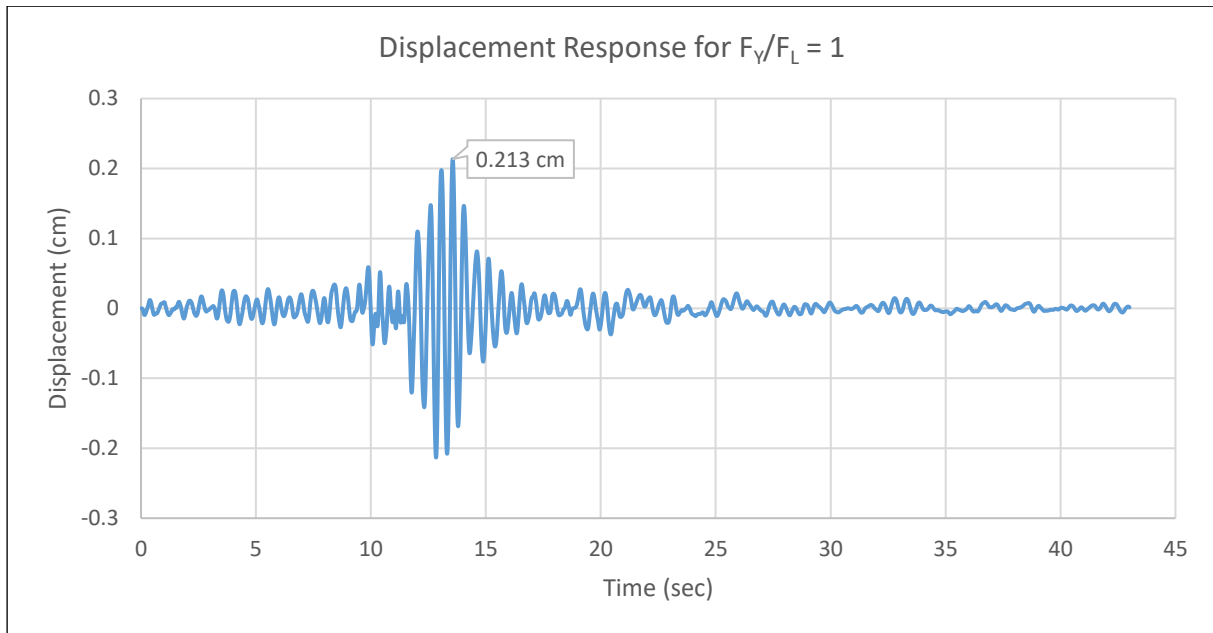
Figure 3.19: Displacement response of a linear system ($m = 1$ kg, $\zeta = 5\%$ and $T = 0.5$ sec) due to Thabeikkyin Earthquake.

Figure 3.19, and 3.20 showed the responses of a linear S.D.O.F system with $m = 1$ kg, $\zeta = 5\%$ and $T = 0.5$ sec due to the Thabeikkyin Earthquake data. It can be seen from figures that the system oscillates about the equilibrium position with the maximum displacement value of 0.213 cm and the maximum resisting force to remain the system elastic was 0.034 g.

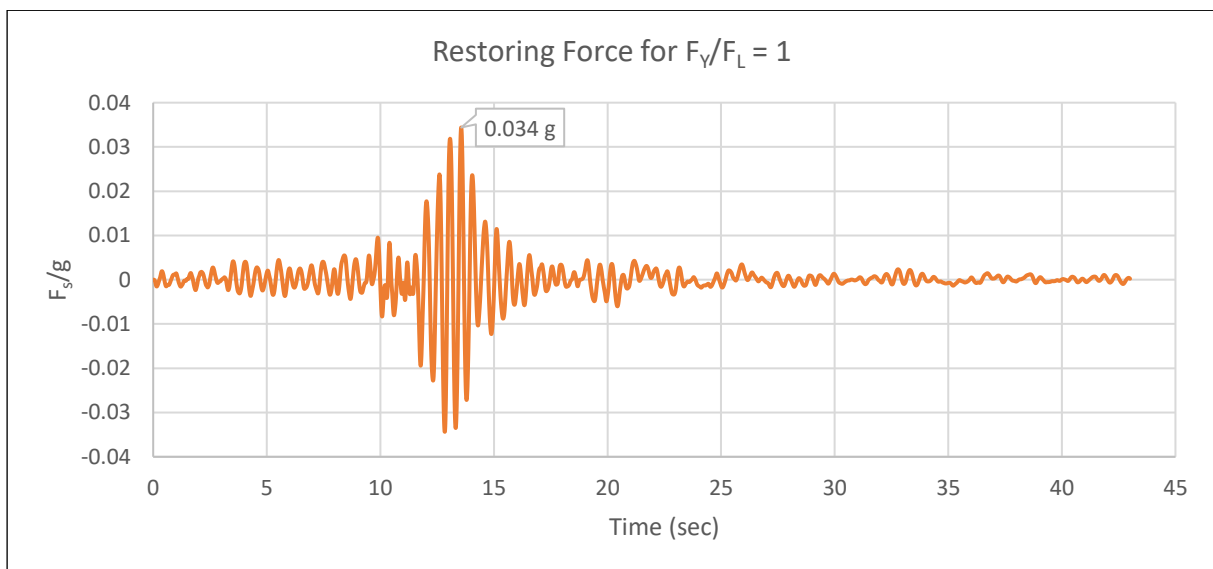
Figure 3.20: Restoring force necessary for a linear system ($m = 1$ kg, $\zeta = 5\%$ and $T = 0.5$ sec) due to Thabeikkyin Earthquake.

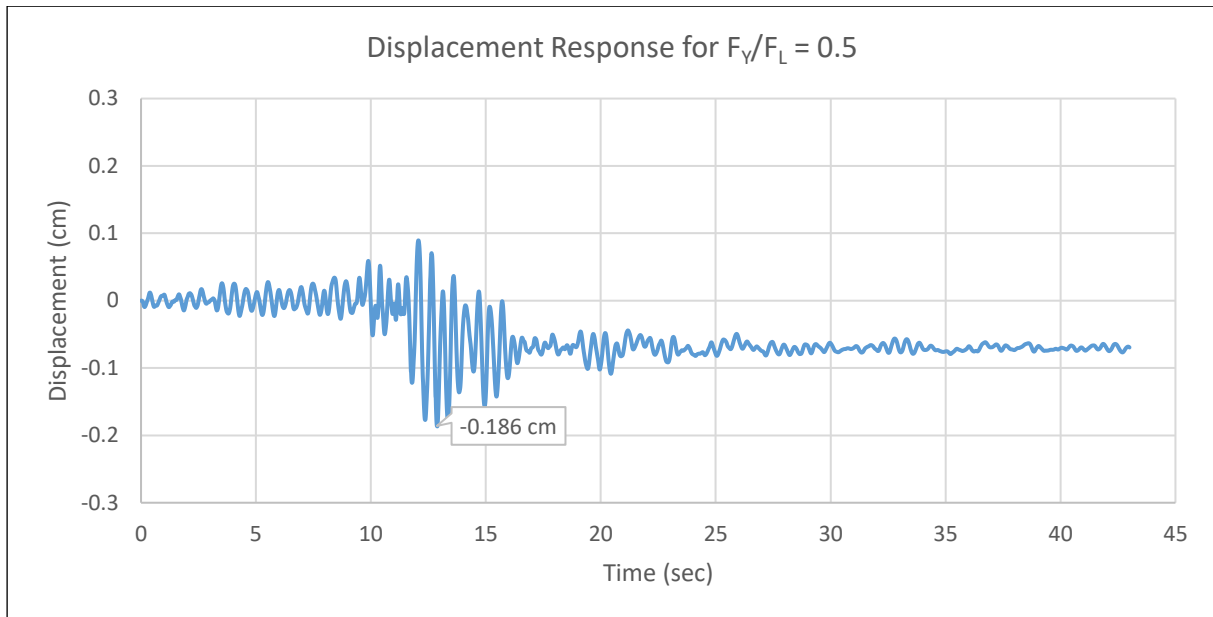
Figure 3.21: Displacement response of nonlinear system ($m = 1 \text{ kg}$, $\zeta = 5\%$ and $T = 0.5 \text{ sec}$) with $(\bar{F}_Y = 0.5)$ due to Thabeikkyin Earthquake.

The responses of three nonlinear (elastoplastic) S.D.O.F systems with the same m , ζ and T values were also drawn for three different values of normalized yield strength (0.5, 0.25, 0.125) as shown in Figures 3.21 to 3.23 and it can be seen that the deformation responses were no more oscillating around the equilibrium after yielding showing some permanent deformation. The ductility demand of these three different systems can be found out from equation (3.16) as, $\mu_{0.5} = 1.76$, $\mu_{0.25} = 3.0$, $\mu_{0.125} = 10.25$ respectively.

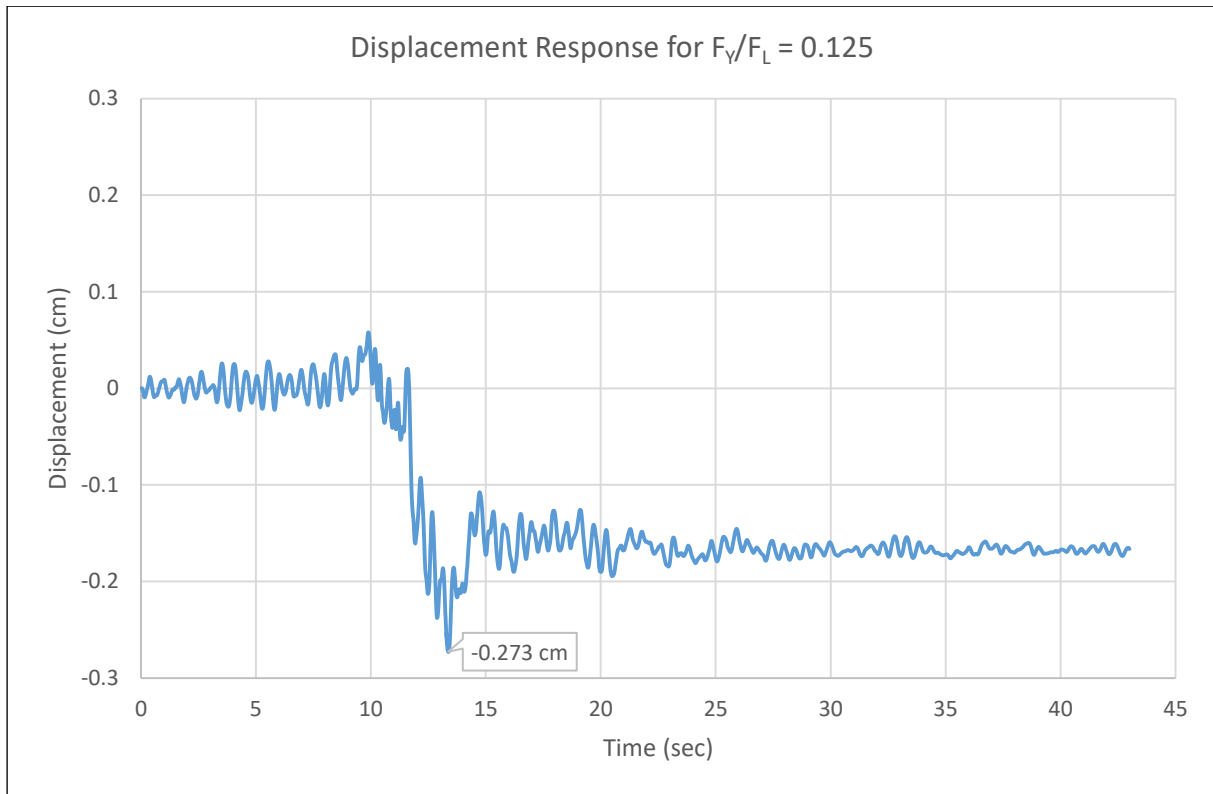
Figure 3.23: Displacement response of nonlinear system ($m = 1$ kg, $\zeta = 5\%$ and $T = 0.5$ sec) with ($\bar{F}_Y = 0.125$) due to Thabeikkyin Earthquake.

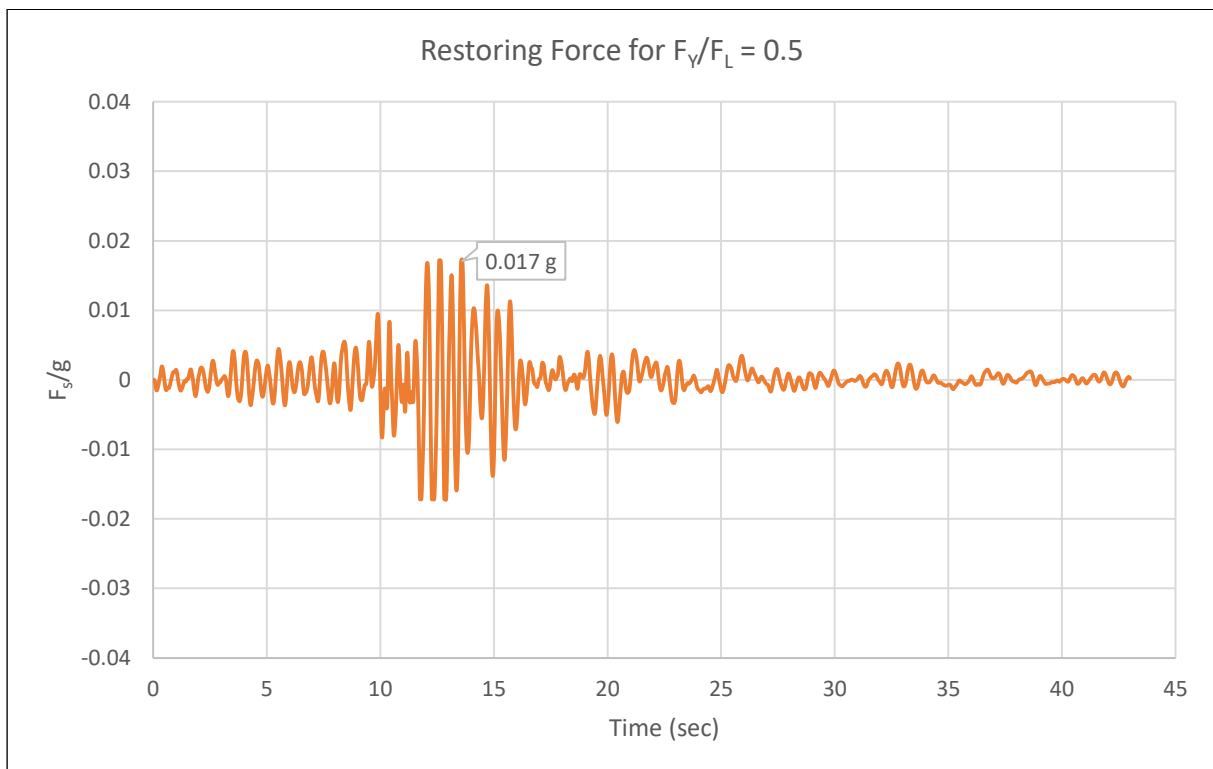
Figure 3.24: Restoring force necessary for a nonlinear system ($m = 1$ kg, $\zeta = 5\%$ and $T = 0.5$ sec) with ($\bar{F}_Y = 0.5$) due to Thabeikkyin Earthquake.

However, the maximum restoring forces (or yielding force) for three different systems necessary for stable equilibrium were decreasing with 0.017 g, 0.009 g, 0.004 g as shown in Figure 3.24 to 3.26 due to the decreasing normalized yield strength with 0.5, 0.25, and 0.125 of the corresponding linear system. It can also be seen that more yielding occurs when the yield strength of the system decreases from 0.5 to 0.25 and 0.125, increasing the chance to occur permanent deformation of the system after ground shaking.

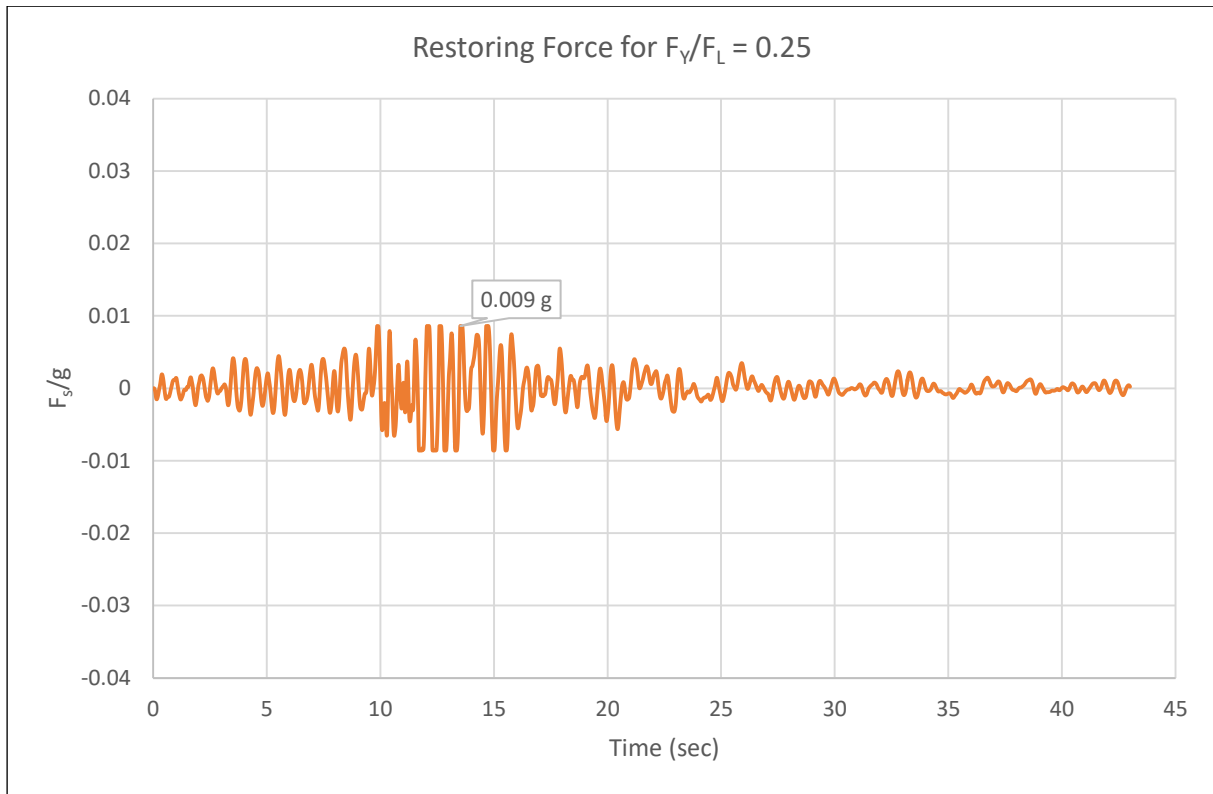
Figure 3.25: Restoring force necessary for a nonlinear system ($m = 1$ kg, $\zeta = 5\%$ and $T = 0.5$ sec) with ($\bar{F}_Y = 0.25$) due to Thabeikkyin Earthquake.

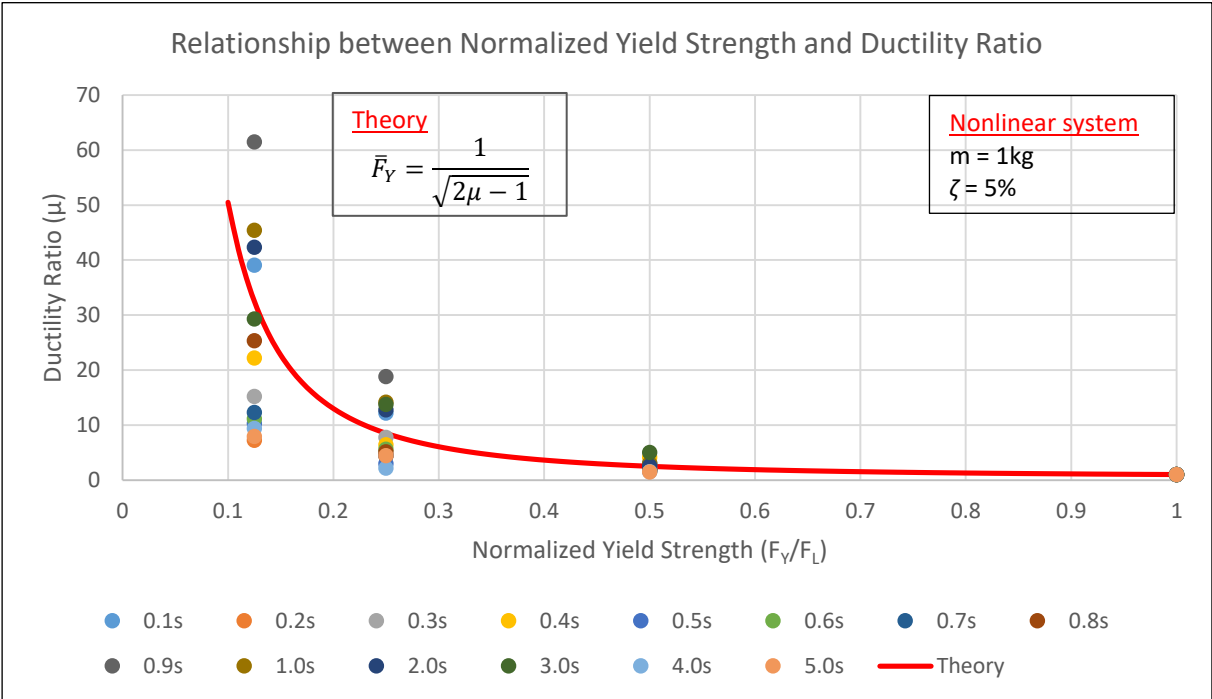
Figure 3.27: Relation between the normalized yield strength (\bar{F}_Y) and the ductility ratio (μ).

Then, the relation between the normalized yield strength (\bar{F}_Y) and the ductility ratio (μ) of different S.D.O.F systems with different periods was presented in Figure 3.27. From the graph, it can be seen that the required ductility ratio or (ductility demand) of a nonlinear system is inversely related to the normalized yield strength of the system, and more ductility is required if the ratio between the yield strength (F_Y) and the linear elastic strength (F_L) is reduced. Moreover, response of nonlinear systems with different periods (0.1s ~ 5s) and different ratios of F_Y/F_L (0.125, 0.25, 0.5, and 1) under Thabeikkyin Earthquake showed the same characteristics comparing with theoretical relation.

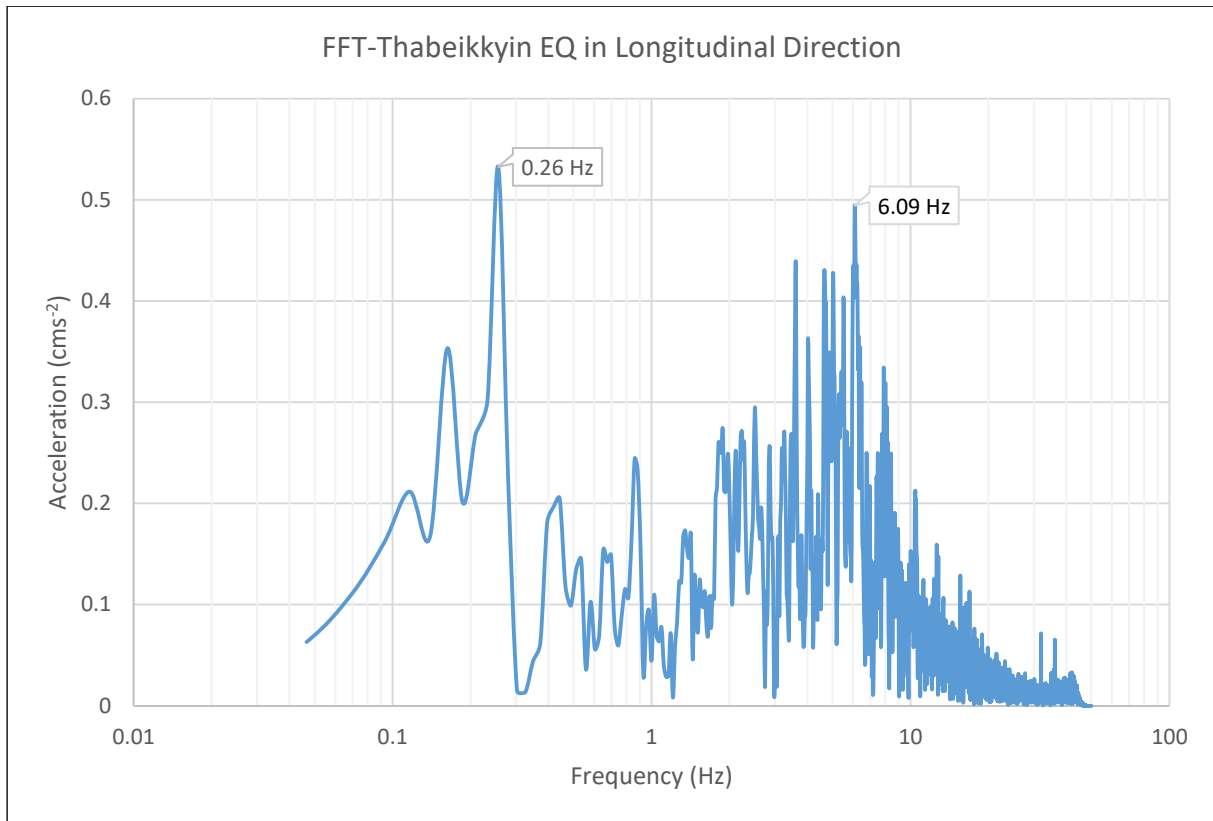
Figure 3.29: Fourier spectrum of Thabeikkyin Earthquake in longitudinal direction.

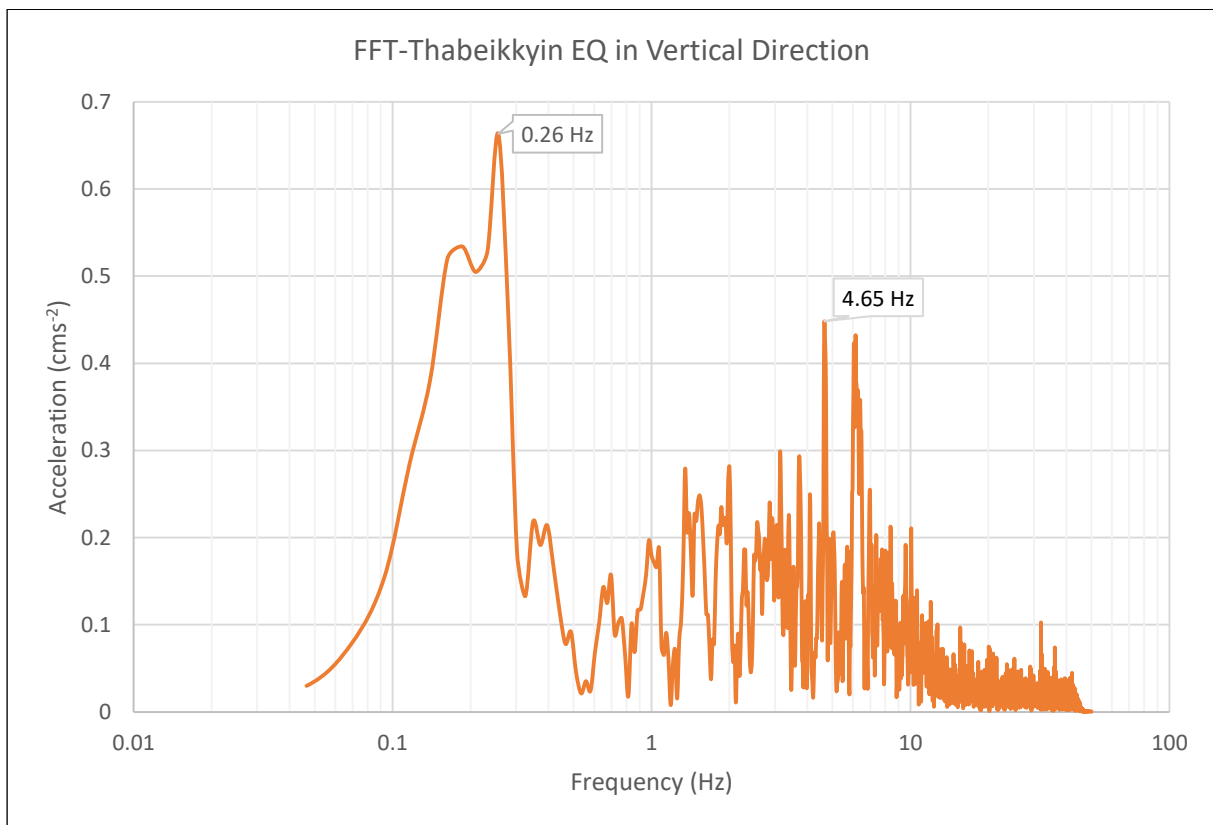
Figure 3.30: Fourier spectrum of Thabeikkyin Earthquake in vertical direction.

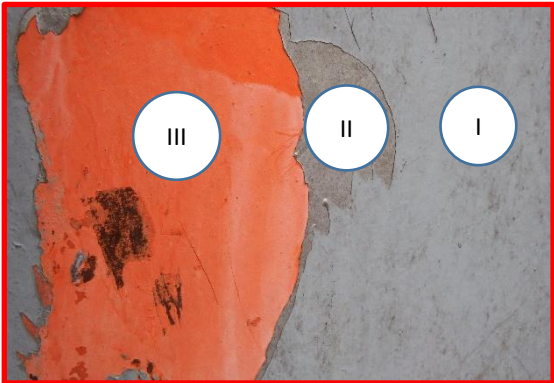
Figure 5.4: Peeling off paint layers in Maubin Bridge

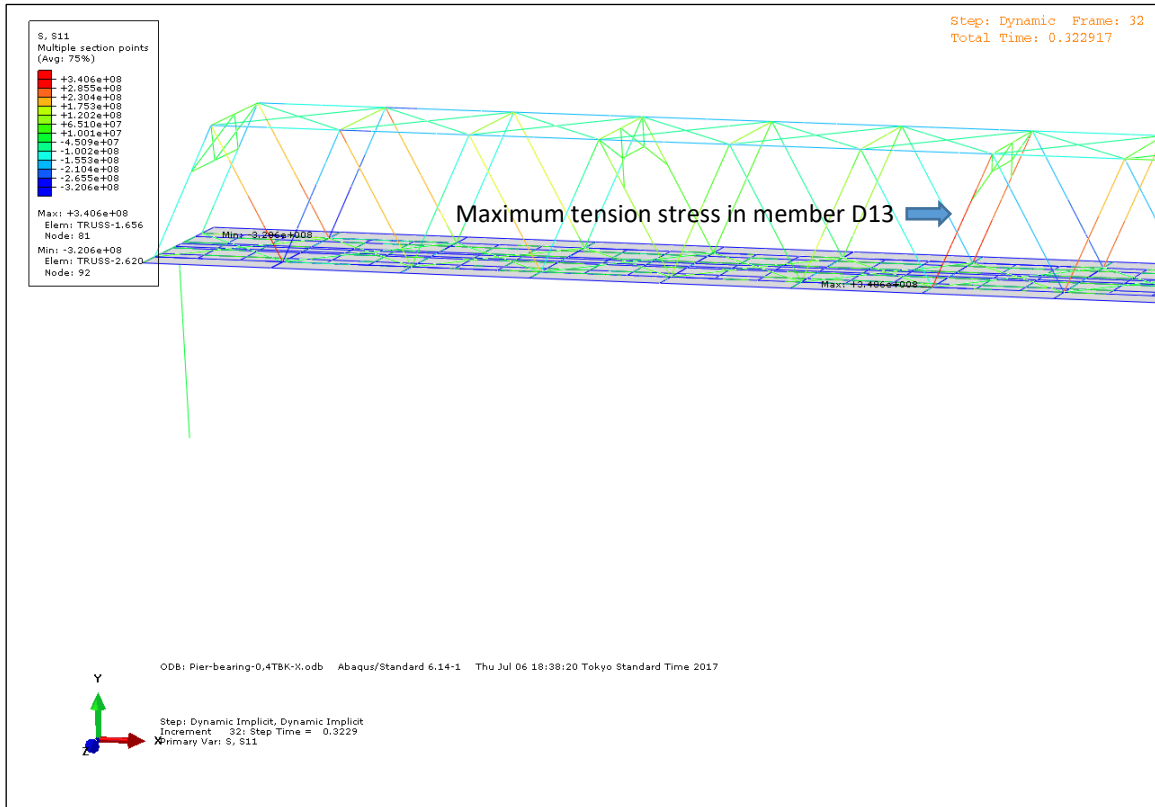
Figure 7.12: Maximum stresses with elastomeric bearings due to 0.4g Thabeikkyin Earthquake in X-direction.
