11th Nordic Symposium on Building Physics, NSB2017, 11-14 June 2017, Trondheim, Norway

Deterioration and Preservation of City Wall in Nanjing

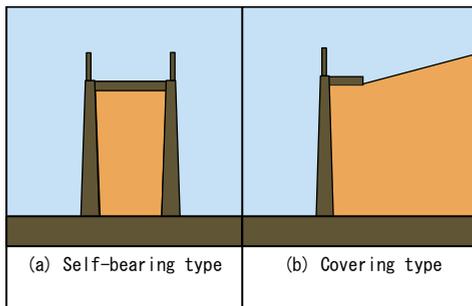
Fig. 1 Overview of City Wall

Nanjing City Wall was constructed during a 21-year period during the Ming Dynasty, from 1368 to 1644 (Fig. 1). Although the City Wall is currently separated into five sections, more than two-thirds of the originally constructed wall, i.e., 25,091 km, still remains. The City Wall is made of bricks and stones. The bricks are of different sizes and materials (ingredients) because they were produced at various places throughout China. Plaster and soil were used as masonry joints. The wall structure is roughly categorized into two types. One is a self-bearing type, which is not in contact with any large masses of soil on the rear face, and where both sides of the wall are made of bricks. The other one is a covering type, whose rear side is large mass of soil, where the wall is constructed such that it surrounds the soil mass (Fig. 2). The inside of a self-bearing type wall is either soil or only bricks.

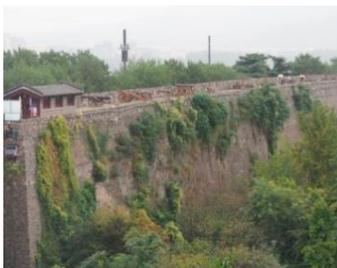
Fig. 4 Plant growing on south side of wall

On the side face of the wall, as shown in Fig. 4, a number of plants are growing, and an exfoliation or extrusion of bricks from the forces caused by tree roots or trunks can be seen. In contrast, the side faces of the wall in front of tall trees, as shown in Fig. 5, are in relatively good condition despite being covered by algae or moss. This is probably because of the protection from solar radiation and precipitation by the trees, and because of the evapotranspiration by the plants and microorganisms. The plants around the wall and on its side faces are thus closely related to the deterioration of the wall. In addition, solar radiation has a significant influence on the plant growth around the city wall. Therefore, the plants, microorganisms, and orientation of the wall have a drastic influence on its deterioration.

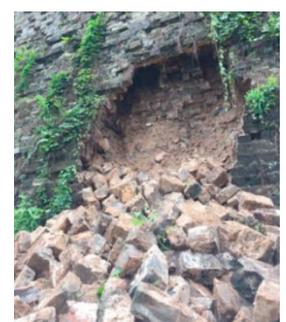
Fig. 6 Extrusion of bricks

Because a portion of the rain falling on the wall is stored inside the wall, thereby causing internal pressure, extruding bricks can be seen (Fig. 6). As the worst case, a large-scale destruction of the wall has occurred (Fig. 7).

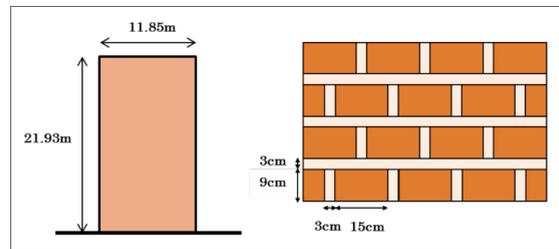
Fig. 8 Schematic of wall and layering of bricks

A self-bearing type portion of the wall near Kaiho-mon was analyzed. The inside of the wall is assumed to have been filled with bricks and plaster, excluding air voids or soil. This portion of the wall was modeled as a two-dimensional rectangle with a height of 21.93 m and a width of 11.85 m. The end of the brick is a rectangle 15.0 cm by 9.0 cm in size, and the bricks are connected to each other by plaster with a thickness of 3 cm. The way of laying bricks was a type of header bond, as shown in Fig. 10. This section of the modeled wall and the manner in which the bricks were laid are shown in Figure 8.

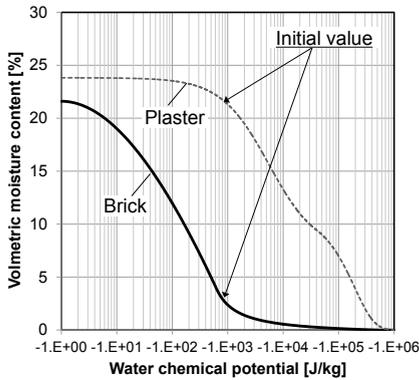
Fig. 9 Equilibrium moisture content of brick and plaster [11,12]

The physical properties of the wall are listed in Table 1, and the equilibrium moisture content of each material used is shown in Fig. 9 [11, 12]. Because the bricks and plaster comprising the present City Wall are considered more brittle and rougher than standard, the moisture transfer coefficients of the bricks and plaster were set to 10-times and a million-times greater than the standard values (Fig. 10), respectively [11, 12].

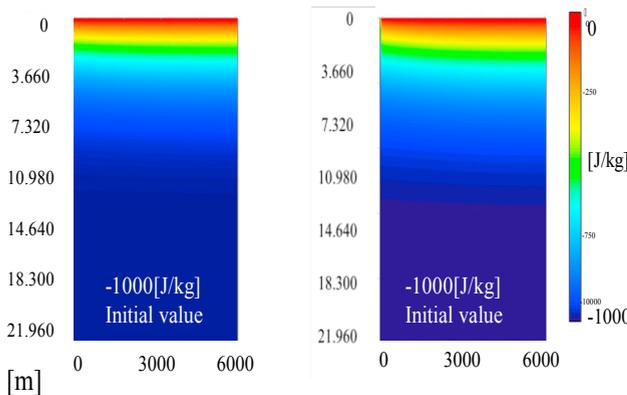
Fig. 11 Water chemical potential after half a year (left) and one year (right)

Heat and moisture transfer inside the wall when the upper surface is saturated with rainwater was calculated for a full year. Figures 11 and 12 show the water chemical potential and temperature after half a year and one year, respectively. Because the wall is symmetric to the centerline, only the results of the left half are shown.

The water chemical potential increases particularly at the upper part of the wall owing to the penetration of rainwater. Because the increased region of the potential extends wider after one year than after half a year, it can be stated that the moisture content inside the wall increases over time. From the detailed results of the moisture transfer within the region 1.65 m from the upper surface (corresponding to 14 layers of bricks) after one year, it can be understood that the moisture moved mainly through the plaster layers (figure omitted here), which resulted from setting the value of the moisture transfer coefficients of the plaster to larger than that of the brick.

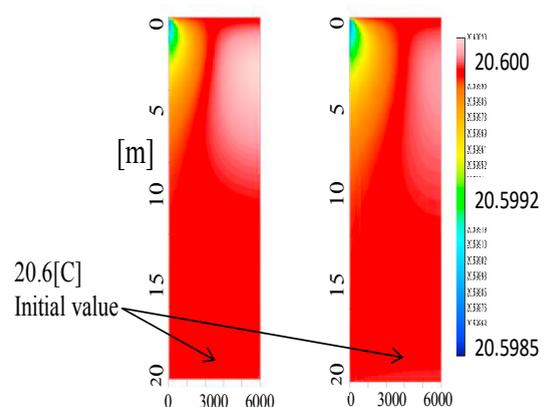
Fig. 12. Temperature after half a year (left) and one year (right)

The temperature increases slightly in the center region of the wall (by less than 0.0002 °C). The temperature increase after one year is less than that after half a year because the moisture content increases with the water chemical potential, which causes a temperature increase owing to the heat of condensation. In addition, the temperature drops near the side face of the wall because the water evaporates there.

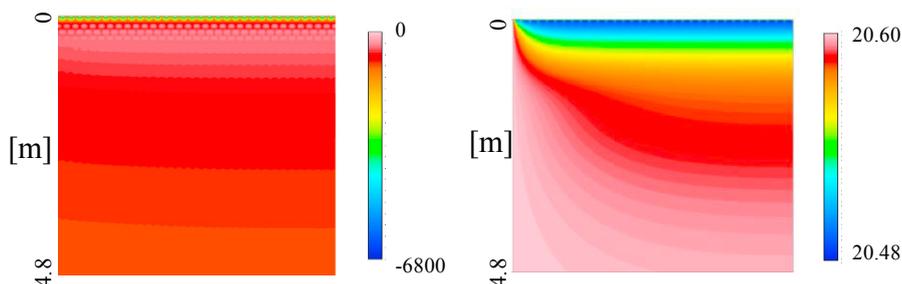
Fig. 13 Distributions of temperature and water chemical potential after two months

because the average annual relative humidity in Nanjing is 74.9%. Figure 13 shows the temperature and water chemical potential after three months (90 days). This figure only shows the results at the upper 4.8 m region (corresponding to 40 layers of brick), where the change can be clearly seen.

After a cyclic repetition of rain and a drying period, the water accumulated in between 2 to 4 layers of brick from the upper surface, although the upper part of the bricks remained dry. Furthermore, the repetition of temperature increases and decreases with increases and decreases in moisture content created a characteristic temperature distribution.
