## Evolution of Alluvial Meandering Channels: Comparison between Laboratory Experiments and Natural Channels

### Synopsis

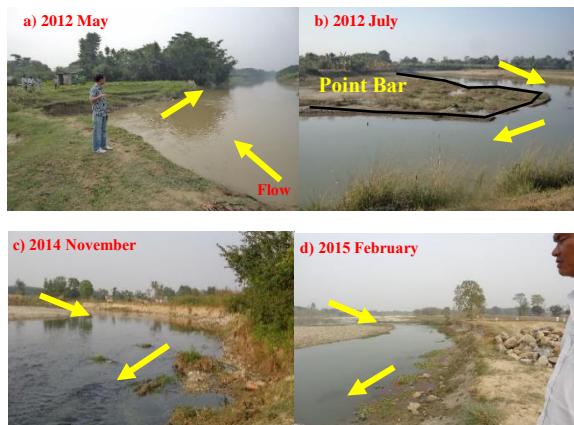
**Photo 2:** River Channel in the study reach; (a and b) Sunsari River, (c and d) Lohandra River

River channel characteristics can be briefly explained based on the channel shape, width, depth, slope, in-channel morphology, etc. Sunsari River is a perennial river originating in the Siwalik Hills, JICA (2003). In the study reach about 4.5kilometers downstream of East-West Highway, it consists of a single thread sinuous channel with narrow and deep cross-section i.e. having a low width-depth ratio. The width and depth of the study reach vary between 30-40m and 3-5m respectively. The distinct meandering pattern is evident throughout the river reach. Formation of the curvature related point bar can be seen in the inner bank of the channel. These point bars are gradually armoured by the growth of vegetation which eventually develops into a mainland floodplain as seen in Photo 2. This formation has a significant implication on the channel planform evolution. Also, ox-bow Lake has been formed due to the meander cut-off at different meander bends. Most of these cut-offs are man-made for river channelization while few are naturally formed. Various kinds of cultivation can be seen on the adjacent floodplain. During monsoon, the

Lohandra River also originates in the Siwalik Hills. The study reach is located approximately 12 kilometres downstream from the foothills and 3.5 kilometres downstream of the Bridge at East-West Highway. The river channel is wide and braided in the upper reaches and gradually becomes narrow towards the lower reaches. Unlike Sunsari River, it has a relatively low bank with height 2-2.5m in the study reach. The main channel frequently wanders within the bankline. The average width of the main channel varied between 10-23m during the period of last 7 years from 2010-2017. However, the bank to bank width varies between 100-140m. The average channel slope of the channel for the study reach is about 1 in 250. Riverbed is composed of gravel, sand and silt while the bank materials basically constitute of sand, clay and silt mixture. Meander development, bank

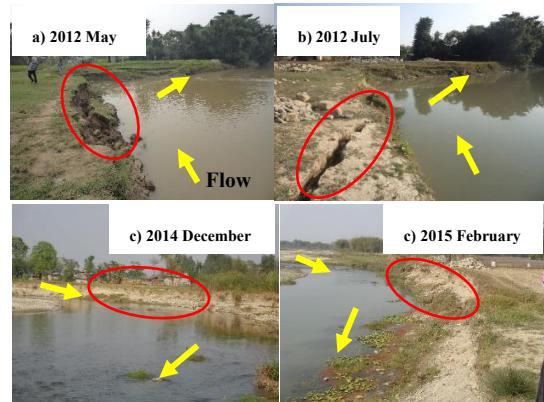
Photo 4: Bank erosion in the study reach; (a & b) Sunsari River and (c & d) Lohandra River

Photo 4 (a-d) shows the bank failure along the study channels. It was seen that in case of Sunsari River, the mass failure mode was dominant while fluvial erosion was principal mode of bank erosion in Lohandra River channel. High and steep banks with deep channels in Sunsari River resulted in the instability of the bank. Consequently, failure of the bank as a mass of soil was observed (see Photo 4a). Similarly, due to the undermining of the lower bank layer, cantilever or overhang bank was formed. As a result, tension crack was observed in the upper bank layer as can be seen in Photo 4b which ultimately resulted in the mass failure. The arrow in the photo represents the flow direction. Unlike in Sunsari River, in case of the Lohandra River, as it can be seen in Photo 4(c,d), mass failure is not the active mode of bank failure although some failed materials can be seen near the bank. It suggests that the erosion of bank toe caused some of the bank materials to fail. As a response, the bank readjusted to the stable slope by the failure of some materials. During the low flow, the failed bank materials tend to get armoured by the growth of vegetation which during the next flood period resist the bank erosion to some extent. In order to control the bank erosion process, different counter-measures were implemented along the study reaches of both the Rivers. The next sub-section discusses the performance of such counter-measures against bank

Before the implementation of groynes, as discussed in subsection 5.1 and shown in Photo 4 (a & b), the mass failure of bank materials along the outer bank was very active due to the concentration of flow along the outer bank. However, the implementation of counter-measures resulted in a massive evolution of channel alignment as well as morphology. As it can be clearly seen from Photo 6 (c, d) that a considerable amount of land has been reclaimed as a result of the deposition induced by the implementation of the counter-measures. This deposited land has eventually turned into a mainland floodplain. However, the risk of erosion is now shifted to downstream and hence bank protection is required in that portion. This had a positive impact on the outer bank but the opposite bank has been eroded significantly due to the shifting of the channel towards it. As a result, almost the same amount of area deposited on the outer bank has been

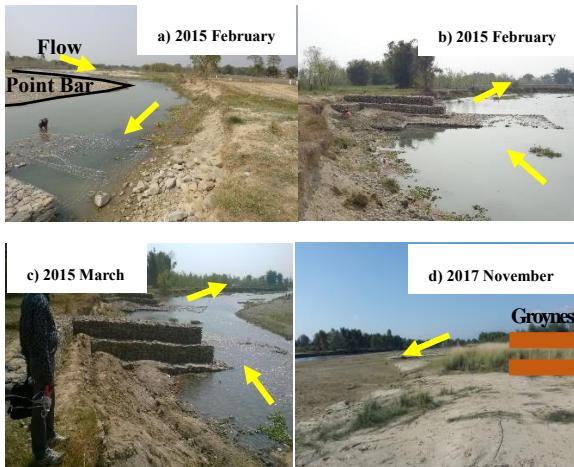
Photo 5: Implementation of groynes in Lohandra River.

A conceptual orientation of groynes in a channel bend is shown in Fig.7. In general, groynes are placed at the outer bank where the erosion is severe. In this regard, impermeable groynes made up of galvanized iron (GI) gabion wire and boulders were constructed in the study reach as shown in Photo 5.

Before the implementation of groynes, it can be clearly seen from Photo 5(a-c) that the flow is concentrated on the outer bank. Also, the point bar located on the opposite bank tend to push the flow further towards the outer bank. However, after the implementation of groynes, it had a significant influence on the flow and the bed morphology as seen in Photo 5d. Due to the effect of groynes, the point bar on the opposite side has been reduced and the main flow is now shifted towards the opposite banks. A significant amount of deposition has occurred in the space between the groynes as well as at the immediate downstream. In fact, the deposition is nearly upto the crest of groynes. Also, the growth of vegetation further strengthened the deposited sediments. Although it seemed that the purpose of implementing groynes was achieved, there are certain factors that need to be taken care of. As the flow is now shifted towards the opposite bank, there are high chances of erosion along that bank. Similarly, along the groynes implemented bank, the erosion shifted downstream. So it needs to be protected as well. This suggests that the phenomena of erosion and channel adjustment are complicated in a meandering channels. Therefore in case of meandering channel, the analysis of the problem needs

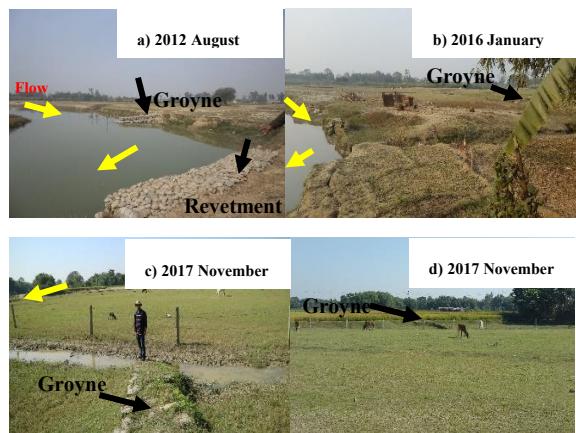
Photo 6: Implementation of Groynes for bank protection and its effect in Sunsari River.

In case of Sunsari River, as seen in Photo 6a, one straight type impermeable groynes, as well as a revetment, were implemented in the year August 2012 on the outer bank to check the bank erosion. The length of the groyne was 9m the top-level of which coincide with the level of the bank and slightly sloping towards the channel. The other configuration was similar to the groynes of Lohandra River with launching apron at the nose and at upstream and downstream of the main body. About 30m downstream of the groyne, a revetment wall of length 9m and height 1.5m was also installed.

a consistent erosion and shifting of the channel towards the right bank occurred. The implemented groyne as seen in Photo 6 (b-d) has been completely filled with the sediment and is about 100m away from new bankline. The deposited portion of land on the left bank has been reclaimed but the almost same amount of land has been lost to erosion on the opposite bank. The major factor that can be attributed to this evolution of channel pattern is the location of the apex-2. At first, the implementation of groyne pushed the flow towards the channel center. As it can be seen that the apex-2 has a very sharp bend almost  $90^{\circ}$ . Also, the bank just downstream of apex-2 is protected by the revetment as well as there is plenty of vegetation which further strengthened the bank against erosion. Due to this reason, the outer bank couldn't be eroded. This factor along with the groyne implementation behaved as an external forcing to the channel. Consequently, the channel tends to adjust to this external factor by eroding the bank that is weak and easy to erode. The consistent shifting of the channel centerline between the apices from left bank to the right bank clearly justifies the above discussion.
