Water shielding mechanism of a double-layered compacted earth structure and its application to conservation of tumulus mounds

Mai Sawada & Mamoru Mimura

Mitsugu Yoshimura

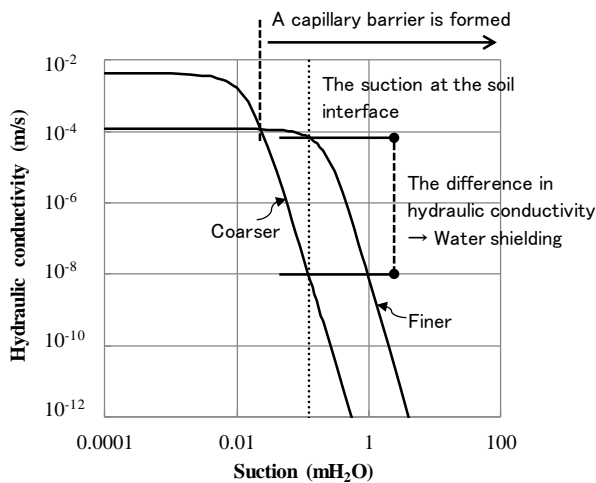
Figure 5. The mechanism of water shielding by a capillary barrier.

The mechanism of water shielding by a capillary barrier is illustrated by relations between suction and hydraulic conductivity of the finer and coarser grained soils shown in Fig. 5. The unsaturated hydraulic conductivity of the soils is determined by experimentally obtained soil water characteristic curves and Mualem's model (Mualem 1976). A capillary barrier is formed as far as the suction at the soil interface is located to the right of the intersection shown in Fig. 5, and the diversion capacity degrades as the suction moves toward the intersection.

As described in above, a capillary barrier is caused by the difference in hydraulic conductivity of the finer and coarser grained soils, and the diversion capacity is largely controlled by precipitation. As precipitation increases, the suction at the soil interface moves toward the intersection in Fig. 5 so that the infiltrating water equals to the sum of the lateral flux in the finer grained layer and the vertical flux into the coarser grained layer. A capillary barrier is not effective anymore for heavy rain. In the restoration of the Garandoya Tumulus, the burial chamber is hence designed to be protected by both the capillary barrier and the concrete building. The capillary barrier is expected to perform as the first water shielding layer. The water

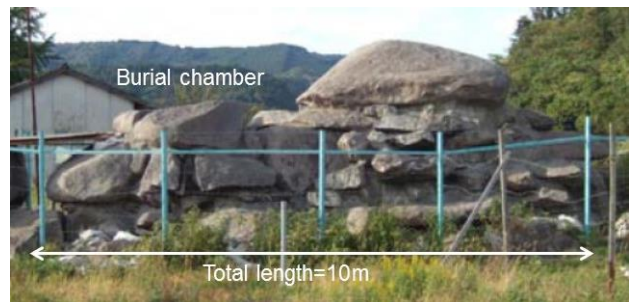
Figure 6. The Garandoya Tumulus before the restoration (Mimura and Yoshimura 2011).

earth mound of 30m in diameter. As shown in Fig. 6, the mound was, however, completely destroyed and the burial chamber had been exposed to natural environment for several decades. Due to the destruction of the mound, the mural painting had been deteriorated by dew condensation and salt crystallization promoted by temperature change in the chamber.

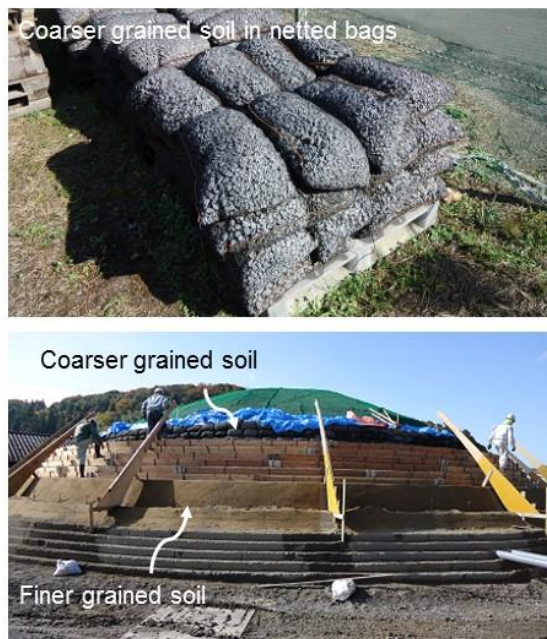
Figure 8. The construction of the double-layered earth mound (September, 2014).

Fig. 7 shows the Garandoya Tumulus restored by constructing a double-layered earth mound. The earth mound has been applied to cover around the concrete building that stores the burial chamber. The coarser grained soil was packed in netted bags and placed on the building. Then, the finer grained soil layer was compacted on the coarser grained layer using a lightweight compaction machine. The soils used for the restoration were the same with those used in the model chamber tests. They were
