Fracture behavior of single crystal silicon with thermal oxide layer

Toshiyuki Tsuchiya, Kenji Miyamoto, Koji Sugano, Osamu Tabata

Department of Micro Engineering, Kyoto University

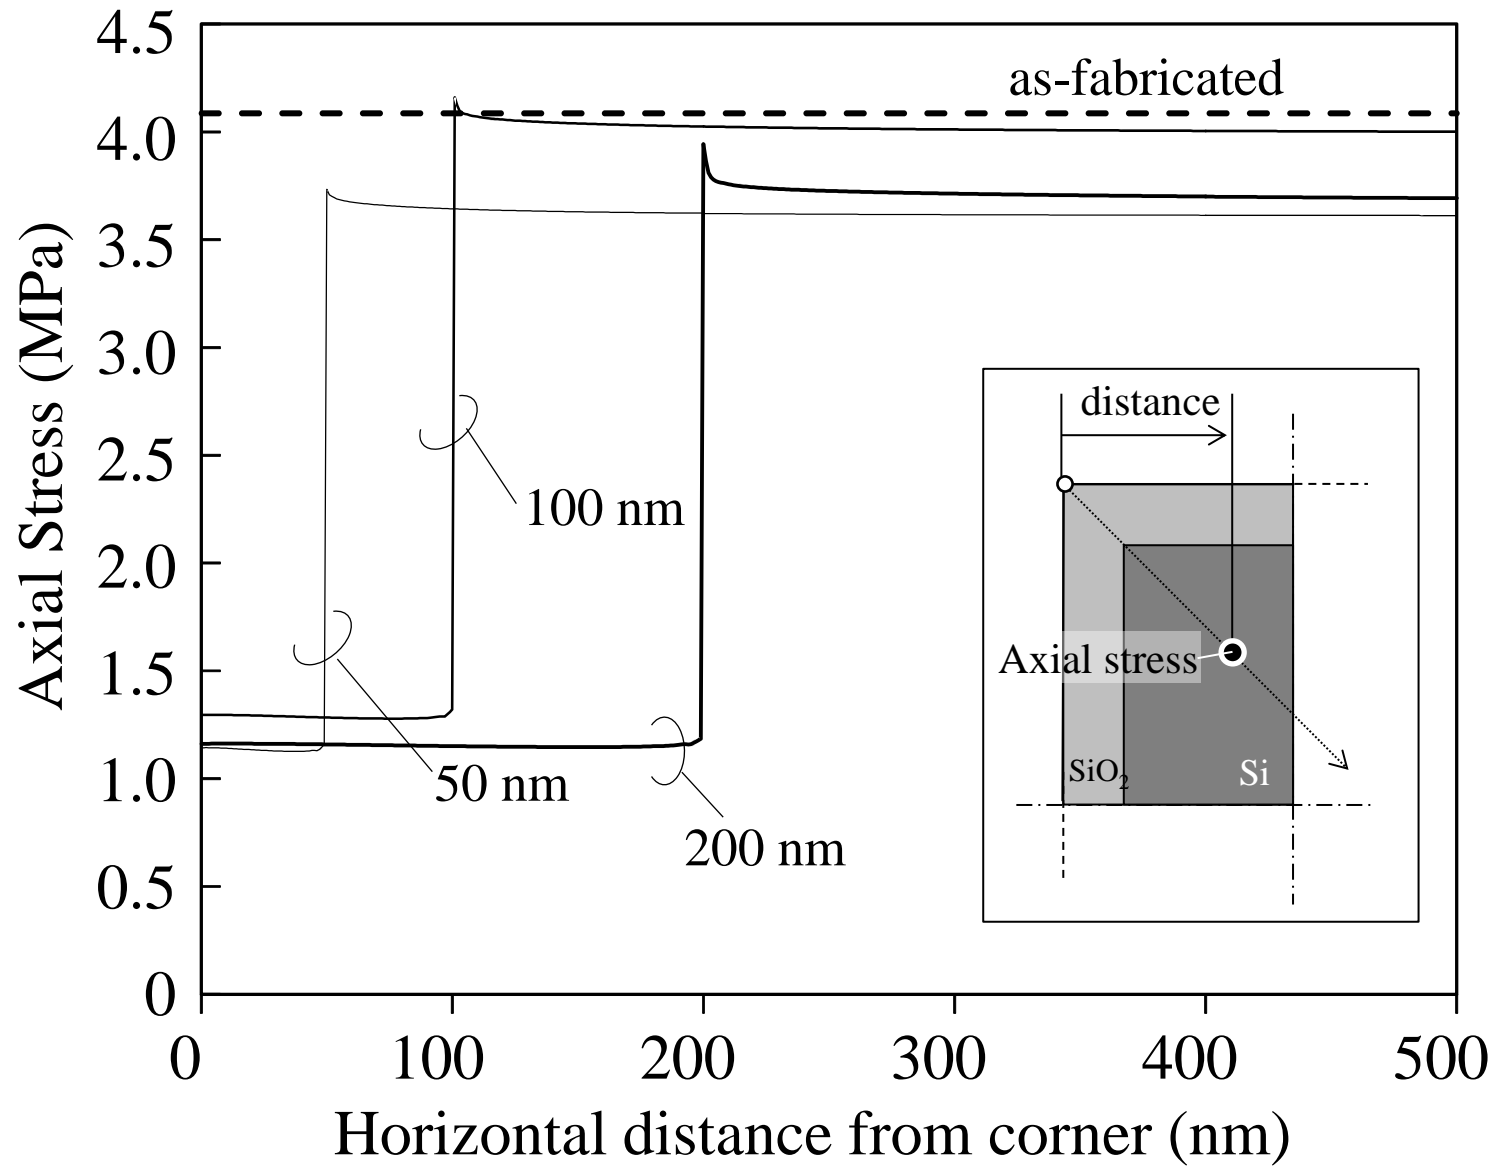
Fig. 12

Figure 12 Simulated axial stress distribution along 45-degree direction from corner applying average tensile stress. Horizontal axis indicates vertical and horizontal distance from corner.

The axial stress distribution of the gauge part at the average strength was simulated using FEM. The distribution of each specimen was extracted along the diagonal direction (45°) from the corner and is plotted against the horizontal distance from the corner in Fig. 12. The axial stress in the oxide layer is smaller than 1.3 GPa in all oxide thickness. The stress is high but it is lower than the tensile strength of SiO_2 film (1.85 GPa) [12]. The oxide prepared from the single crystal silicon beam, fully oxidized using thermal oxidation the tensile testing was conducted in the air. The measured Young's modulus and fracture strain was 74 GPa and 2.5 % respectively. Since the surface was smoothen by the oxidation process so the oxidized silicon sample without any post processing (dry or wet etching) has high strength.
