Conservation of a decorated ancient tomb in harsh climate conditions

Odkhuu Angaragsuren

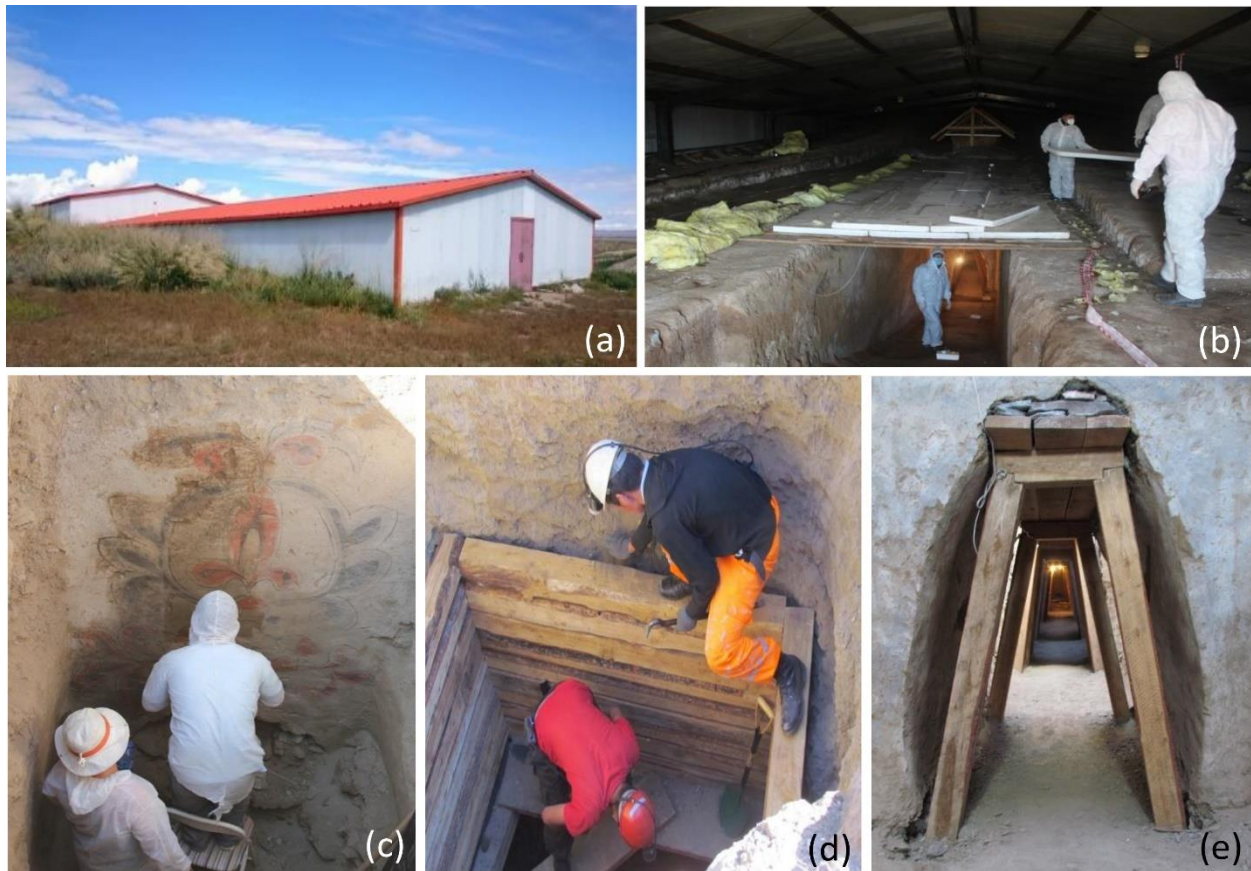
Figure 1.3. Mongolian team carried out protection works for the preservation of the mural paintings in situ. a) Permanent shelter with metal panels, b) Open dromos condition (closure method), c) Consolidation intervention, d), e) Work to prevent the mural painting from collapsing

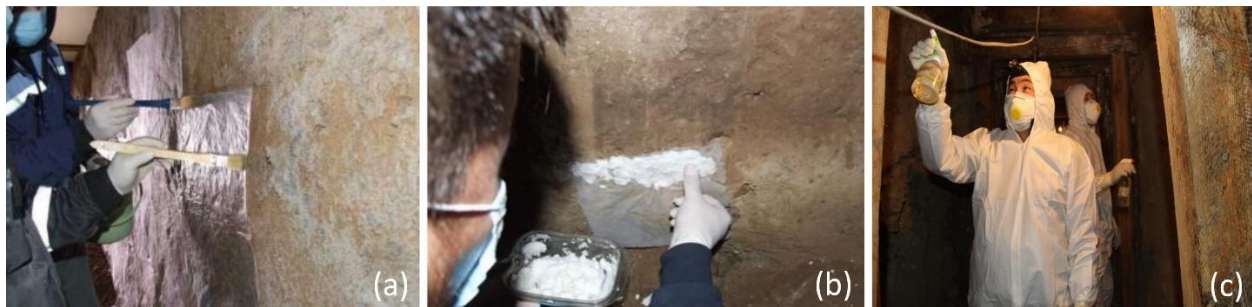
Figure 1.4. Preservation-Conservation workshop (UNESCO). a) Re-positioning of paint layer detachment, b) Desalination test, c) Removal of microorganisms from wooden propping

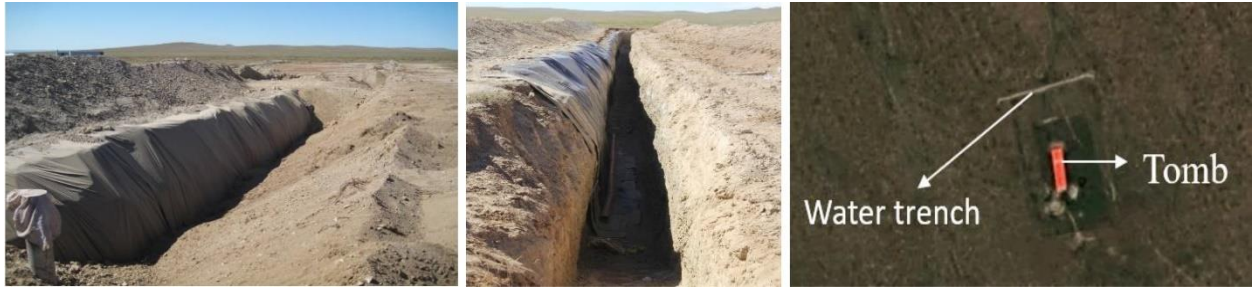
Figure 1.5. The trench was dug about 50-60 m north of the tomb's fence

From 2014 to 2019, UNESCO experts carried out on site field surveys under the framework of protecting, conserving, promoting, and transmitting tangible heritage of the UNESCO/Monaco Fund-in-Trust project "Capacity-Building and Awareness-Raising for the Preservation, Conservation, Visibility, and Sustainable Management of the Archaeological Site of Shoroon Bumbagar of Mount Makhan, Mongolia" in addition to holding a series of capacity-building workshops for the preservation and conservation of ancient mural paintings at the site (Lunsford, 2015, para.1). Within the framework of cooperation, re-positioning of paint layer detachment, desalination test and removal of micro-organism from the wooden propping were carried out (Figure 1.4). Moreover, a Turkish Cooperation and Coordination Agency (TIKA) specialist visited the site and carried out a field survey and some preservation activities that digging the trench at the north side of the tomb and installing drainage pipes and pump for extracting water concluded (Figure 1.5).

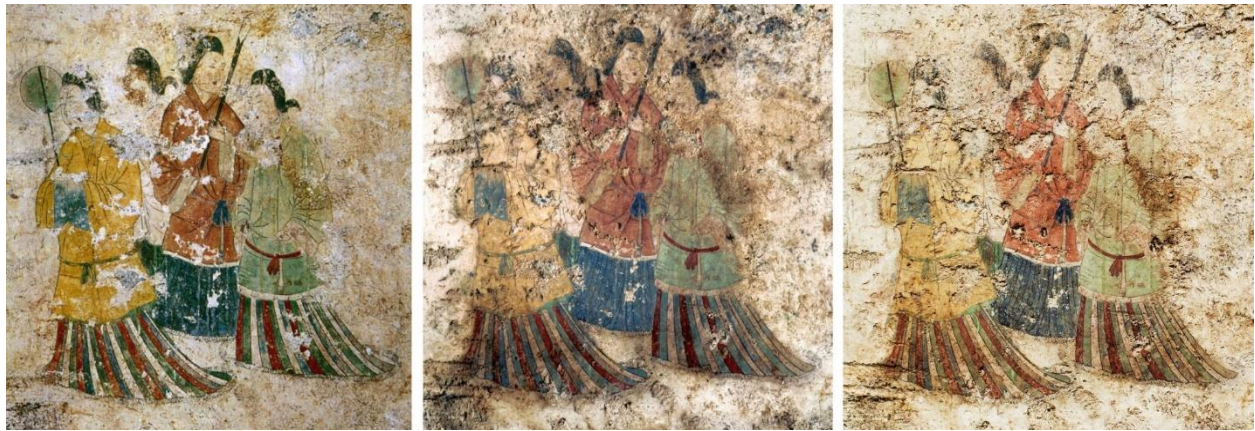
Deterioration of wall paintings caused by biological weathering is a serious problem in the field of cultural heritage (Figure 1.7). Biological weathering can be attributed to the increasing level of biodeterioration observed in decorated tombs and mural paintings (Kiyuna et al., 2021; Kiyuna et al., 2018; Kigawa et al., 2013; Wang et al., 2010; Miura, 2007). Microorganisms like fungi, algae, and lichens develop rapidly when exposed to air with a relative humidity of over 65%. They may take the form of stains or they may be spotty in character and of varied color, and change the appearance of the paint layers and the rendering of the decorations (Mora: 1974).

Figure 1.7. Biological weathering on the Takamatsuzuka mural painting. “Asuka Bijin” mural is shown as it was first discovered in 1972 (left), darkened by mold in 2006 (center), and current condition (right). (© The Japan times).

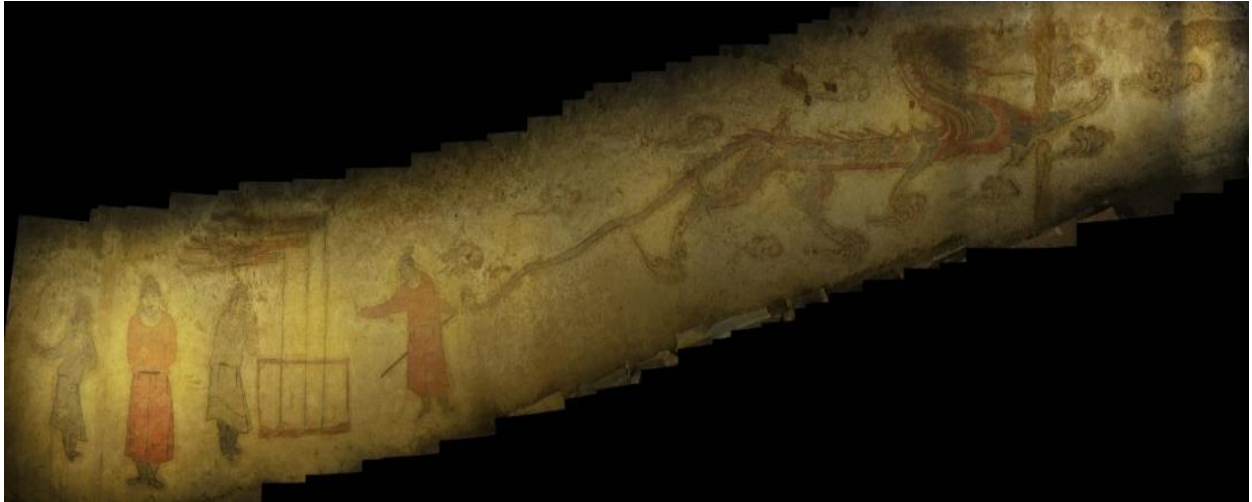
Figure 2.2. Mural painting on the east side of the open dromos (© Institute of History and Archaeology)

Sergey A. Yatsenko clearly included the image of the mural painting in his research. On the west and east sides of the open dromos were the tiger and dragon, and on either side of the northern end of these walls, groups of three men dressed in red and brown caftan that pledged to each other with a sword were standing under three banners (Figure 2.2). The north wall of the open dromos above the entrance to the corridor with covered passages and airshaft was depicted as a wooden building with roof eaves from which the birds could fly away (Figure 2.4a). On the walls of the first airshaft (on either side) were included two grooms dressed in a Turkic costume holding the two saddled horses (Figure 2.3). The upper part of the north wall of the first airshaft had a lotus flower (Figure 2.4b) (Yatsenko, 2014).

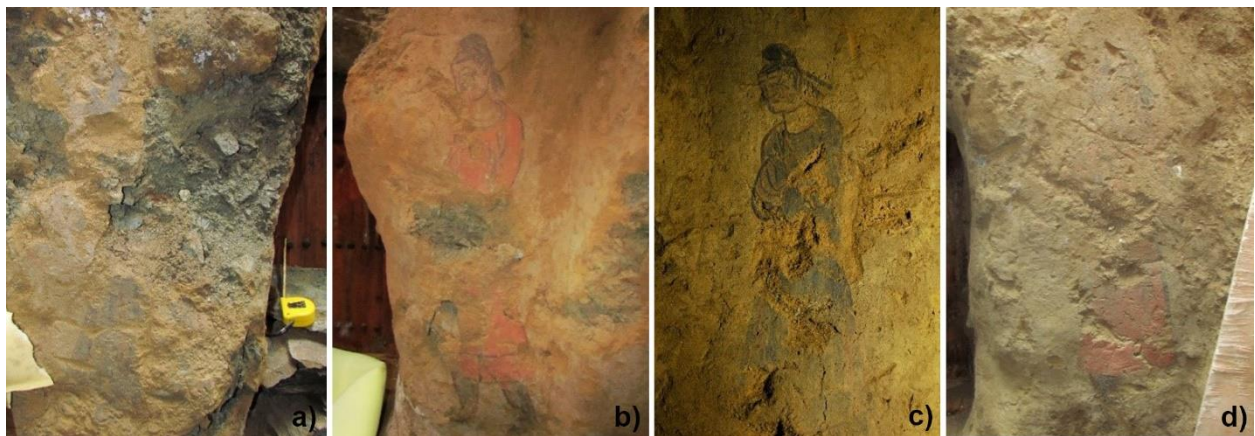
Figure 2.6. ‘A standing man’ painting which is painted on the south and north side of the niche

In the next compartment, that is the second airshaft, family members of the deceased were shown on both sides. The portraits of a man and lady were included on the west and east walls. On the west side, a man dressed in a Turkic caftan and a lady dressed in the Chinese costume of that period were shown (Figure 2.5a). Unfortunately, the left portraits were poorly preserved. The image of the youth and young lady with the Chinese costume was included on the east wall (Figure 2.5b, c). On the upper part of the north wall of the second airshaft, a mythical animal head⁵ was displayed (Figure 2.4c). The image on the east wall of the third airshaft contained a standing man and a dog (Figure 2.5d). The men dressed in black and red caftan with hats were observed on the south and north sides of the antechamber located on the east and west walls (Figure 2.6). On the upper part of the north wall, a wooden building was observed (Figure 2.4d).

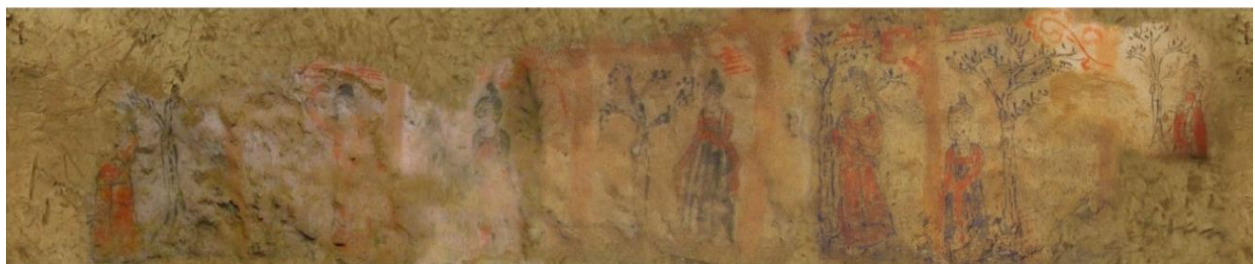
Figure 2.7. The mural painting inside the burial chamber (© Institute of History and Archaeology)

In the burial chamber, the mourners including the junior members and young relatives who were praying for the deceased were shown. The left of the entrance showed a symbolic row of men and women (seven of them preserved) with a predominant red colored attire. Each of them prayed next to a tree (Figure 2.7).

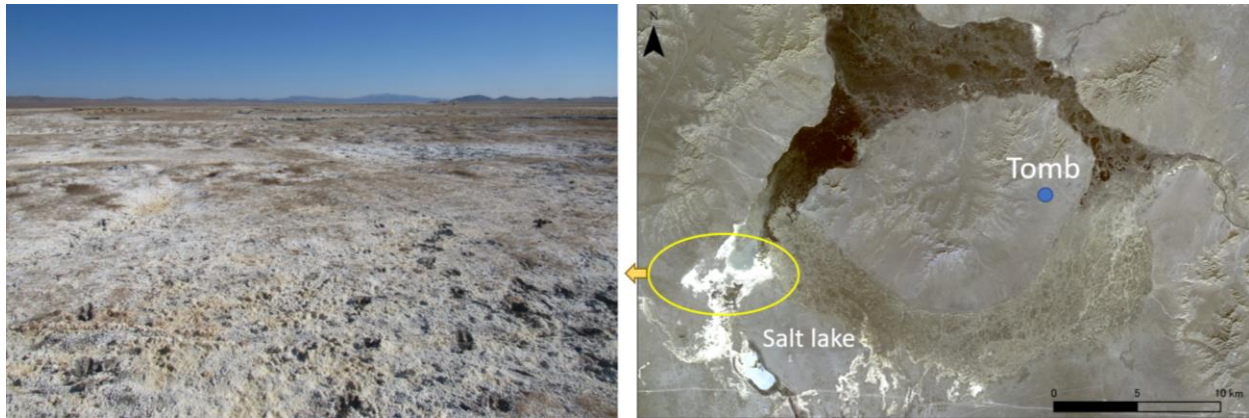
Figure 2.8. Salt lake near the Shoroon Bumbagar site

One of the features of the site is its natural saline formation are widely distributed. There are small salt lakes to the west of the Shoroon Bumbagar site (Figure 2.8).

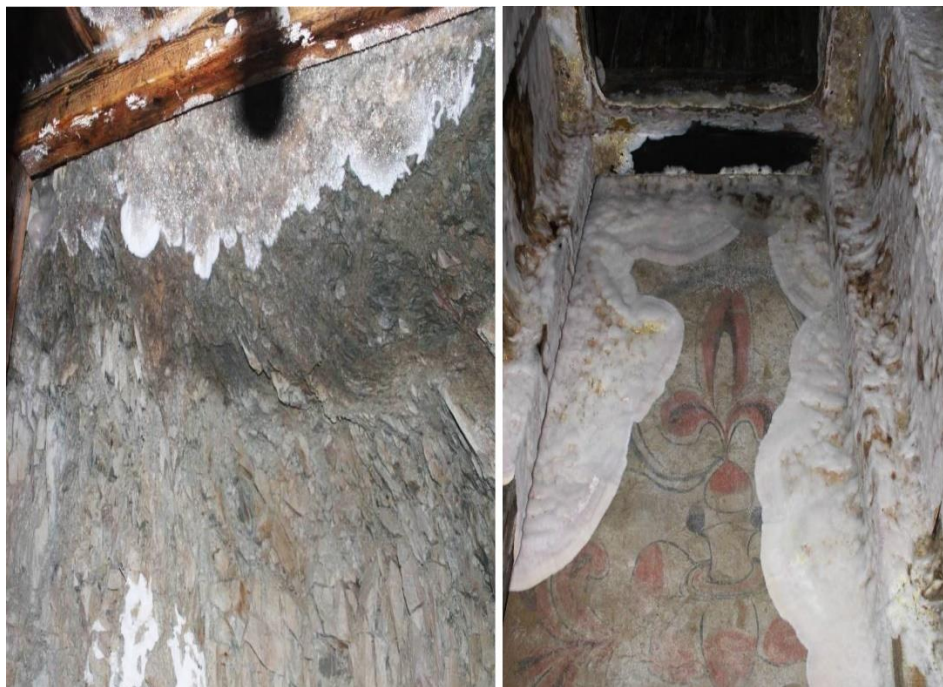
Figure 4.2. Fungus developing on surface of the mural painting in the airshafts and burial chamber

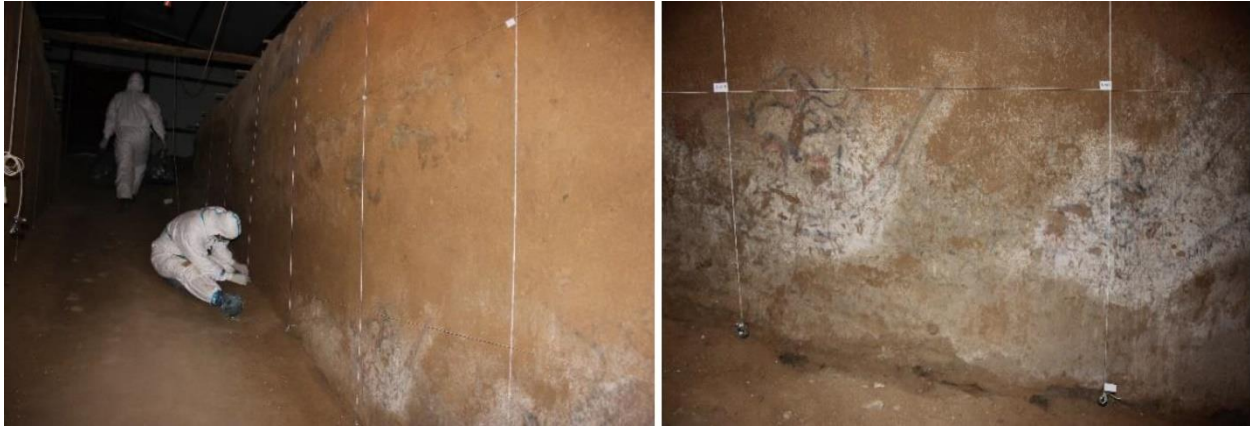
Figure 4.6. Preparation to photographic documentation

The open dromos was approximately 200-cm wide and 20-m long. The floor level was five meters below the ground level. As the first step of the monitoring and documentation of the deterioration area of the open dromos, photo documentation was required to record the preservation conditions. Each wall was subdivided into 100 cm × 100 cm grids, which were installed five centimeters above the surface of the mural painting using fitted threads (Figure 4.6). Each subdivided section was numbered horizontally from "I to XVII" (from the entrance to the north side) and vertically from the ground level to down as "A to D" (Figure 4.7). The subdivided parts were individually photographed for an extended interval to monitor the surface changes or deterioration processes and subsequently compared.

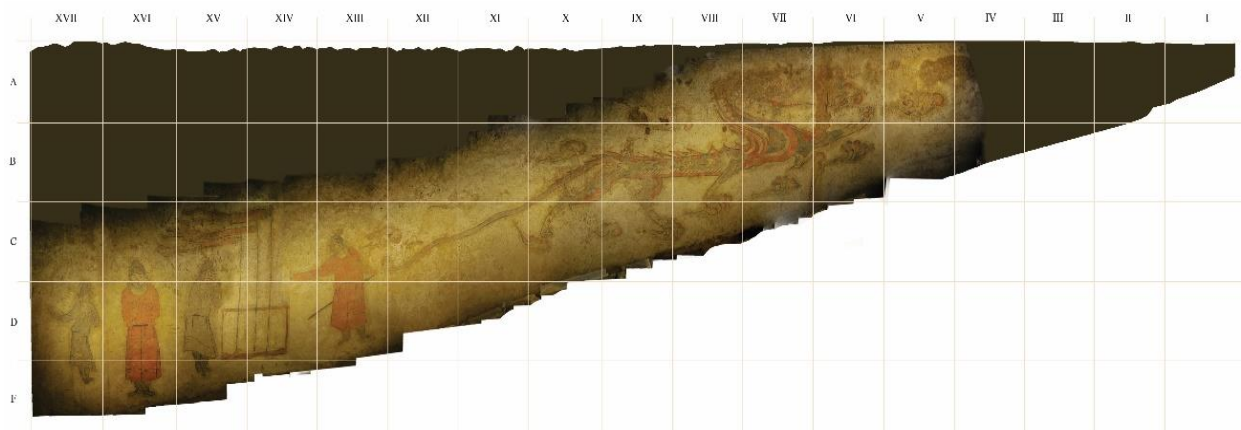
Figure 4.7. Horizontally and vertically subdivided parts on the wall (Eastern wall of open dromos)

- Part I (orange) showed minimal deterioration in which peeling of the paint layer was observed in some places.
- Part II (light blue) showed that the paint and ground layers were lost, but there was no mortar layer loss.
- Part III (red) showed significant deterioration on the walls. The paint, ground, and mortar layers were completely destroyed. The underlying bedrock was visible.

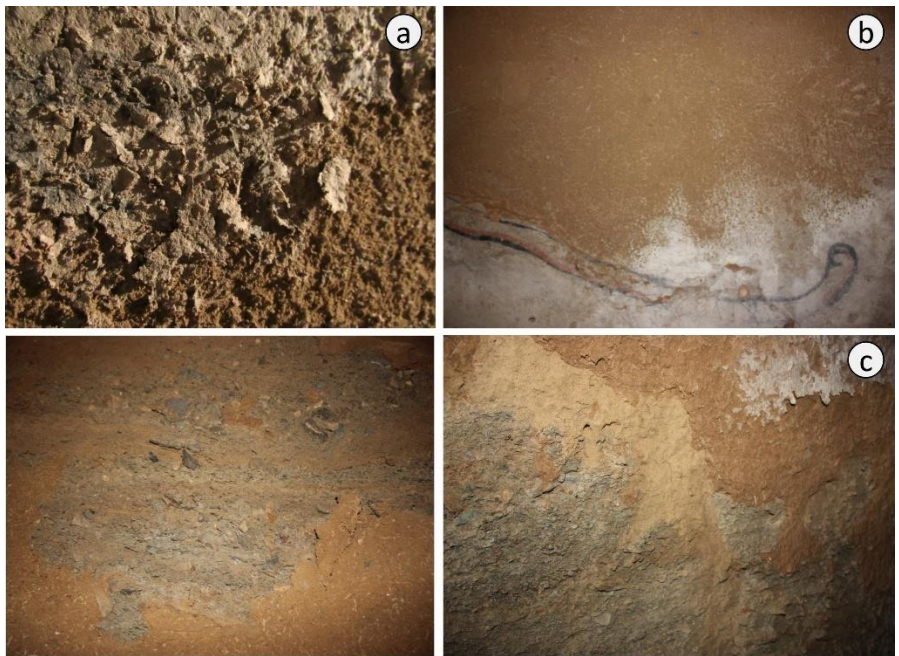
Figure 4.8. Mural deterioration. a) loss of the paint and plaster layer, b) Detachment c) Scaling process

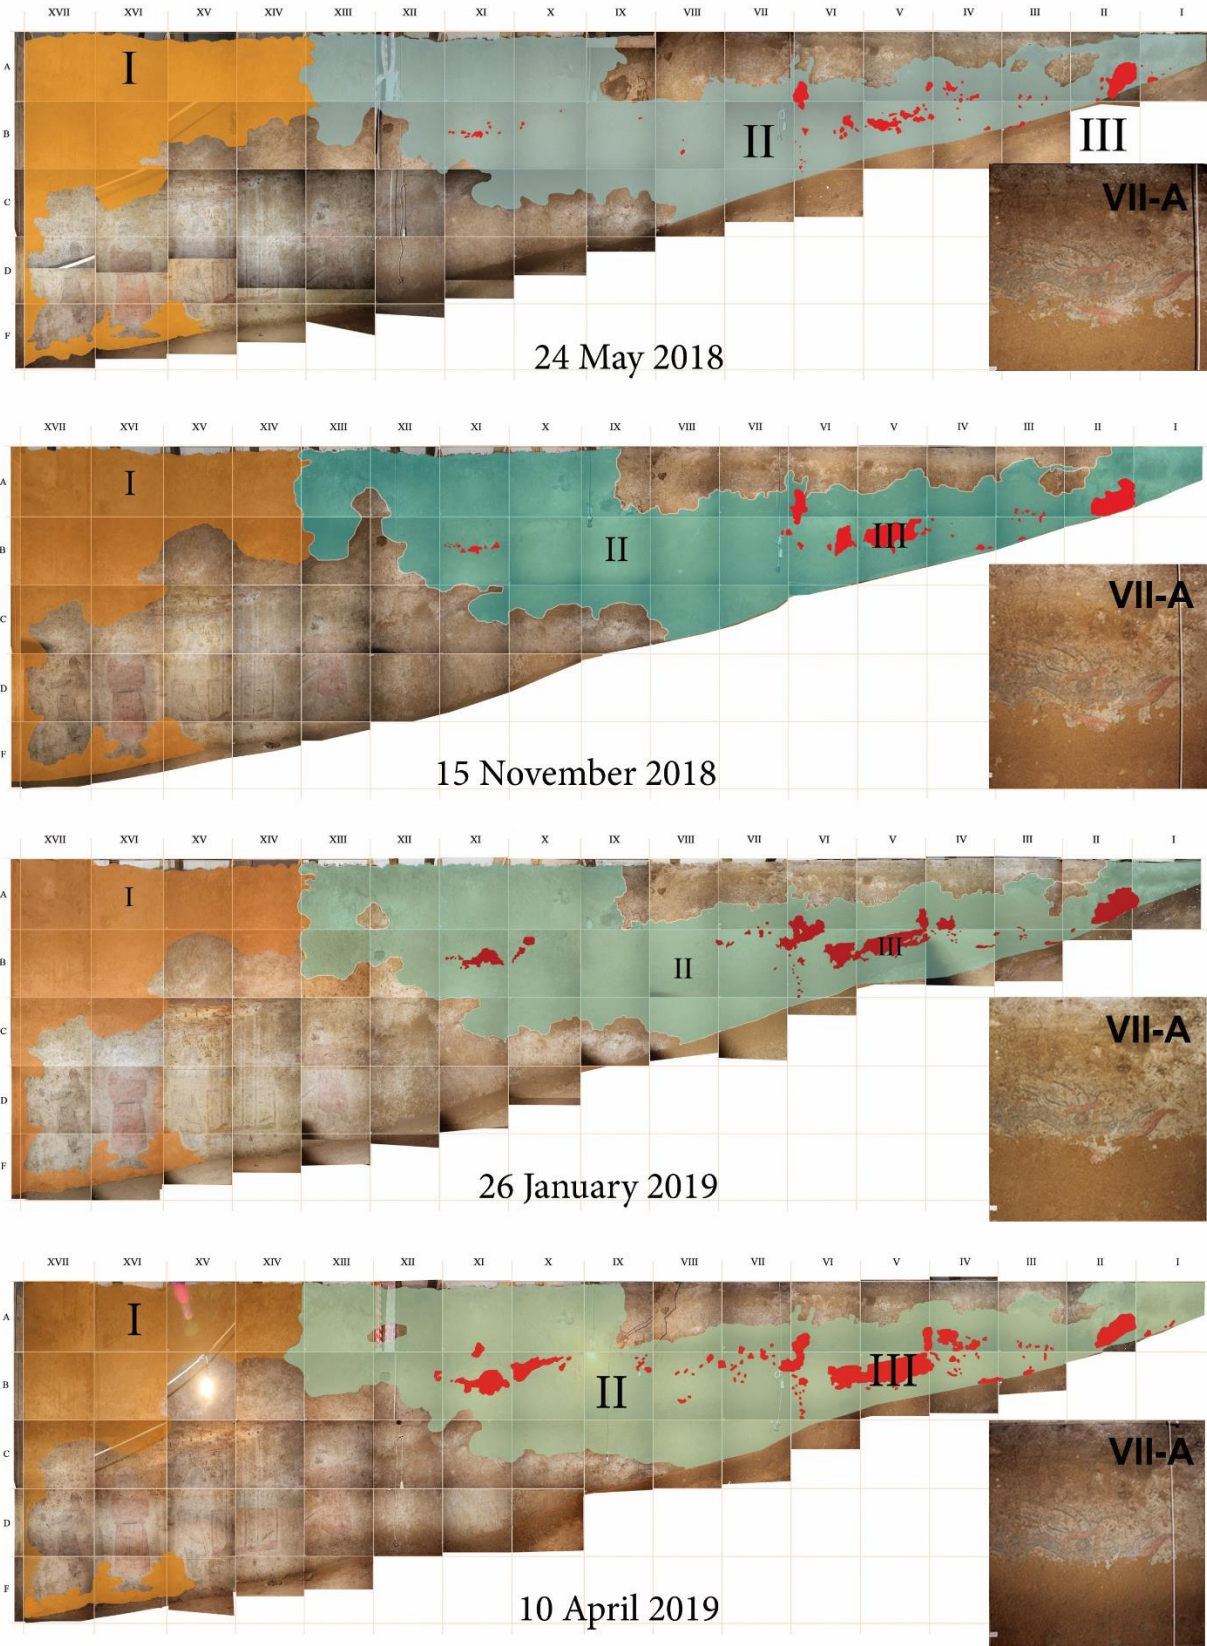
The distribution of the eastern wall is shown in Figure 4.10. In 2014, no deterioration was observed. In September 2017, a peeled off paint layer was detected in some places on the middle part below the ground level. The light blue part spread from IA to XIII. Similar deterioration was observed in the lower parts of the eastern wall (Figure 4.10). According to the observation survey in January and May 2018, the orange and blue parts did not change. Nevertheless, the lost area of the mortar layer (red part) was spread from IA to VIA, VIB, and V IIIB to XIB. The orange and light blue parts did not change, and the red parts were slightly spread in VB, VIB, and VIA during November 2018 and January, April, and June 2019 (Figure 4.10).

Figure 4.10. Condition assessment and deterioration distribution of the eastern wall

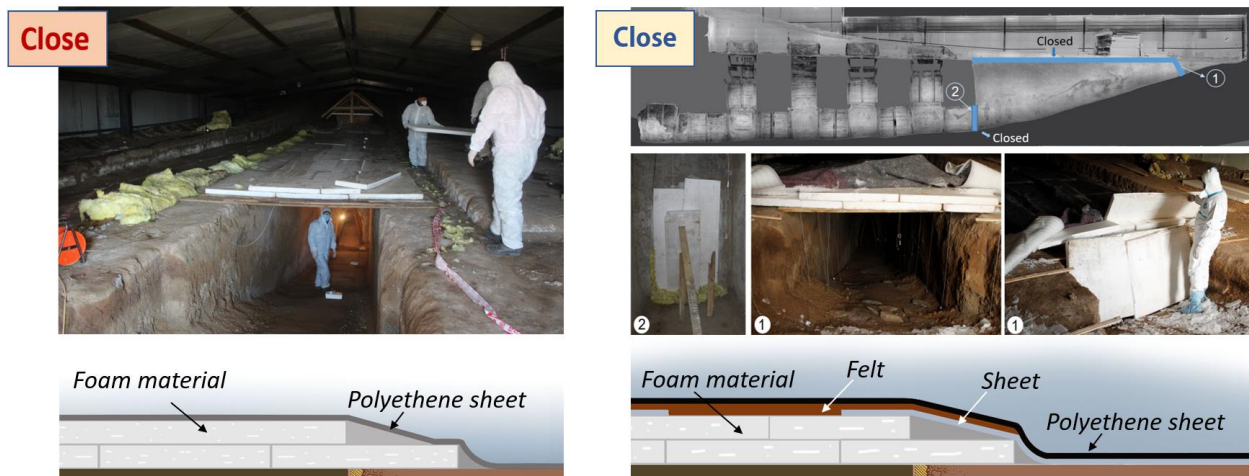
Figure 5.8. Open dromos condition during open and close period. a) Before sealing method, b) After improving the sealing method (1) and closed the first corridor (2)

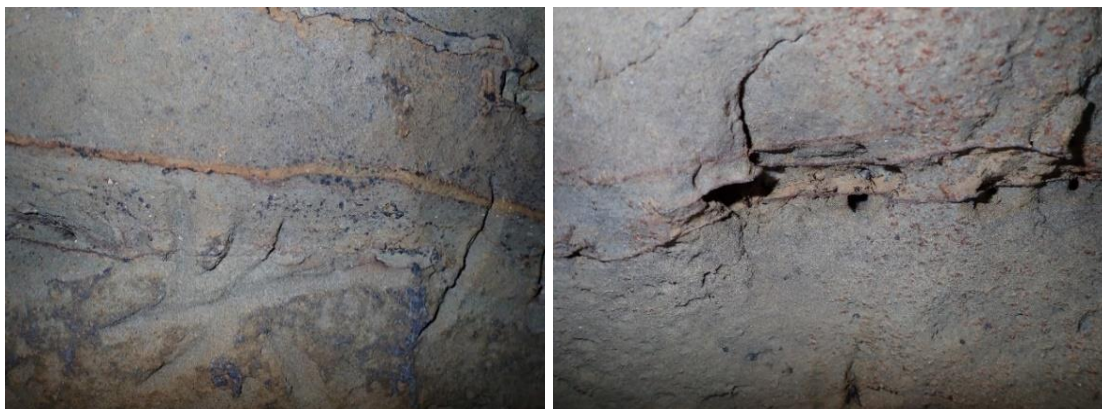
Figure 6.6. Hydrated iron oxide precipitation on wall of the Yokoana tomb No.16

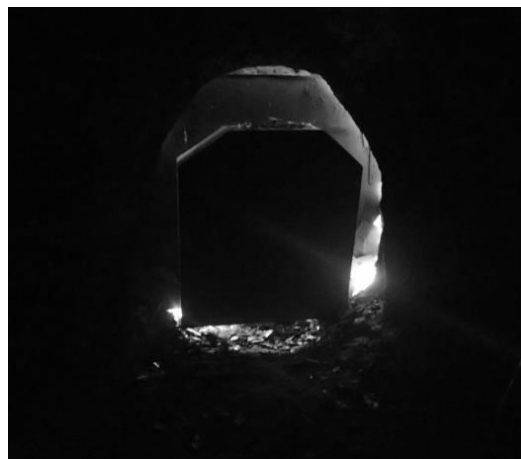
Figure 6.17. State of the gap between the entrance and the door of the Yokoana tomb No.17. The photo captures the gap from the inside with the tomb closed

As per the results, outside air ventilated the lower part of tomb during winter probably through the gaps around the closed door (Figure 6.17). When this tomb's entrance was closed, there was less diurnal variation than tomb No.16.

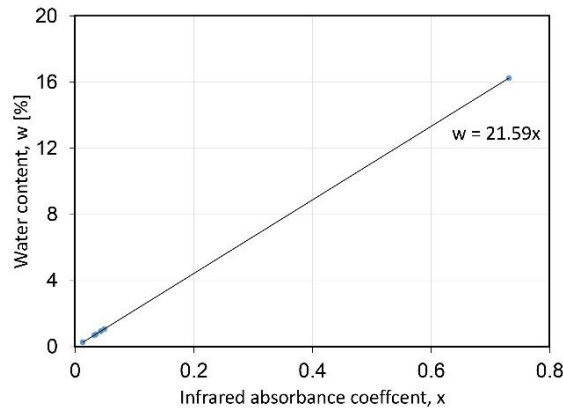
Figure 6.21. Correlation between coefficient of IR absorbance (x) and the sandstone water content (w). Dashed lines accompanied with the equation and correlation coefficient (R) indicate regression lines

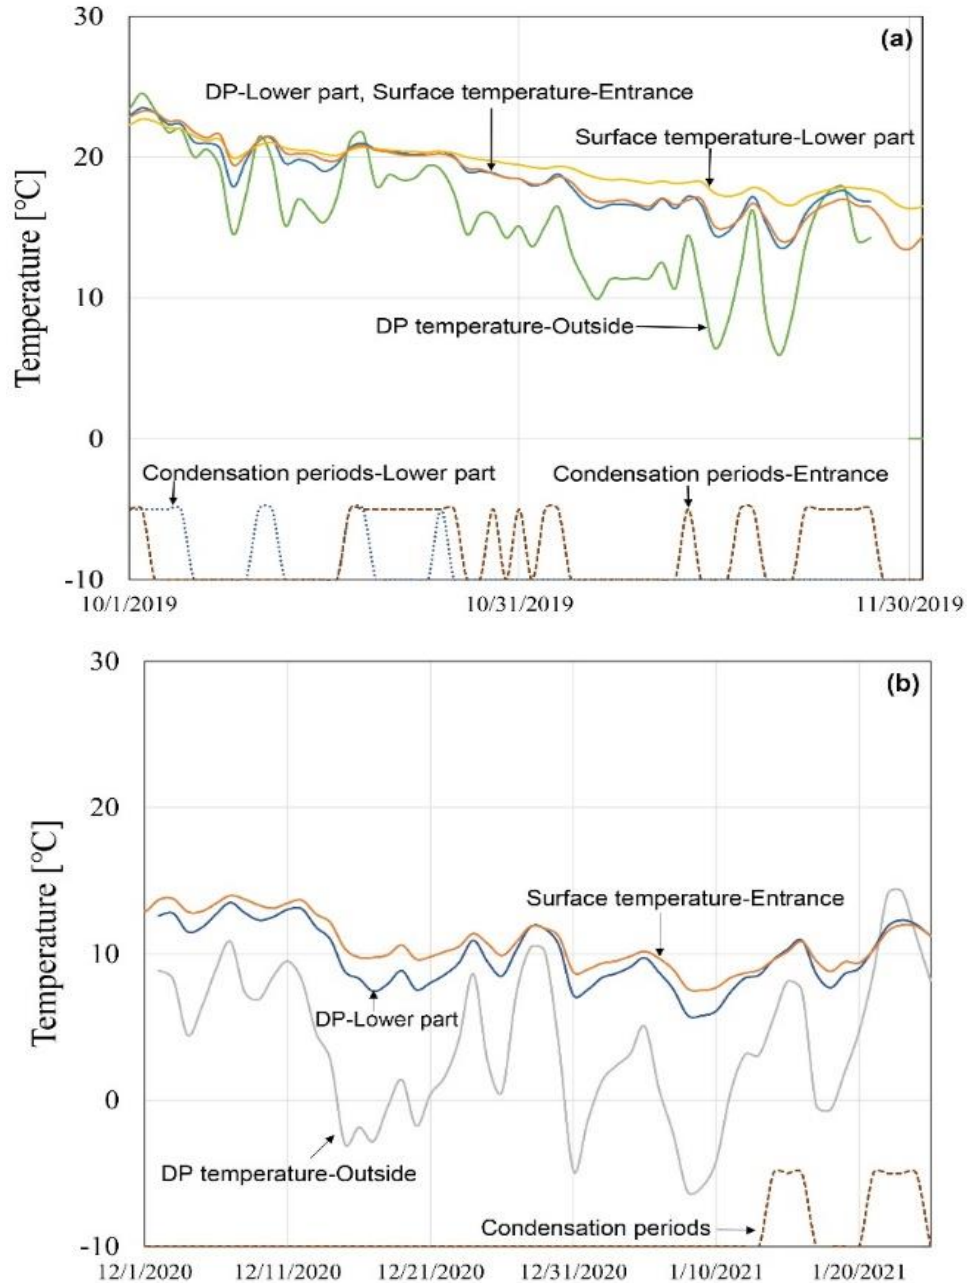
Figure 6.24. Dew point temperature for the lower part of the tomb, the north wall (lower part), south wall (near entrance) of the tomb No.16 after close. a) October 1 to November 30, 2019, b) December 1, 2020 to January 25, 2021

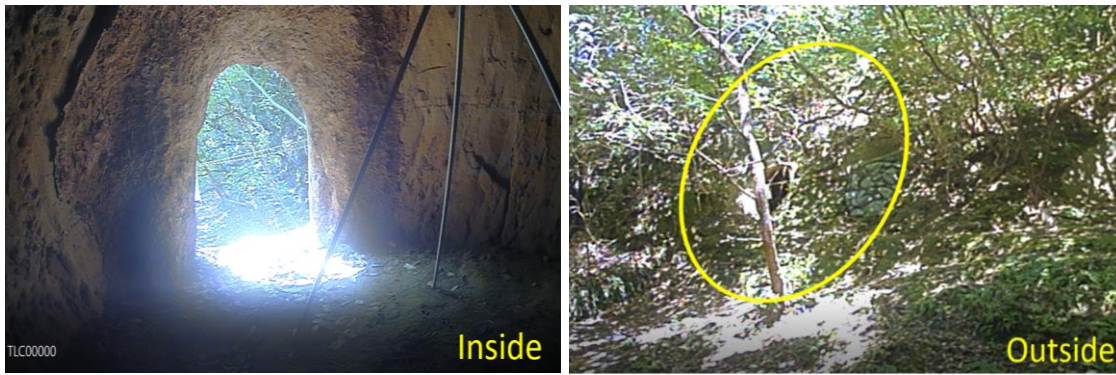
Figure 6.25. Solar radiation inside and outside the tomb No.16 at 10:35 am, August 28, 2018

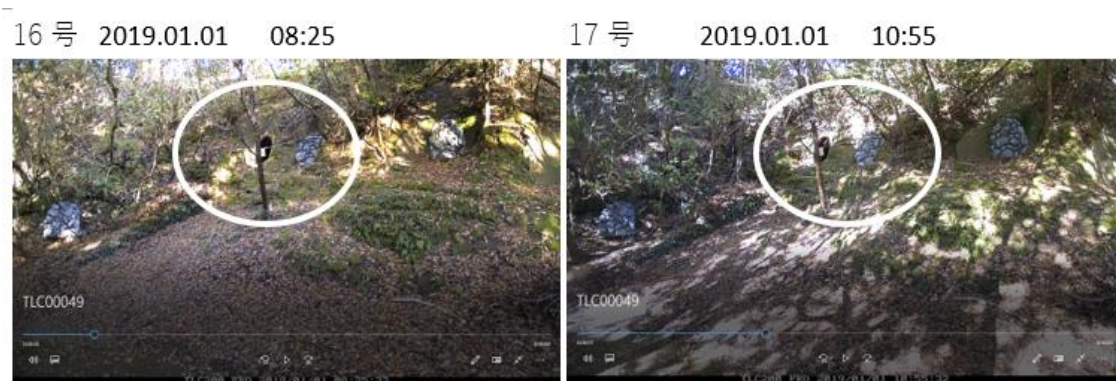
Figure 6.26. Solar radiation outside the tomb No.16 and No.17

The solar radiation reflected on tomb No.16 in the morning from 9:10 am to 10:30 am on August 28, 2018 (Figure 6.25). To examine the documentation, the solar radiation reflected on tombs No.16 and No.17 from 8:25 am of the morning to 14:40 pm in the mid-afternoon on January 1, 2018 (Figure 6.26). This result indicates that the heat is transferred to the tomb initially by radiation, followed by the flux of heat through the stone material. Therefore, under the influence of the above phenomenon, the moisture on the wall surface may evaporate.
