Geo-disaster Prediction and Geo-hazard Mapping in Urban and Surrounding Areas Progress Report in FY 2004

Masahiro CHIGIRA, Susumu IAI, Roy C. SIDLE, Toshitaka KAMAI,
Mamoru MIMURA, Hiroshi SUWA, Takashi SAITO,
and Tetsuo TOBITA

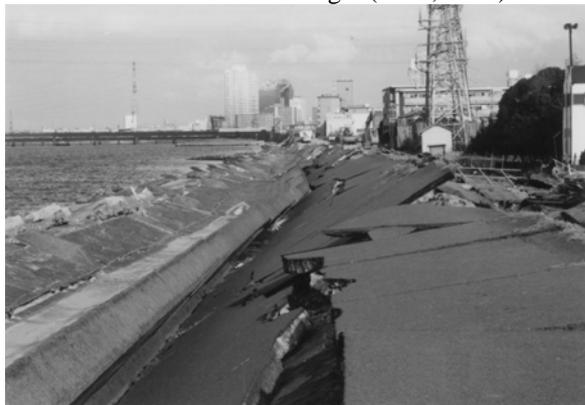
Fig. 1 Typical damage to river embankments (Yodo river embankment during 1995 Hyogoken Nambu earthquake) (after Ozutsumi et al, 2002)

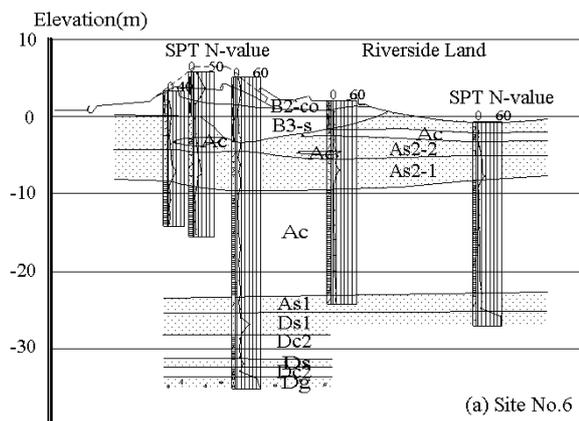
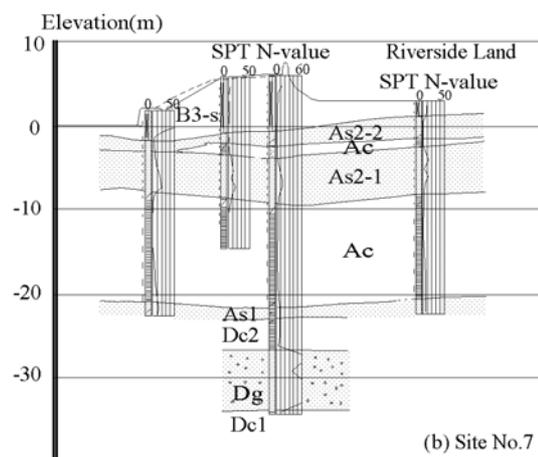
(a) Embankment with serious damage

(b) Embankment with minor damage

Fig. 2 Cross sections and soil profiles (after Ozutsumi et al, 2002)

The cross sections and soil profiles of these embankments are shown in Fig.2 (JICE, 2002). These

embankments about 3 m high were constructed on a Holocene deposit about 20 m thick. The deposits consist of, from the top, the upper sandy layer (As2) about 10 m thick, clay layer (Ac) about 10 m thick and the lower sandy layer (As1) about 1 m thick. The SPT N-value of As2 layer is about 10. The soil profiles at both sites are similar to each other except for the existence of a cohesive layer Ac about 2 m thick below the embankment at the site of the embankment having smaller settlement as shown in Fig. 2(b). Foundation conditions significantly affect the seismic performance of embankments.

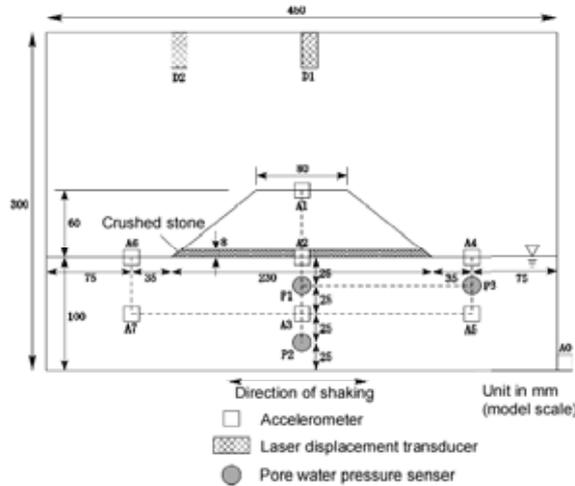
Fig. 3 Cross section of an embankment in centrifuge model tests (1/50 scaling at 50g field)

Centrifuge model tests were performed in 50g centrifugal acceleration using the geotechnical centrifuge at Disaster Prevention Research Institute, Kyoto University, with an arm length of 2.5 m. The cross section of an embankment was determined by referring to that at the Yodo river and shown in Fig. 3. The model embankment and foundation ground was made of Soma No.5 sand. The foundation ground condition was varied using a loose deposit for one series of tests, and a dense deposit for other. In each series of tests, amplitude of input motion was varied

in three levels. Total of six cases of mode tests were performed. Relative density of model foundation ground was about 30% for loose deposit, and 70% for dense deposit. Input motions were sinusoidal wave, 1Hz in prototype scale, with 20 cycles of loading.

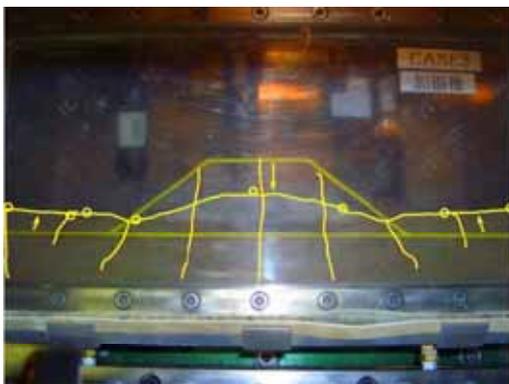
Fig. 4 Measured deformation of embankment on

loose foundation ground after shaking (Case3)

Typical examples of residual deformation of the embankment model are shown in Figs. 4 and 5. The one shown in Fig. 4 is the results for loose foundation ground subject to a peak acceleration of 313 Gal (Case3). Excess pore water pressures in the loose foundation ground gradually increased as cyclic shear is applied due to shaking. Foundation ground gradually softened due to the excess pore water pressure rise. The embankment pushed down the softened foundation ground, resulting in settlement at the crest associated with lateral spread deformation at the foundation ground.

mode is in good agreement with that measured and shown in Fig. 4. The agreements include the overall pattern of settlements associated with the lateral movement of foundation ground.

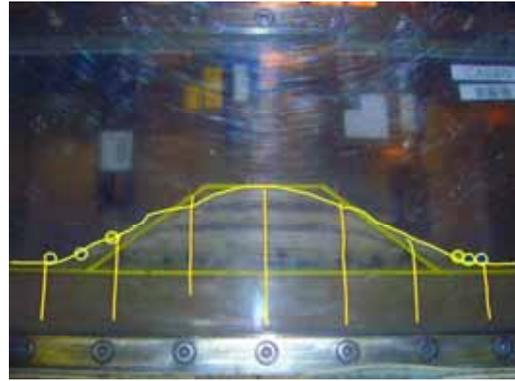
Fig. 5 Measured deformation of embankment on dense foundation ground after shaking (Case6)

The deformation shown in Fig. 5 is for dense foundation ground subject to a peak acceleration of 574 Gal (Case6). Failure mode of embankment in this case is represented by slide of embankment soil along the surface of embankment. Settlement of the crest is induced by this slide type of failure. There was no significant deformation in the dense foundation ground.

The computed deformation shown in Fig. 8 is for dense foundation ground. The agreement with the measured deformation shown in Fig. 5 is apparently not very good, especially the analysis was not successful in simulating the sliding of embankment slopes as shown in Fig. 5. This discrepancy is presumed to be due to the fact that, in the analysis, the nodes at both ends of the slopes share the same displacements as those of the foundation ground, whereas, in model tests, the soil of the embankment is free to slide over the foundation ground. If much finer meshes or other improvements in the analysis are adopted, the agreement would be improved. Within the scope of the present study, the results of analyses and model tests agreed in that deformation of embankment is confined within the embankment itself, without significant deformation in the dense foundation ground.

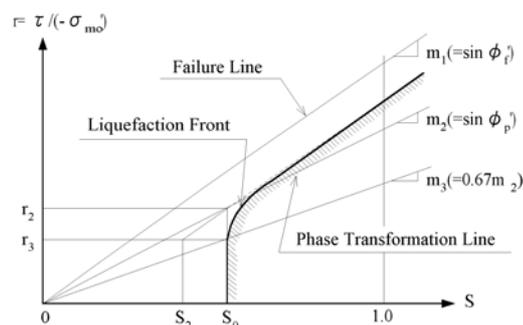
Fig. 6 Liquefaction front model

The constitutive model used for the analysis is based on multiple inelastic shear mechanism model (Iai et al, 1992). The computer code incorporating this model is called FLIP (Finite element analysis of Liquefaction Program). The model takes into account the effect of rotation of principal stress axis directions, the effect of which is known to play an important role in the cyclic behavior of anisotropically consolidated sand. In addition to the conventional assumption of hyperbolic relationship assigned for each shear mechanism, the model uses the extended Masing rule to reproduce realistic hysteresis loop for cyclic loading. The excess pore water pressure generation due to dilatancy is modeled using the concept of liquefaction front, which is defined in the equivalent normalized stress space shown in Fig. 6, where S represents the mean stress ratio relative to the initial mean stress, and r represents the deviator stress ratio relative to the initial mean stress.

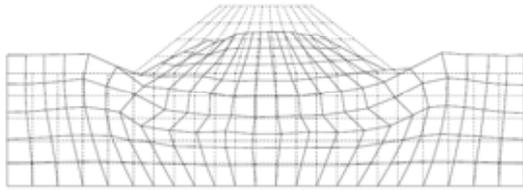
Fig. 7 Computed deformation of embankment on loose foundation ground after shaking (Case3)

Computed deformation of embankments is shown in Figs. 7 and 8. The one shown in Fig. 7 is the results for loose foundation ground.

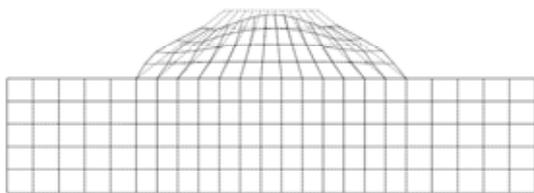
Fig. 8 Computed deformation of embankment on dense foundation ground after shaking

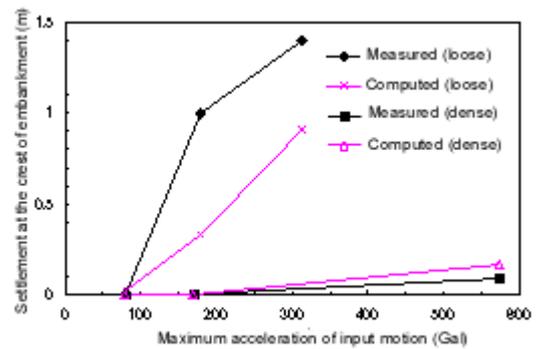
Fig. 9 Settlements at crest of embankment at various levels of acceleration

In order to evaluate the overall performance of embankment subject to various levels of shaking, the measured and computed settlements obtained from all the six cases are shown in Fig. 9.

For a loose foundation ground, settlements reached 1.4 m at the maximum, equivalent to about 50% of the original height (3 m) of the embankment. For a dense foundation ground, the settlement was only 0.1 m at the maximum, equivalent to about 3% of the height of the embankment. Both the computed and measured results showed similar trends in settlements with increasing levels of shaking, although the computed results for loose foundation ground are smaller than those measured and the computed results for dense foundation ground are larger than those measured. In order to achieve better agreement, more studies may be necessary. The settlements for dense foundation ground are reduced to only 0.5 to 6.5% of those for loose foundation ground, indicating that the densification of foundation ground is effective in improving the performance of embankment.

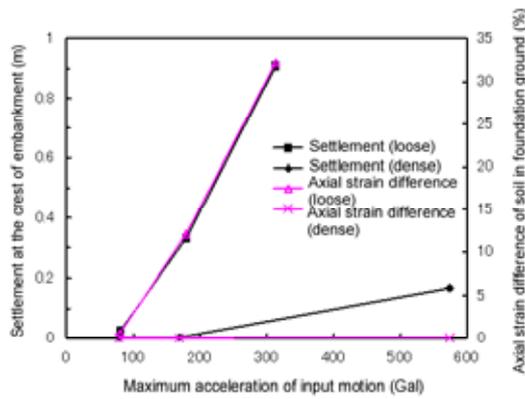
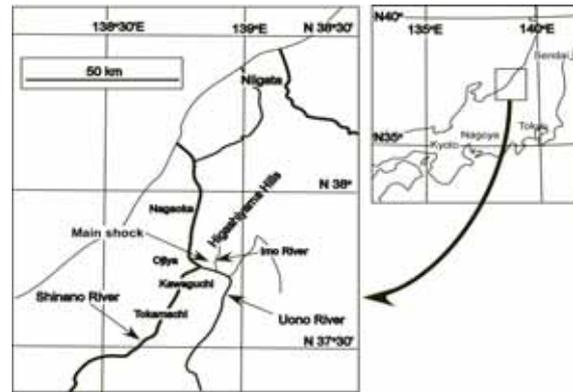
Fig. 10 Settlement and axial strain difference in foundation soil below the embankment

In order to identify the mechanism of settlement in embankment, computed settlements are plotted in Fig. 10, superposed by the plot of axial strain difference in soil element in the foundation ground below the embankment. The results indicate that the settlement is closely correlated with the axial strain difference in foundation soil for loose condition. For dense foundation ground, the correlation is not good. Consequently, the settlement of embankment constructed on loose foundation ground is induced by deformation of foundation ground associated with axial strain difference of soil whereas the settlement of embankment on dense foundation ground is induced by due to deformation of embankment itself.

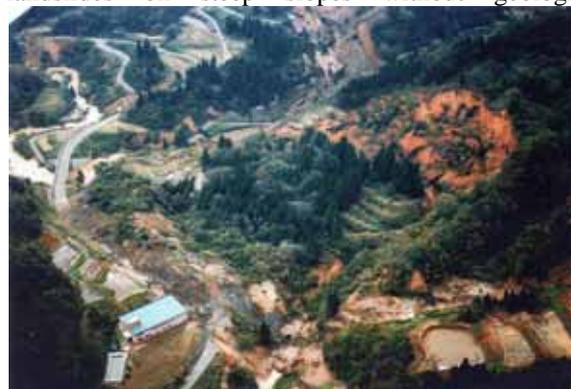
Thousands of landslides of natural slopes occurred in hilly areas in the Higashiyama Hills, where Plio-Pleistocene sedimentary rocks are distributed. The most common landslides of natural slopes triggered by the earthquake were shallow disrupted landslides on steep slopes without geologic

preference, which has been common to many previous disastrous earthquakes in the world (KEEFER, 1984). The Chuetsu earthquake also triggered many deep landslides, damming streams and flooding villages. Field investigation and interpretation of aerial photographs taken before and after the earthquake clarified that many of these slides had occurred due to the reactivation of previous landslides (CHIGIRA, 2004). These had planar sliding surfaces along bedding planes or along the oxidation front (Fig. 13). The bedding-parallel sliding surfaces were made at the boundary between the overlying permeable sandstone and underlying siltstone (1 in Fig. 13, Fig. 14) or along the bedding planes of the alternated beds of sandstone and siltstone (2, 3, and 4 in Fig. 13). Sliding surfaces along the oxidation front were made in the area of marine black mudstone (5 in Fig. 13). New landslides (rockslide-avalanches) occurred with the sliding surfaces in an a-few-cm thick tuff interbedded in siltstone (6 in Fig. 13). Most of the deep landslides occurred on slopes undercut by erosion or artificial excavation, notwithstanding they were reactivated or new ones. One rockslide-avalanche occurred on a slope where buckling deformation preceded the earthquake (7 in Fig. 13). Gentle valley bottom sediments were mobilized in many locations, probably because they were saturated and partial liquefaction occurred by the earthquake (8 in Fig. 13).

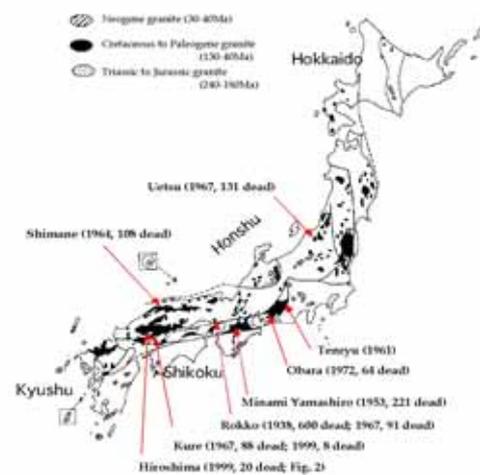
Fig. 15 Landslide disasters occurred in the granitic rock areas.

One of the rock types, which are very susceptible to landslides and has been suffering serious damage by rainstorms, is granite (Fig. 15, (CHIGIRA, 2001).

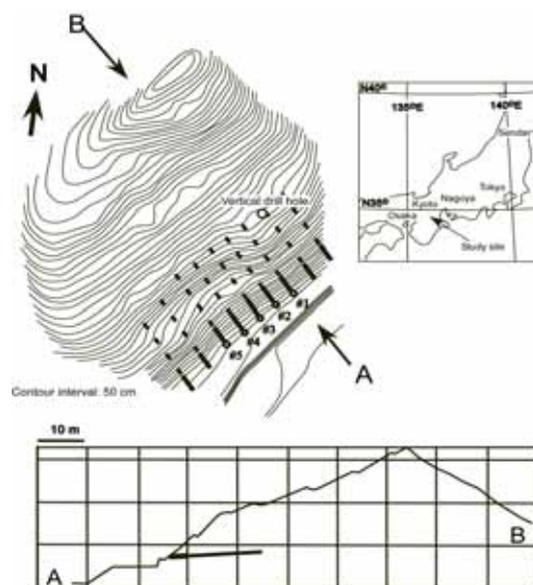
Fig. 16 Locality and topographic map and a cross section of the study site.

The investigation site is located in the southern part of Shiga Prefecture, central Japan (Fig. 16). This site is a hilly area with elevations from 450 to 650 m above sea level, and is underlain by the Cretaceous Shigaraki granite (Collaborative Research Group for the Granites around Lake Biwa, 1982). The landform has low relief with a relative height of less than one hundred meters from flat river bottom. The granite is deeply weathered, and almost all outcrops above the river bottom consist of decomposed granite except for sporadically exposed core stones, while beneath the stream bottom less weathered and sound granite rock is expected. This area was struck by a heavy rainstorm in 1953; widely distributed, destructive landslides occurred, killing forty-four people.

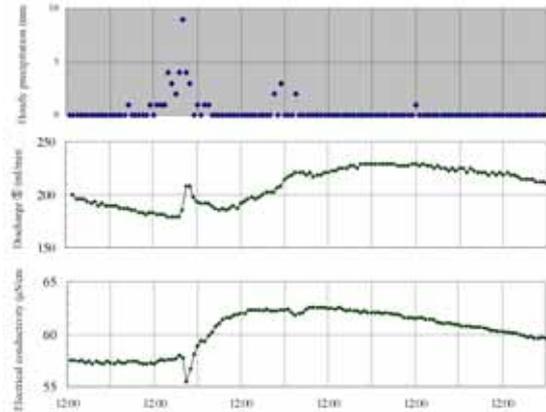
Typical response of electrical conductivity and discharge amount against rainfall events is shown in Fig. 17. We found that when precipitation exceeds about 30 mm, electrical conductivity decreases spontaneously, then soil water with high electrical conductivity is pushed down and subsequently dilute rainwater itself reaches to the groundwater table. The conceptual model of water filtration suggested by the monitoring results is shown in Fig. 18. The pushing down occurs at almost all rainfall events exceeding 10 mm precipitation. The immediate decrease of the electrical conductivity is due to quick inflow of rainwater to the groundwater table through “express ways” like cracks, and its increase is due to the

pushing down of soil water. The electrical conductivity reached to its maximum 20 to 40 hours after the peak of rainfall events and then decreased, while the discharge from the drill holes increased further after the peak of the electrical conductivity to become its maximum 2 to 5 days after the peaks of precipitation. The time delay of the maximum of discharge amount from the maximum of the electric conductivity suggests that the pushing down of the soil water is caused by the pressure propagation by the downward movement of the wetting front as was suggested by Bianchi and Haskell (1966).

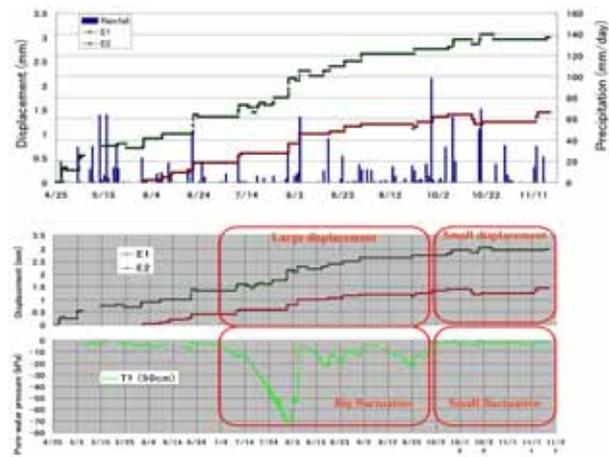
Surface deformation by creep movement of a loosened layer was observed on the monitored slope. Figure 19 shows the displacements measured with extensometers along with precipitation and matric suctions in the loosened layer in the depth of 50 cm. Monitored suction data indicated that positive pore water pressure occurred only several times during the monitored interval. Accumulated creep displacement during 7 months was about 3 mm. The displacement was not directly related to the amount of precipitation but to the fluctuation ranges of matric suction as is seen in Fig. 19. In July and August, there were not so heavy rainstorms in comparison with the other months, but most of the displacement occurred. Figure 19 also shows that the fluctuation ranges of suction were the largest in these two months. These findings indicate that displacement occurs in response to the repetition of wetting and drying rather than to positive pore pressures.
