**【自然災害研究協議会突発災害調査報告】**  
「トンガの噴火による非地震性津波に対する避難  
状況の確認の調査」

有川 太郎（中央大学理工学部都市環境学科）

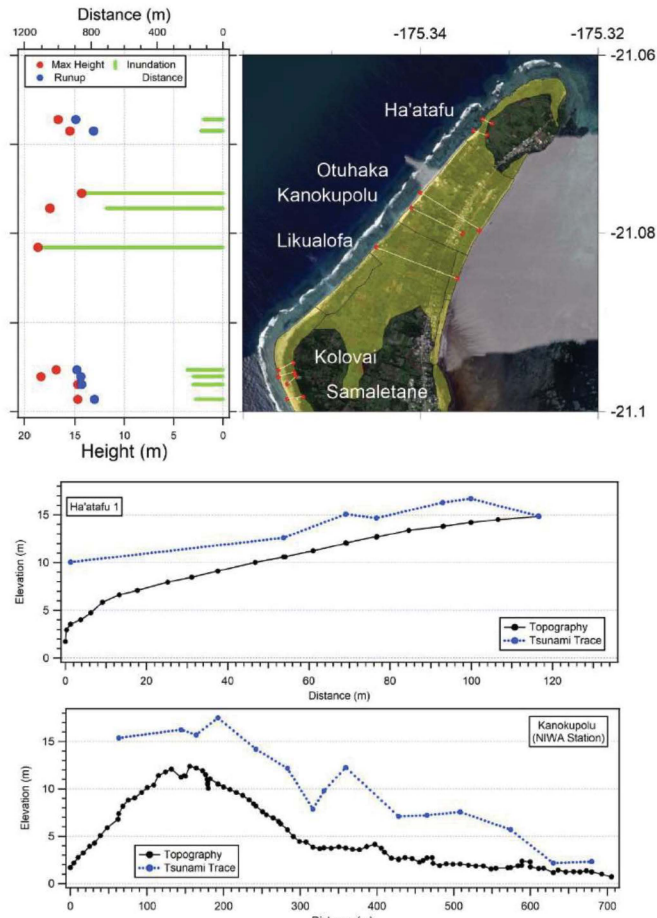
**Fig. 7** Locations surveyed along the western coast of Tongatapu. The start and endpoints of each transect are indicated with the red dot. Green triangle indicates the location of the NIWA weather station. Yellow shaded area indicated extents of inundation. Left plot shows maximum tsunami trace height and maximum run up height along each transect, right plot shows maximum inundation distance.

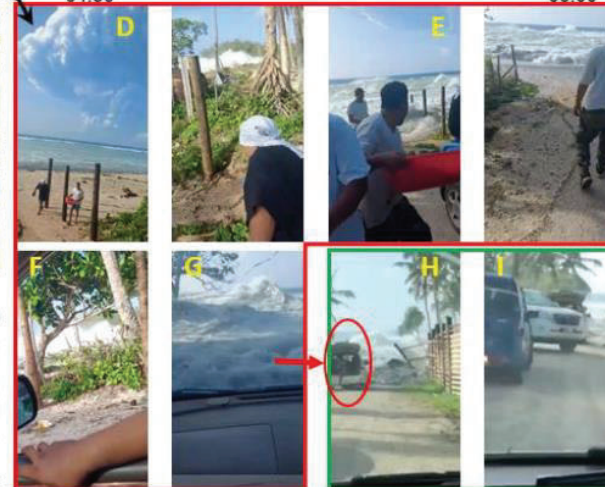
Video 1 (red), shows men evacuating the beach after the first surges. They filmed as a wave hits, then continue filming from a car as a larger surge comes ashore. Video 2 (green) shot from further inland shows the back of the car (circled in red) and the departing car of the Ha'atafu beach resort guest who took the photos shown to the left

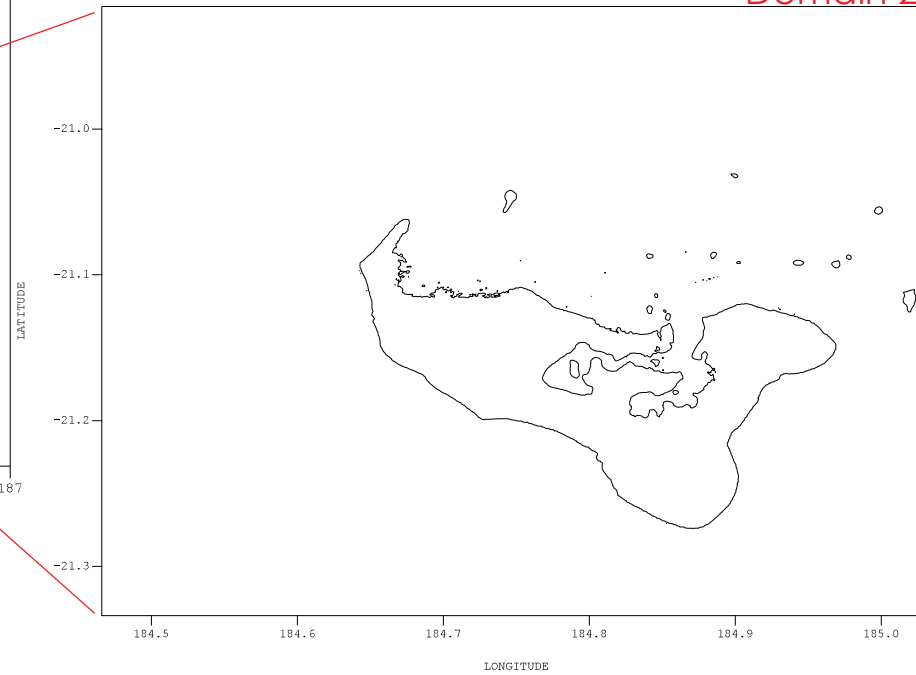
Size Width x Height	Grid size [m]
Domain 1	960 x 1200	450
Domain 2	680 x 500	90
Domain 3	1740 x 1140	30

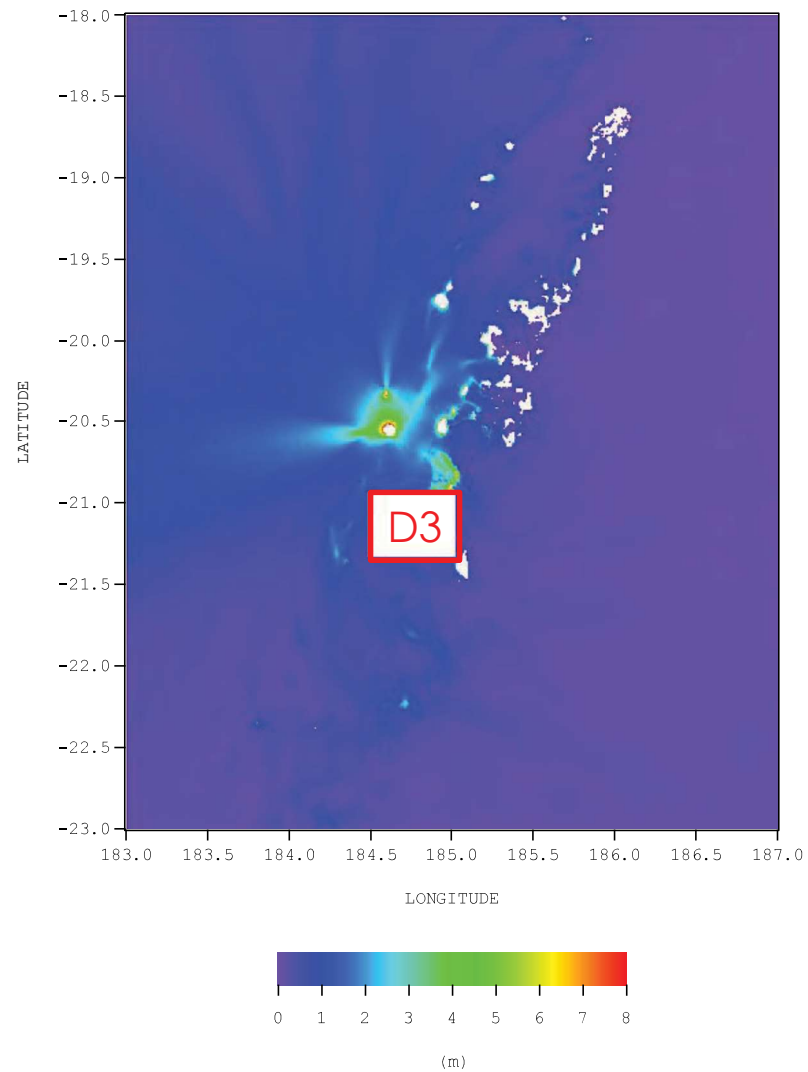
Domain1

# Maximum Water Level

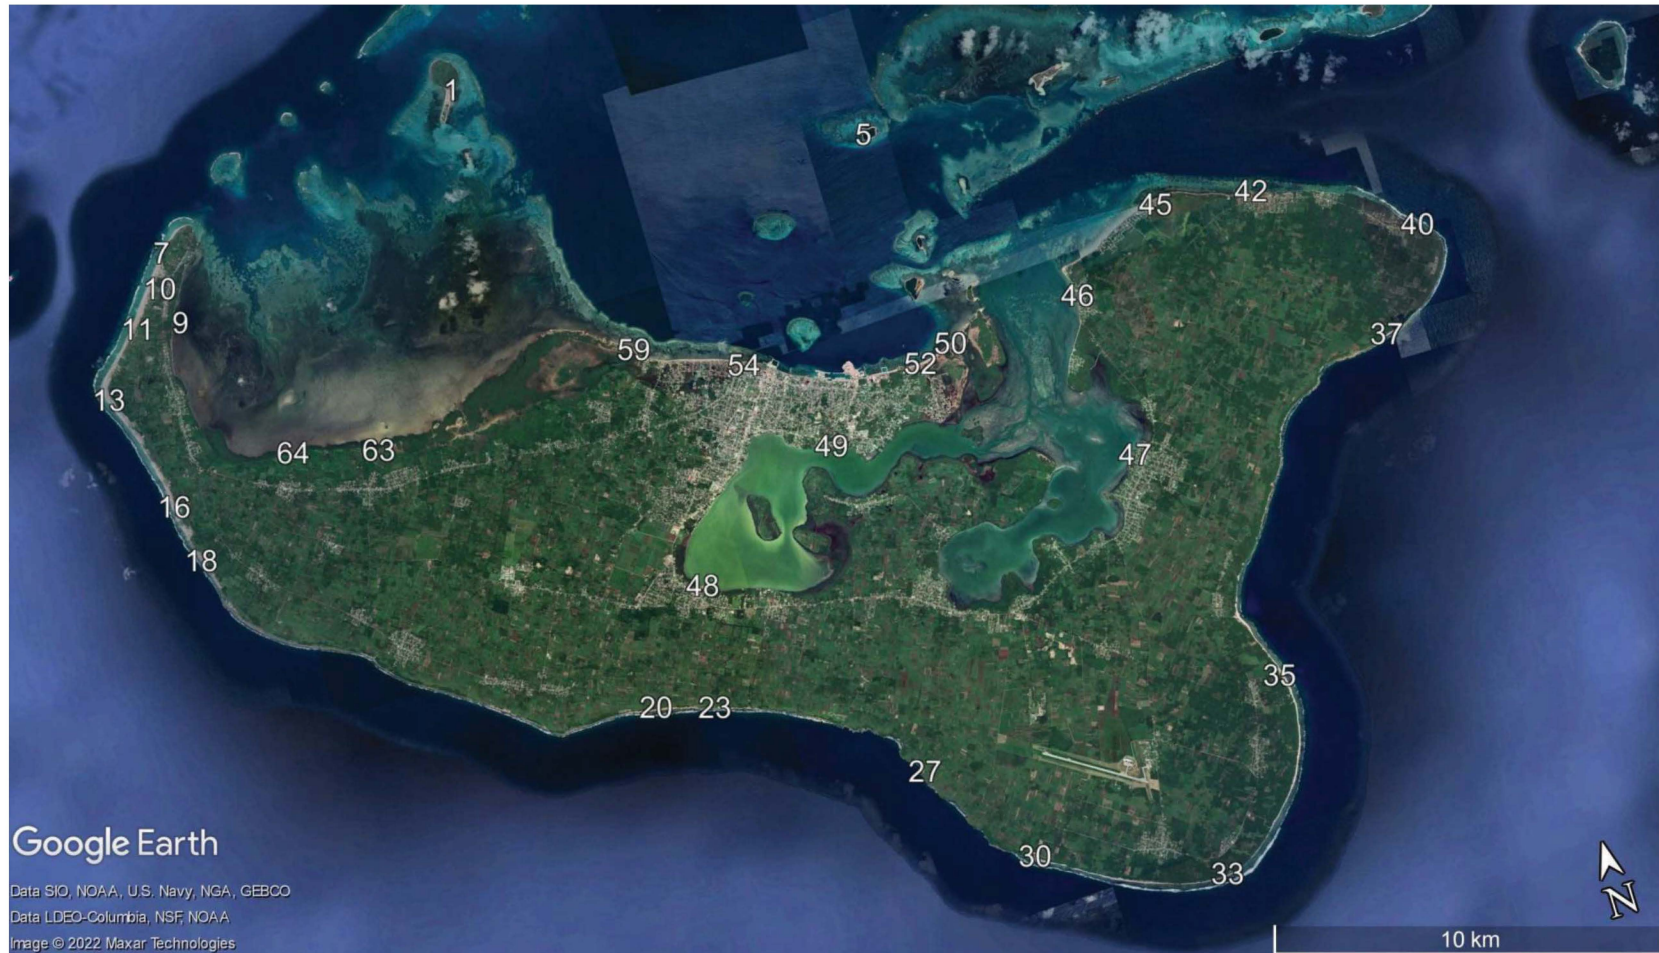
# Survey Point from Prof. Cronin

● Surveys

● Calculation

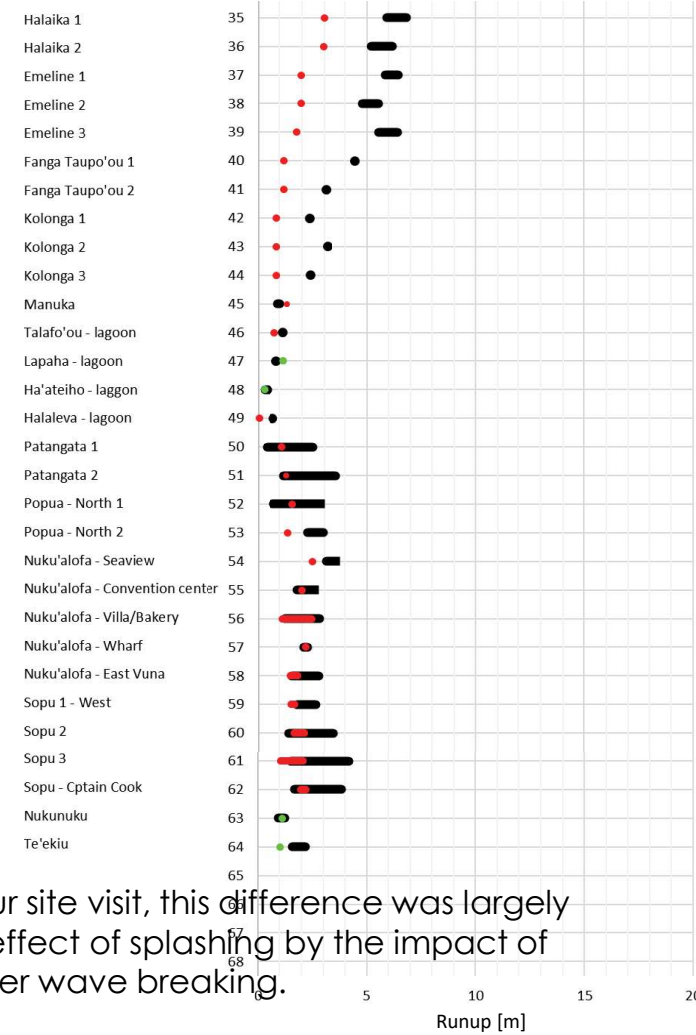
Based on our site visit, this difference was largely due to the effect of splashing by the impact of the bore after wave breaking.

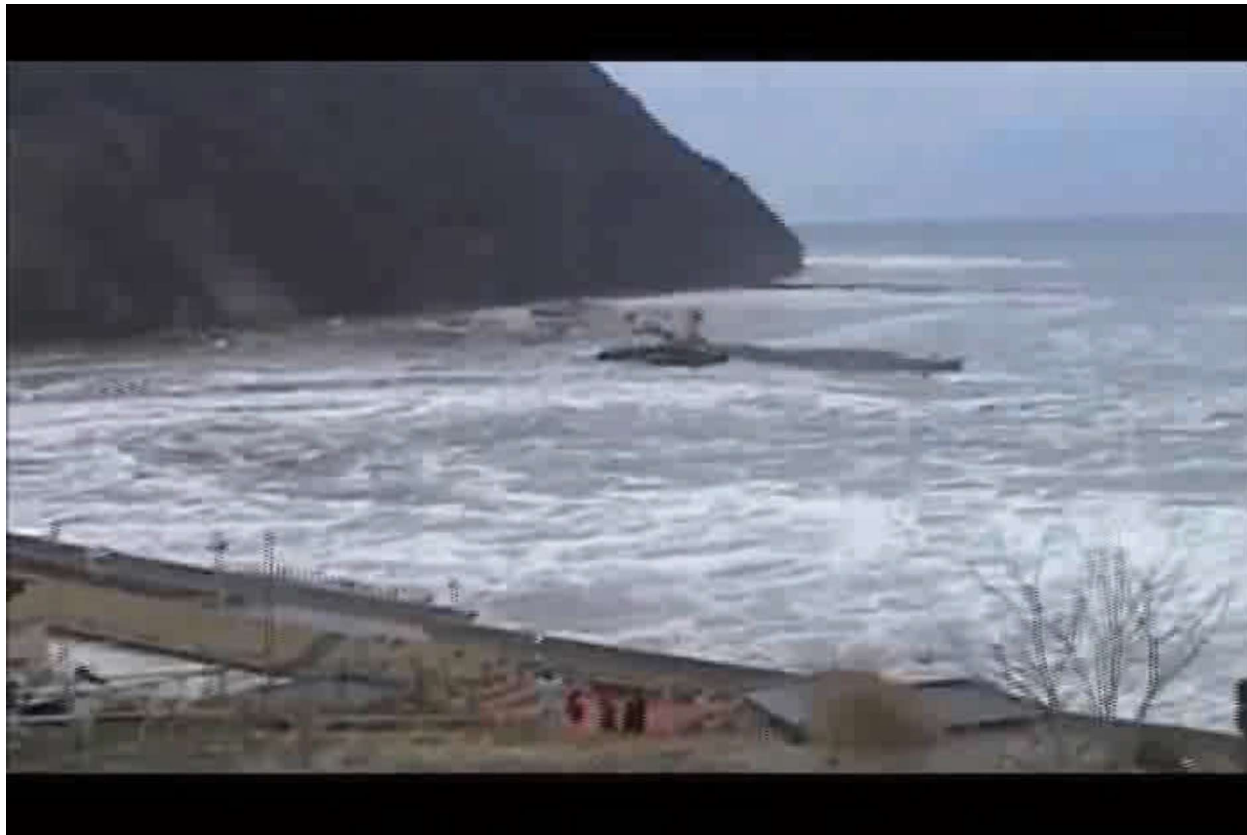
# Breaking (Kuji fishery port)

2011, Great East Japan Earthquake Tsunami

taken by a residence

● Surveys

● Calculation

● cell height

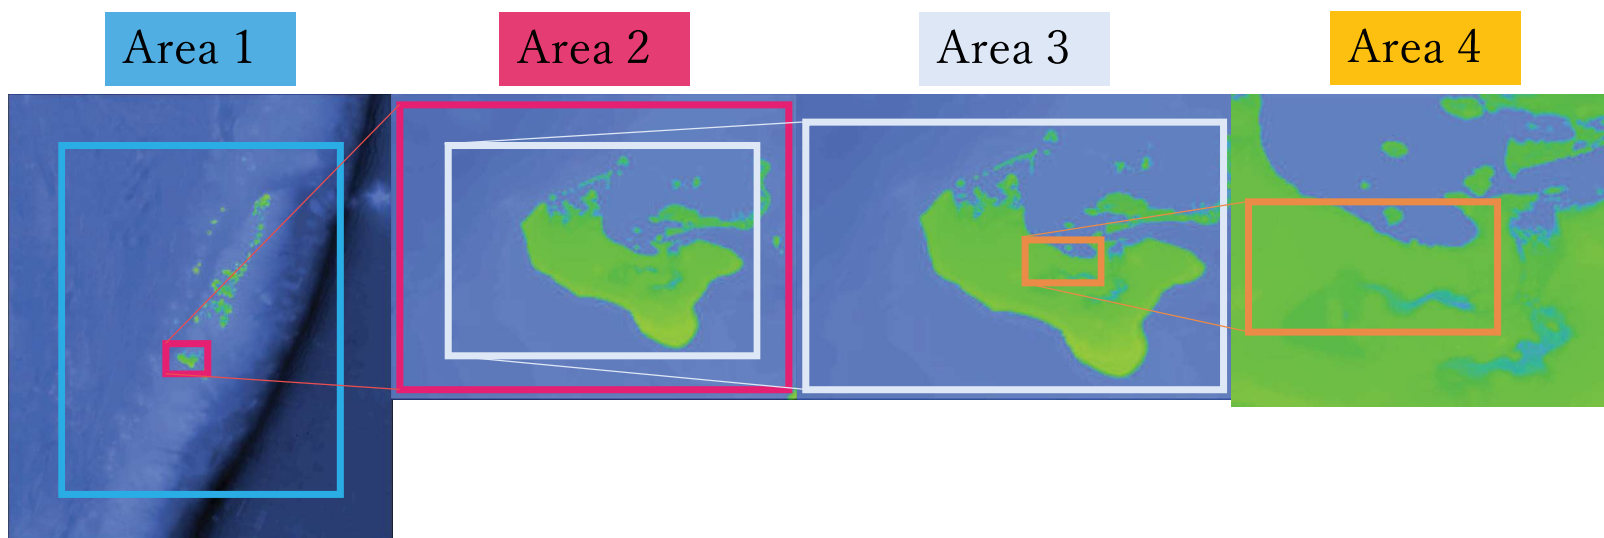
Area	Size (x × y × z)	Grid size [m]
1	960 × 1200	450
2	680 × 500	90
3	1740 × 1140	30
4	1020 × 510	10

- Calculation Time : 7200s
- DT=AUTO(0.001~0.1s)

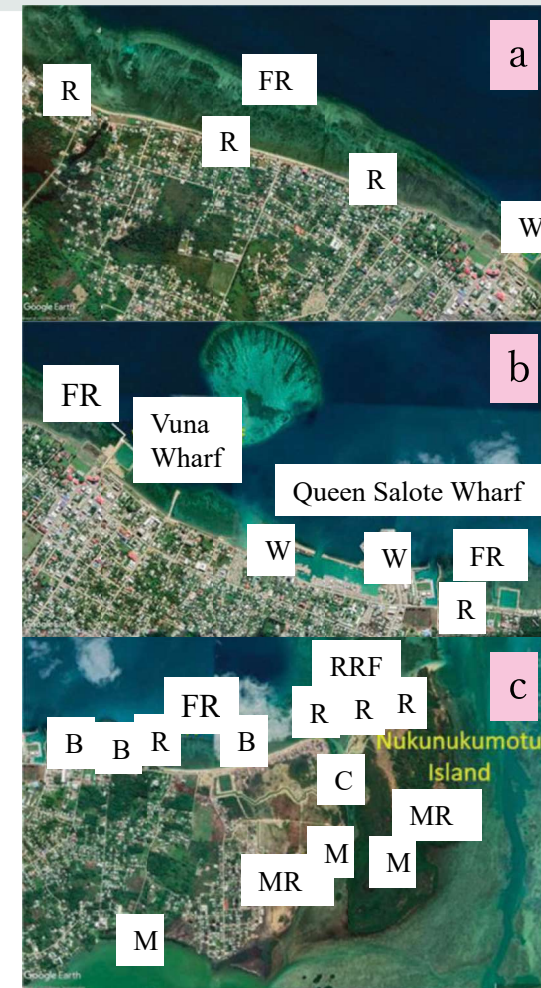
FR=fringing reef, R=revetment, W=Wharf, C=channel,  
MR=mangrove removal, and M= mangroves,  
RRF=rocky reef flats, and B=breakwater
