Repeated Stressing and Crystalline State of Annealed Steel.

Toshio Nishihara and Atsuro Kobayashi.

Abstract.

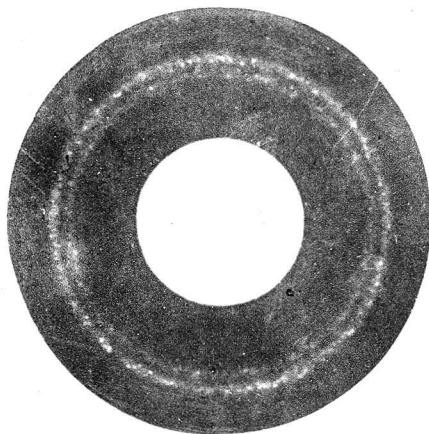
Photo. 10.
Specimen H5,
 $\sigma_a = \pm 14$, $\sigma_m = -14$, $N = 3.08$.

Photo. 8.
Specimen H5, initial state.

Photo. 11.
Specimen H5,
 $\sigma_a = \pm 14$, $\sigma_m = -14$, $N = 10.86$.

Photo. 9.
Specimen H5,
 $\sigma_a = \pm 14$, $\sigma_m = -14$, $N = 0.58$.

In the case of the specimen H5 which was stressed a little above the lower yield point, similar change occurred after a large number of repetitions (photo. 8-11). Stress a little below the lower yield point was applied to H11 and one can hardly perceive similar change after $N=13.36 \times 10^6$, but slight blurring seems to appear in many spots (photo. 12-13).

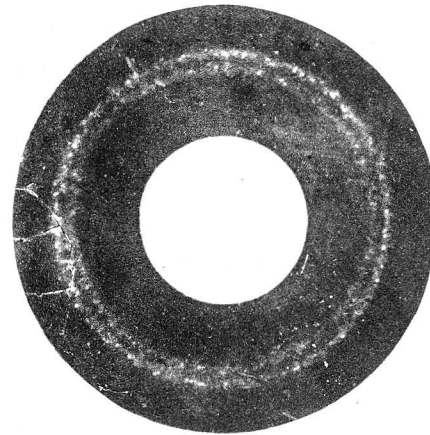
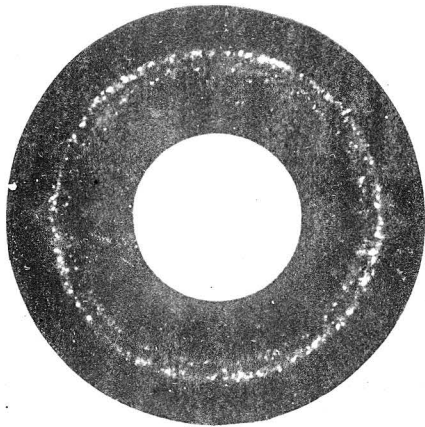
Photo. 12.
Specimen H11, initial state.

Photo. 13.
Specimen H11,
 $\sigma_a = \pm 12$, $\sigma_m = -12$, $N = 13.36$.

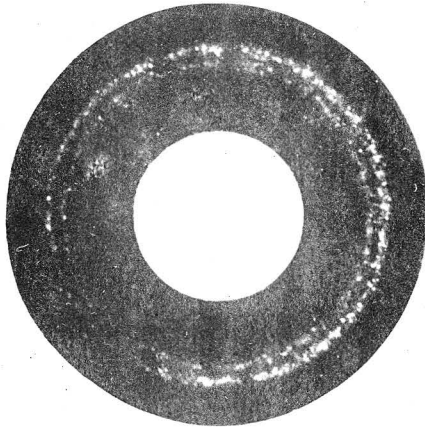
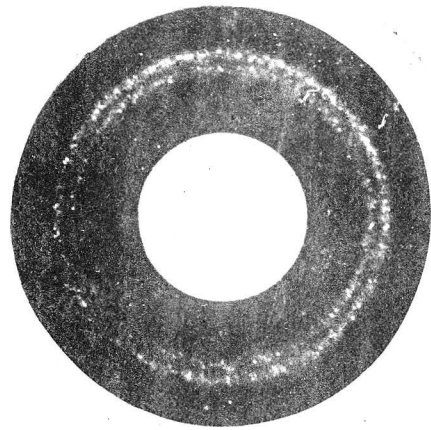
Photo. 16.
Specimen H3,
 $\sigma_a = \pm 10$, $\sigma_m = -10$, $N = 9.02$.

Photo. 14.
Specimen H3, initial state.

Photo. 15.
Specimen H3,
 $\sigma_a = \pm 10$, $\sigma_m = -10$, $N = 6.44$.

Specimen H3 was stressed still lower than the yield point and after $N=9.02 \times 10^6$ on the photograph we can read no conspicuous change mentioned above except faint blurring of interference spots

(photo. 14-16). Test piece H 7 was subjected to the repeated loading whose amplitude was small but whose maximum value exceeded the yield point of the material and already at $N=0.48 \times 10^6$ there was noticed a marked change as shown in photo. 18.
