火山噴火時の噴石の飛散性状の解析－予測手法の開発

Analysis of scattering properties of cinders during volcanic eruption

報 告 書

Impact Resistance Test of Cladding by Using Gravel

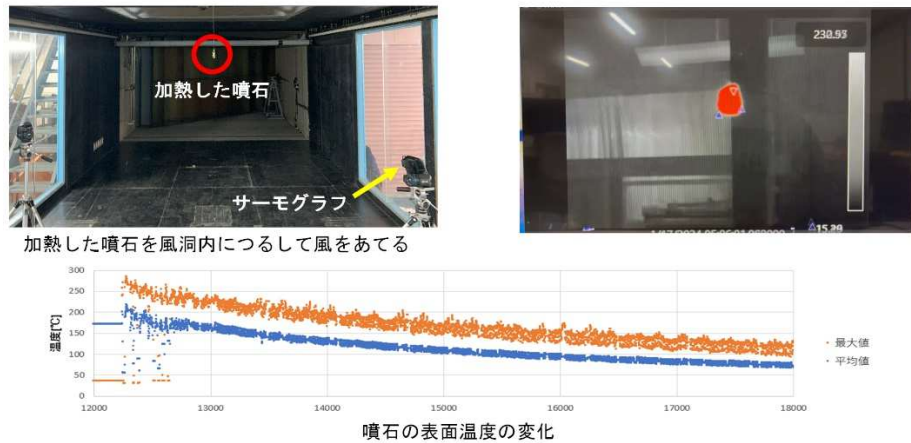
風洞内に加熱した噴石をつるし、風を吹かせて表面温度の変化をサーモグラフで明らかにする実験

作成した解析手法の適用性と精度検証を行うためのデータを得るため、大気と噴石の熱伝達特性を明らかにする風洞実験、密度流れの再現ができる水槽を使った実験装置を開発した。

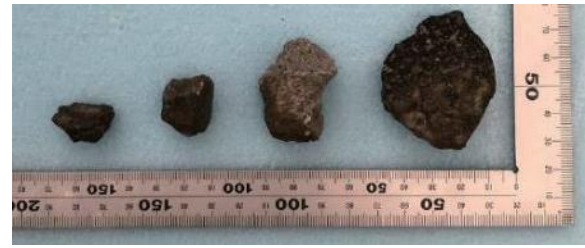
Fig. 3. Gravels as impact missiles.

We conducted an initial test using volcanic cinders from Sakurajima. In this test, pumice, characterized by its low density and high fragility, was crushed upon impact. Although it has the ability to scratch the specimens, it failed to cause cracks or holes. Accordingly, andesite gravel collected from Sakurajima, as depicted in **Fig. 3**, was employed as missile in the impact test. The mean density of the andesite gravel was 3.0, Mohs's hardness ranged from 5.5 to 6.5, and the mass was up to about 100 g. According to JIS A 1204:2009 [8], it is categorized as "coarse gravel."

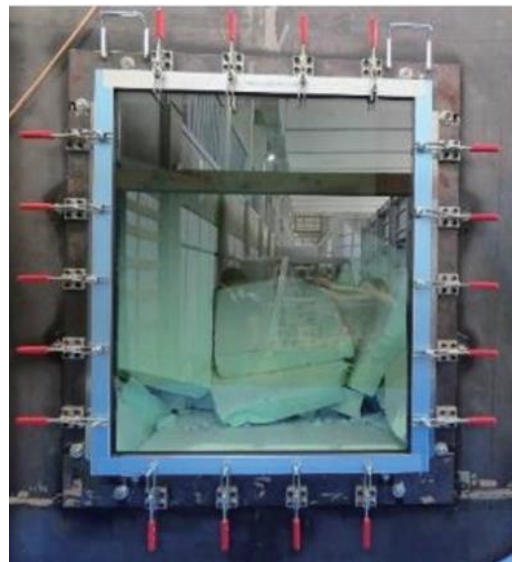
(a) Small specimen

(b) Large specimen

Fig. 4. Experimental set up for float glass.

Two types of float glass specimens, "small specimens; 5 mm-thick, 30 cm × 30 cm-area" and "large specimens; 5 mm-thick, 90 cm × 110 cm-area" were used for the impact test. Small specimens were mounted on an iron frame (24.5 cm × 24.5 cm) with rubber on both sides. The frame was then set in front of the injection device vertically. A perforated polycarbonate plate was set in front of the small specimens, as shown in **Fig. 4(a)**. The holes in the

plate were aligned with the centers of the specimens, ensuring that the missiles would strike the central area of each specimen. The mounting and impact destruction test of large specimens, as depicted in **Fig. 4(b)** were carried out in accordance with ISO 16932.

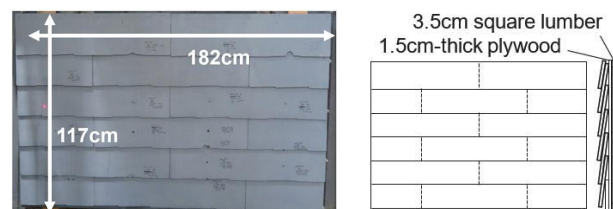
Fig. 6. Slate Tiles Roofing. Slate tile: Knew Colonial, Base material: lauan plywood, 12 mm-thick.

As shown in **Fig. 6**, slate tiles were installed as they would be on an actual roof. The area of the slate tiles was 117 cm × 182 cm. The points of impact were set approximately at the center of each tile.

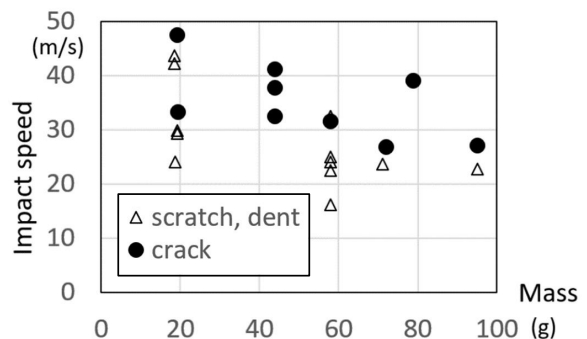
Fig. 13. Effect of missiles' mass and impact speed on destruction modes (slate tile).

For slate tiles, scratches and dents were formed (Fig. 12(a)) while impact speed was low. When impact speed increased, cracks started to be formed (Fig. 12(b)). The destruction speed decreased as missile mass increased (Fig. 13).

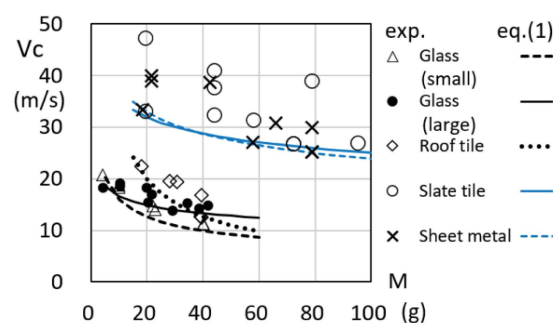
Fig. 16. Relationship between the mass of gravel M [g] and destruction speed V_C [m/s].

When viewing experimental specimens as cladding, the formation of scratches and dents that do not penetrate through to the backside of the specimens does not represent damage to the buildings' interiors. This study thus considered and evaluated the minimum impact speed causing damages that reached the back side of experimental specimens as destruction speed V_C . The relationship between destruction speed V_C [m/s] and the mass of gravel M [g] for each cladding material was found as shown in Fig. 16. The V_C - M relationship approximate curves were calculated, and the relationship is represented with the following Eq. (1) and Table 1.

$$V_C = CM^\alpha \quad (1)$$

Specimen	C	α
Float glass (small)	35	-0.34
Float glass (large)	24	-0.16
Japanese roof tile	140	-0.65
Slate tile	50	-0.15
Sheet metal	60	-0.20
