# Field research on cyclone damage and housing reconstruction in Fijian Village—Case study of Navala Village after tropical cyclone Winston

The Republic of Fiji was hit by Tropical Cyclone Winston in 2016, and housing reconstruction was enabled through government support. This study was aimed at observing the impact on housing in a rural village consisting of both modern and traditional housing types, as well as identifying the reconstruction process. The results show that the distribution of materials was delayed, and housing quality depended on local carpenters. We concluded that there was a need to train carpenters, and the reconstruction of traditional houses should be considered. This is to reflect the natural environment in tropical islands and enhance traditional building knowledge.

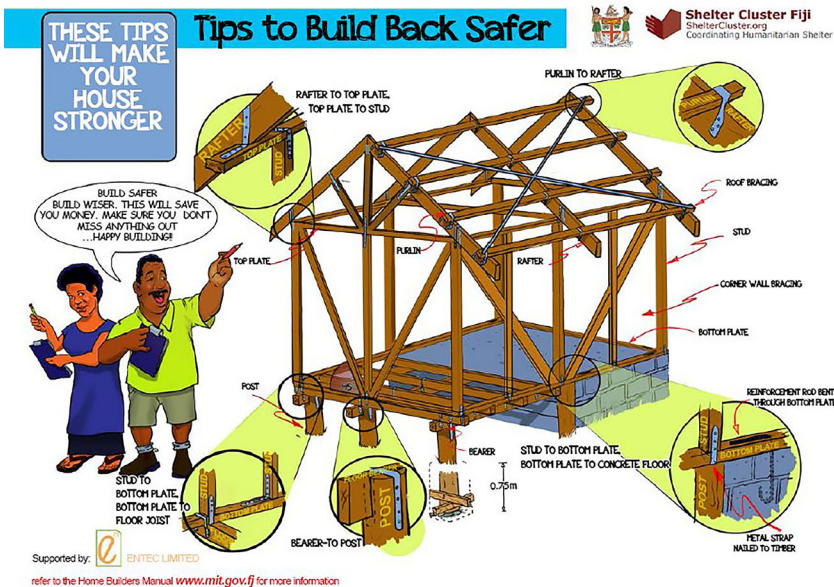
Figure 3. Tips to Build Back Safer (Ref: Shelter Cluster)

Economy, and the Social Welfare department of the Ministry of Women, Children, and Poverty Alleviation of the government of Fiji with the cooperation of domestic building material suppliers. The structure of the HFH is shown in Figure 2. This project aimed to provide 7000 FJD to households whose houses were completely destroyed, 3000 FJD to households whose roofs were damaged, and 1500 FJD to households whose roofs were partially damaged by Winston. The e-card provided by the government enabled people to purchase the building materials needed from a list of 11 building material suppliers in the country. This was the first instance of a Fijian government offering e-cards as a post-disaster housing reconstruction project. In addition, the local government conducted a damage assessment to determine the extent of damage across Fiji; however, the victims were allowed to self-declare the amount in their e-card applications based on their own assessment of the extent of damage. Households with an annual income  $\leq$  50 000 FJD and with homes in the affected area, which suffered housing damage and did not receive any housing reconstruction assistance from NGOs or other organizations, were eligible to applying for the e-cards.<sup>15</sup> The original plan intended to provide benefits to approximately 30 000 households<sup>13</sup>; however, interviews with Ministry of Economy officials revealed that 37 100 households had received e-cards as of March 2018, thereby exceeding the initial plan.<sup>16</sup> Moreover, construction guidelines developed by the shelter cluster were distributed to the affected people along with the guide to apply for the e-cards (Figure 3).

(3) Dissemination of guidelines for reconstructed housing  
“Tips to Build Back Safer” is a set of construction guidelines that were designed to ensure disaster resistance of the disaster-affected reconstructed houses. Although the guidelines were meant to be distributed at the instant of application for the e-card, the residents in Navala did not receive them. This was evident from the questionnaire-based interviews conducted with the villagers, indicating that none of the rebuilt houses appropriately fulfilled the Fijian government’s Build Back Safer standards; therefore, continuous promotion is required to enforce the intended guidelines.

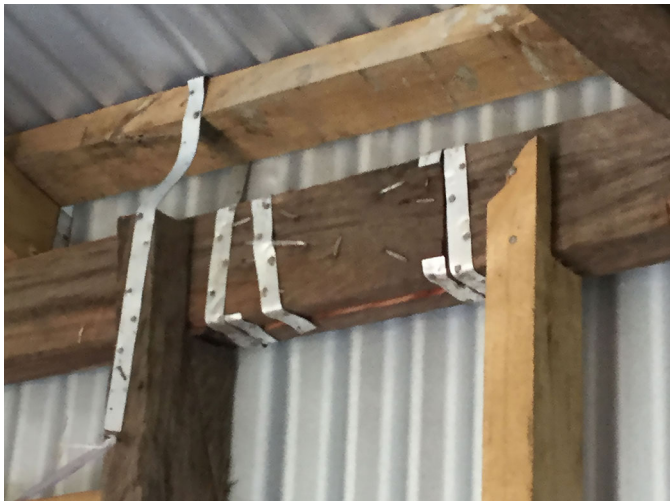
Figure 4. Cyclone Strap

A broad-based survey conducted to determine the actual status of HFH housing reconstruction revealed that the village of Nakoroboya had received HFH-supported building materials but was unable to rebuild the houses owing to the lack of carpenters in the village. In September 2017, eighteen months after the Winston disaster, HFHF built a house for a disabled child. Thereafter, the reconstruction of houses using HFH construction materials began after HFHF trained 20 village volunteers in house construction techniques. Specifically, it was planned to rebuild 22 HFH houses. As of March 2018, 15 housing units were completed using cyclone strips, as recommended by the construction guidelines (Figure 4).

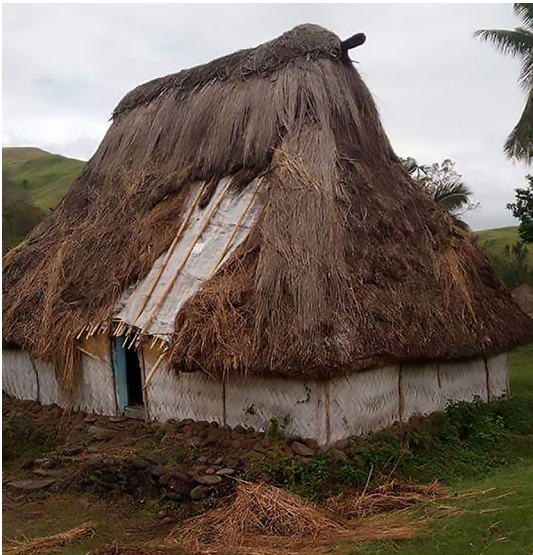
Figure 5 shows a Bure with a roof that was damaged by Winston, and Figure 6 shows a Bure with a completely destroyed roof. The residents of Navala were aware that the roof frame was mounted on a pillar, and as the pillar collapsed under strong winds, it tilted and descended slowly, thereby leaving the roof frame intact and creating a space for survival without the need for evacuation. This behavior was witnessed by several families who sought refuge in Bures. Surprisingly, the roof structure remained intact in the Bures that were completely destroyed, but the pillars were in a state of collapse. In contrast, the tin sheets used for constructing the roofs and walls of modern houses were either blown away by the strong winds or collapsed together with the structural materials, resulting in the injury or death of the people seeking refuge inside (Figure 7). Furthermore, the tin roofs of newly constructed modern houses were found scattered around Navala (Figure 8). Numerous residents stated that tin roofs are prone

Figure 5. Roof of traditional house (Bure) damaged by Cyclone Winston (Ref: Ba office)

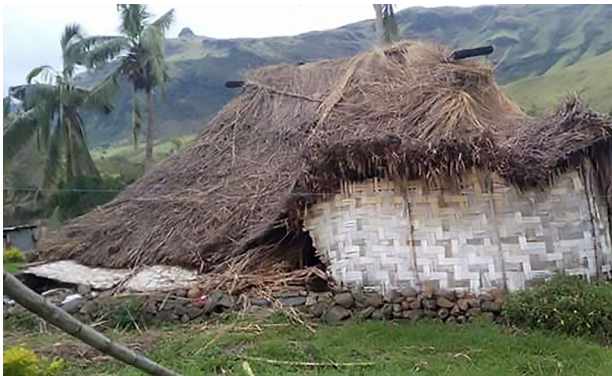
Figure 6. Traditional house (Bure) completely destroyed by Cyclone Winston (Ref: Ba office)

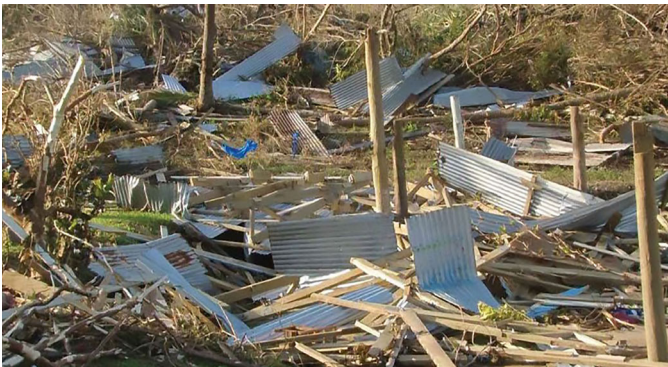
Figure 7. Modern house completely destroyed by Cyclone Winston (Ref: Ministry of Education)

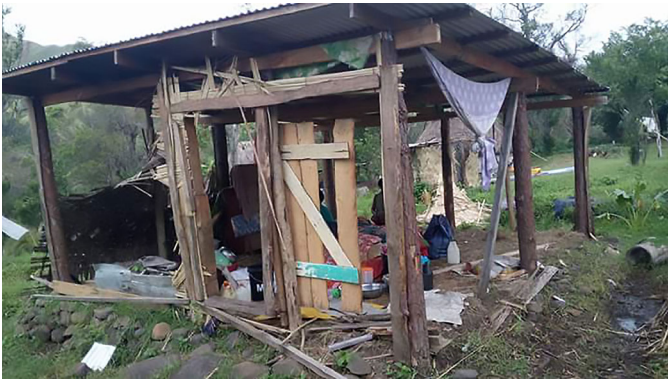
to shattering under high winds and may even injure people, whereas thatched roofs are much safer.

Figure 8. Wall of a modern house damaged by Cyclone Winston (Ref: Ba office)
