Verification of Early Impacted Area Estimation Method Using DMSP/OLS Night-time Imagery on the Basis of Field Survey

Masasuke TAKASHIMA
Haruo HAYASHI

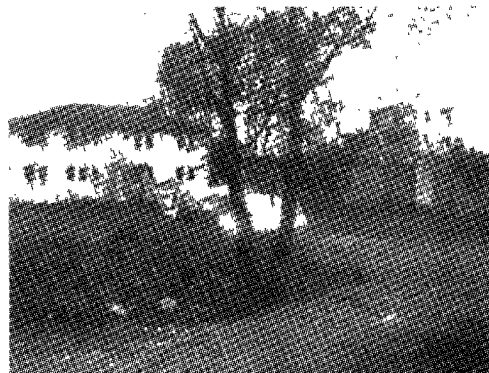
Figure 1 The examples of each damages

1)damaged structures and 2)demolished structures

3) tent village

4) tent block

5) tents around building structure with no apparent damages

ples of each damages. Damaged structures mean collapsed or apparently damaged structures. Demolished structures mean rubble-strewn vacant lots left after demolition. The existence of damaged or demolished structures could tell us that the area was severely impacted by the earthquake. Tent villages mean mass of tents for evacuation deployed at public space such as parks in a organized manner. Tent blocks means groups of tents smaller in number than tent villages located in more tight place. The existence of these two types of tents could

show indirectly that the area was impacted. On the other hand, the existence of tents around building structures with no apparent damages could tell us that people in the area felt a great deal of fear as to the safety of their houses, even they show no apparent damages. Although difference of three types of tents is not distinct, we can see the level of suffering at each area from these signs. Fig. 2 shows the qualitative relationship between signs left in the impacted area and the level of impact. Fig. 3 shows survey route, distribution of observed damages

Through the ground observation in Marmara region, we could record the following five different damages due to the earthquake, 1) damaged structures, 2) demolished structures, 3) tent villages, 4) tent blocks and 5) tents around building structures with no apparent damages. **Fig. 1** shows the exam-

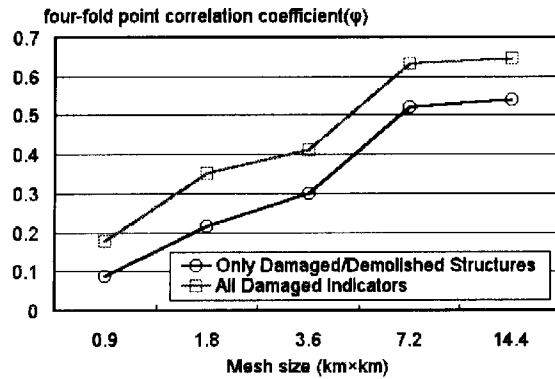
Firstly, As shown in Fig. 5, the larger the mesh size is, the larger the ϕ coefficient is in both damage type. Additionally, the grow rate of coefficient gets small over the mesh size of 7.2km \times 7.2km. As a result, it can be seen that appropriate mesh size for the estimation may be 7.2km \times 7.2km. This result suggests the DMSP estimation may be reliable for the detection of major impacted cities.

Secondly, the ϕ coefficient of the test detecting all kinds of damages including tents is larger than that of the test detecting only damaged/demolished structures. This means their estimation can detect whole impacted area rather than only severely impacted area.

Figure 5 The relationship between the four-fold point correlation coefficient (ϕ coefficient) and mesh size, group of damage indicators

Figure 5 shows the relationship between the four-fold point correlation coefficient (ϕ coefficient) and mesh size, damage types in each check. From the result shown in Fig. 5, the following two things concerning the characteristics of the estimation were revealed.
