Failure and Triggering Mechanism Analysis of the Bitchu-Matsuyama Castle Rock Using Distinct Element Method

GREIF Vladimir, SASSA Kyoji, FUKUOKA Hiroshi

In this paper a rock slope failure of Bitchu-Matsuyama castle rock located near Takahashi city in the central part of Okayama prefecture is presented. Rock mass creep movement, which mechanism and triggering factors are studied here, endangers the castle, which walls are suffering damage and need to be repaired. In order to find the reason of the damage various triggering factors such as weathering progress, slope-toe erosion (toe sliding) and a special phenomena for this site – wind tree action are simulated using distinct element method (DEM), namely UDEC (Universal Distinct Element Code) as one of the numerical modeling codes. The joint shear displacements of several points are observed in the model as key factors for result comparison. Further a failure analysis of rock slope is carried out in order to find out the future behavior of the rock slope and optimize the design of monitoring system, which is in process of installation.

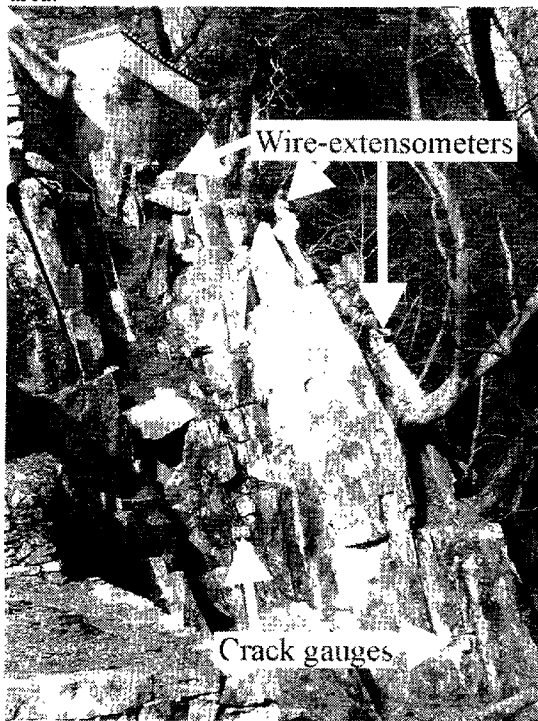
Fig. 6 Photograph of the studied rock slope with installed monitoring devices

Using the results of the simulation and in order to be able compare the UDEC simulation with reality a monitoring system composed of crack gauges and extensometers (Fig. 6) was installed at the end of year 2000. Movements up to 1.2 mm were recorded since the beginning of this year. However the period is not satisfactory for decision of rates of movement or comparison with simulation, it shows that the rock slope is not stable and is in constant creep movement.

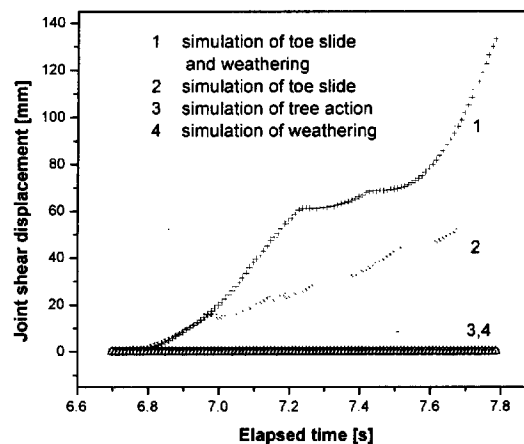
Fig. 7 Joint shear displacements for various triggering factors recorded in point No. 3

In order to keep maximal accuracy of numerical model the chosen timestep was very small 1×10^{-4} s, which allowed compare various triggering factors of movement. Figure 7 shows the comparison between four factors possibly causing the movement recorded in point No. 3. It is clear that weathering and tree action doesn't cause any shear displacement, but the toe slide is the most probable cause of the movement. However the weathering is the accelerating factor for movements if is applied together with toe block removal. This confirms the theory which assumes the toe slide to be the triggering factor of the rock instability, based on the presence of tension crack in the upper part of the rock slide right under the fortification fence.
