On Heavy Rainfall Disaster in Tokai District in September 2000

Kazuya INOUE, Motoyuki USHIYAMA, Taisuke ISHIGAKI, Keiichi TODA
and Kensaku KURIYAMA*

* Graduate School of Engineering, Kyoto University

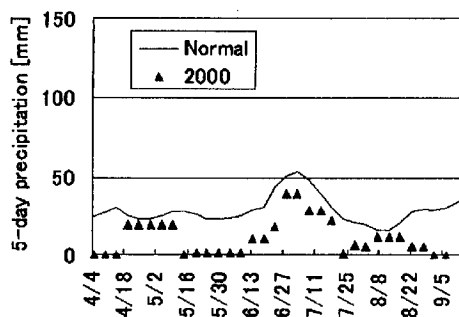
Fig.3 5-day precipitation at Nagoya (Normal year: average from 1961 to 1990)

and August (JMA, 2000a-2000e). The five-day precipitation from April to September 2000 at Nagoya Local Meteorological Observatory is shown in Fig.3. No five-day precipitation exceeded the normal during this period. Rainfall was not recorded from the middle of May to the middle of June. In Baiu season (June to July), seasonal precipitation was slightly less than normal; very few rainfalls had occurred since August. The total precipitation at Nagoya was only 23 mm (four small rainfall events) from the beginning of August to 10 September.

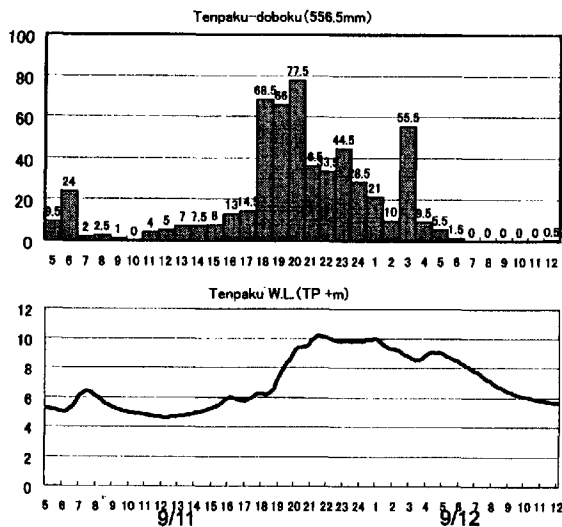
Fig.13 Hyetograph and hydrograph of water level in Nonami area

Figure 13 is the hyetograph in this area and hydrograph of water level measured at the Tenpaku water level station in Fig.12. The water level was higher than the design H.W.L. of TP 8.66 m for nine and half hours during the flood. The maximum level was only 15 cm lower than the top level of embankment. It was very dangerous situation for the embankment. Some protection works for leakage from the embankment have been done along this river. In this river, the bank protection of main channel was broken as shown in Photo 3. Sand was sucked out from the back of the bank protection, and the wall sank down. There were plenty of same damages in Tokai district and 722 banks were restored by the government in Aichi prefecture.

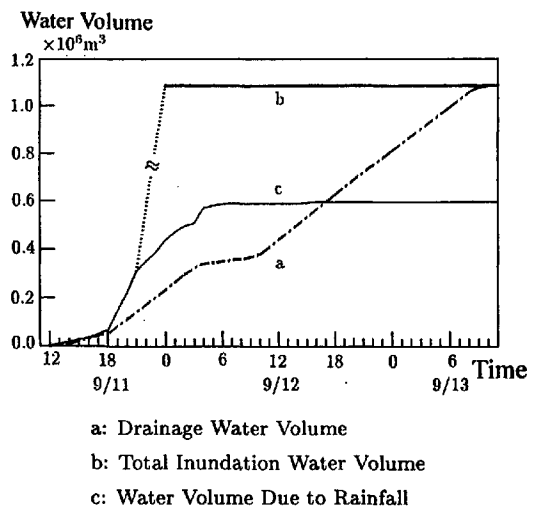
Fig.14 Cumulative drainage water volume and inner water volume

The drainage area of Nonami pumping station is 1.14 km² and its maximum drainage capacity is 8.6 m³/s which corresponds to the disposal of 50 mm hourly rainfall. This inundation was caused by both the heavy rainfall over 50 mm hourly rainfall intensity and the overflow from the Goshita river. As the inundation water volume was beyond the drainage pump capacity, the inundation damage was enlarged. Figure 14 shows the cumulative water volume drained from Nonami pumping station to the Tenpaku river (a in Fig.14), the cumulative inundation water volume (b in Fig.14) and the cumulative inner water volume (c in Fig.14). The inner water volume is calculated by the rainfall water volume per unit area multiplied by Nonami drainage area. The difference between b and c denotes the inundation water volume coming from the area except for Nonami drainage area. The overflowing water volume from the Goshita river is included here. The total inundation water volume was about 1.1 million m³, of which 0.6 million m³ was the cumulative inner water volume. The water volume coming from the area except for Nonami drainage

area was 0.5 million m³, which was almost half of the total inundation water volume. By this huge inundation water volume, the pumping drainage lasted until the morning of 13 September.
