2004年スマトラ島沖地震津波災害の全体像の解明  
Comprehensive analysis of the damage and its impact on coastal zones  
by the 2004 Indian Ocean tsunami disaster

平成 16 年度科学研究費補助金  
(特別研究促進費) 研究成果報告書  
Grant-in-Aid for Special Purposes  
Research Report

研究代表者  
京都大学防災研究所  
河田 恵昭

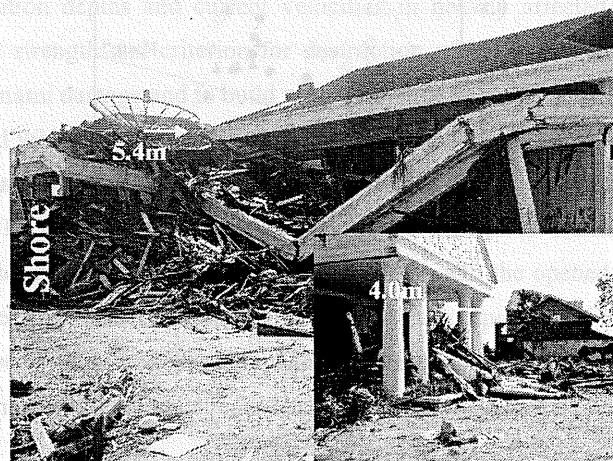
Photo 5 Partially damaged family house located at a distance of about 1.3 km inland from the shoreline in Banda Aceh. Left side is shore and right side inland. Numerals indicate inundation depths.

Photos 4-6 show examples of variation of the inundation depth, current velocity and so on due to the distance from shoreline. The judgments of degree of damage to houses are based on the criterion of destruction defined by Matsutomi and Shuto (1994).

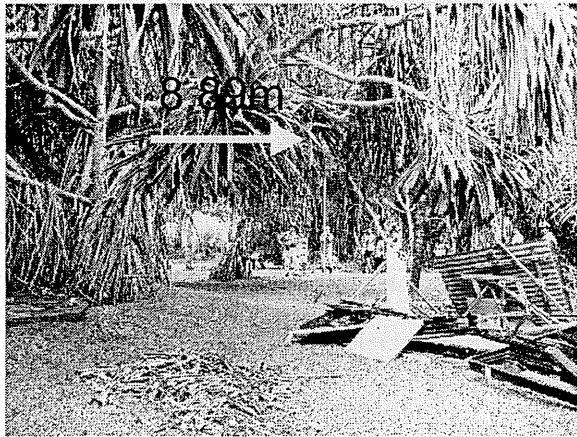
Photo 1 Tsunami trace at the Koggala district

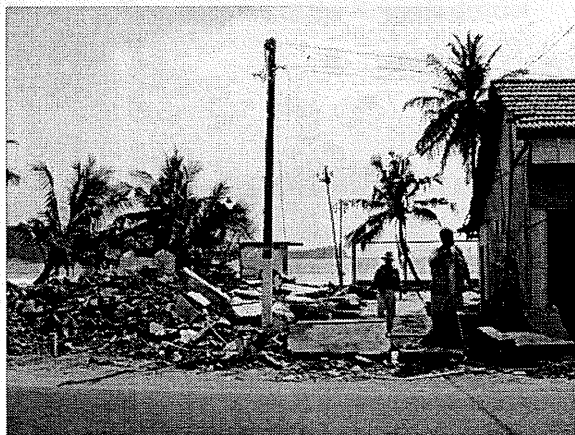
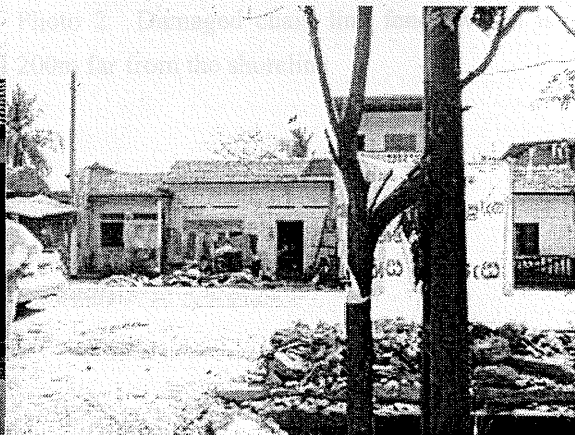
Photo 3 Tsunami inundation level(upper) and destroyed beachfront house (lower)

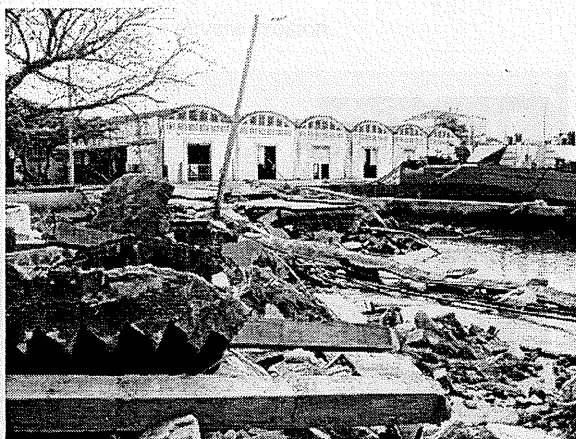
Photo 5 Damage of the quay at the Galle Port

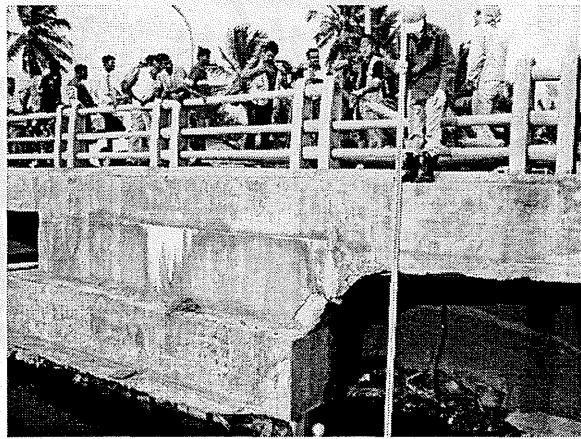
In Dodanduwa which is 12 km in north of Galle. There is bridge constructed at the river mouth, which is made of concrete and seemed to have been built recently. The concrete handrail of the bridge, which thickness is about 20cm had broken and the height was 3.9m, was partially damaged as shown in Photo 7. It is explained from the situation that a broken fishing boat as shown in Photo 8 has been scattered that drifting debris collided. The people at this village told us that some of them were washed away by the tsunami flood though they evacuated through the bridge. Two persons who had taken the motorcycle on the bridge were also washed away by the tsunami.

Photo 7 Damaged concrete handrail of the

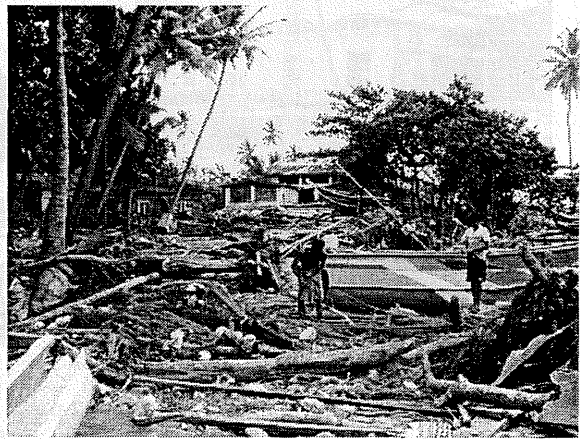
Photo 8 Broken fishing boats at Dodanduwa

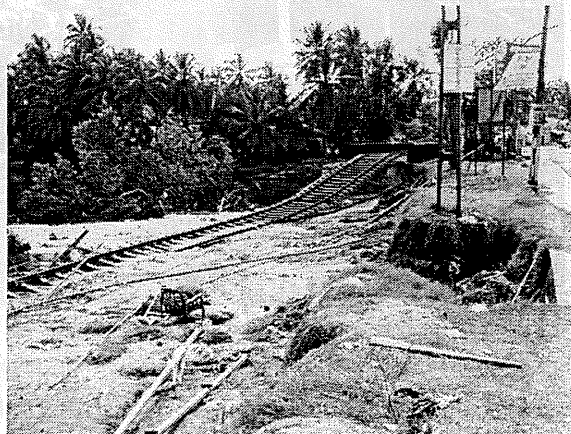
Photo 10 Scouring damage on the foundation of railway at Ambalangoda

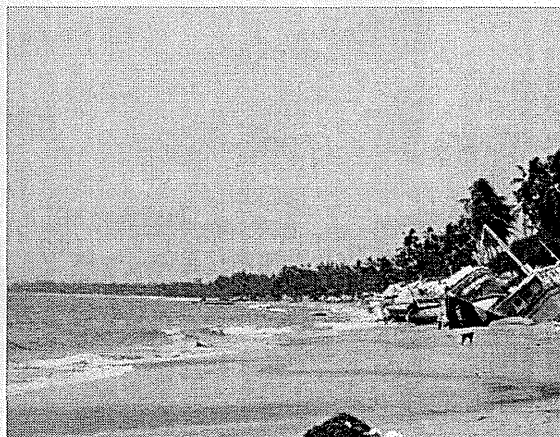
Photo 12 Drifted fishing boats at the north coast of Beruwala fishing harbour

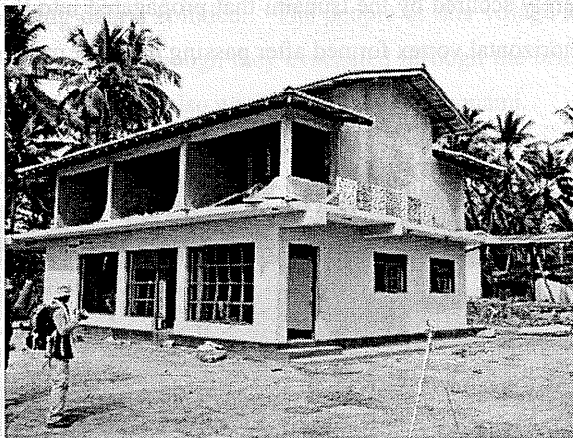
In Paiyagala which is 48km in north of Kahawa, there is a tsunami trace which is about 6m above the mean sea level, it is 4.2m far from the shore in the inundation level. Only a part of house such as windows and doors in the houses made of concrete were damaged as shown in Photo 13.

Photo 13 Barley damaged building made of concrete

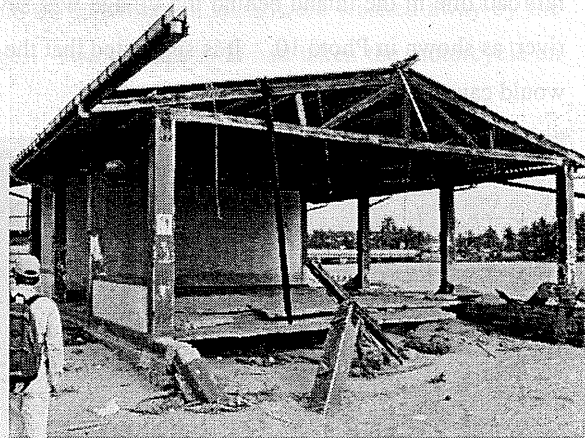
Photo 14 Damaged concrete floor by the tsunami lift force

The Panadura district 25km in south of Colombo is located between the river and the sea. It is indicated that the damage was caused by both of the tsunami running up the river and the overtopped tsunami from the coast. The impact of tsunami, especially lift force, was able to destroy the concrete floor and roof as shown in Photo 14.

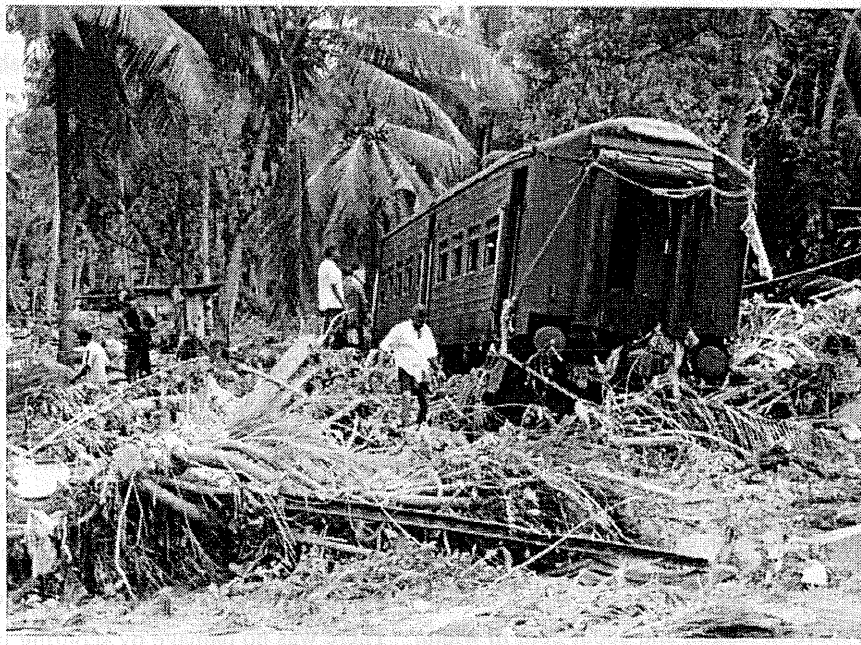
The residents of the district saw the disaster and began to flee inland. Some of them escaped into the stopped train. Generally railway cars are stronger and higher than automobiles etc., the residents probably thought they were safe. This would be why not only passengers but also residents were died in the train cars. But the second wave that struck 30 to 40 minutes later, about 15 minutes according to other witnesses, engulfed the train shown in Photo 15.

Photo 15. View of the Overturned Railway Train

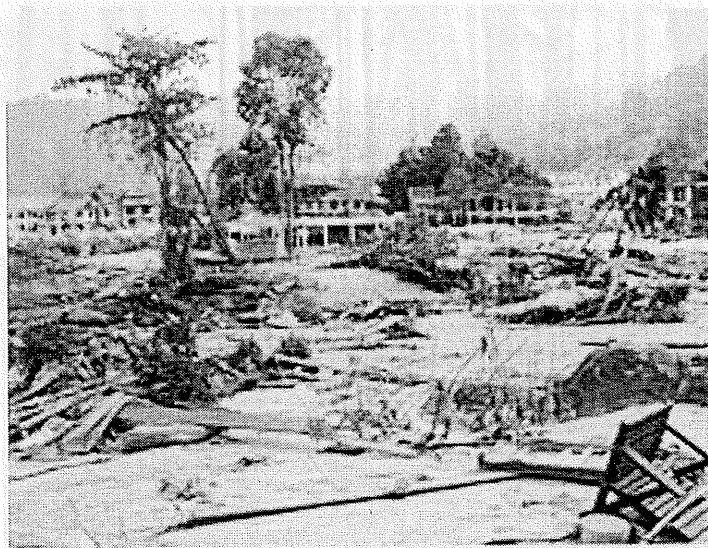
The velocities were 5 m/s and the drag forces were 0.8 to 0.7 kN/m<sup>2</sup> (0.2 to 0.4 lbf/ft<sup>2</sup>) in the inundated area seaward from the inundated depths in the south of Khao Lak (Mitsuru et al., 2005). The area with a few tourist places and their own many hotels and cottages. These cottages and two small houses close to shore were totally damaged. In the end, many of the cottages and houses were

Photo 4.8 The heavy damaged hotels in Khao Lak

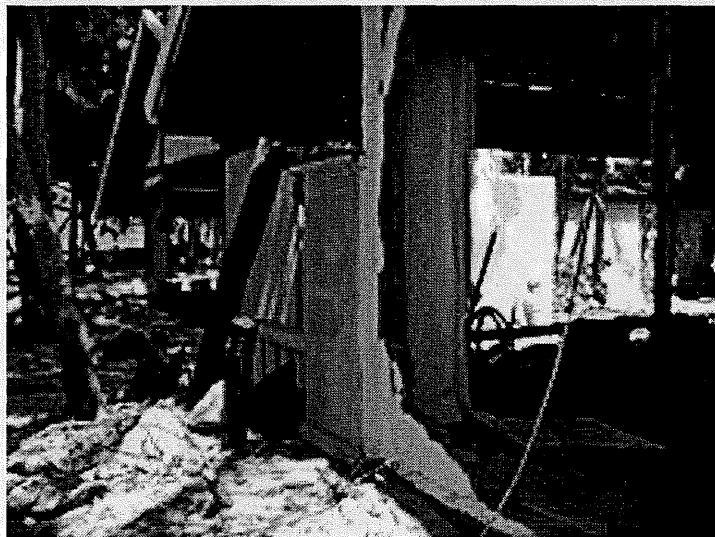
Photo 4.11 The broken wall of a house built of brick in Patong beach

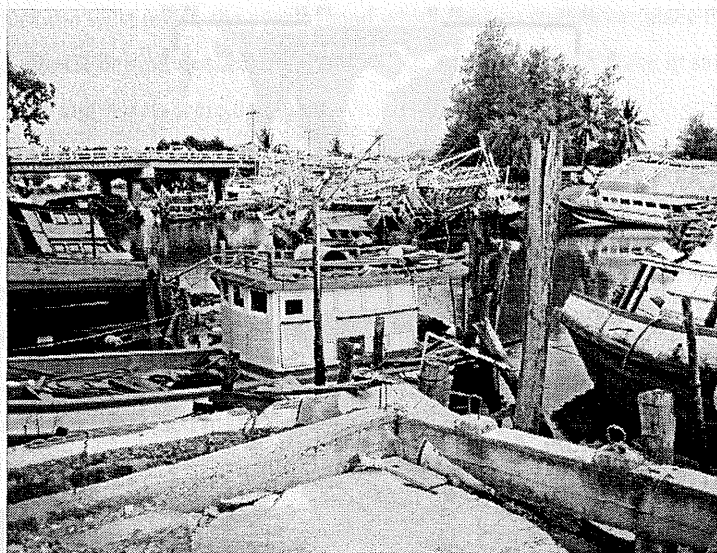
Photo 4.13 Damaged ships in a river in the east of Phuket Is.
