A study on the variation of displacement and  
internal earth pressure in creeping landslides

Thesis submitted to Graduate School of Science  
in partial fulfillment of the requirements of the degree  
Doctor of Science  
in the Division of Earth and Planetary Sciences  
Graduate School of Science  
Kyoto University

Kiminori Araiba

January 1998

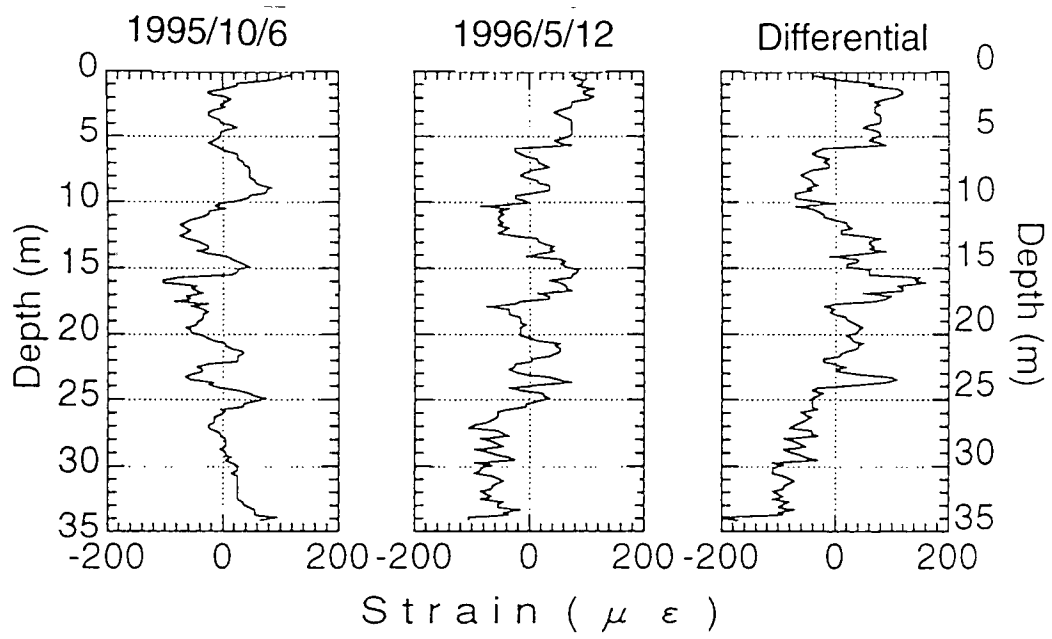
Fig. 2. Results of observation on insertion-type bending pipe at BV in Fig. 1.

Borehole for observation (34 m deep) was drilled at the position of "BV". Ground water table and pipe strains were measured using a polyvinyl chloride (PVC) pipe with drainage holes on the wall for the whole depth embedded in the borehole. Slight variation in ground water table was observed. Measurements by "insertion-type bending-pipe" (Shima and Takeuchi, 1973) were also done in the borehole (October 1995 and May 1996). According to measurement in pipe strains (sampled every month), 2000 ( $\mu\epsilon$ ) output of one strain gauge (attached at the depth of boundary of the debris and the sand stone) was recorded in August 1995. However, only one output is unreliable. According to the measurements by the insertion-type bending-pipe, significant bent of pipe was not observed (Fig. 2). Thus, the output of strain gauge is considered as an error. According to residents and ground surface survey, there is no symptom of landslide in the slope lower than the borehole. Therefore, the ground lower than the borehole was assumed to be stable. The part of slope between cracks and the borehole is discussed in this study.

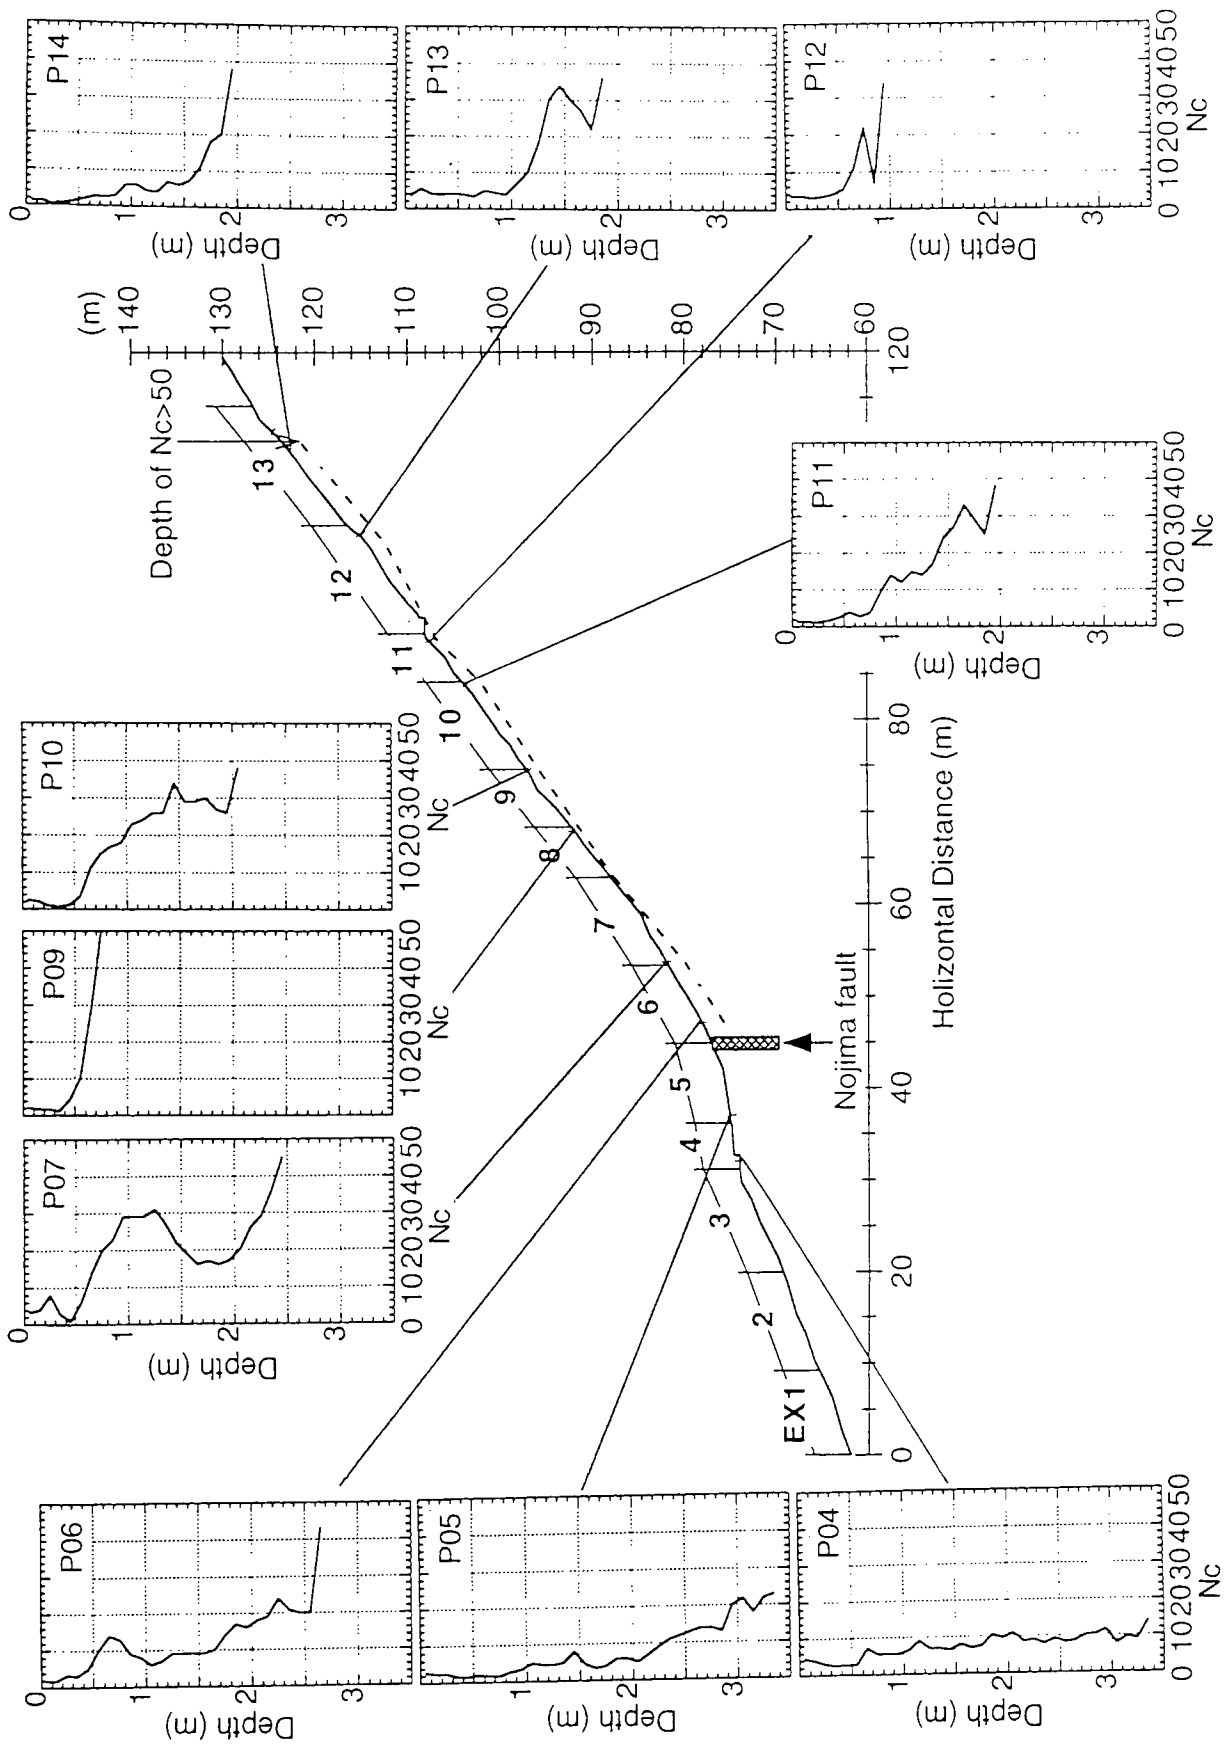
Fig. 3. Results of the portable cone penetration tests (dotted line in the cross section shows depth of layer of  $N_{c10} > 50$ ).

Many researchers performed portable penetration tests in slopes composed of weathered granite. Many of them determined the upper limit of basement in the means of collapse of slope problem as depth of  $N_{c10}$  reached to 30 (e.g. Ohsaka *et al.*, 1992). However, the threshold value was determined as 50 in this research, because that layer of  $N_{c10} < 30$  was found below the layer of  $N_{c10} > 30$  in many results in this study. Moreover, creeping slope movement is discussed in this research, while interests of former researchers were mainly focused on the collapse of slope. By these reasons, the layer of  $N_{c10} = 50$  is considered as the lower limit of weathered surficial soil. Distribution of the depth and  $N_{c10}$  profiles ( $N_{c10}$  depth curve) for each point are shown in Fig. 4.  $N_{c10}$  does not reach to 50 for points lower than the Nojima Fault. For points on the upper slope, the layer of  $N_{c10} > 50$  was detected, especially, it appeared in the layer shallower than 1 m at both ends of EX 8. At P 8,  $N_{c10}$  reached to 50 at 30 cm, which is omitted in Fig. 3 for the sake of clarity. Another test was done at a point with 3 m distant from P 9 and similar result was obtained. Thus, these extremely shallow limits were not error which might have been caused by existence of large gravel.

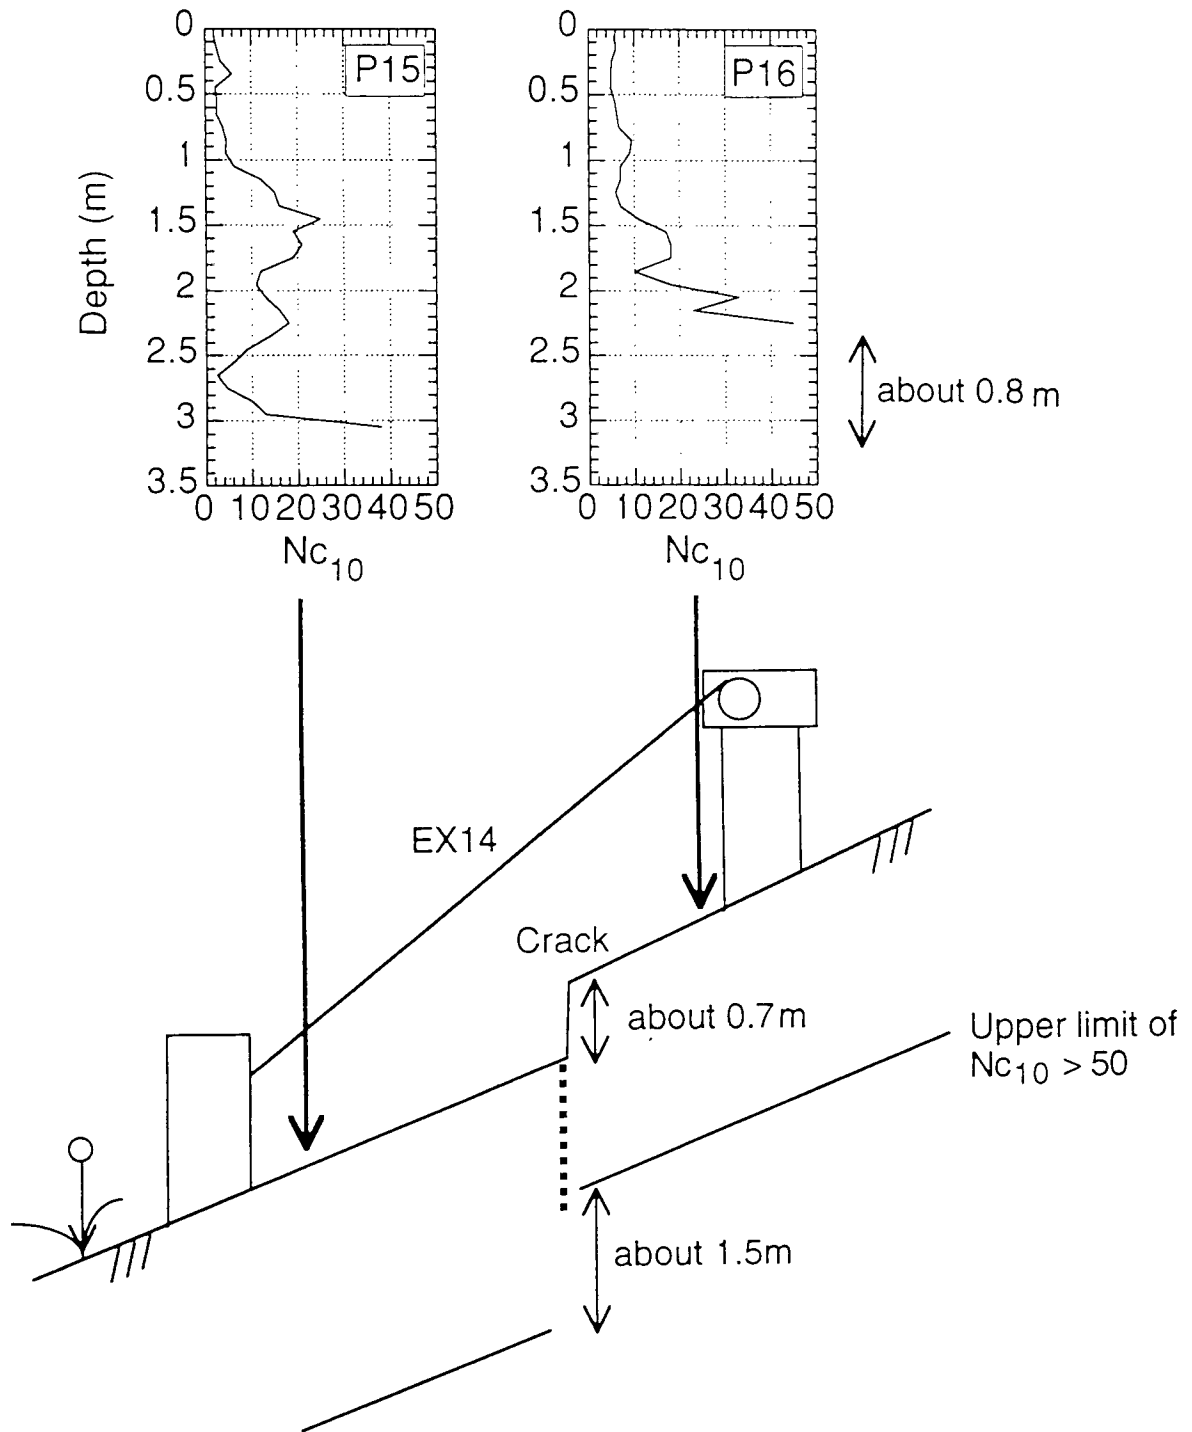
Fig. 4. Schematic figure of ground condition around the crack at EX 14.

Fig. 4 shows the result of portable penetration tests near EX 14. Difference in the elevation of ground surface at the crack was about 70 cm and difference in the depth of lower limit of surficial soil was about 80 cm. Therefore, step of the lower limit at the crack can be estimated as 1.5 m.

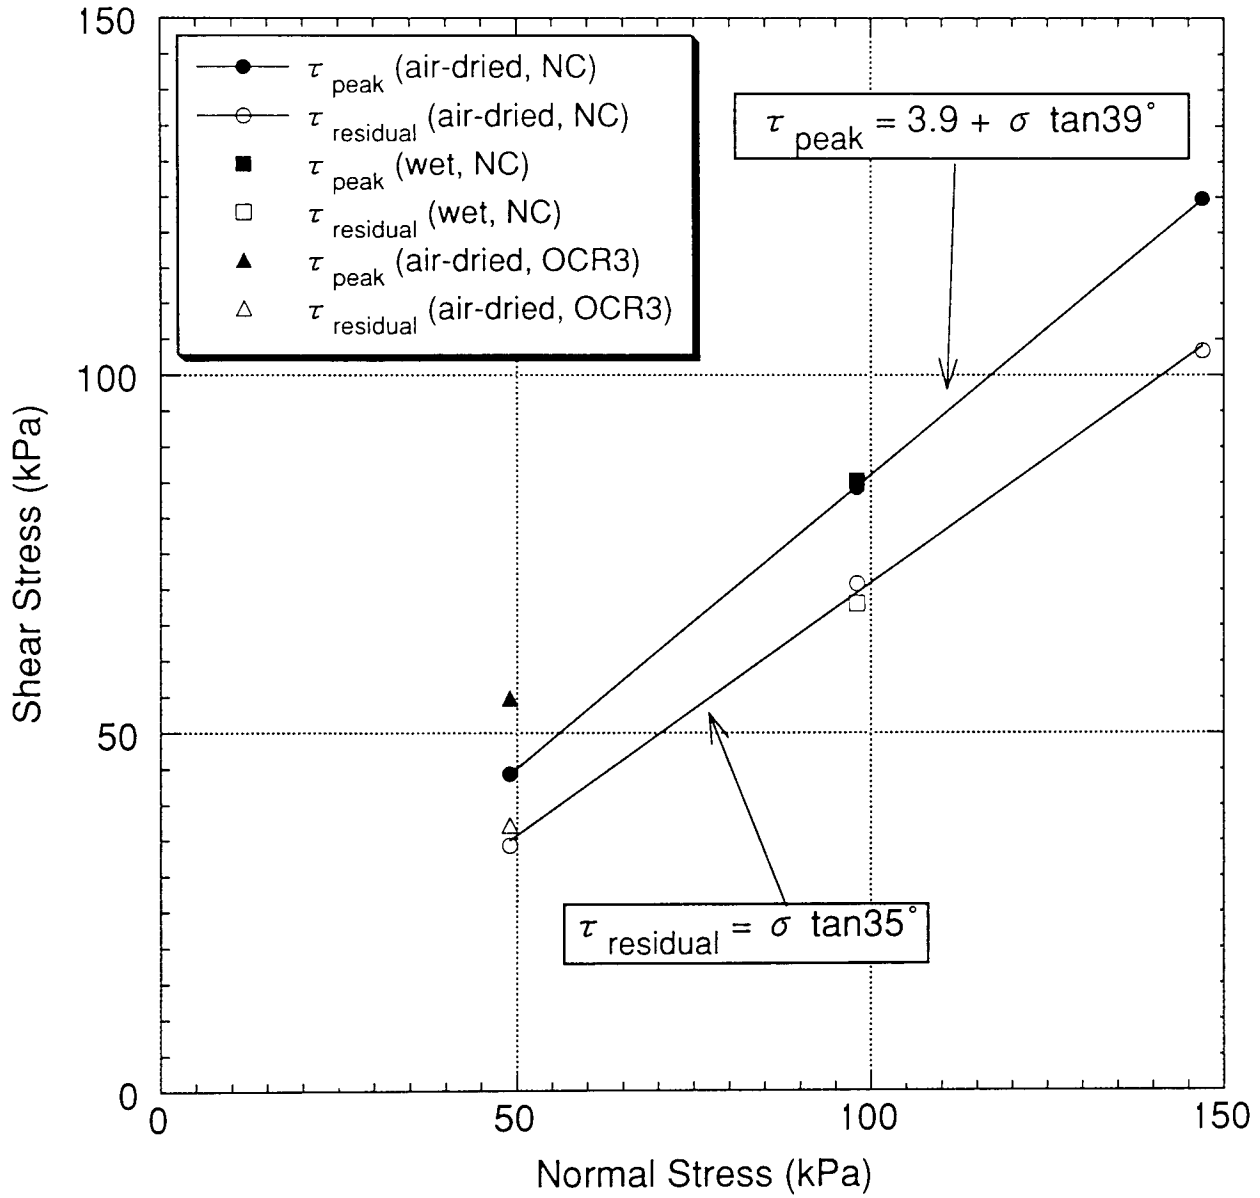
Fig. 5. Results of ring shear tests performed on specimen taken at "sampling point" in Fig. 1. Regression lines were calculated for result of tests on air-dried and NC specimen. Solid marks indicate peak shear stress and open ones indicate residual shear stress.

Ring shear tests (Sassa *et al.*, 1989) were performed on specimen taken from "sampling point" in Fig. 1. An amount of weathered soil of granodiorite was taken from surface of a small failure. The soil was disturbed, air-dried and sieved by 2 mm. Tests were performed

under constant normal stress, constant speed (3 cm / hr) and drained condition. Five tests were performed; three on air-dried normally consolidated (NC) specimen, one on saturated NC specimen and one on air-dried over consolidated (OC, over consolidation ratio = 3) specimen. Their results are summarized in Fig. 5. Peak stress conditions are plotted with solid marks and residual stress conditions are plotted with open marks. Peak strength parameters for air-dried NC specimen were obtained as  $c=3.9$  kPa and  $\phi=39^\circ$ . Residual ones were done as  $c=0$  and  $\phi=35^\circ$ . There is slight difference between the strengths of air-dried NC and saturated NC specimen. Also a slight difference is seen in NC and OC specimen in the peak strength, but difference in the residual strength is not marked. As a result, residual strength of the granodiorite is independent of water content and OCR (in the range of  $OCR \leq 3$ ).

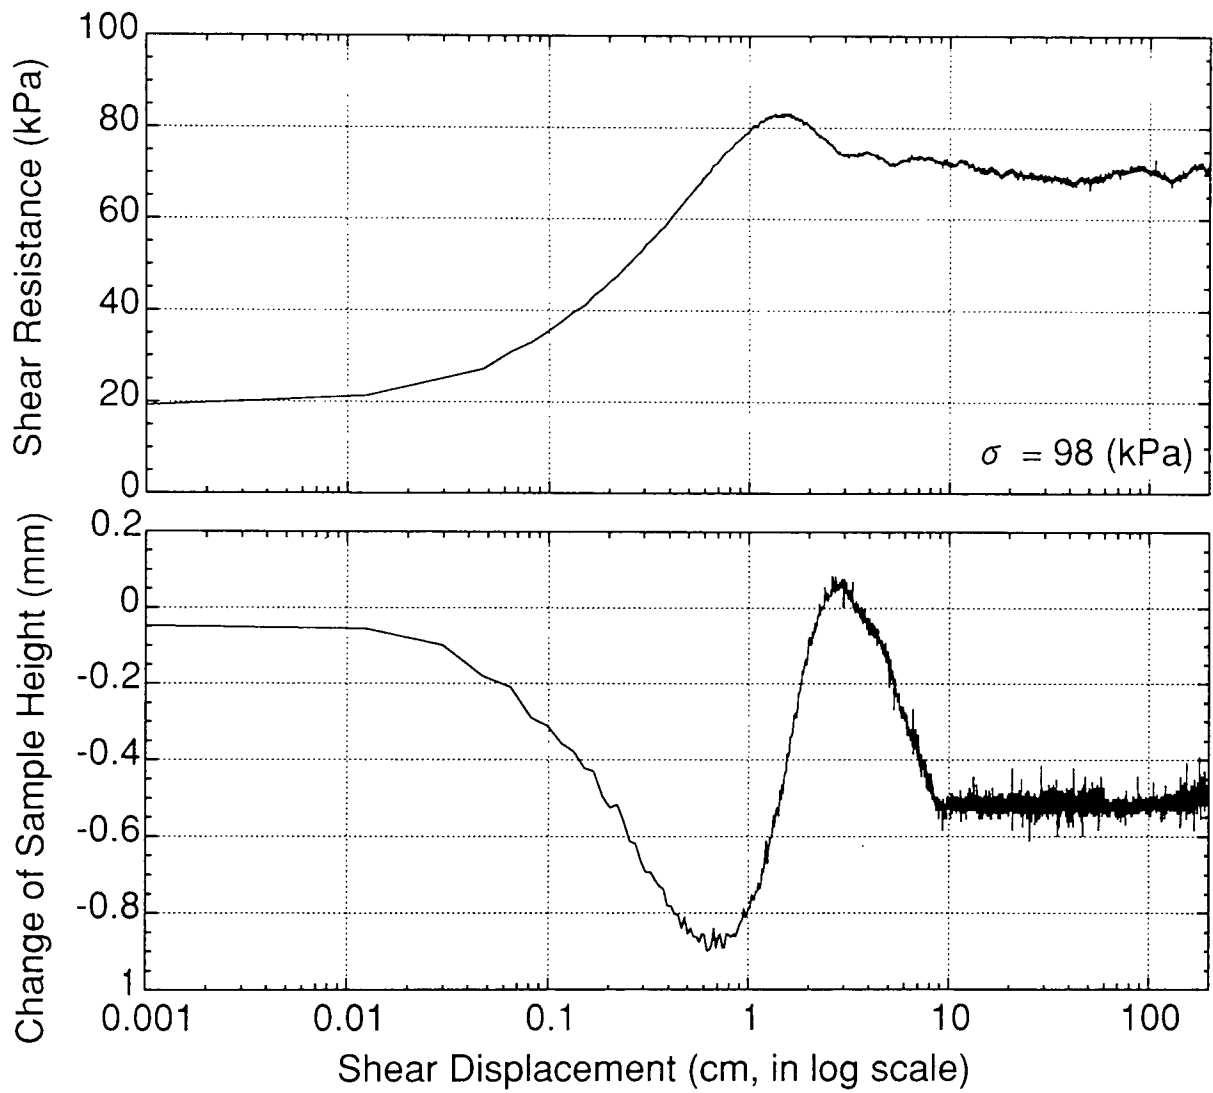
Fig. 6. Change of shear resistance and sample height with shear displacement during a ring shear test on air-dried normally consolidated specimen.

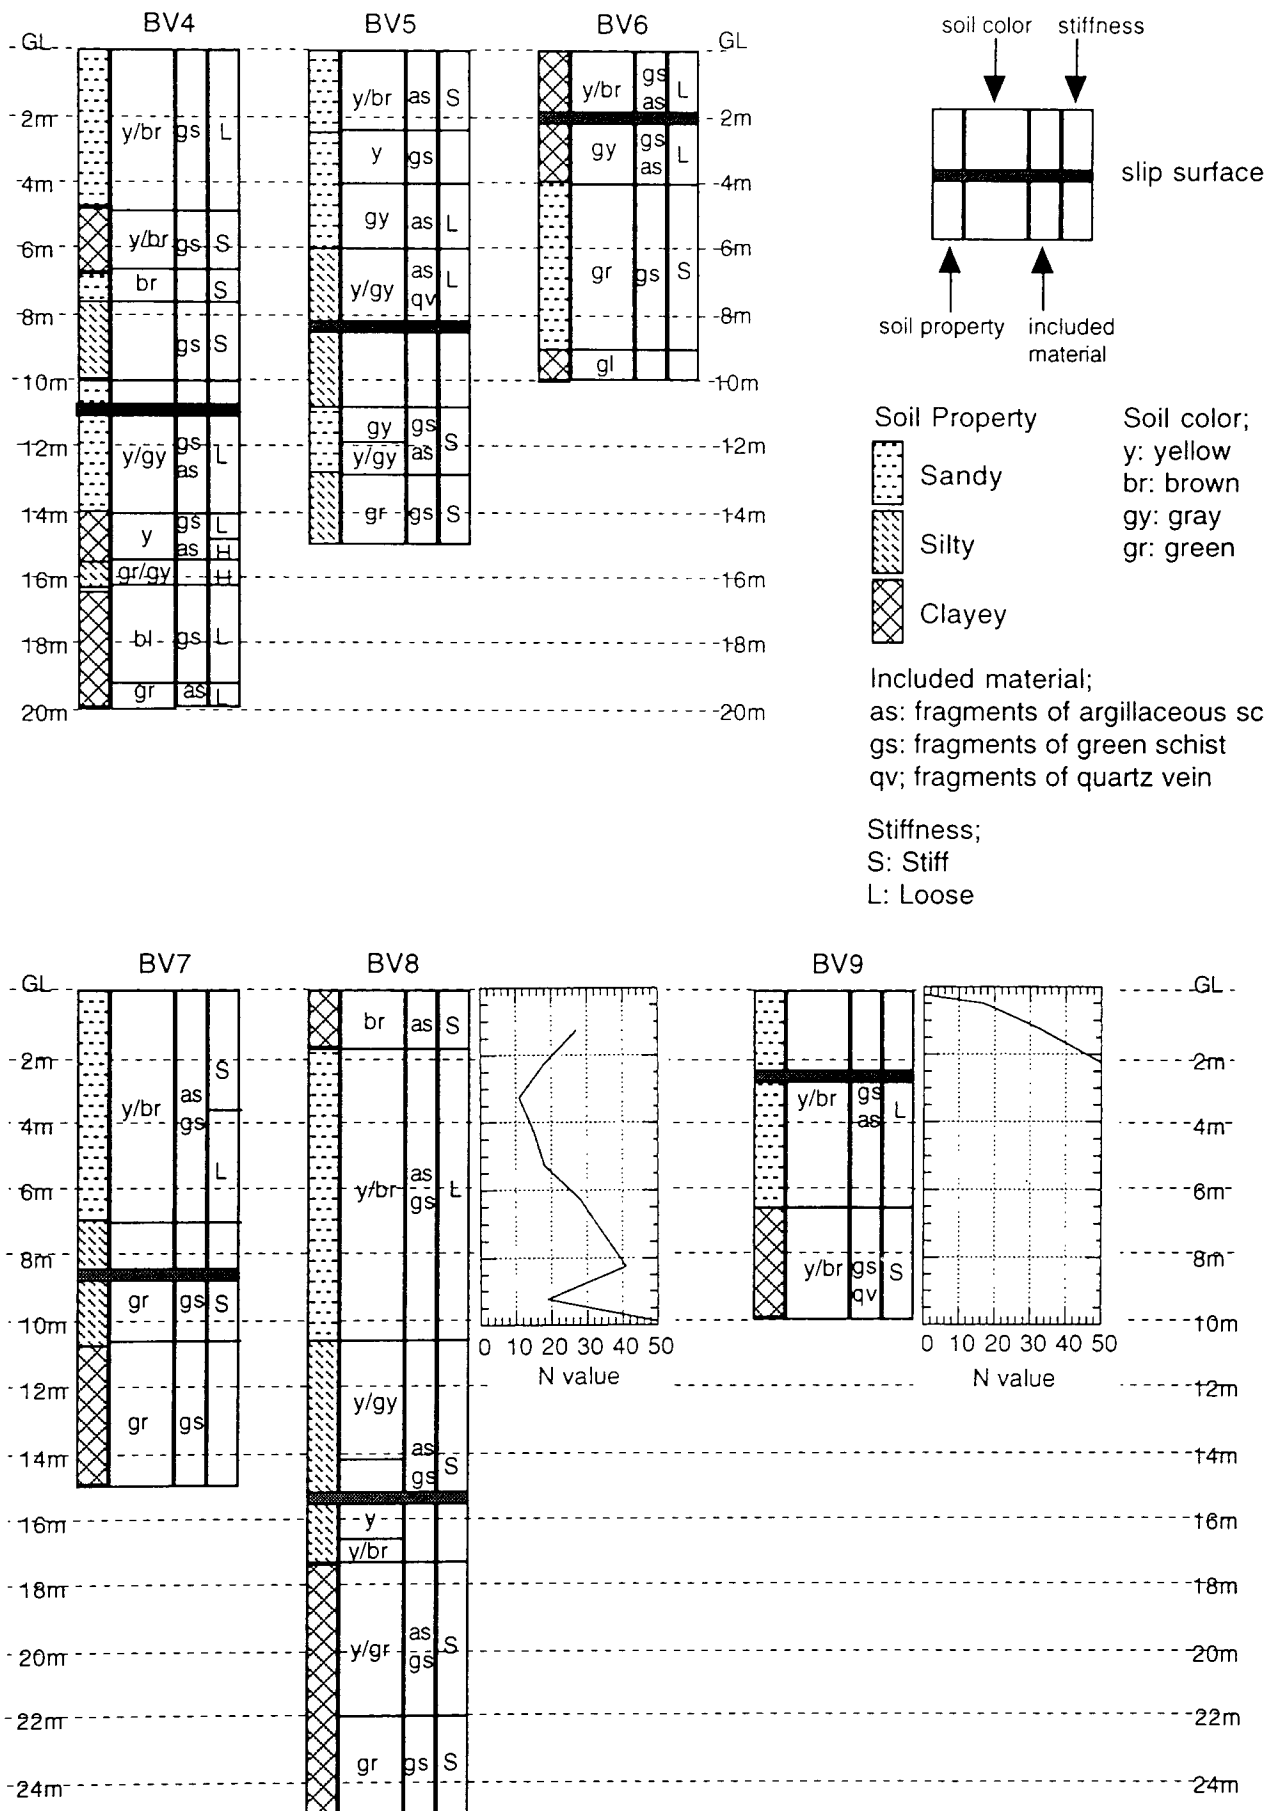
Fig. 9. Result of visual inspection of drilled cores and standard penetration tests in the Nishi-Ikawa landslide.

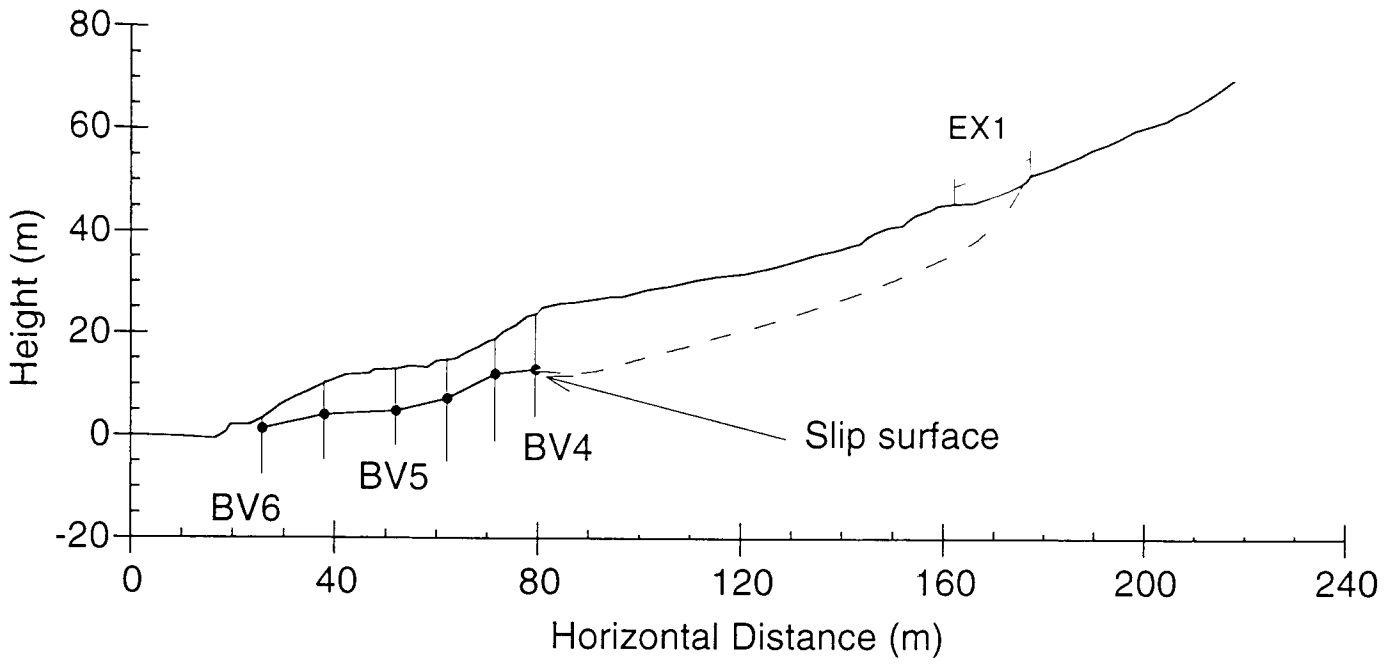
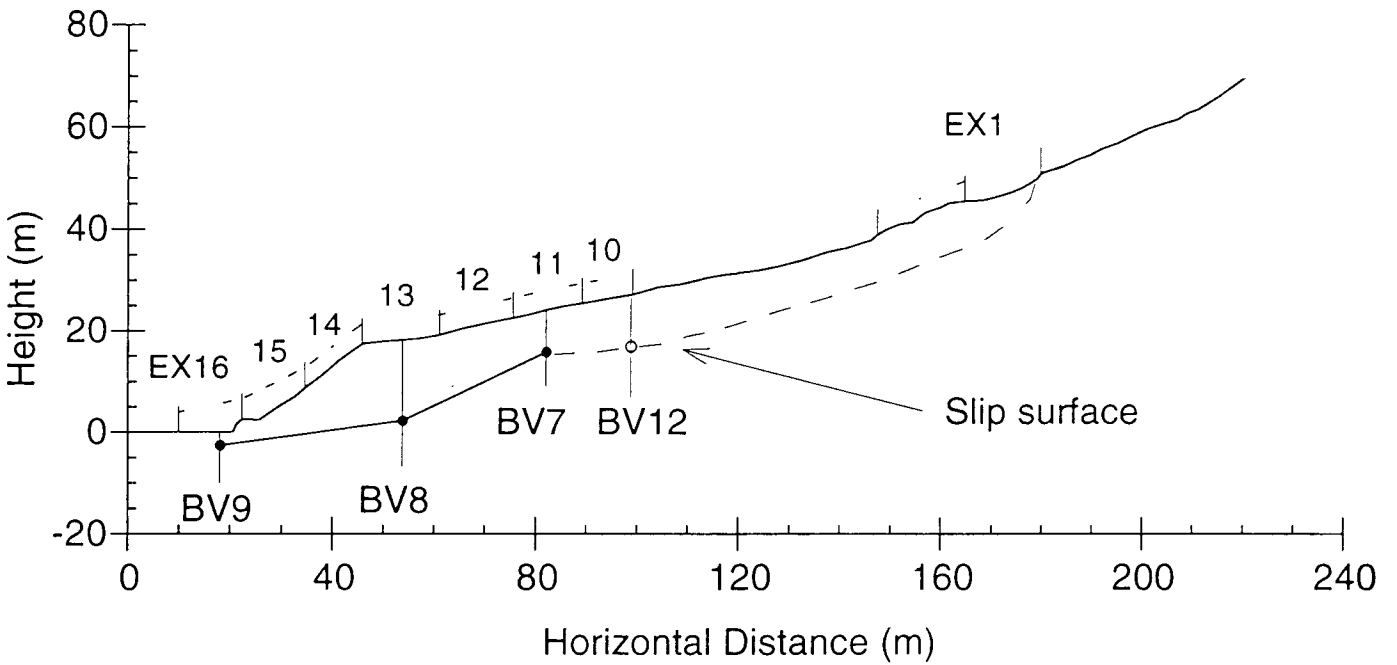
Fig. 10. Two cross sections along survey lines. Depth of slip surface has been confirmed by long-term observation. The head scarp is located in the span of EX 1.

m deep, the second layer of  $V_p = 1200 - 1500$  (m / s) from 20 - 25 m deep and the basement of 3200 (m / s) below that. Fig. 10 shows two cross sections along the survey lines in November 1995. The depth of slip surface at each borehole (Table 1, Fig. 9 and 10), except BV 12, was identified by strain gauges attached on pipes embedded in the landslide area (as stated later) and checked by measurements made on an insertion-type bending-pipe. The depth had been confirmed by long-term investigations (e.g. Shima *et al.*, 1975, Suemine, 1983) and no other slip surface had been found.

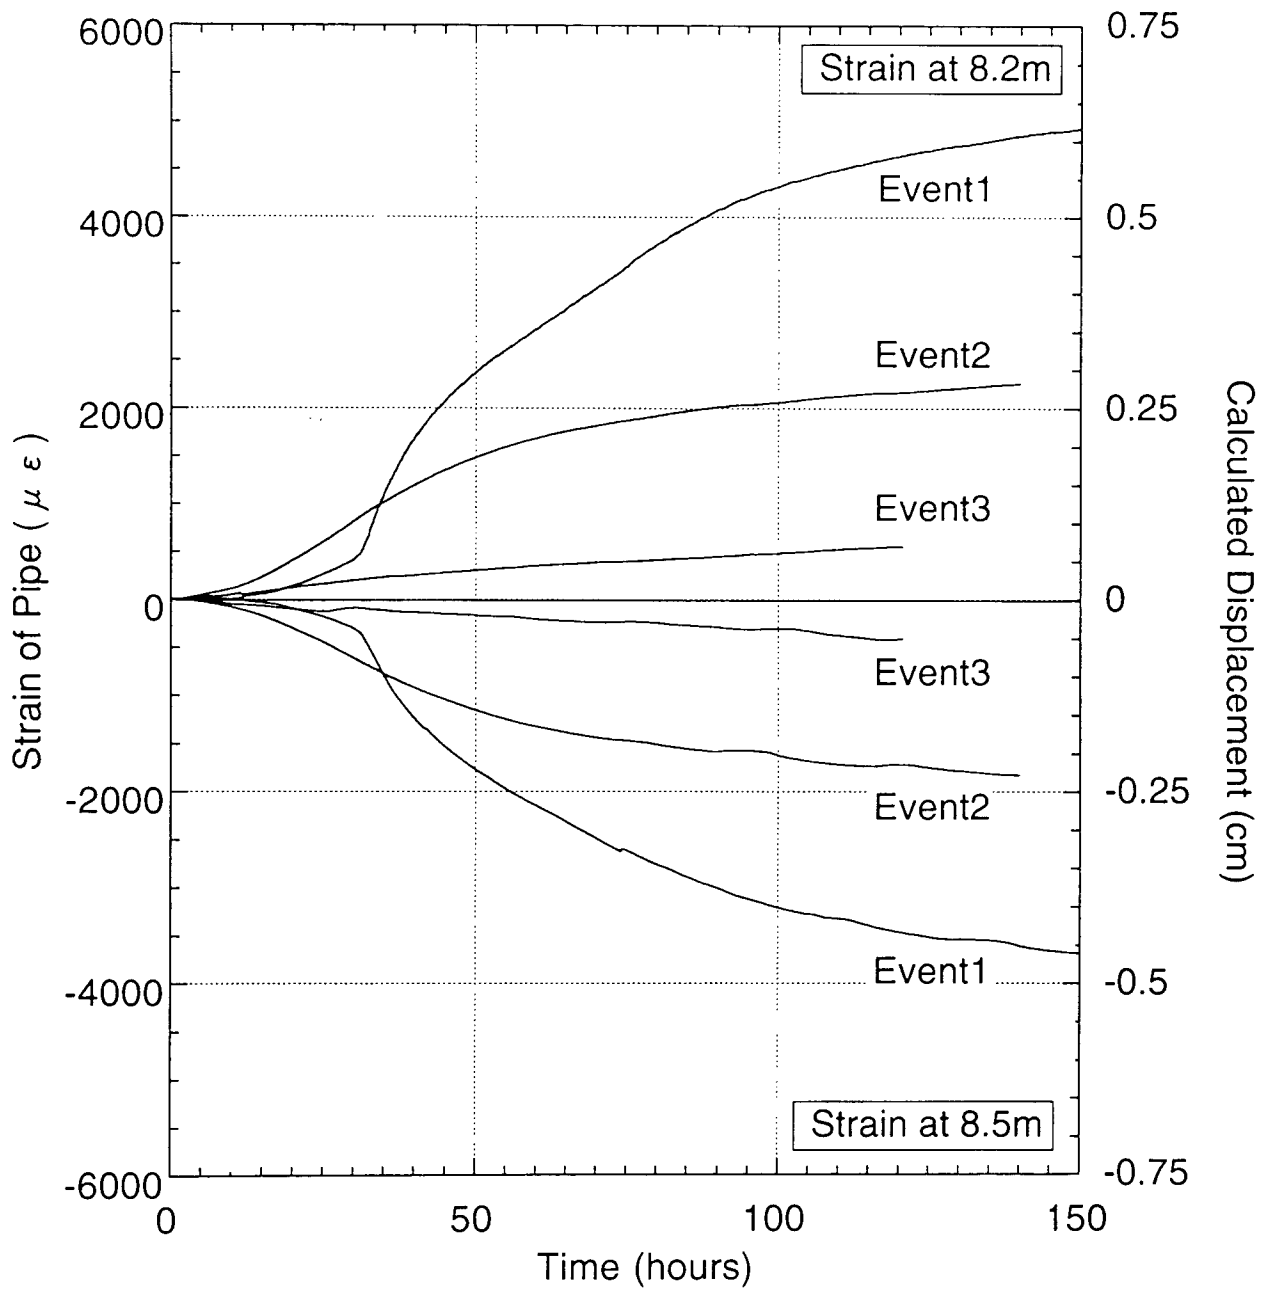
Fig. 11. Result of measurement of pipe strain near the slip surface in BV 7 for three events. Calculated displacement using relationship in Fig. 17 (stated later) is shown in the right axis.

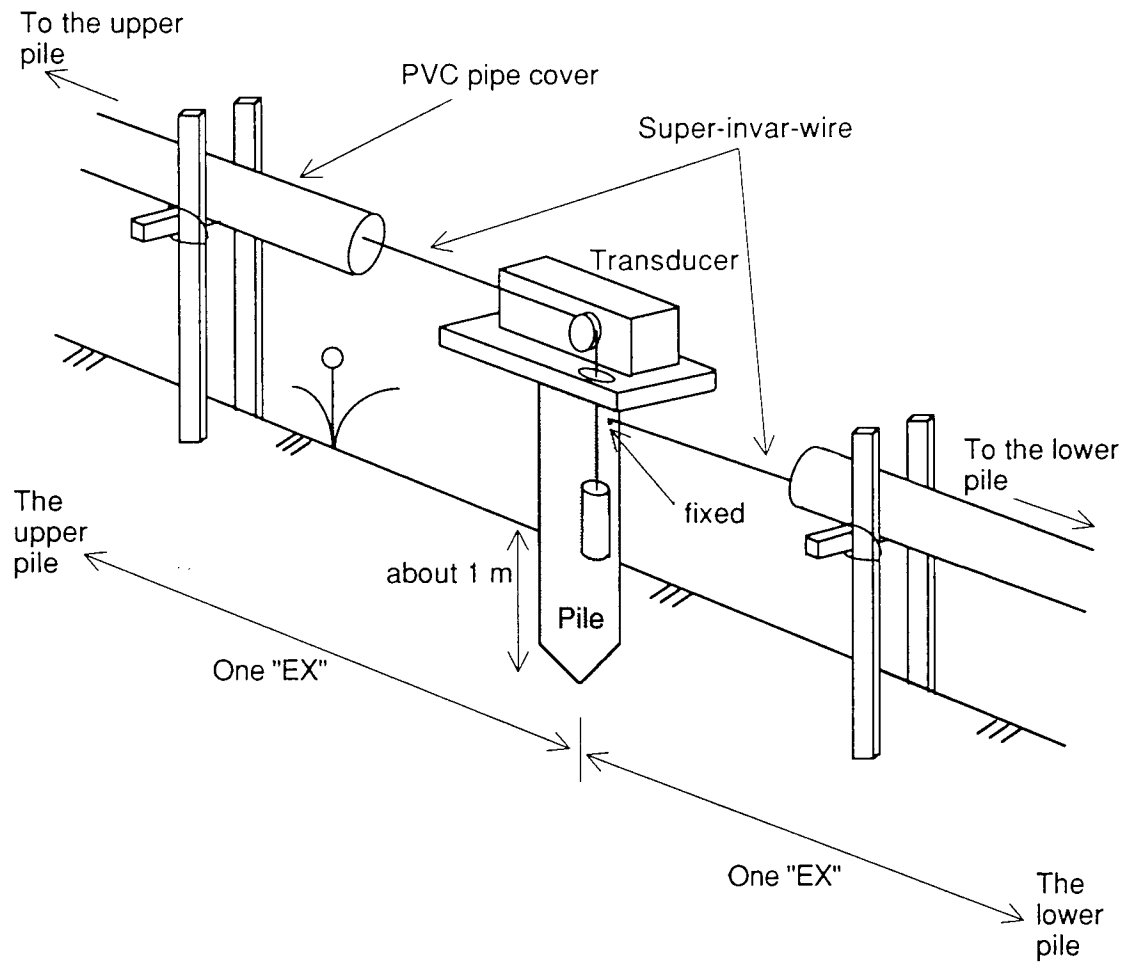
Fig. 12. Schematic structure of extensometers.

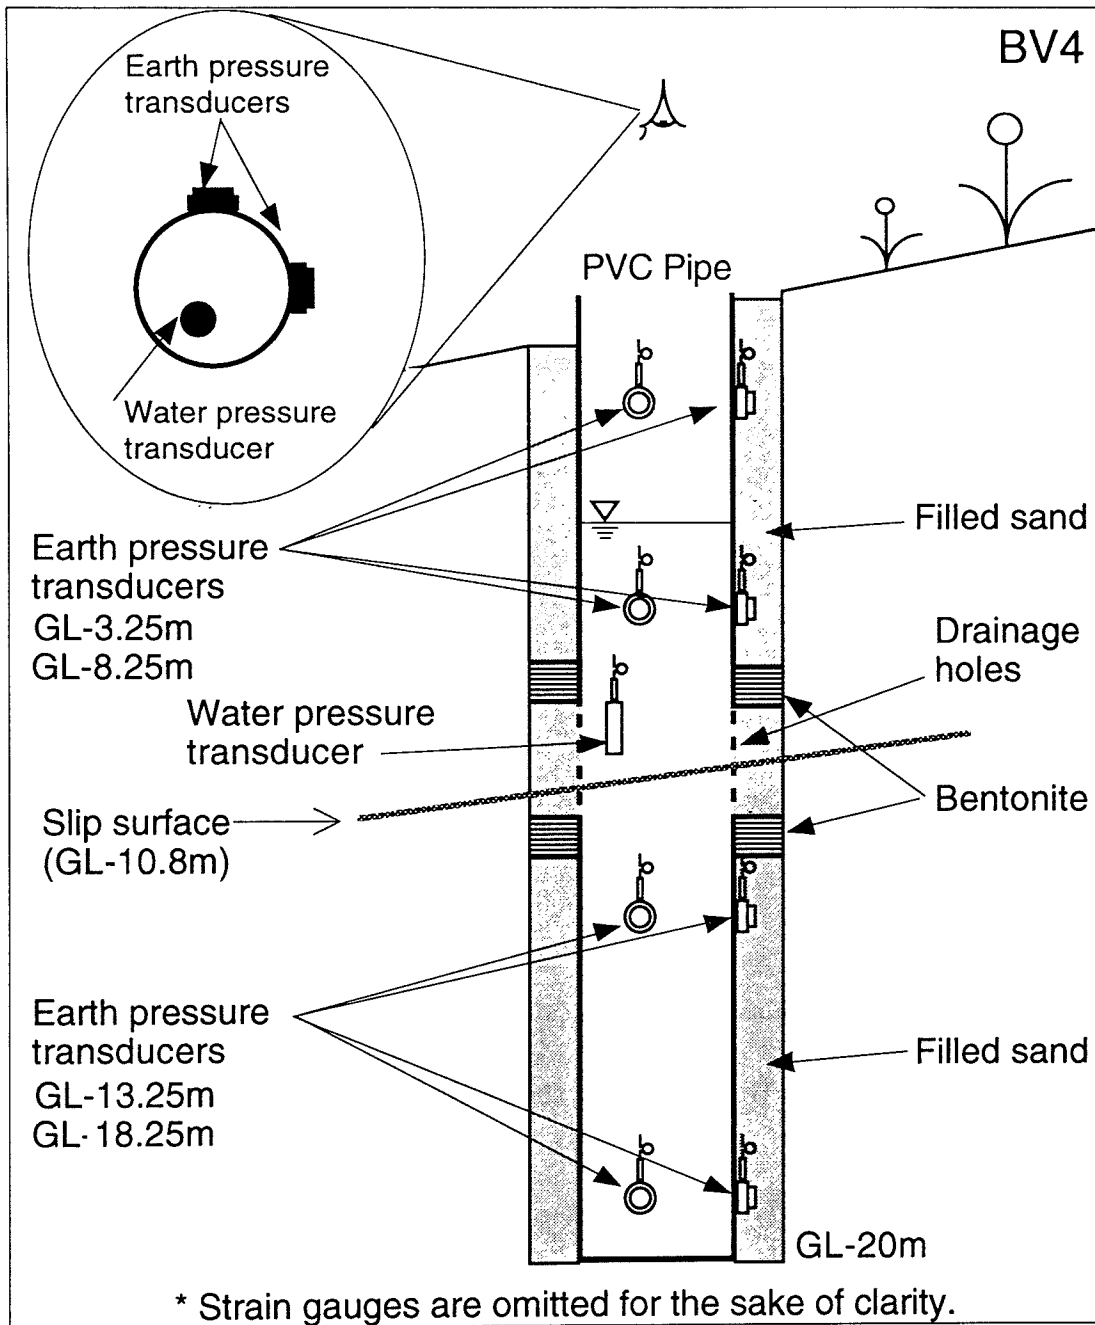
Fig. 13. Schematic structure of an observation borehole.

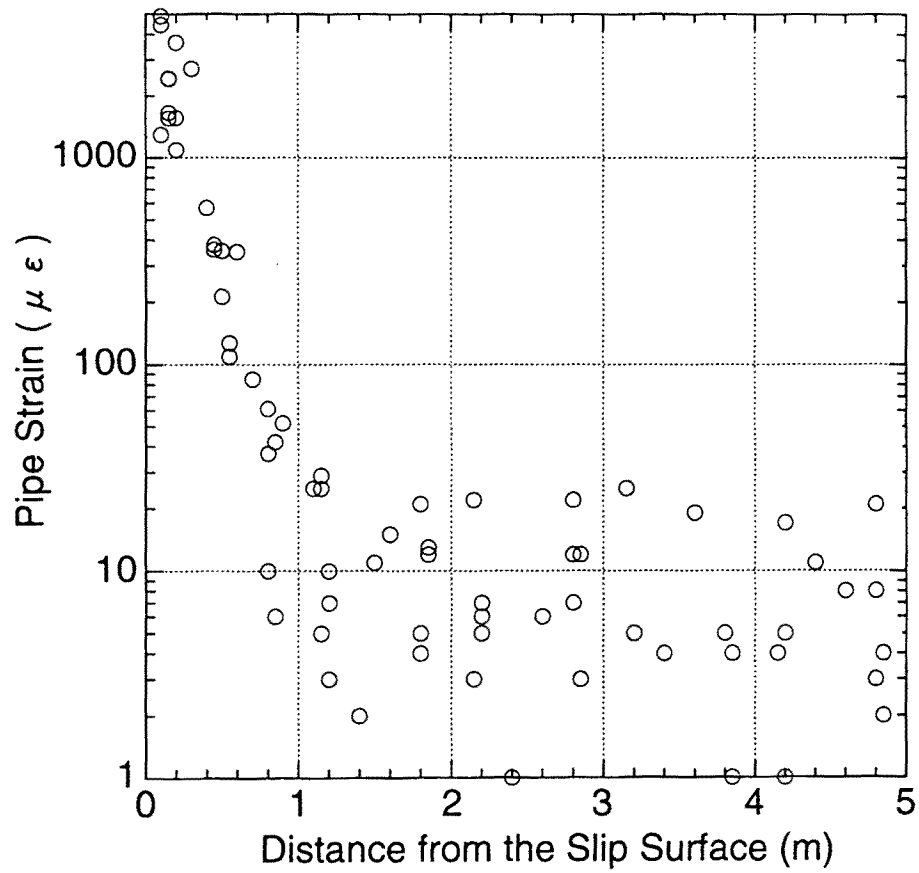
Fig. 14. Attenuation of the maximum variation of pipe strain with distance from the slip surface observed during Event 1 in the Nishi-Ikawa landslide.

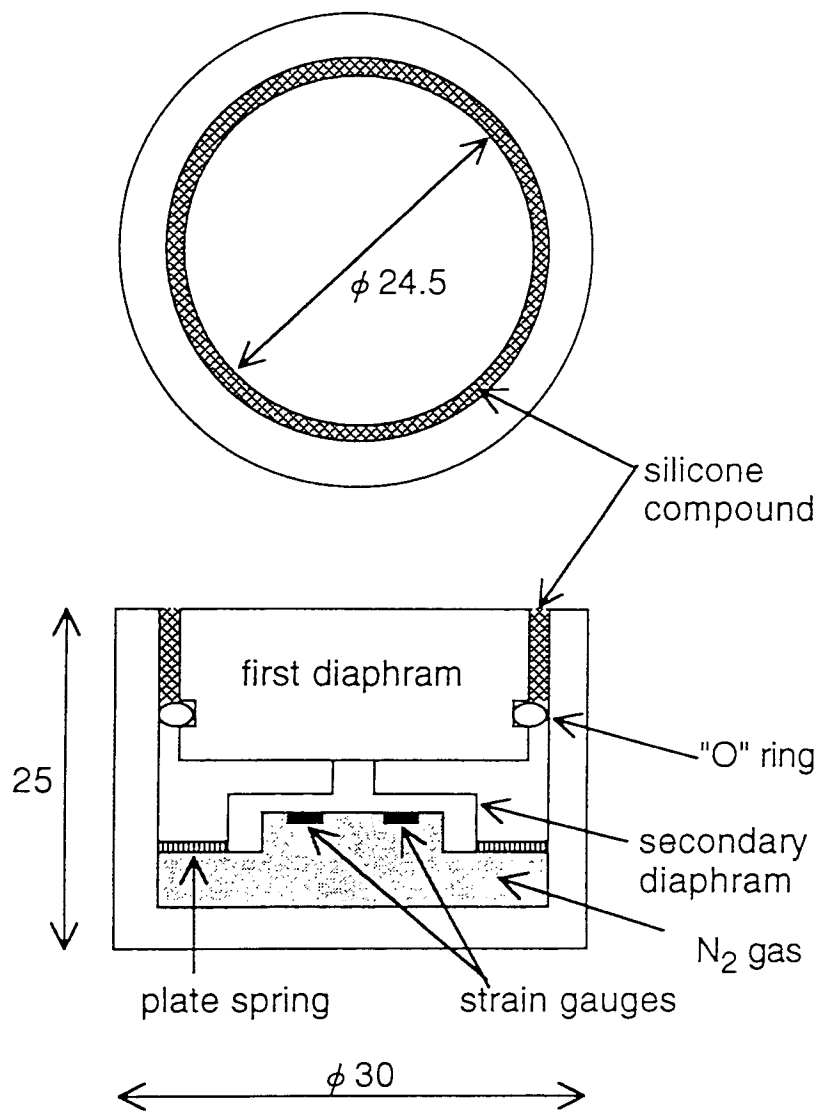
Fig. 15. Structure of the earth pressure transducer used (unit: mm).

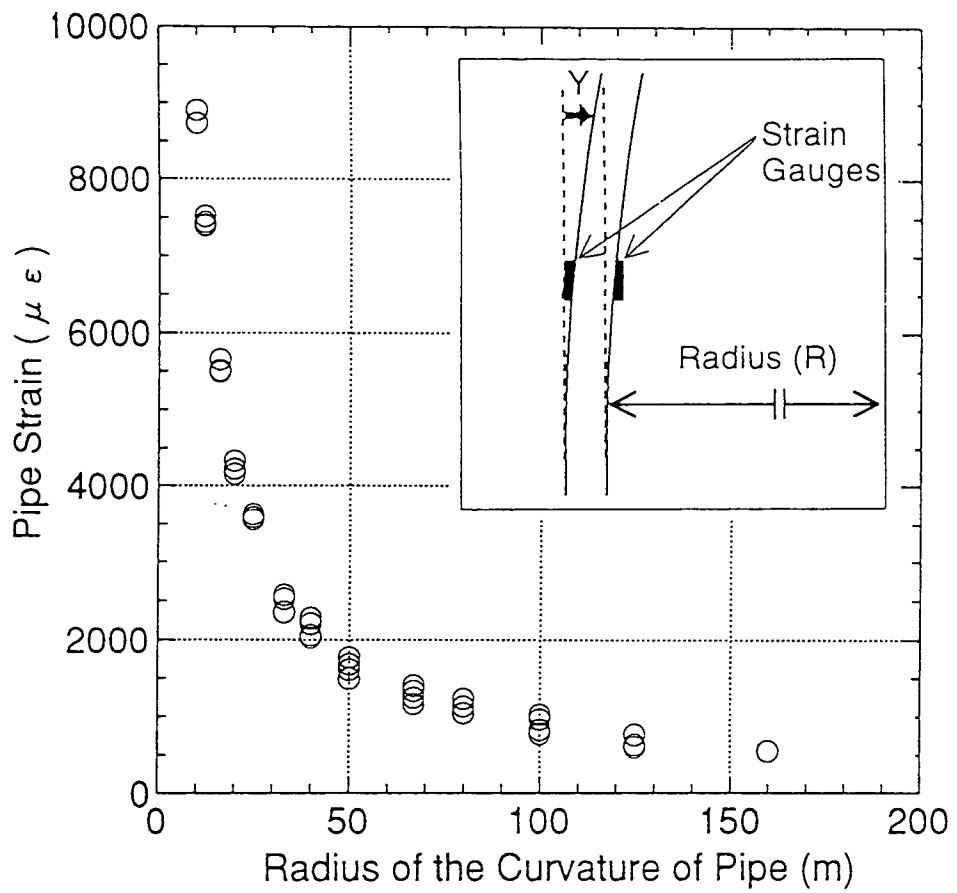
Fig. 16. Calibration test results for measurement of the strain on a pipe.

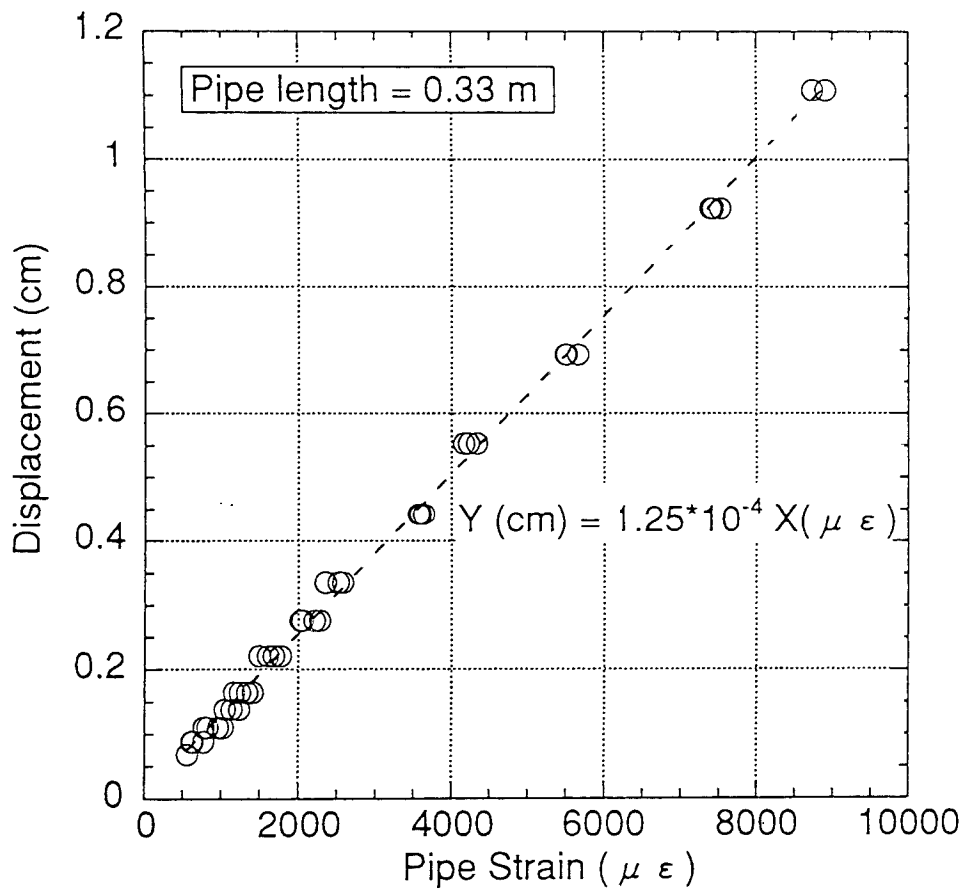
Fig. 17. Relationship between the output of the strain gauge and the relative displacement, calculated from Fig. 16.

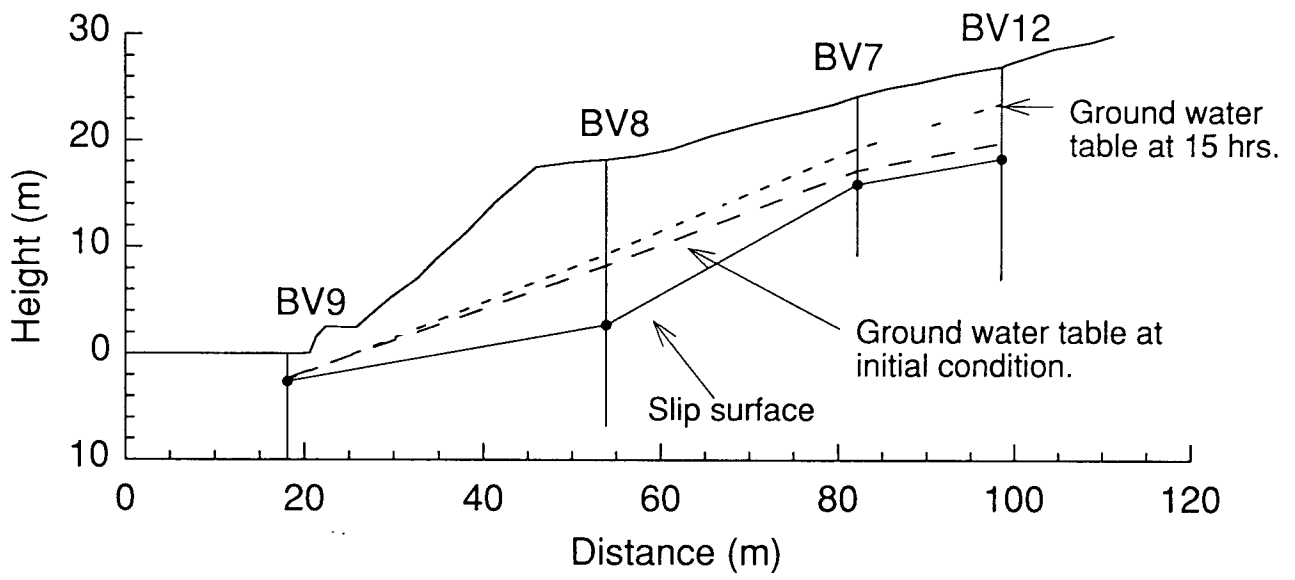
Fig. 18. Ground water table assumed for the FEM analysis.

Static 2-D FEM simulation under plane strain condition was performed using cross section shown in Fig. 18. Though the line curved in the middle part, structure of ground was simplified in a 2-D model. Depths of slip surface at BV 7 to BV 9 in the figure had been

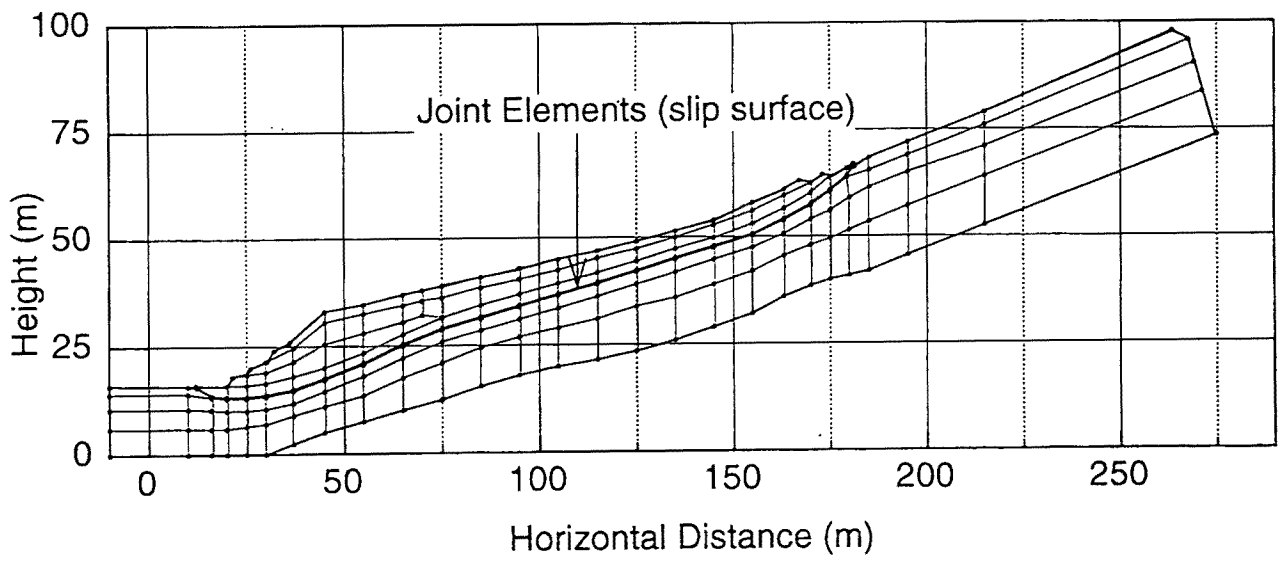
Fig. 19. FEM meshes for calculation (joint elements are expressed as thick line).
