A study on the variation of displacement and  
internal earth pressure in creeping landslides

Thesis submitted to Graduate School of Science  
in partial fulfillment of the requirements of the degree  
Doctor of Science  
in the Division of Earth and Planetary Sciences  
Graduate School of Science  
Kyoto University

Kiminori Araiba

January 1998

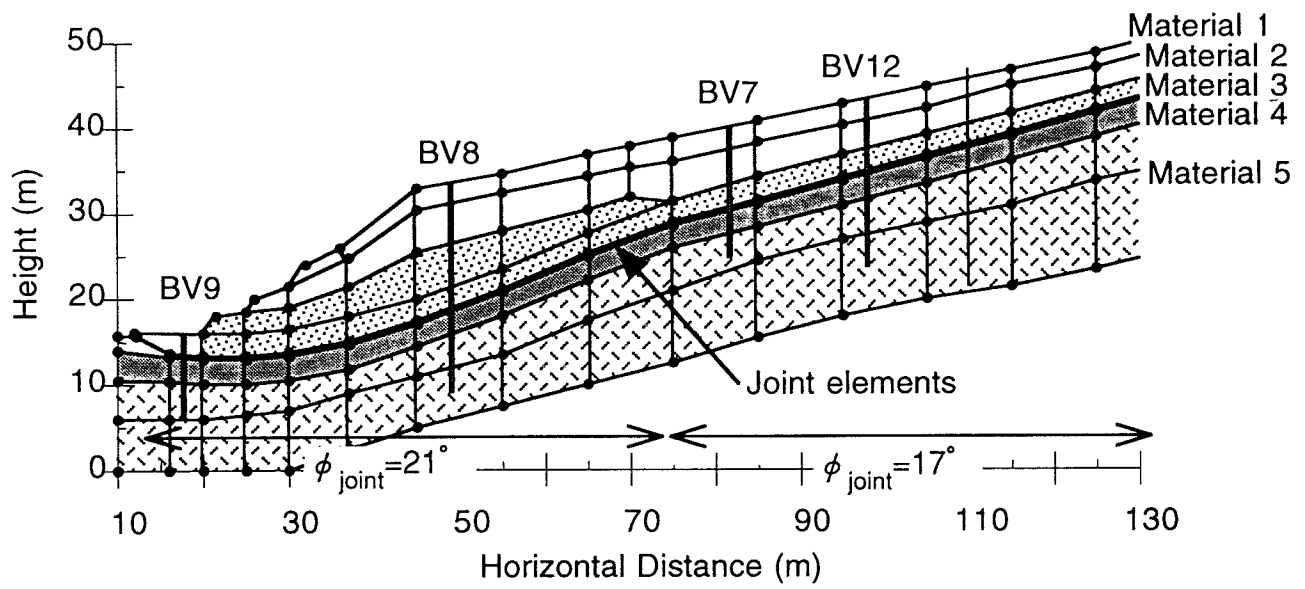
Fig. 20. Structure of model ground in the slope from BV 9 to BV 12.

Except for the slip surface, four-noded 2-D isoparametric elements were used. The constitutive law was elasto-plastic, but yielding condition (Table 2) was not achieved. Therefore, all elements remained in elastic domain. Vermeer (1990) analyzed the biaxial test as a slip of elastic mass on a slip surface. The motion of elastic sliding mass on the slip surface was also reproduced in this analysis. Assumed ground structure is shown in Fig. 20 and table 2.

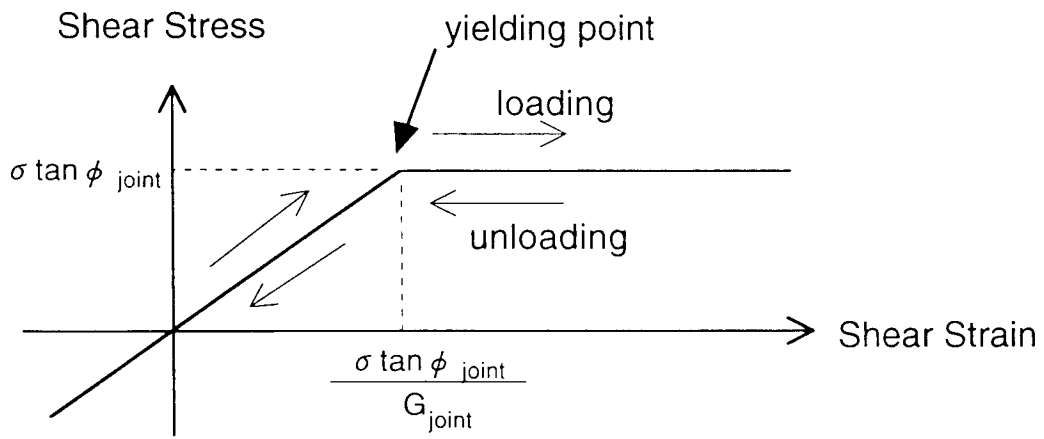
$\phi_{joint}$ : friction angle of joint  
 $G_{joint}$ : Shear stiffness of joint

Fig. 21. Shear behavior of joint element under constant effective stress.

Table 3 shows material property of joint element. The elastic constants (normal and shear stiffness) of joint elements were determined as the same one with material 2. The material 2 (not 3) was chosen in order to illustrate ductile zone around slip surface which is often observed in creeping landslides. Normal stiffness of joint element in rock mechanics is determined by distance of two surfaces which are forming the element to illustrate the change of contact area. However, the normal stiffness is considered to be constant in this study, because the contact area is likely to be almost constant in the case of slip surface in soil. No drop in shear strength after yielding was considered. Such joint element behaves as bi-linear elastic material with stiffness of second spring is zero (because of this reason, the term "yield" is used in this FEM analysis in spite of "failure"). Therefore, there is no hysteresis in shear stress-strain relationship as shown in Fig. 21, in other words, no plastic displacement was reproduced. Shear behavior of real slip surface in soil is likely to have hysteresis which is not represented by this analysis. The omit of hysteresis did not affect the result of this study, because the shear displacement at all joint elements increased monotonously (shear displacement occurred only in the direction of "loading" in the figure). No shear-induced-dilatancy was considered.

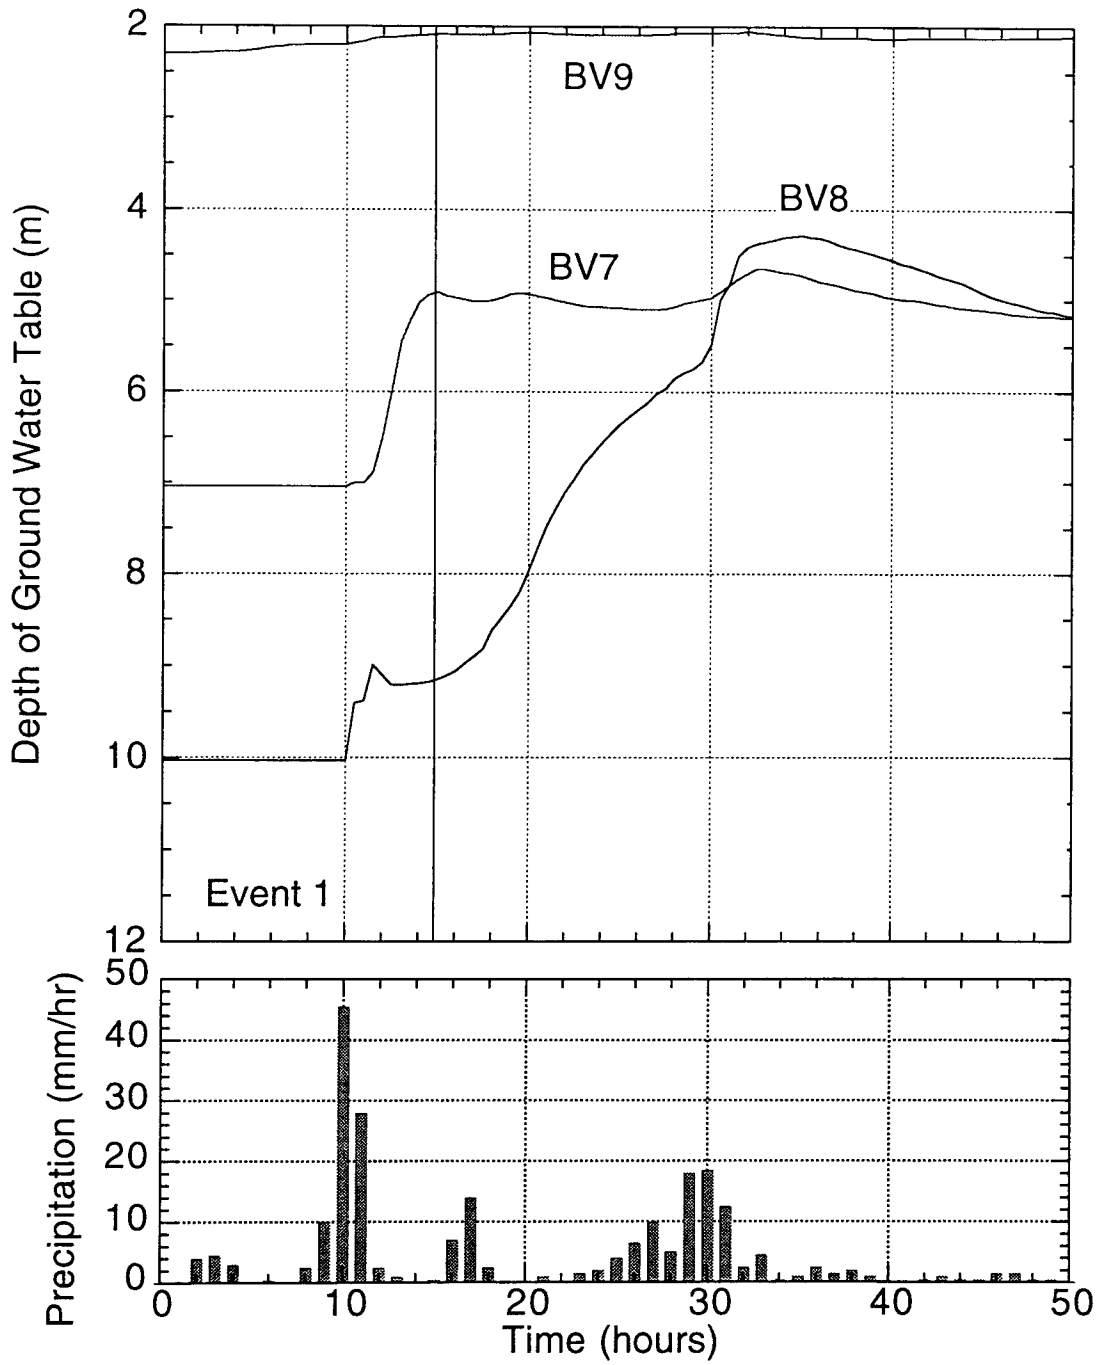
Fig. 22. Depth of ground water table used for the FEM analysis calculated from observed pore pressure at the slip surface.

Fig. 22 shows ground water table in Event 1 which was used for the analysis. Permeability of sliding soil mass was considered to be high and ground water table shown in the figure was calculated from pore pressure at the slip surface measured in BV 7 to BV 9. For BV 12, where measurement was not done at the time of Event 1, the water table was assumed. Fig. 23 shows responses of ground water table to precipitation observed recently. It shows that initial table for BV 7 and BV 12 were almost the same and rising of the table in BV 12 was faster and larger than that in BV 7. The table for BV 12 was determined as; 7.1 m for initial (the same value in BV 7 in Fig. 22) and 3.2m for 15 hours (the highest value in Fig. 23). Soil below the slip surface was considered impermeable. The variation of shape of the table is shown in Fig. 18. This shape can not be explained in this cross section (2-D) and plural source of ground water may exist in 3-D for this landslide. Buoyant and seepage forces were represented by nodal forces. That is;

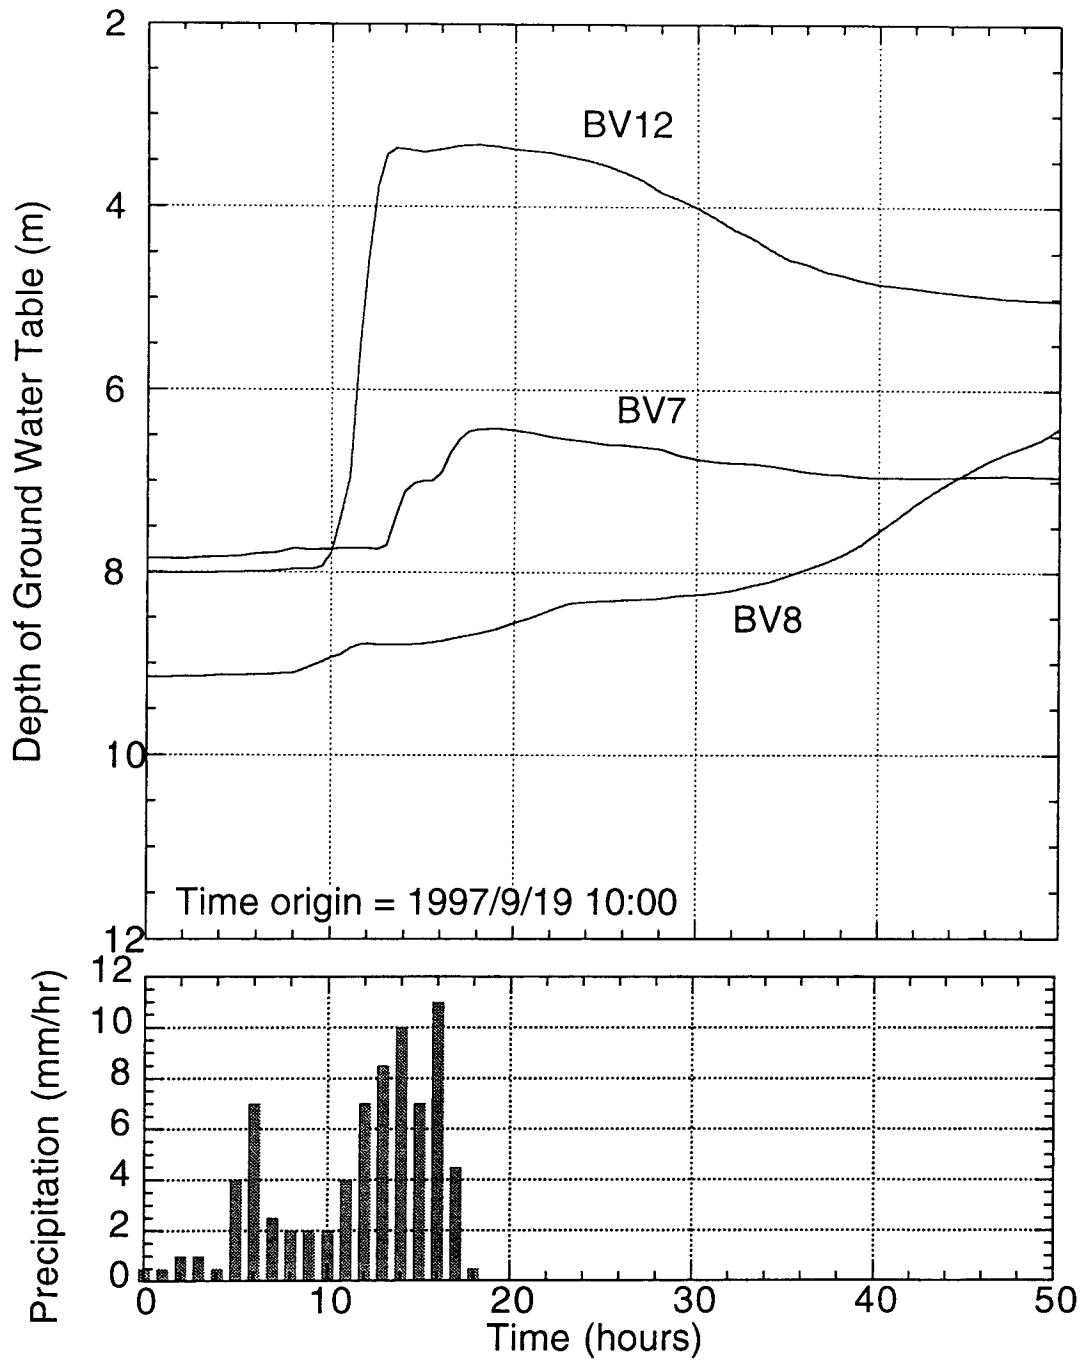
Fig. 23. Depth of ground water table observed in September 1997, after installation of BV 12.

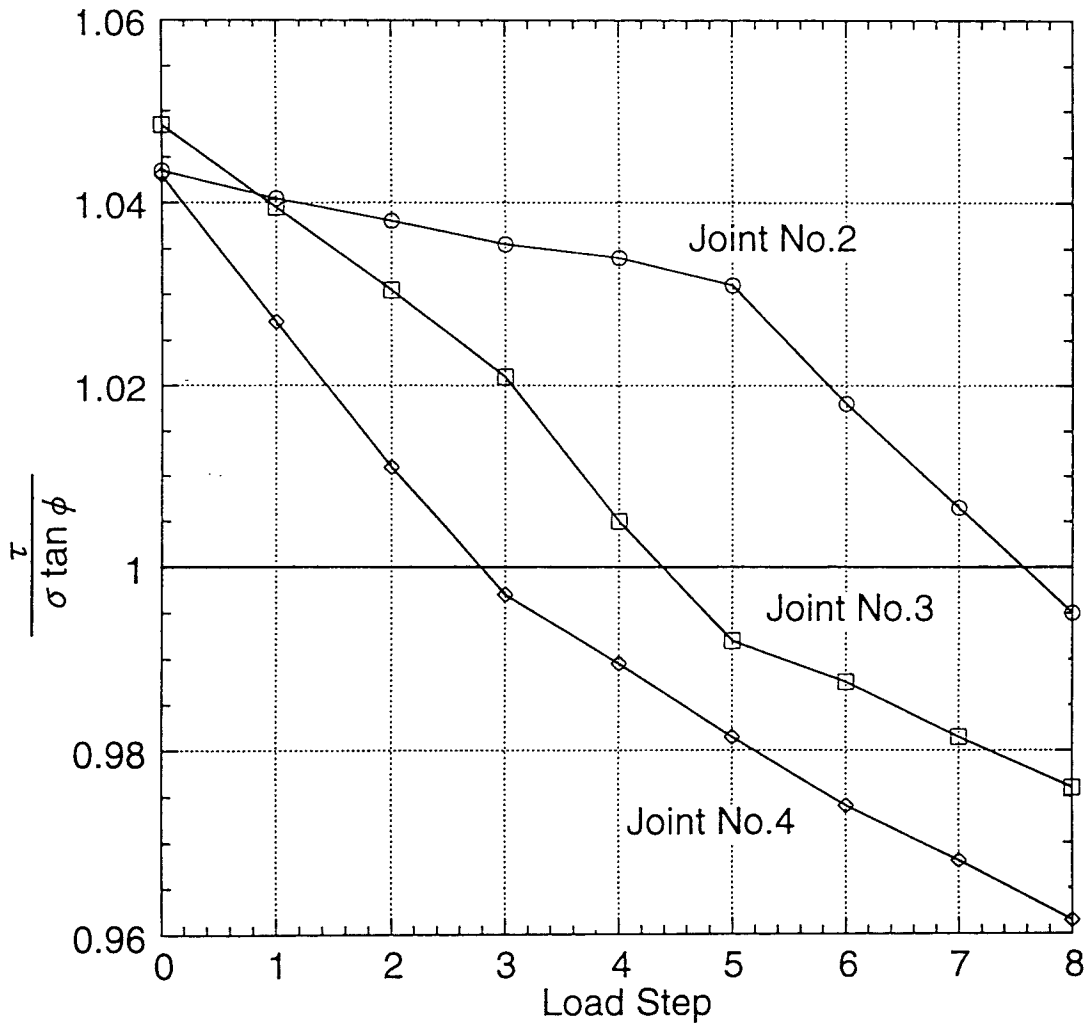
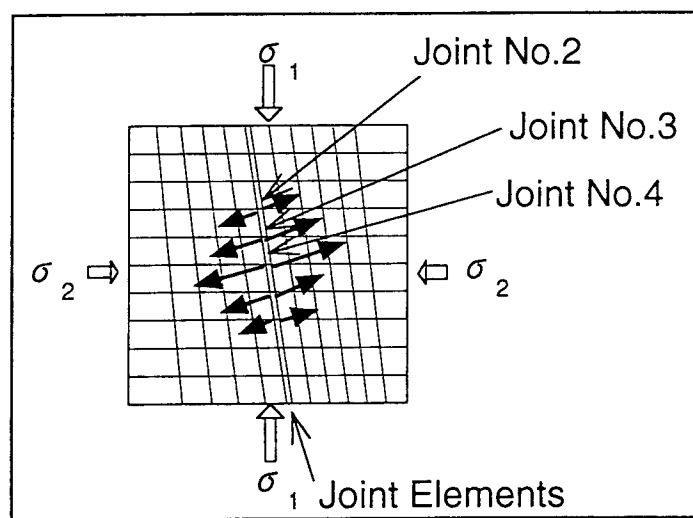
Fig. 24. Result of preliminary test, lower figure shows structure of soil and applied force, upper diagram shows decrease in LSF with load step.

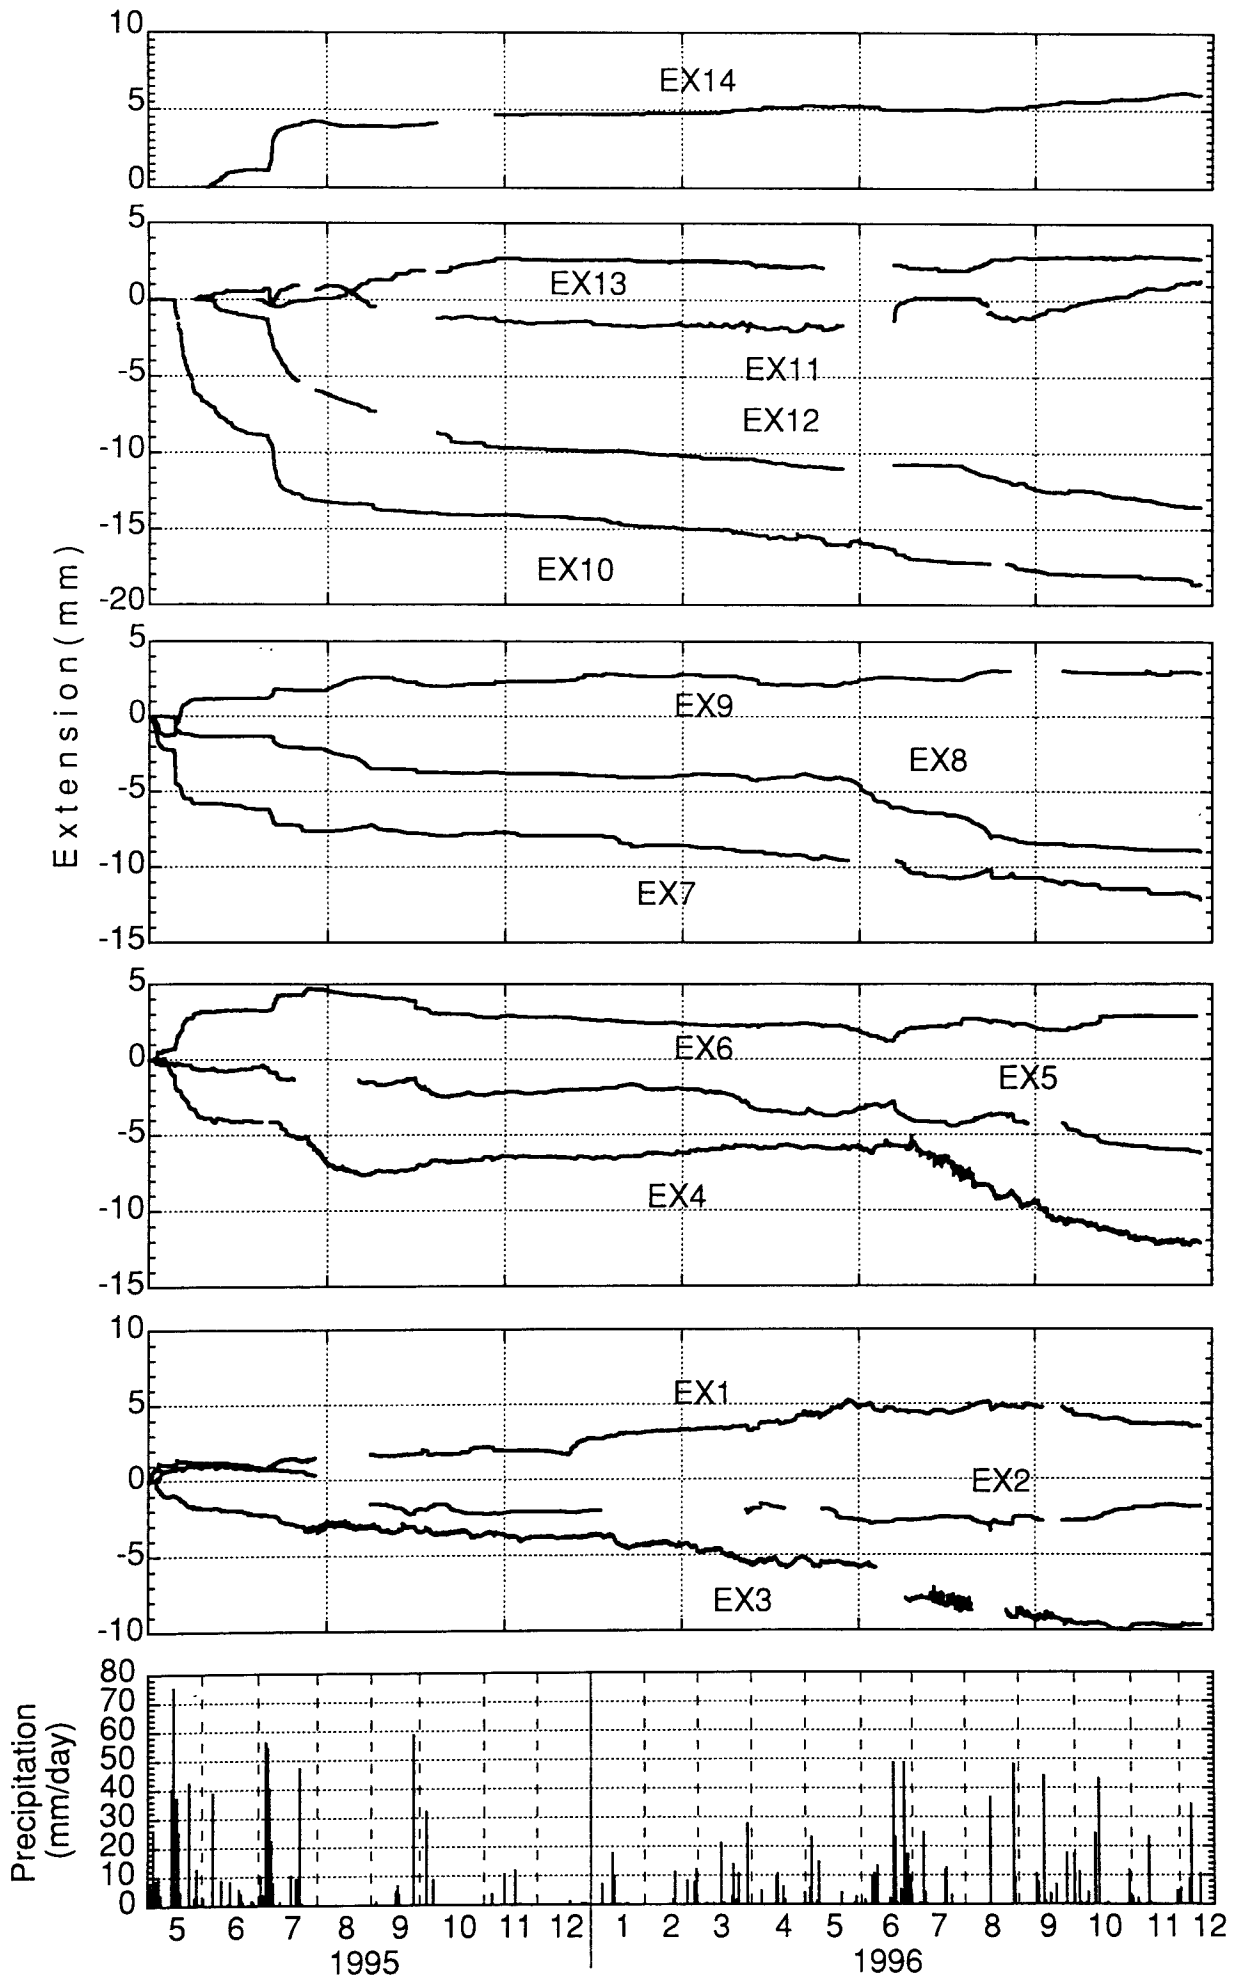
Fig. 25. Result of measurements of extensometers in the Todoroki landslide from 1995/4/28 to 1996/12/11.

Fig. 25 shows the result of measurement on extensometers from April 28, 1995 to December 11, 1996 together with daily precipitation. Periods of data-missing, which differed with extensometers, were caused by break of super-invar-wire, cut of electric line by animals, error of recorder, *etc.*. Variation during a missing period caused by break of super-invar-wire was assumed to be zero because there is no way to estimate it. Variation during a missing period caused by other reasons can be estimated because absolute value of output of the transducer was continuous before and after the period. Marked variations are seen at early period of observation. It is probably partially because of large precipitation then and partially because of effect of damage by the Earthquake. Fig. 26 shows distribution of the final value of each extensometer in the cross section along the survey line. Length of data acquisition period is different in different extensometer because of data-missing periods, as mentioned above. The distribution of extension and compression is in disorder, which is likely to be the result of complex soil movement. Marked extensive values are seen in EX 6, EX 9 and EX 13, suggesting that upper boundaries of blocks of moving soil located around these extensometers. Amount of compression is larger than that of extension throughout the survey line. Large compression is seen even in upper slope (EX 11 to EX 12) and amount of extension in EX 13 is small compared to that of compression in lower extensometers. It indicates that slope upper than EX 13 was also moving. These results can not be explained by a simple landslide model. It is likely that deformation observed was caused by different types of soil movement.

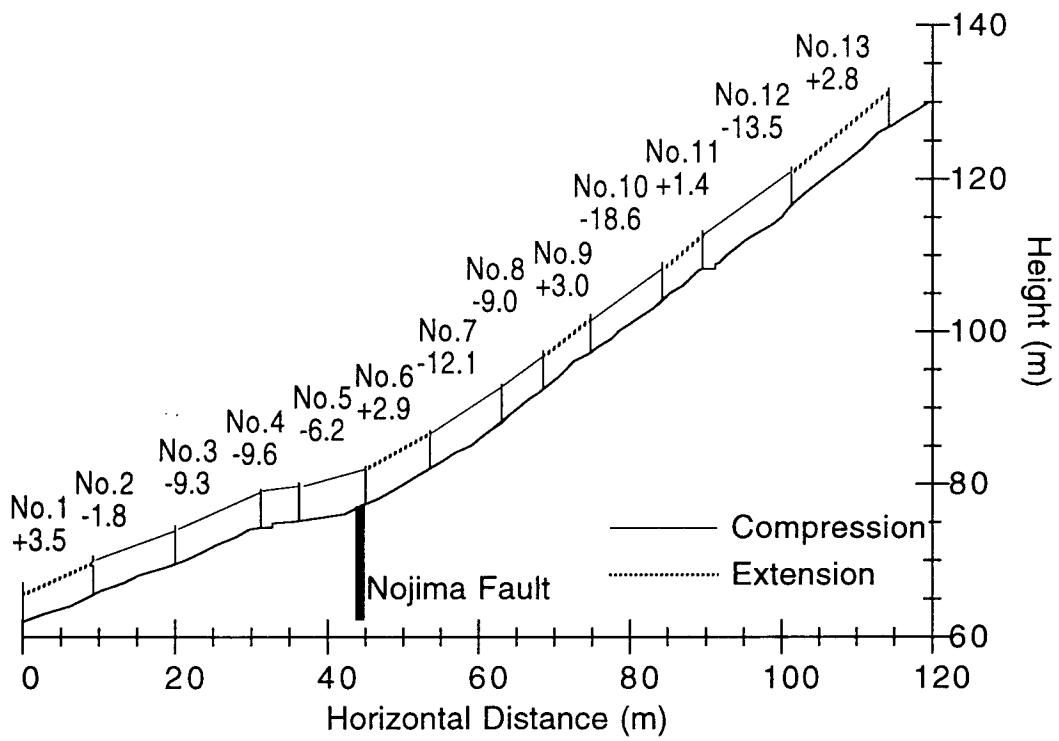
Fig. 26. Distribution of extensive / compressive surface strain.

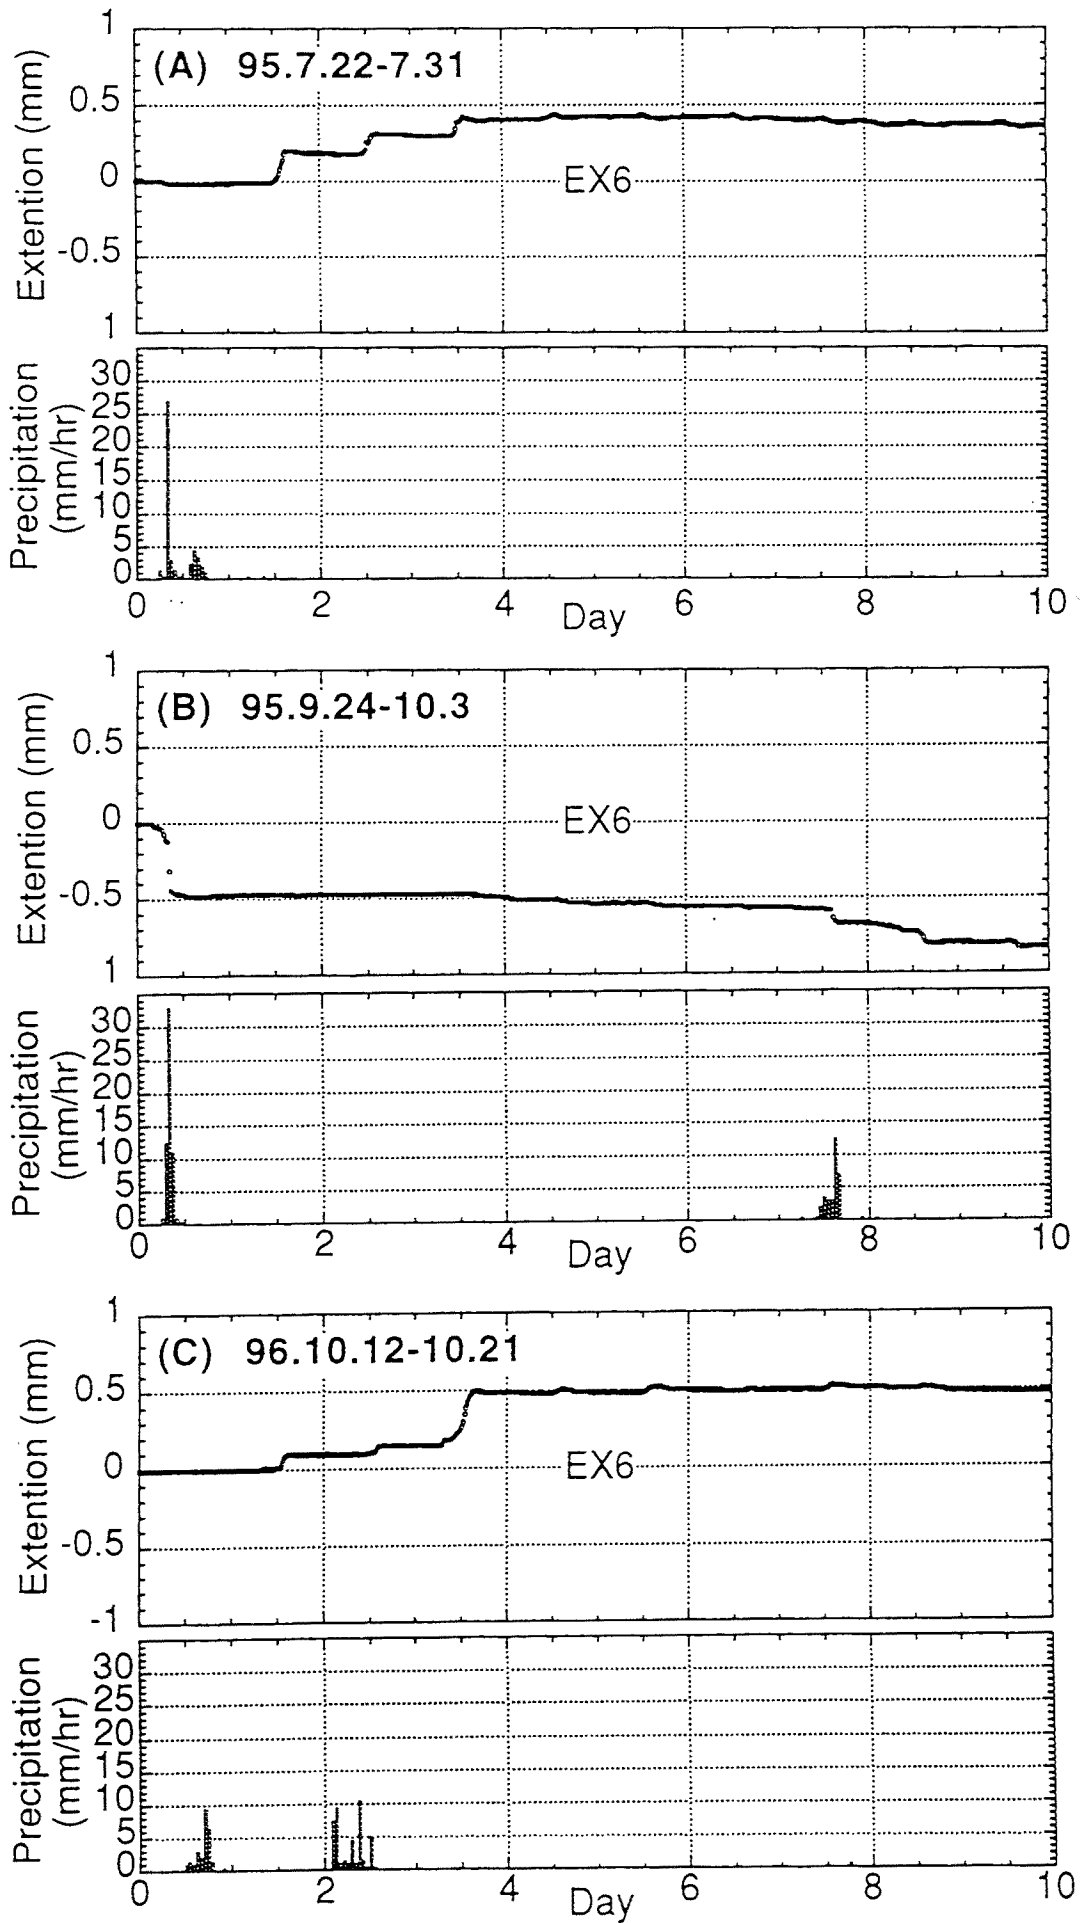
Fig. 27. Variation in EX 6 in three distinct events.

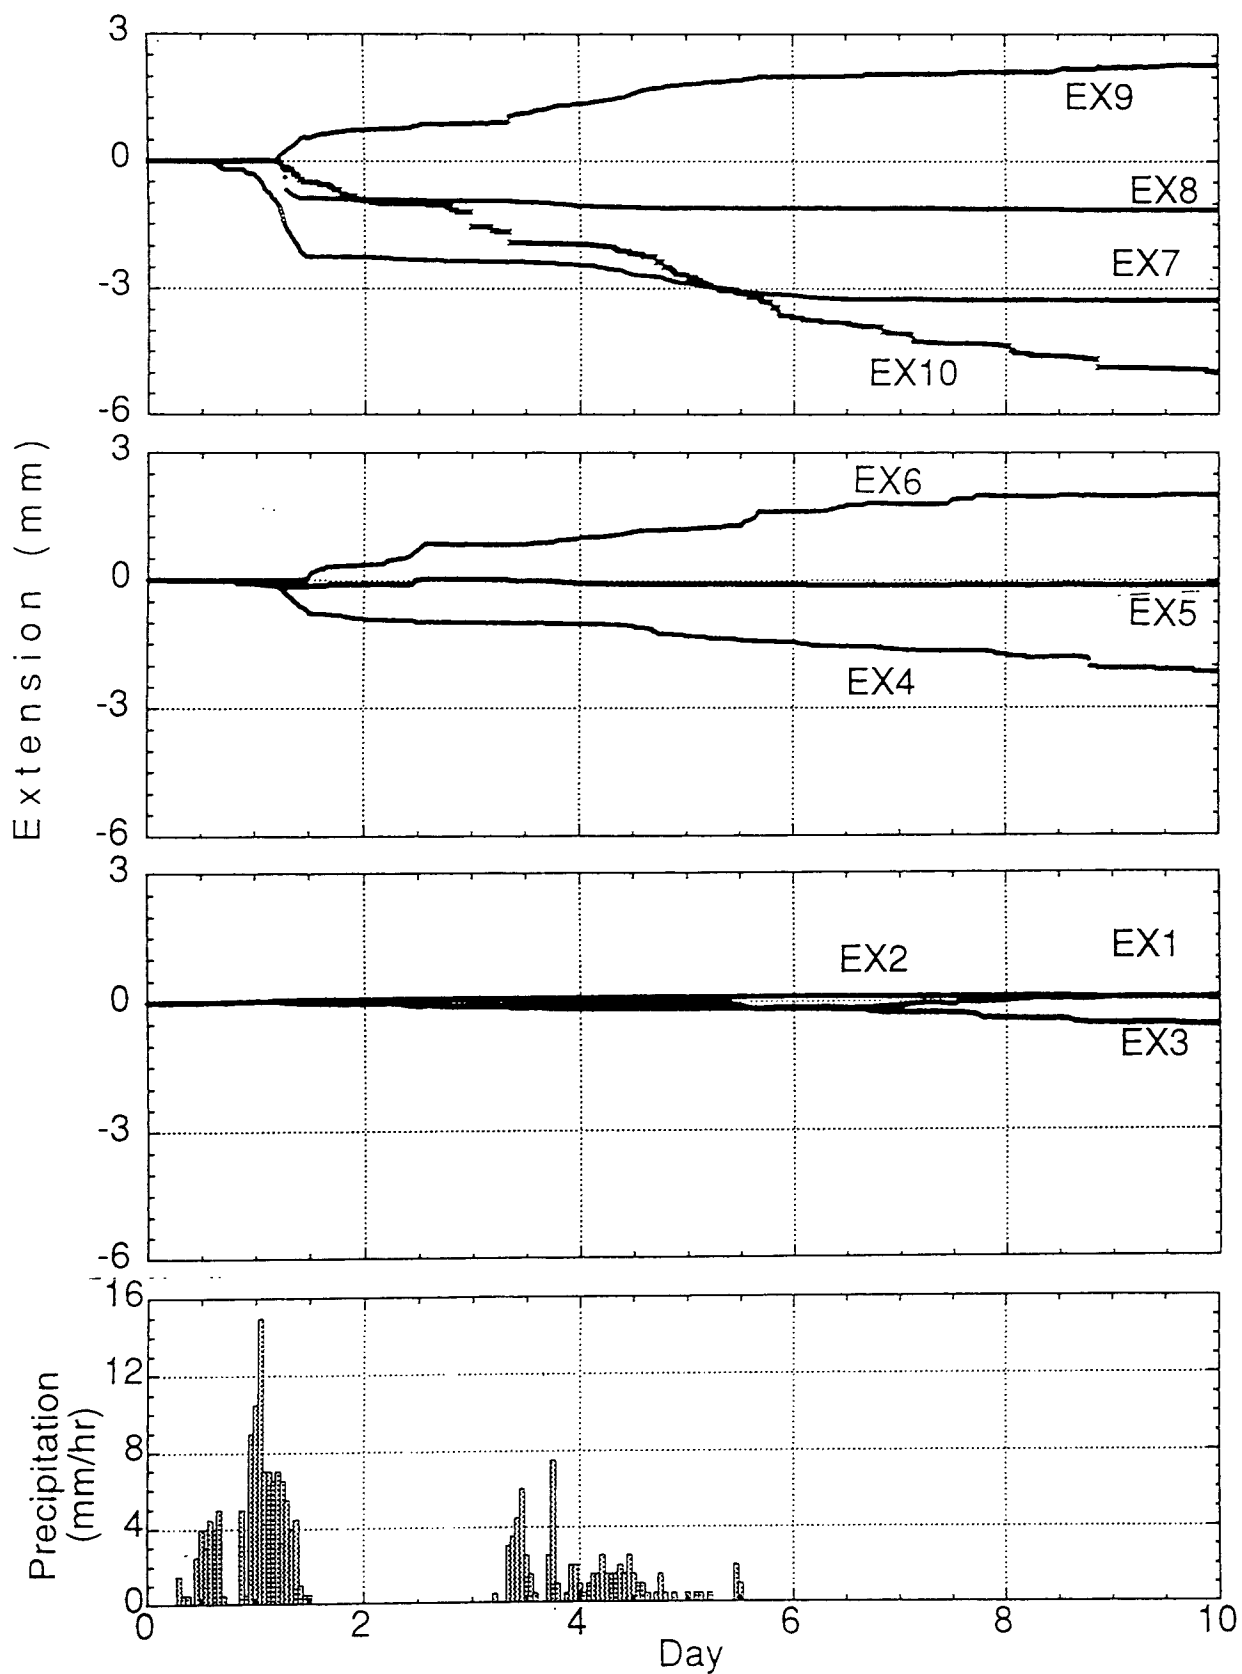
Fig. 28. Variations in EXs in the period of 1995/5/11-20.

An attempt to separate two types of soil movement was done in this section. Data used for this analysis was obtained May 11 - 20, 1995, when the largest variations were observed. EX 1 to EX 10 were working during this period. Fig. 28 shows variations in records of extensometers. Time origin is May 11 0:00. Step-type extensive variations began about one day after the initiation of rainfall in EX 6 and EX 9. On the other hand, compressive variations began soon after the rainfall began and lasted for long after the end of rainfall.

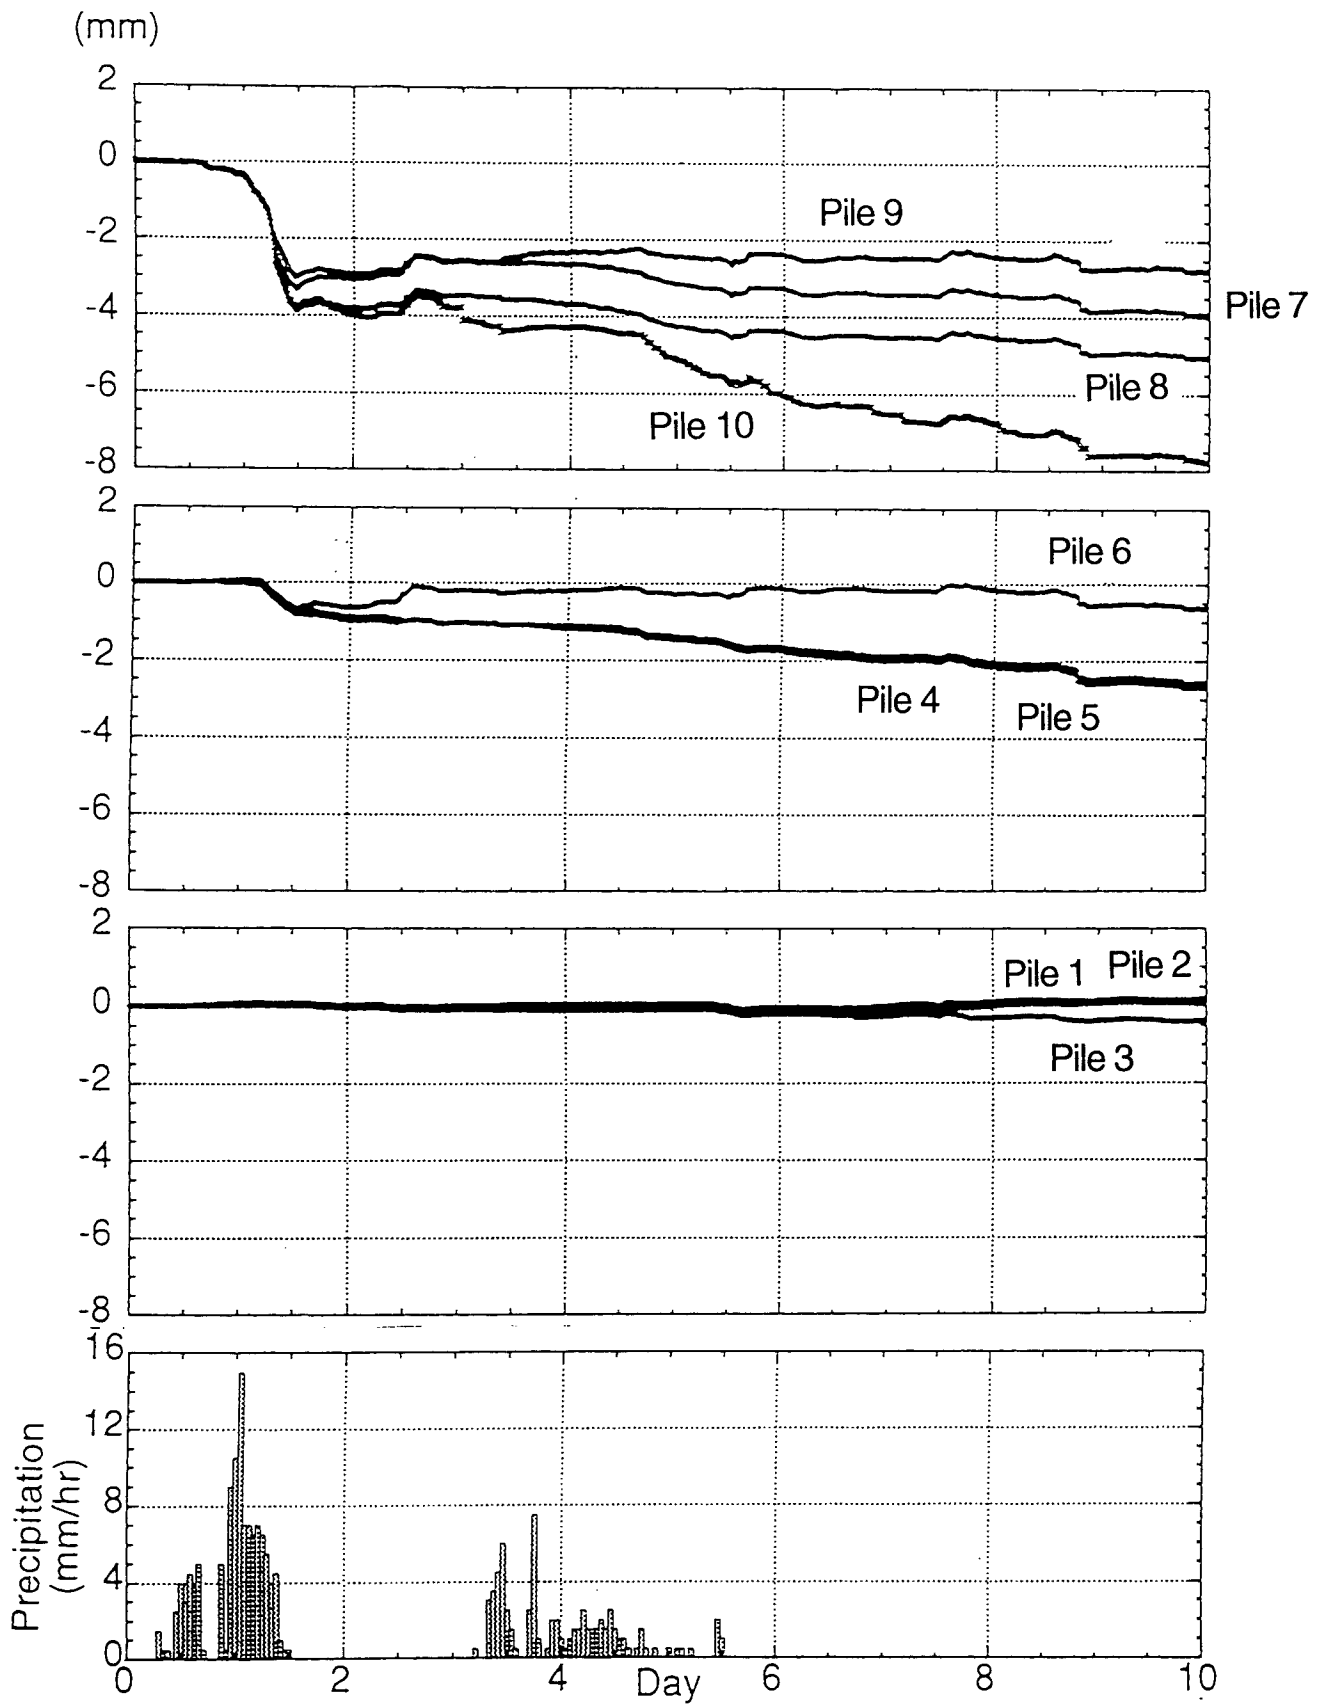
Fig. 29. Variation in the distance from the bottom end of survey line to each pile calculated from Fig. 28.

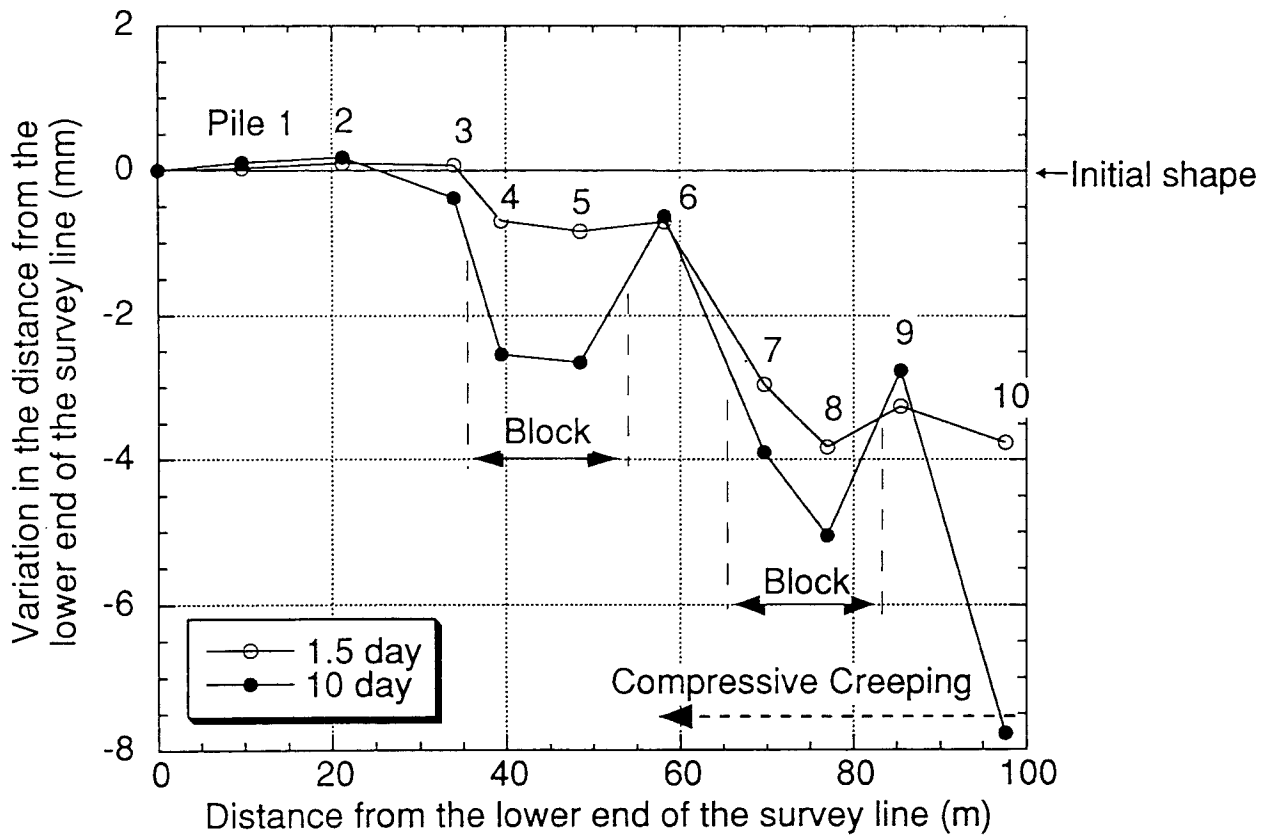
Fig. 30. Distribution of change in the distance from the bottom end of survey line to each pile at 1.5 (days) and at 10 (days) and definition of "block movement" and "compressive creeping"

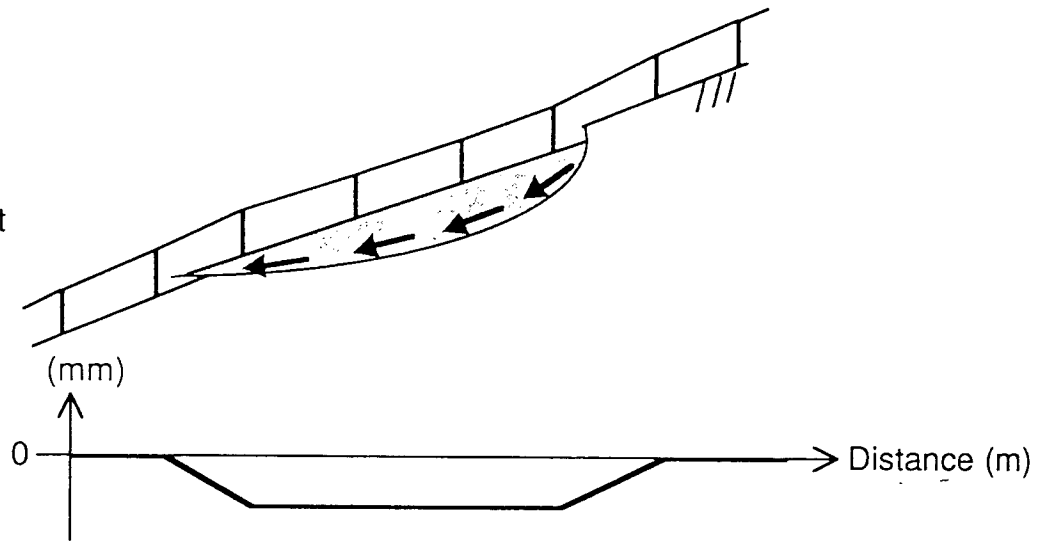
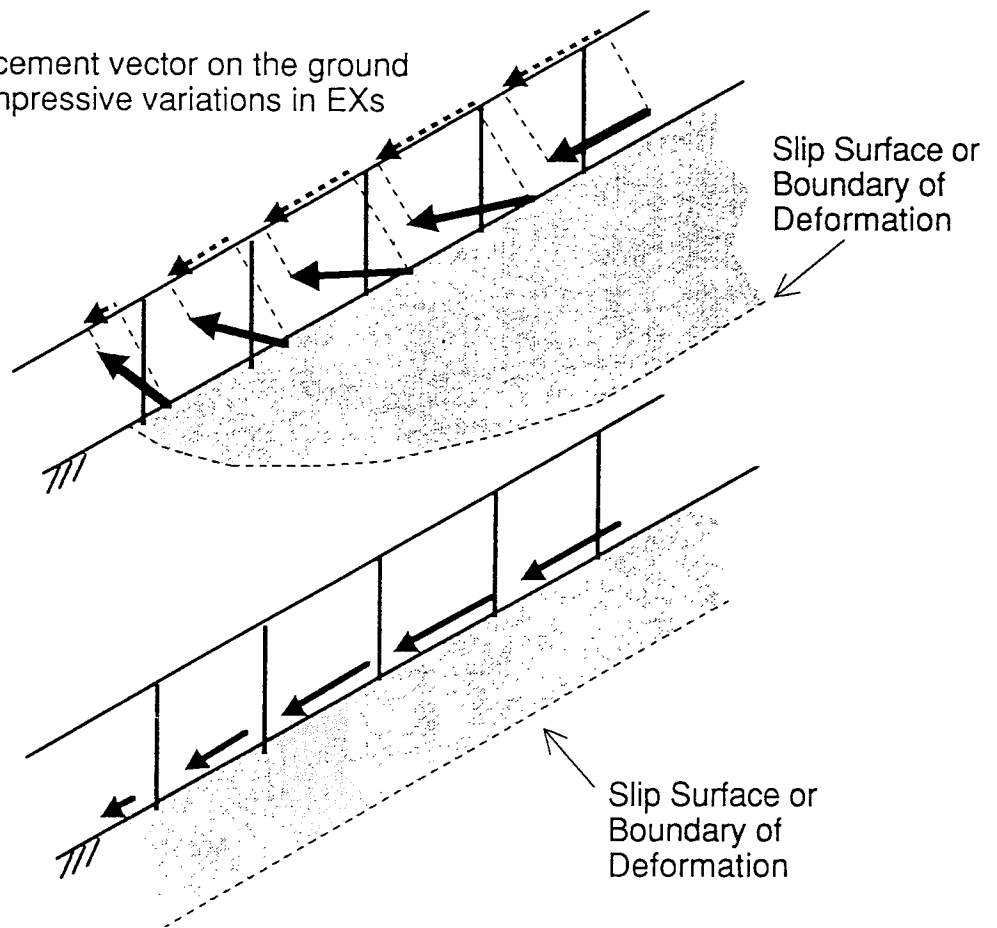
Fig. 31. Models of slope movement and their results in variation in the distance from the lower end of the survey line, the upper is represent block movement and the lower two represent compressive creeping.

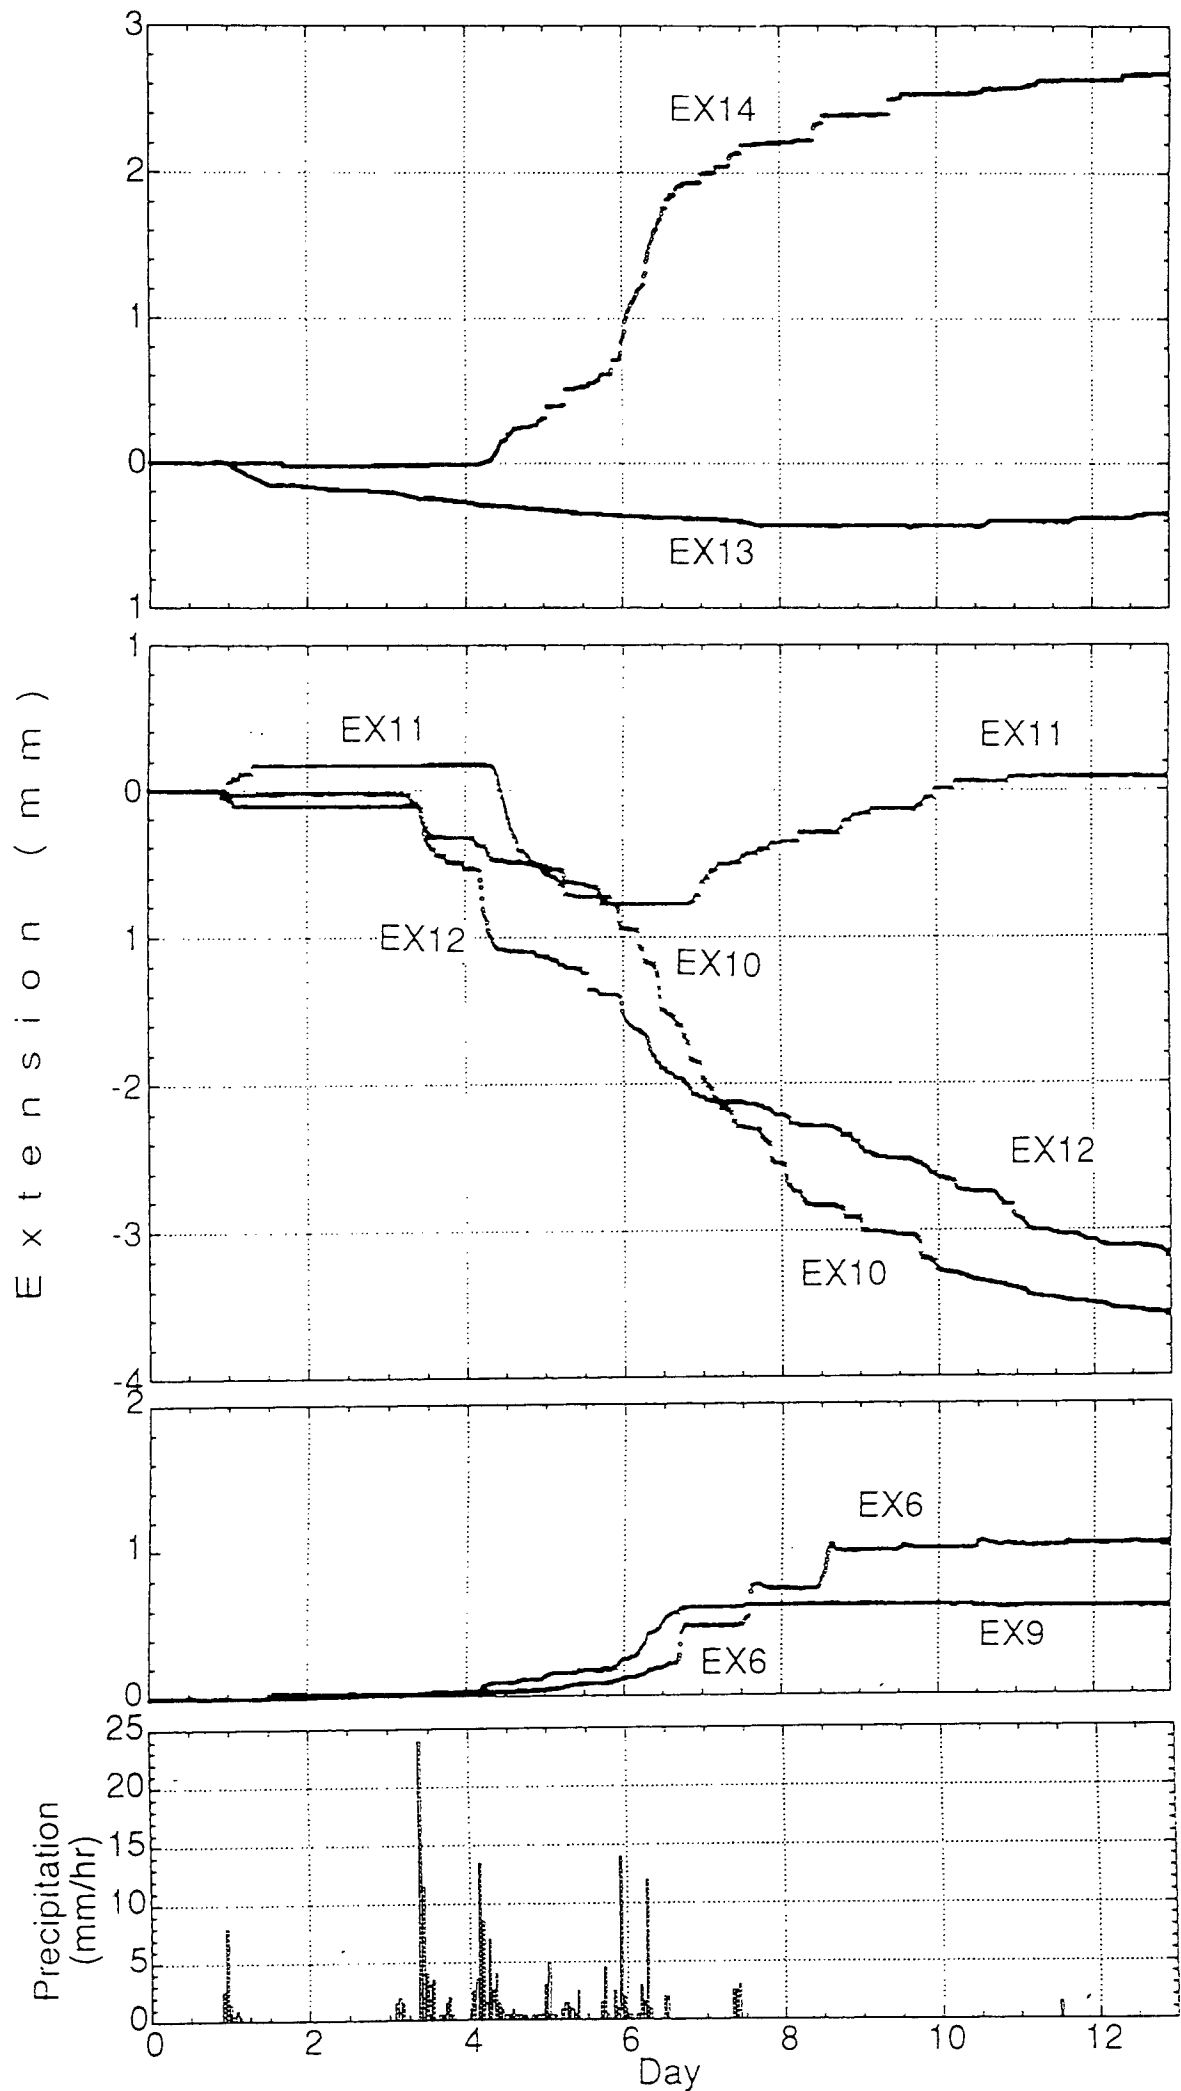
Fig. 32. Variations in EXs in upper part of the survey line in the period of 1995/6/30- 7/14.
