A study on the variation of displacement and  
internal earth pressure in creeping landslides

Thesis submitted to Graduate School of Science  
in partial fulfillment of the requirements of the degree  
Doctor of Science  
in the Division of Earth and Planetary Sciences  
Graduate School of Science  
Kyoto University

Kiminori Araiba

January 1998

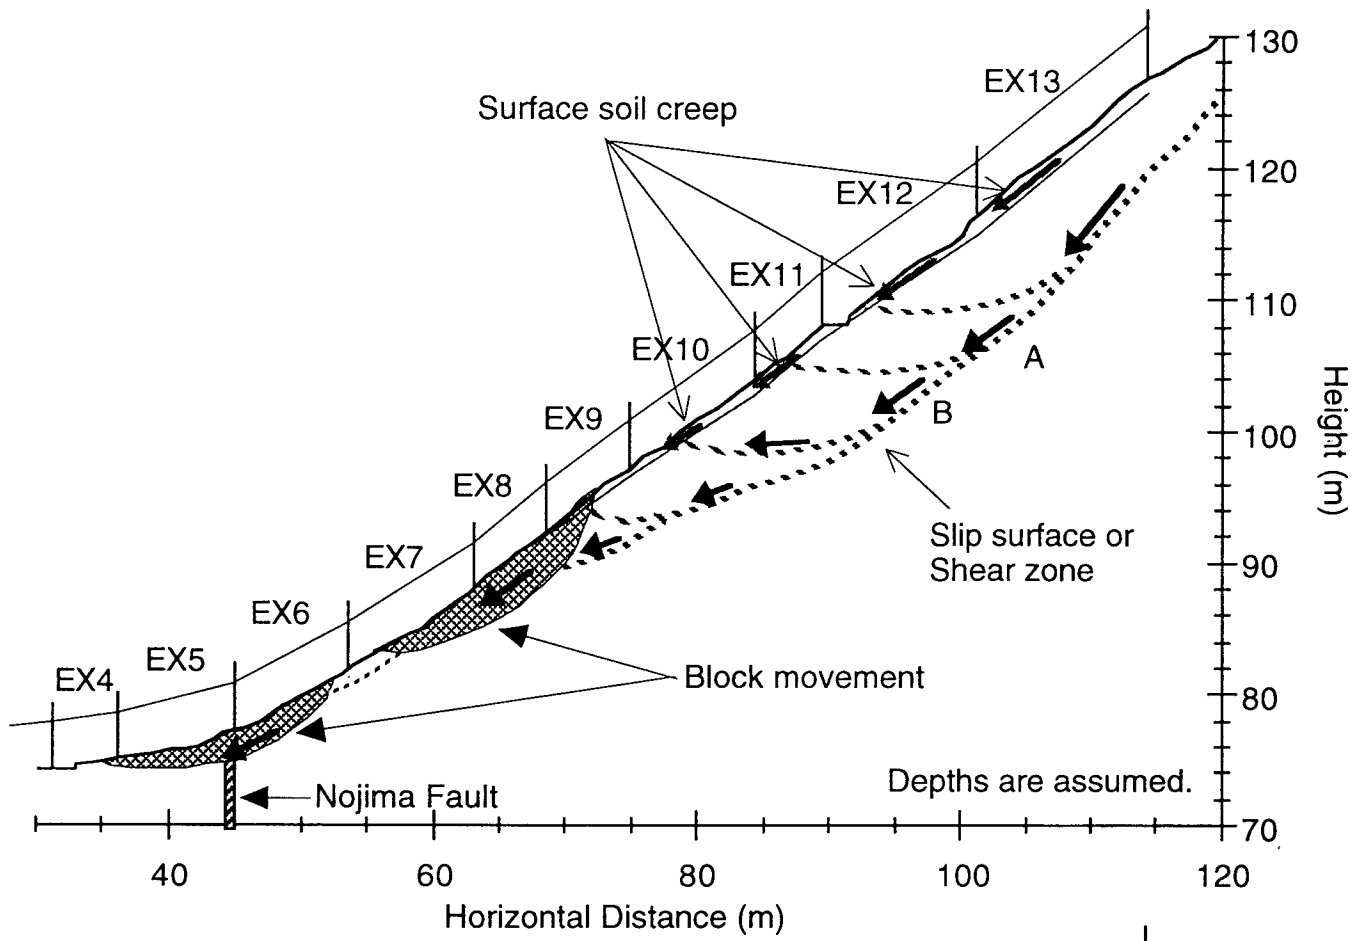
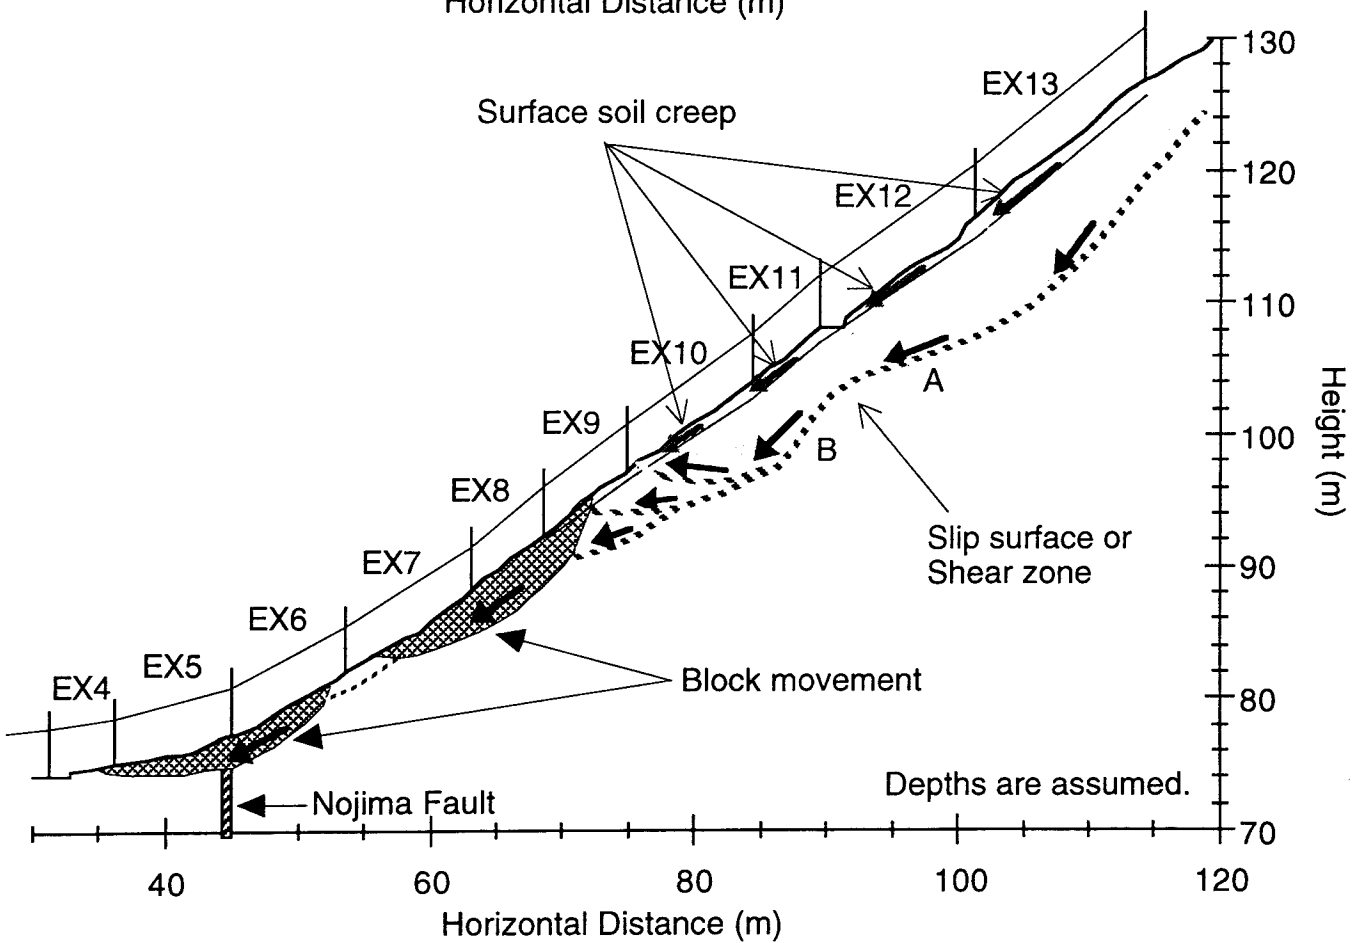
Fig. 33. Two possible models of the Todoroki landslide. The upper model explains propagation of active area observed in EX 11 as a result of relative movement of two blocks. The lower explains it as a result of shape of slip surface.

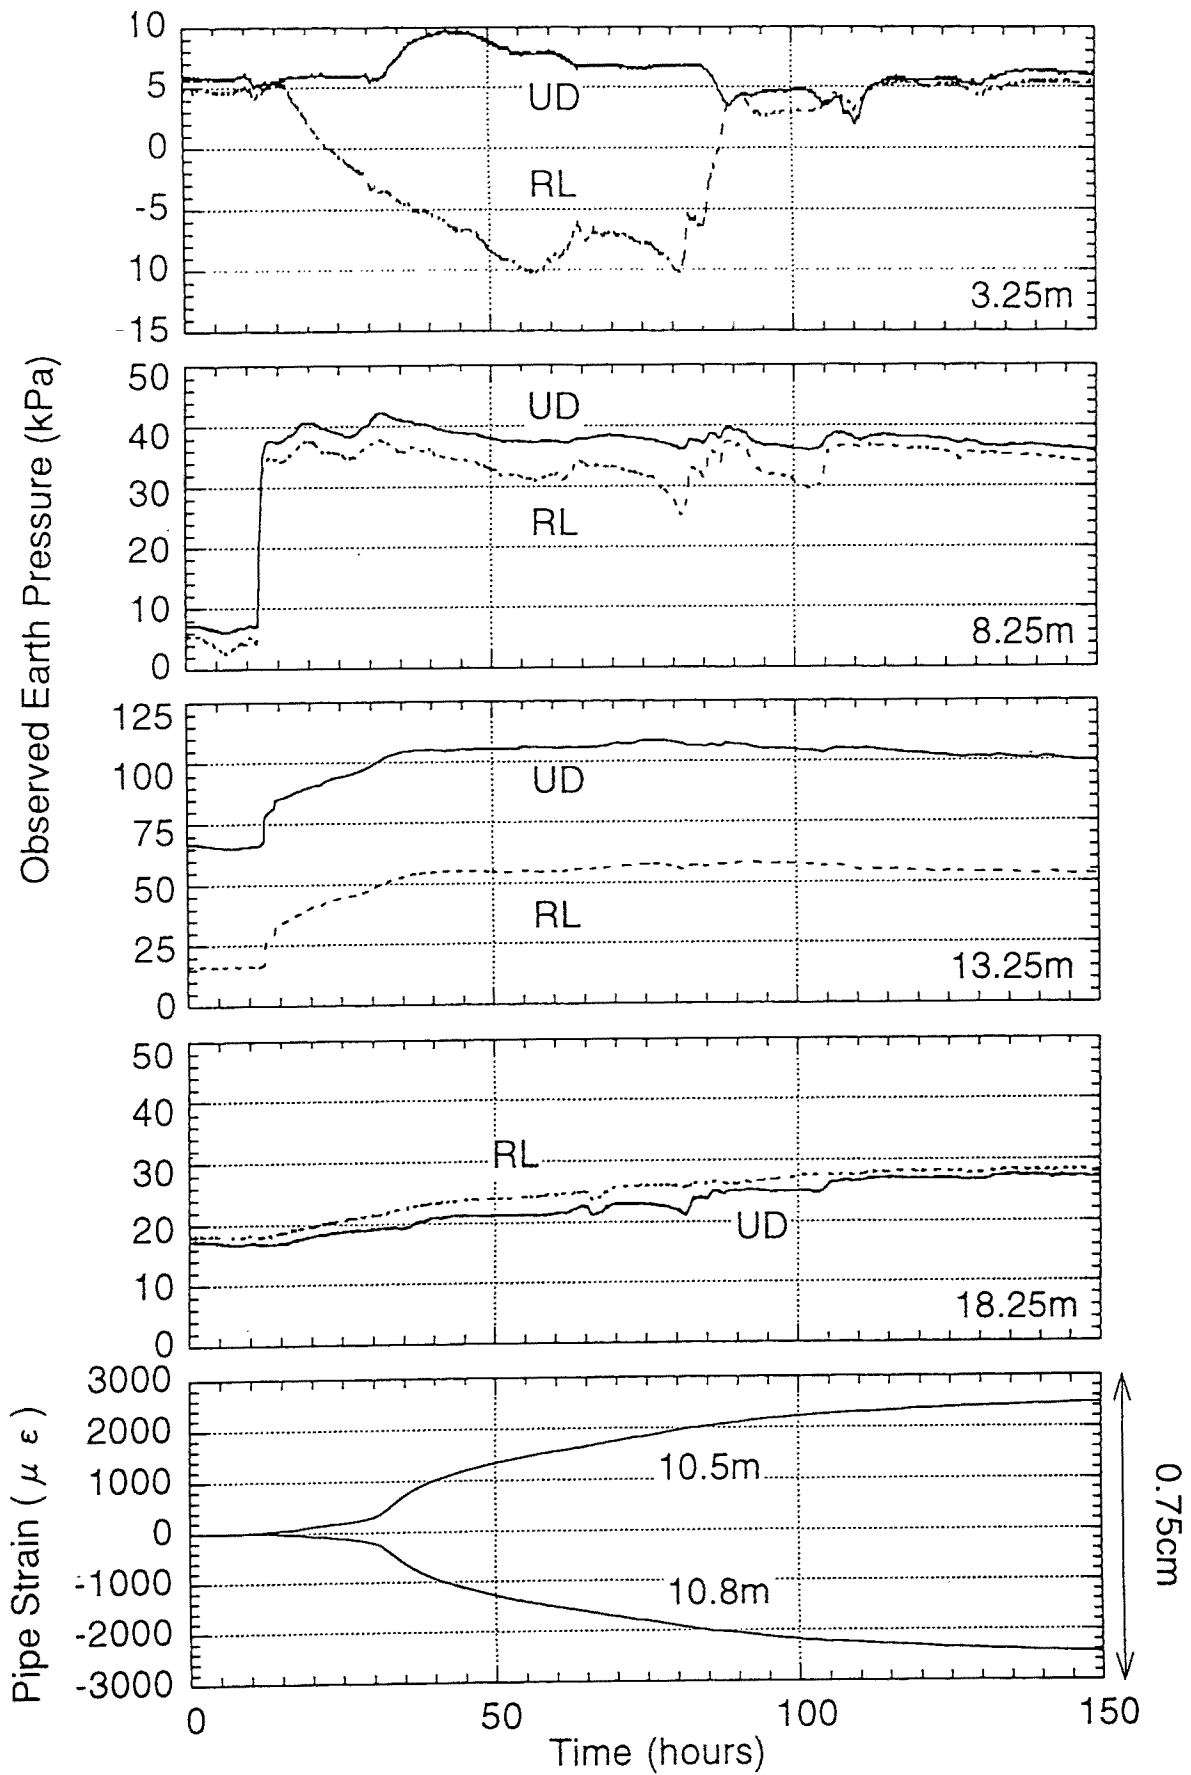
Fig. 34. Earth pressure in BV 4 (upper 4 diagrams) and pipe strain at the slip surface in BV 4 (bottom diagram) during Event 1.

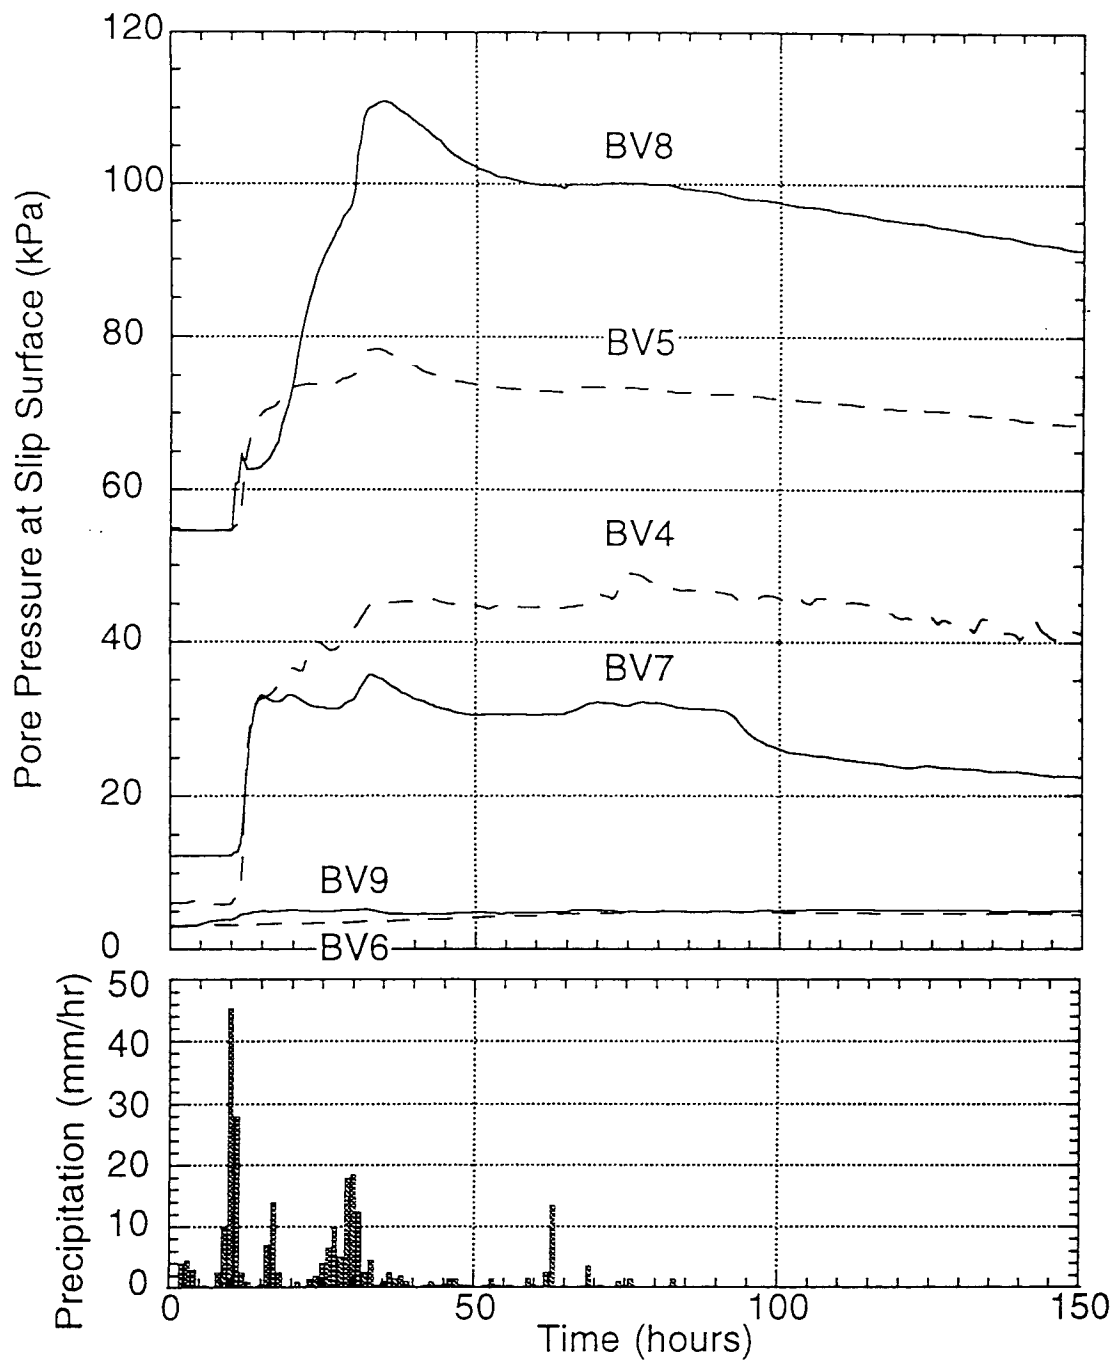
Fig. 35. Pore water pressures at the slip surface during Event 1 and hourly precipitation.

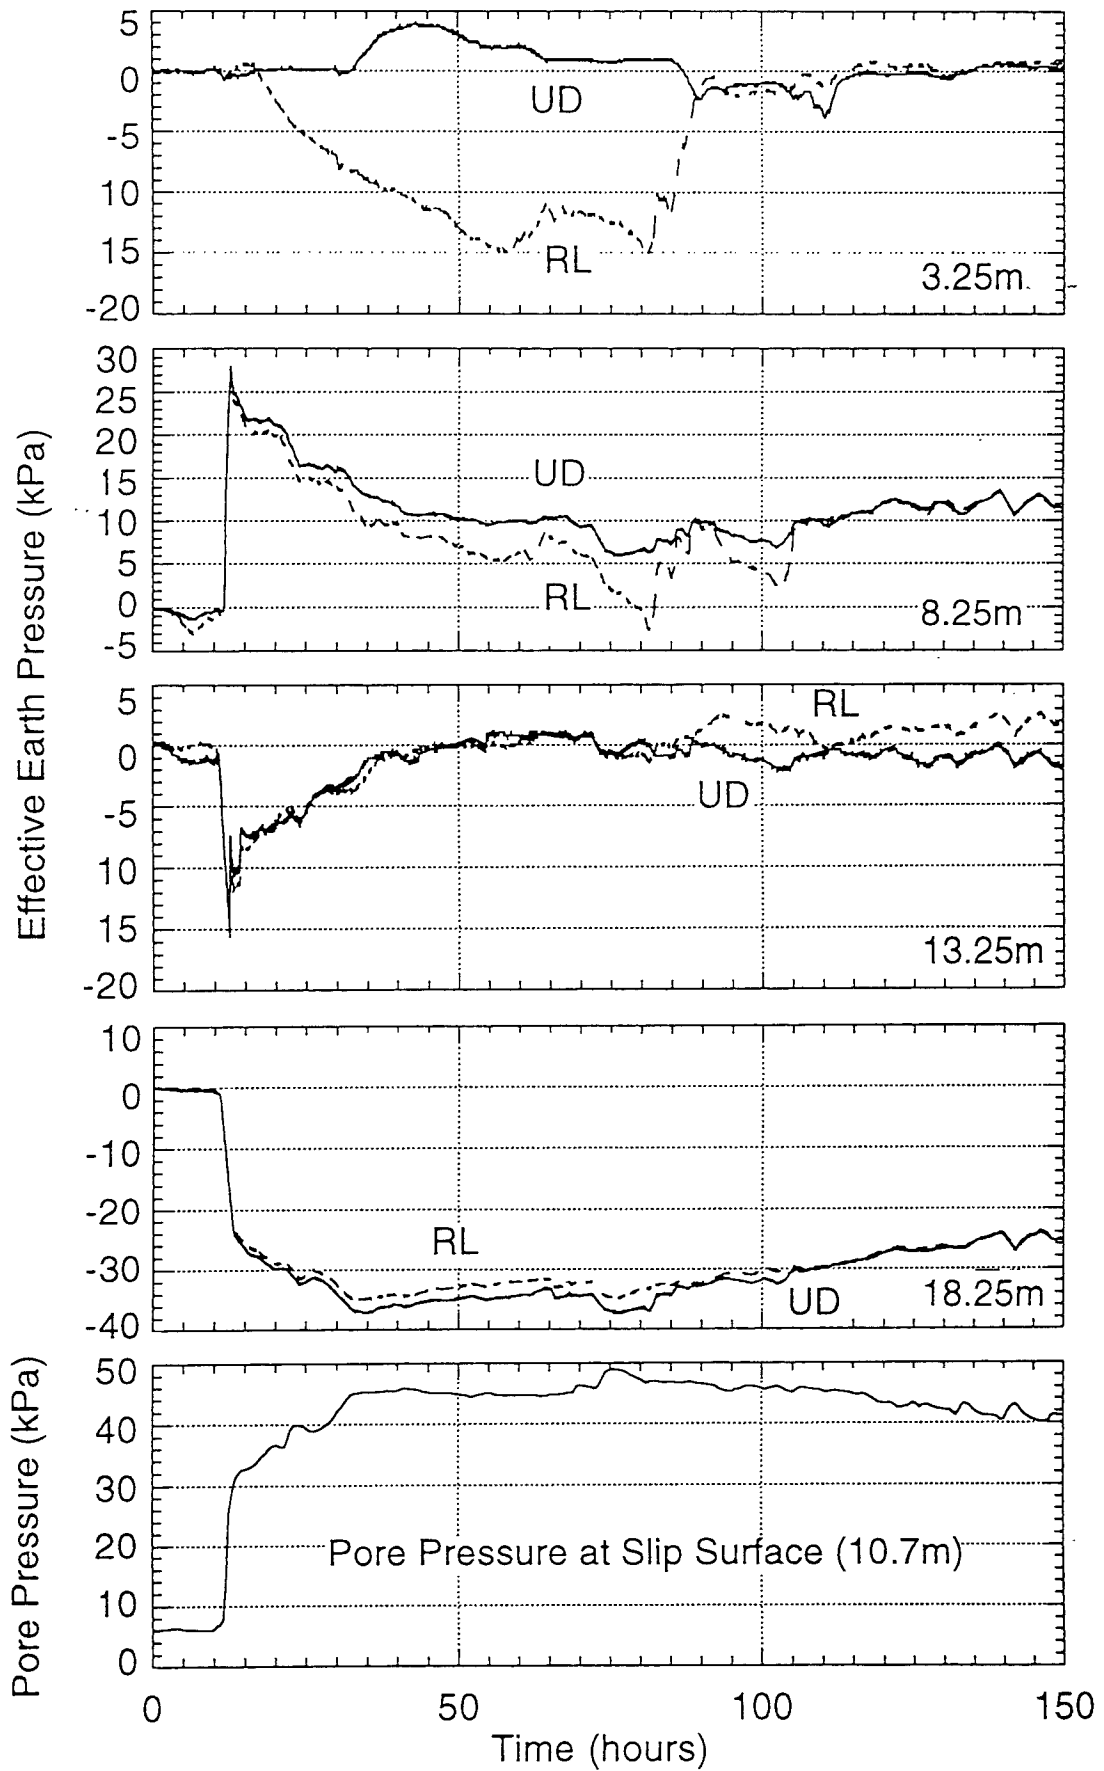
Fig. 37. Effective earth pressure (upper 4 diagrams) and pore water pressure at the slip surface in BV 4 (bottom diagram) during Event 1.

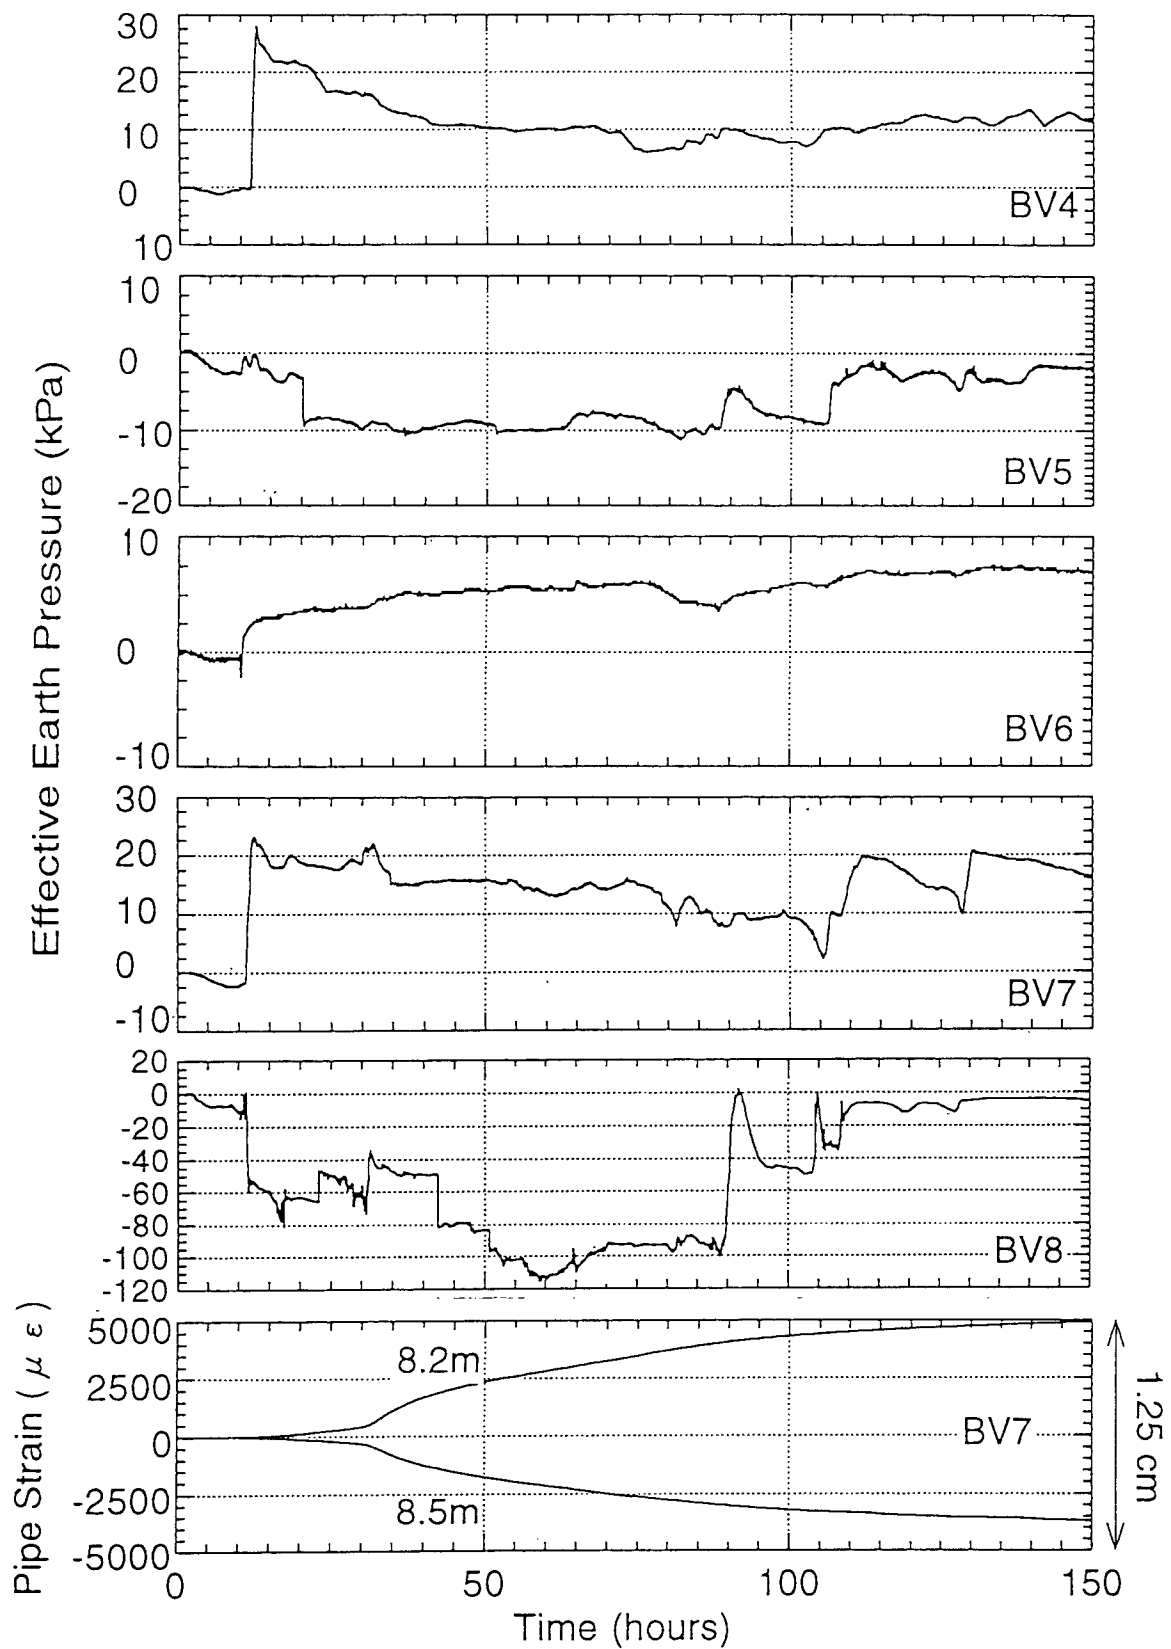
Fig. 38. Variations in the effective earth pressure in the UD direction at the nearest depth above the slip surface in each borehole during Event 1 (upper five diagrams) and pipe strain at the slip surface in BV 7 (bottom diagram).

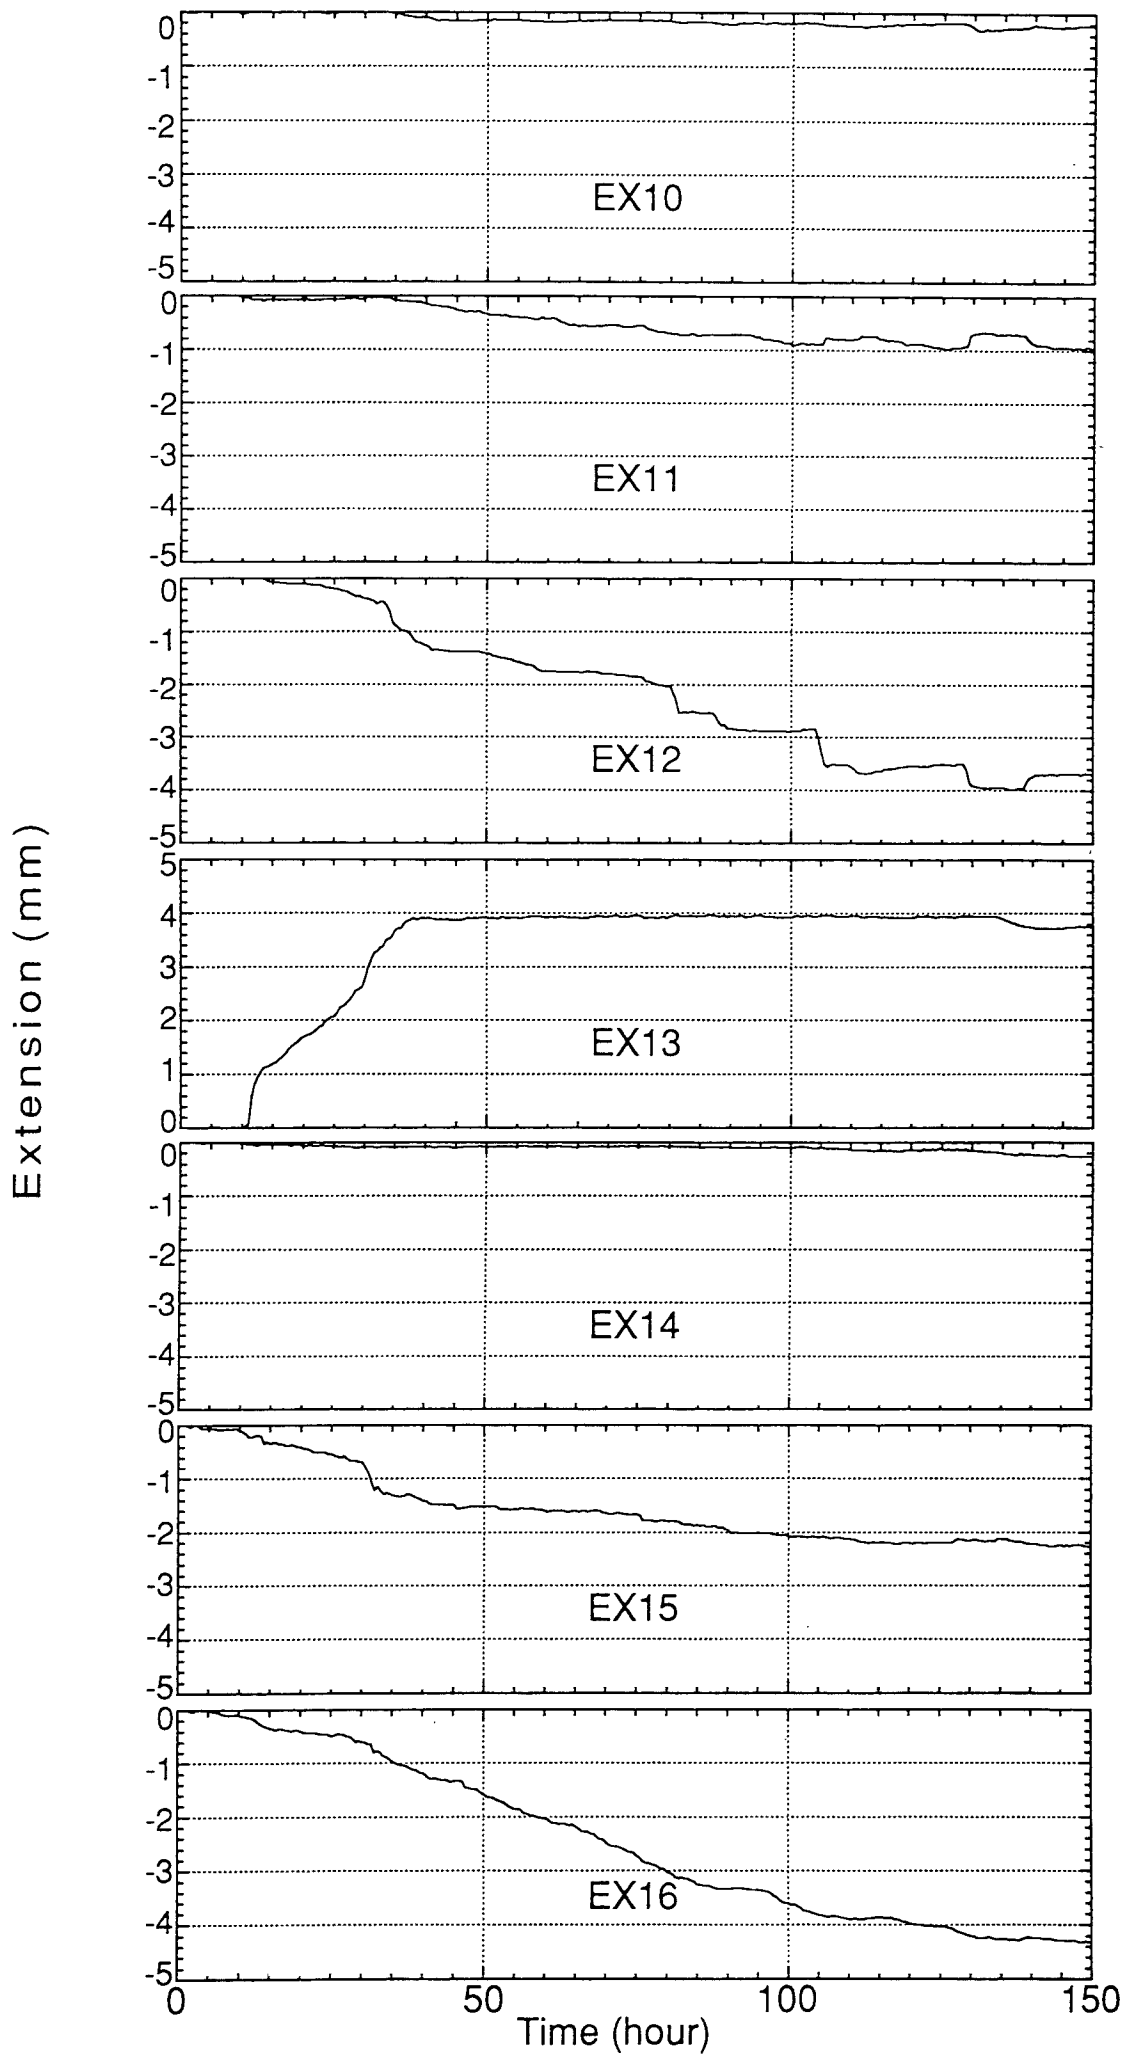
Fig. 39. Results of measurement on EXs during Event 1.

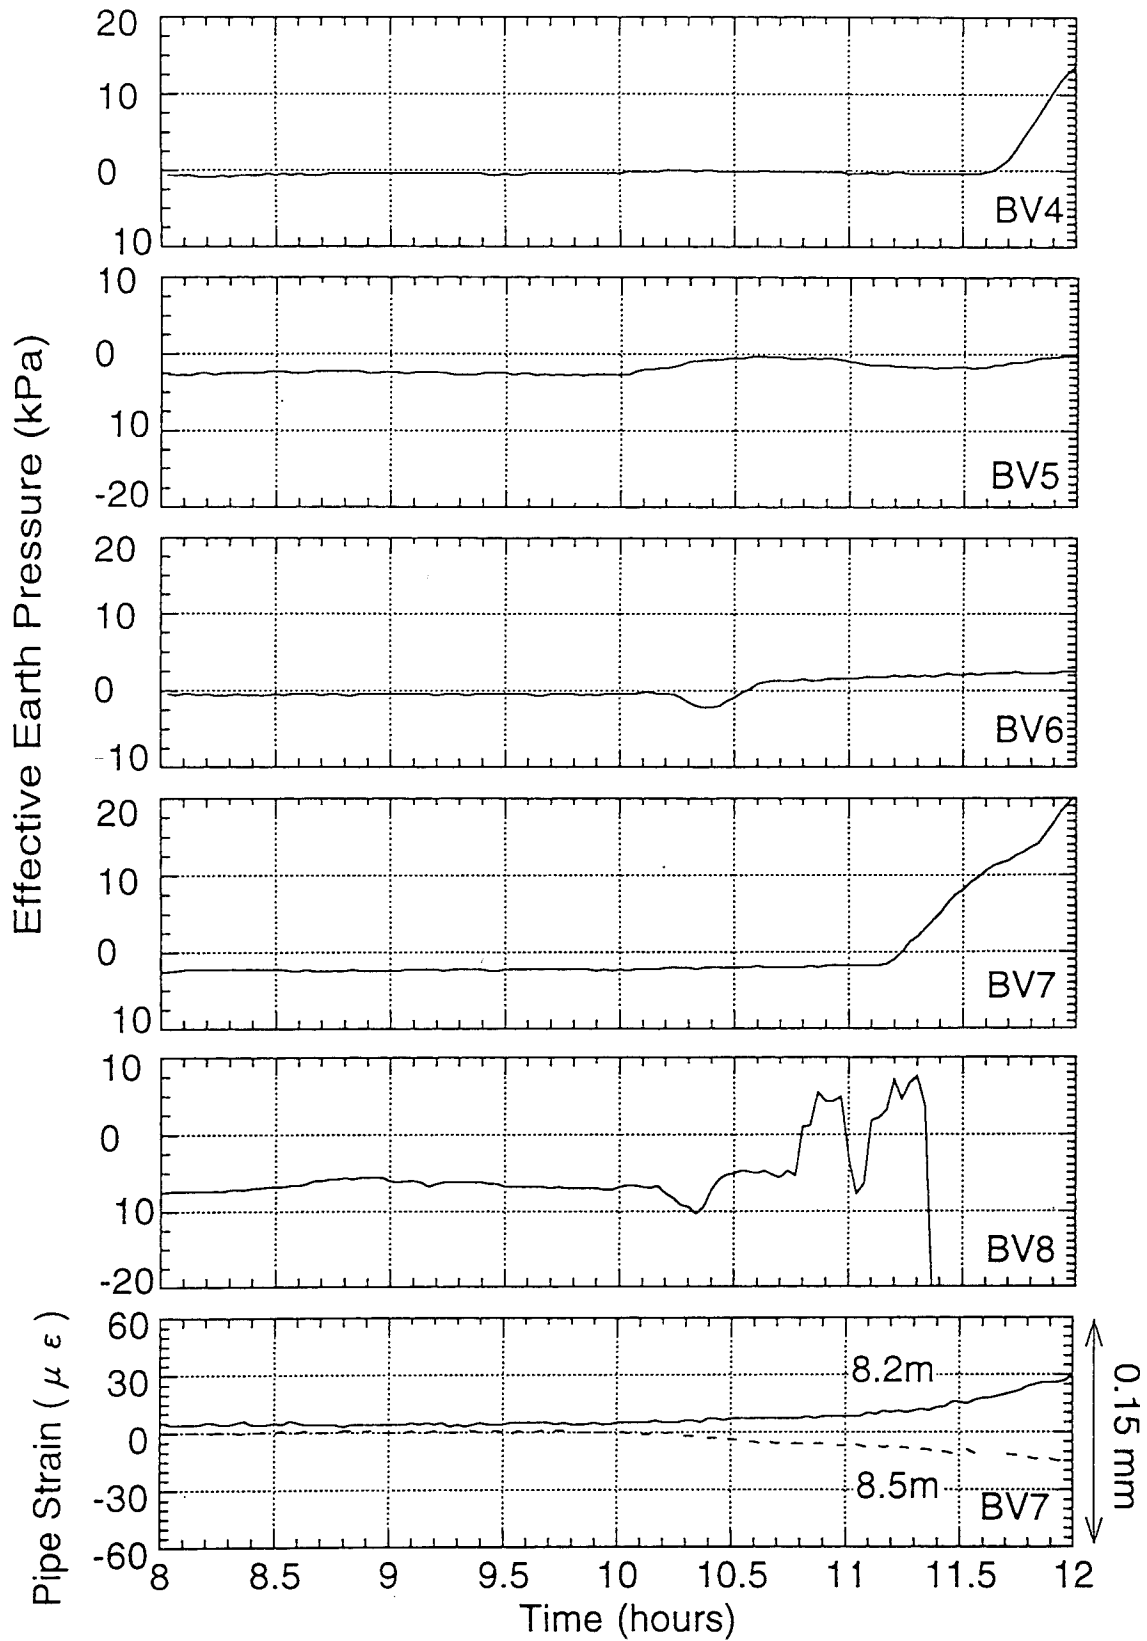
Fig. 40. Variations in the effective earth pressure in the UD direction at the nearest depth above the slip surface at the onset of landslide movement (upper five diagrams) and pipe strain at the slip surface in BV 7 (bottom diagram) during Event 1.

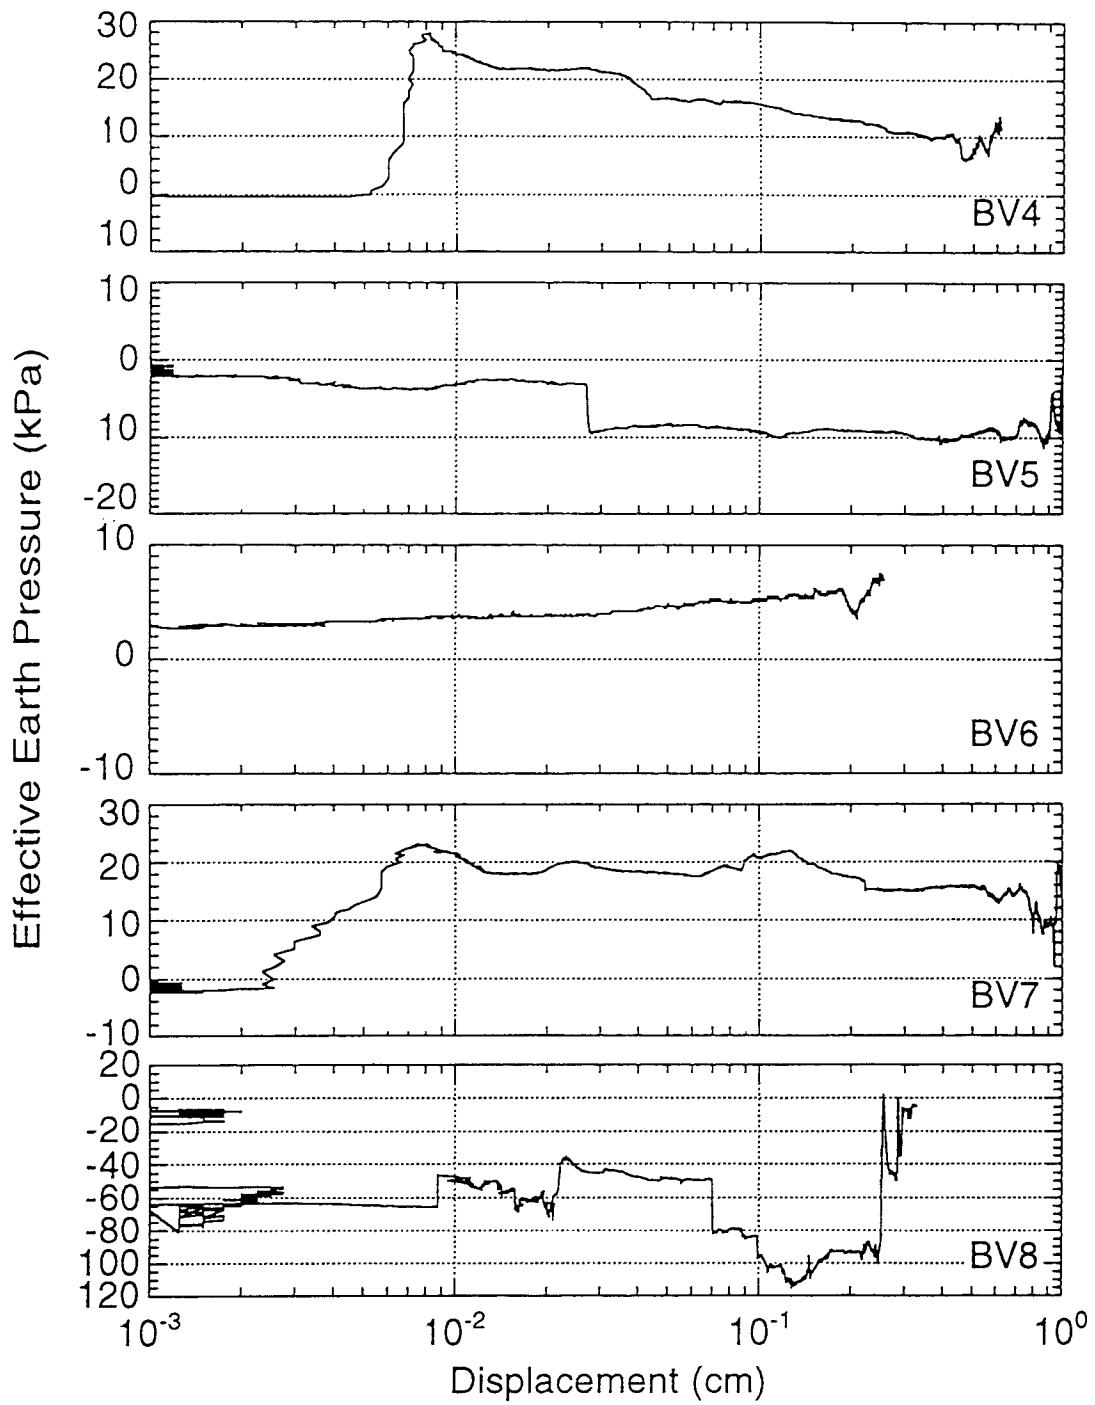
Fig. 41. Relationship between the relative displacement at the slip surface and the effective earth pressure at the nearest depth above the slip surface during Event 1.

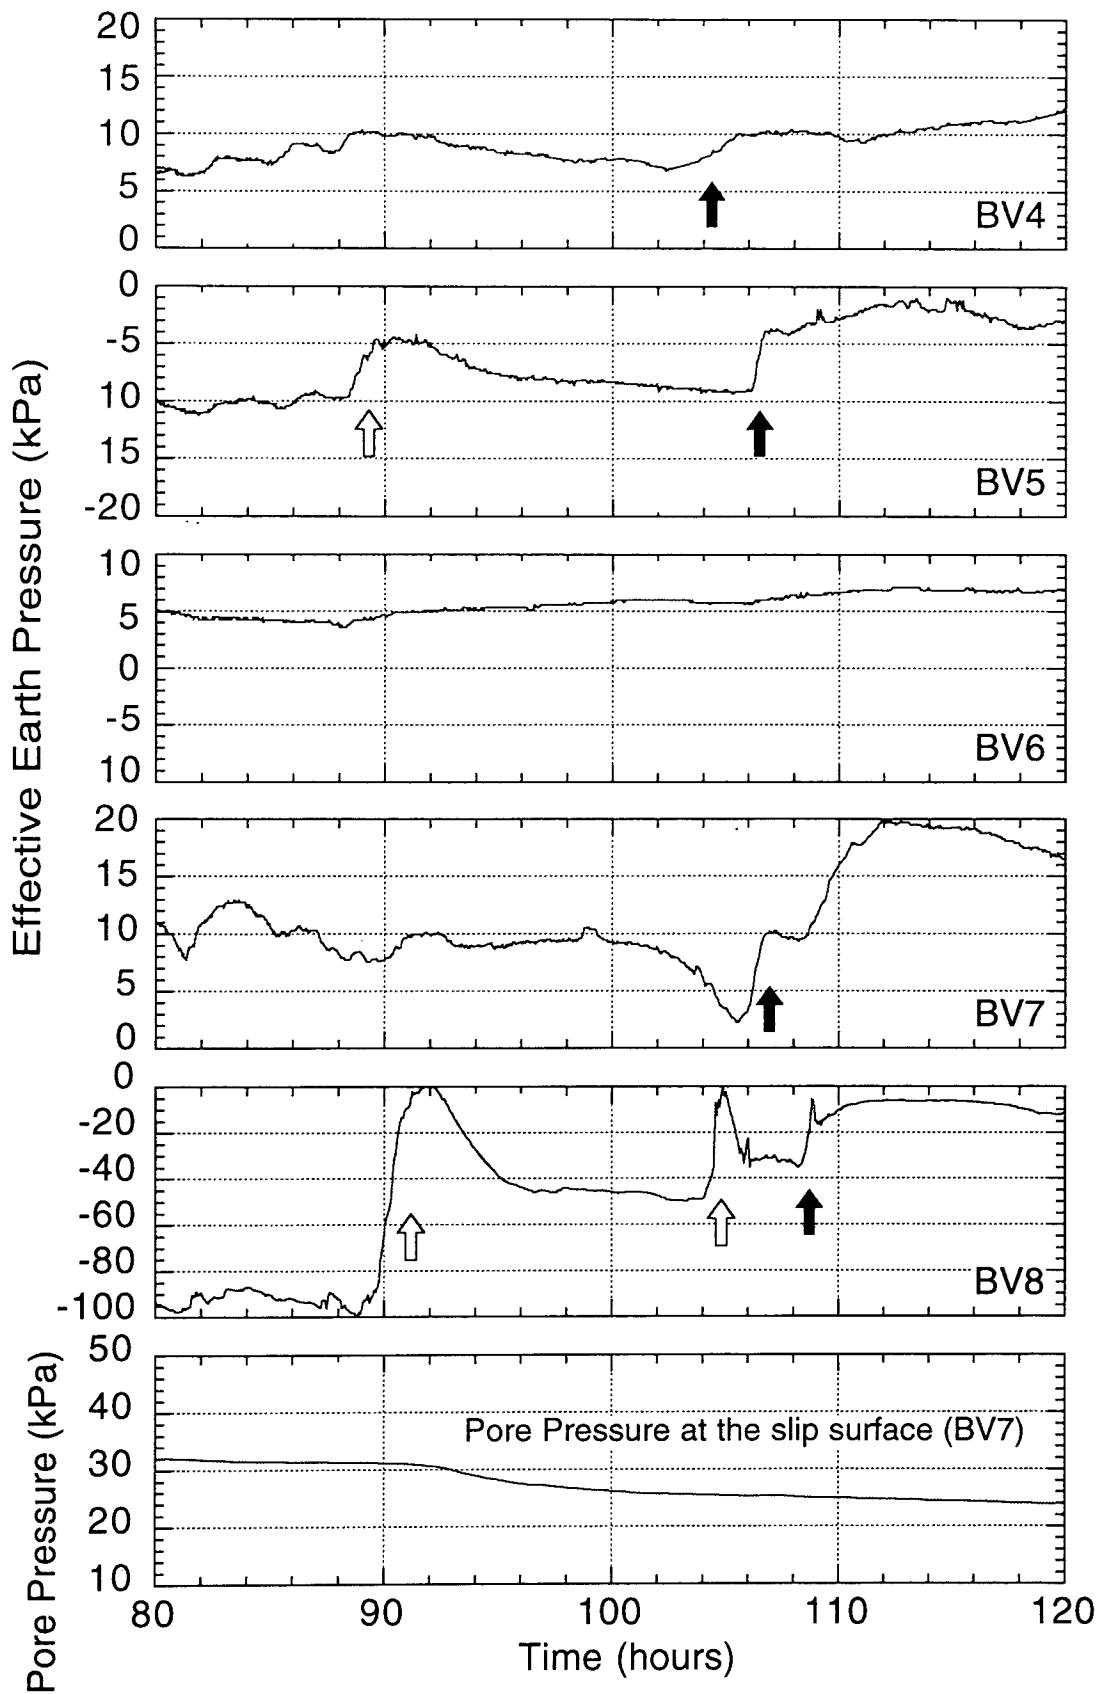
Fig. 42. Variation in the effective earth pressure in the UD direction at the nearest depth above the slip surface and pore pressure at the slip surface in BV 7 at the end of Event 1.

↑ : "Hesitant behavior"    ↑ : "Stopping phase"

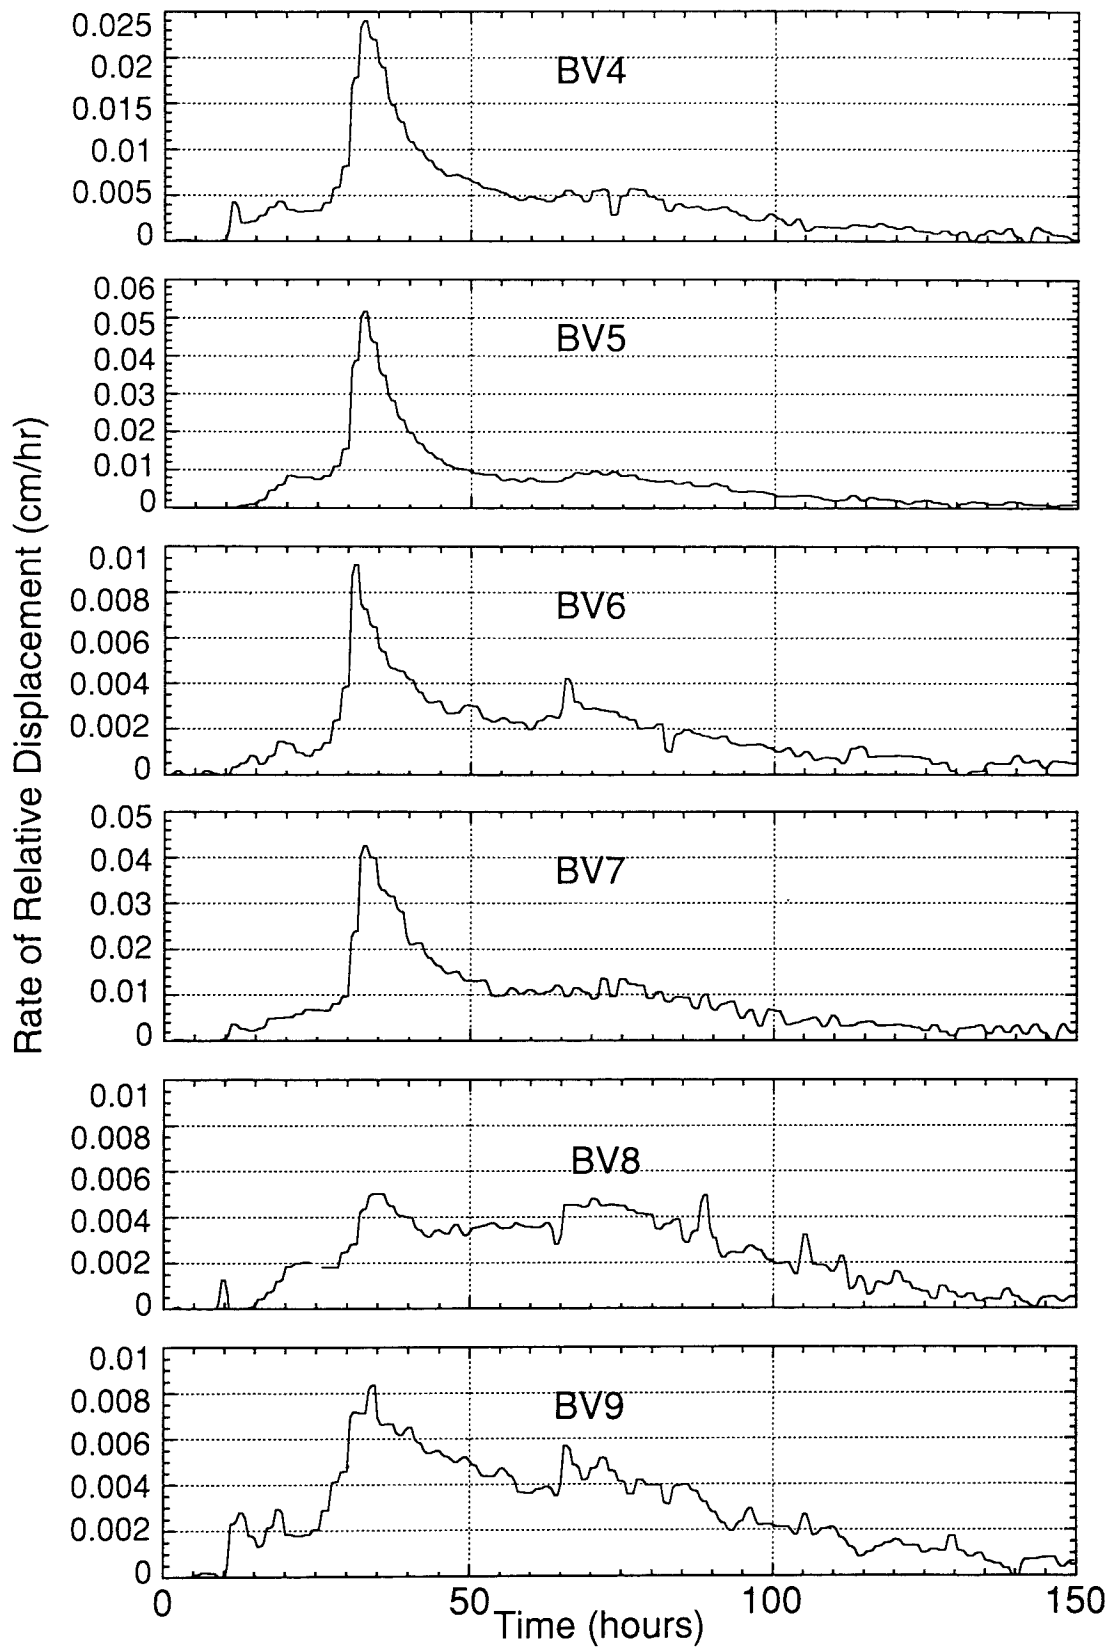
Fig. 43. Variation in rate of relative displacement at the slip surface during Event 1.

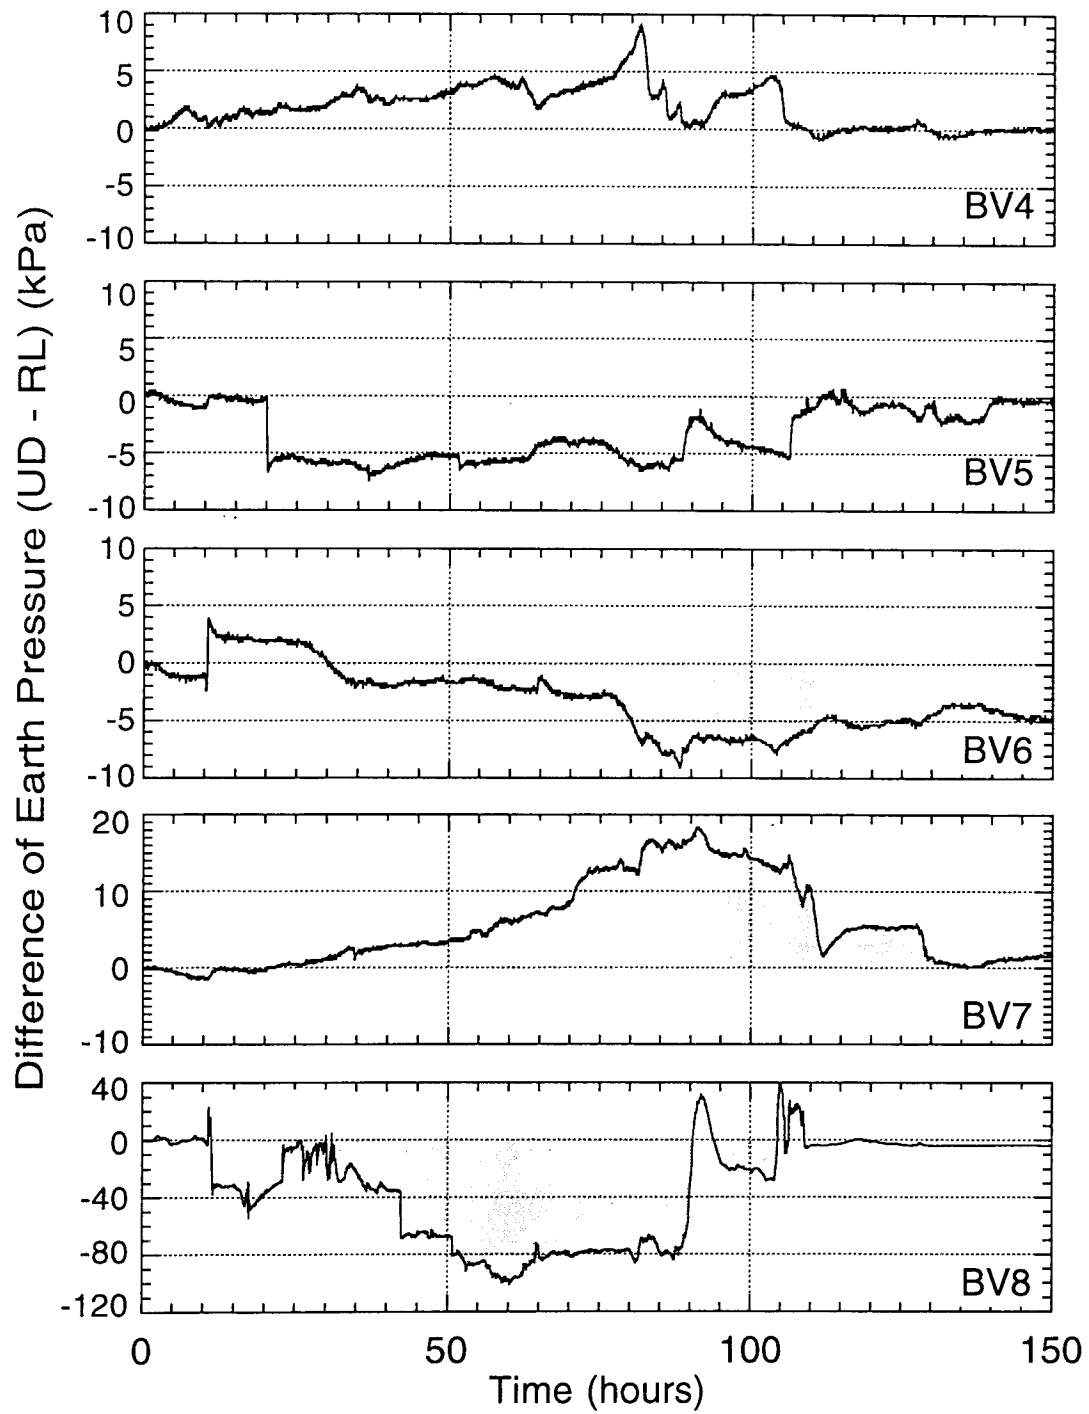
Fig. 44. Variation in difference between earth pressure in the UD and RL directions during Event 1 (UD - RL). Hatched area indicates anisotropic variation.
