A study on the variation of displacement and  
internal earth pressure in creeping landslides

Thesis submitted to Graduate School of Science  
in partial fulfillment of the requirements of the degree  
Doctor of Science  
in the Division of Earth and Planetary Sciences  
Graduate School of Science  
Kyoto University

Kiminori Araiba

January 1998

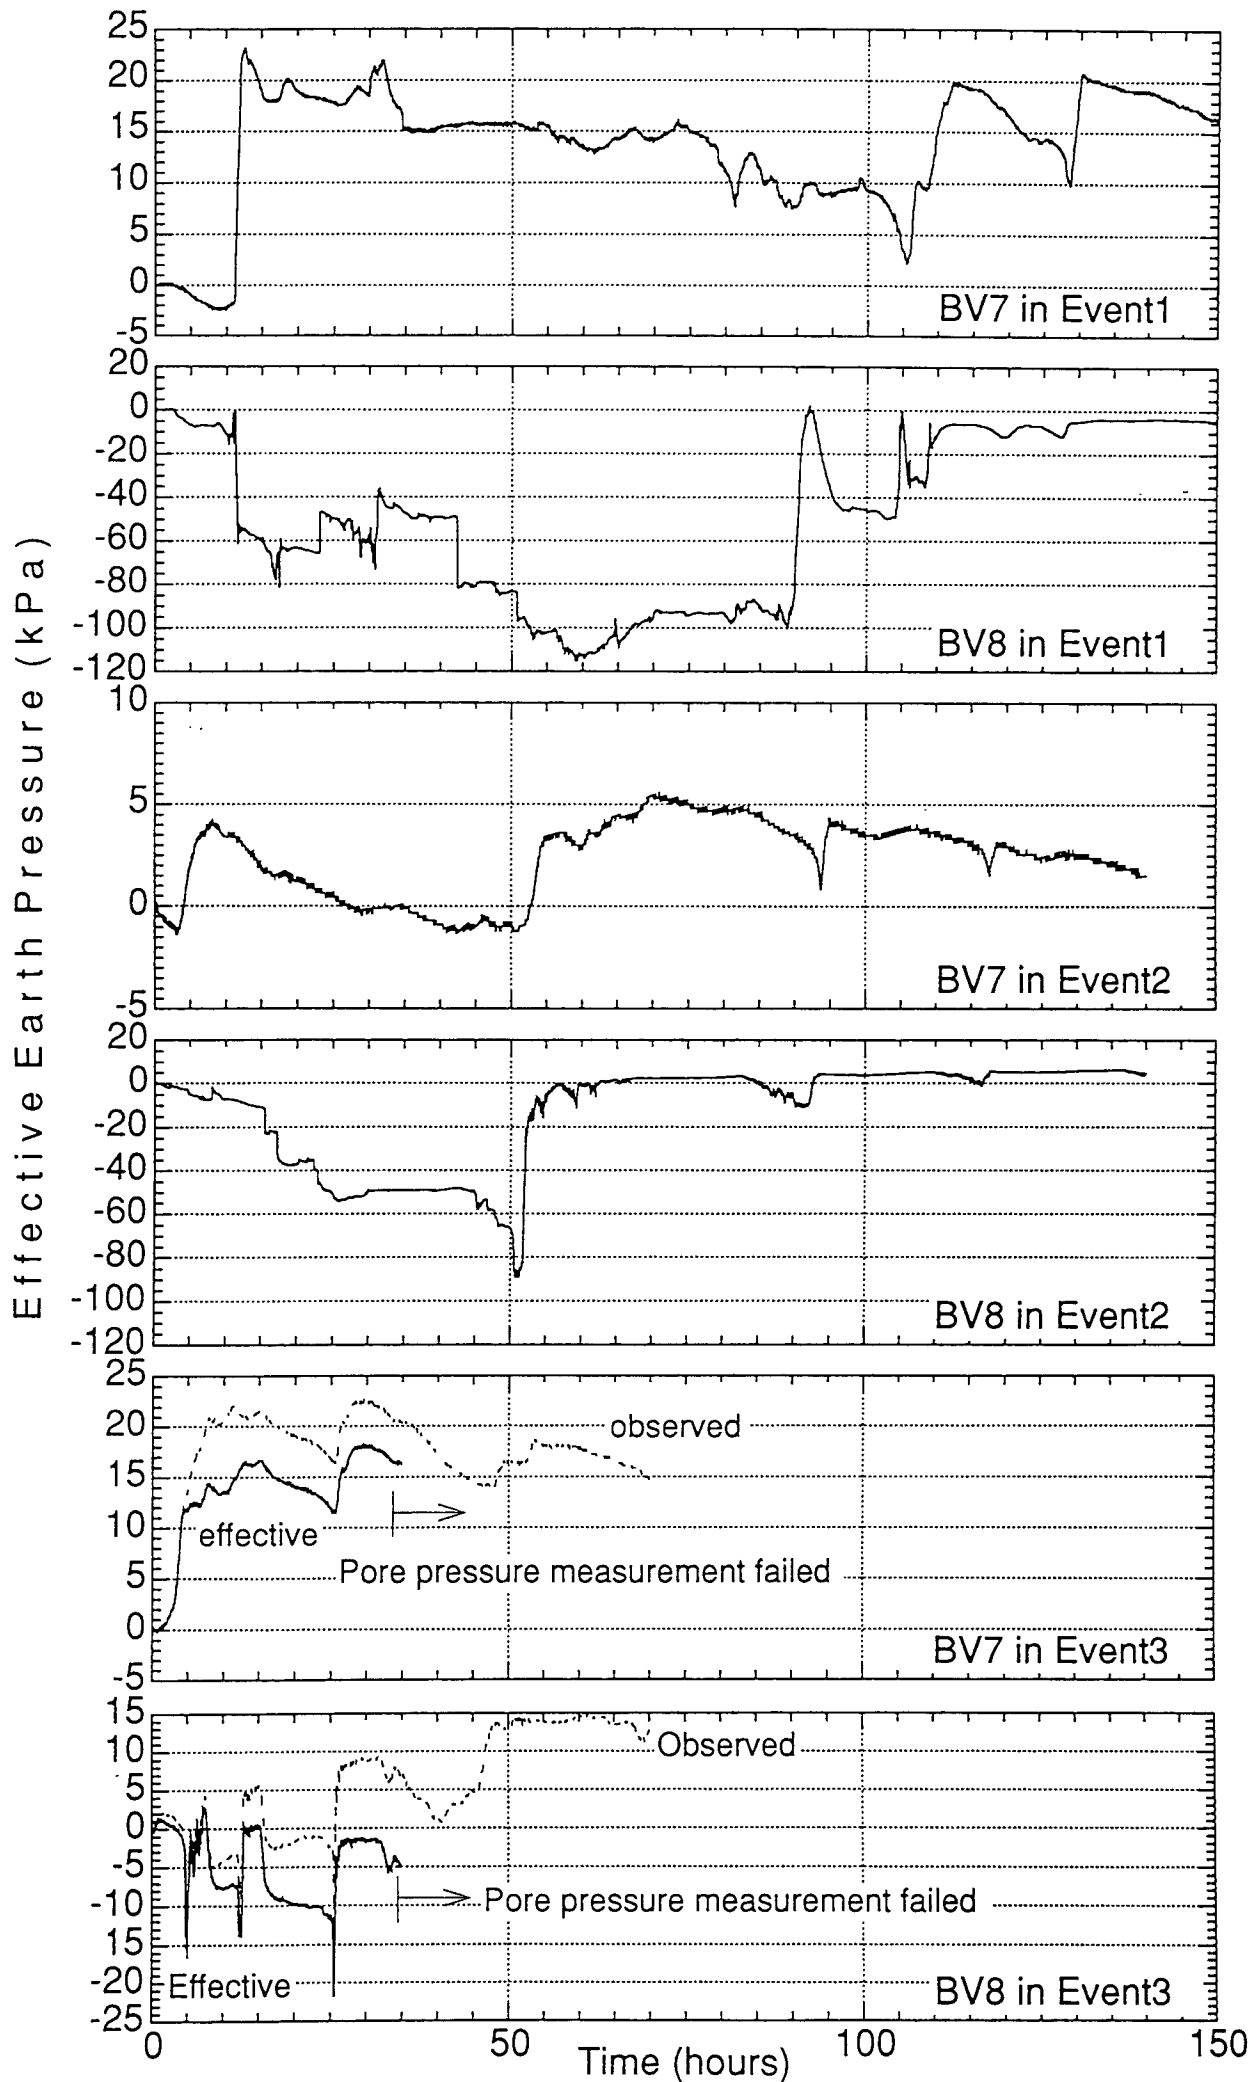
Fig. 45. Variations in the effective earth pressure in BV 7 and 8 during three events.

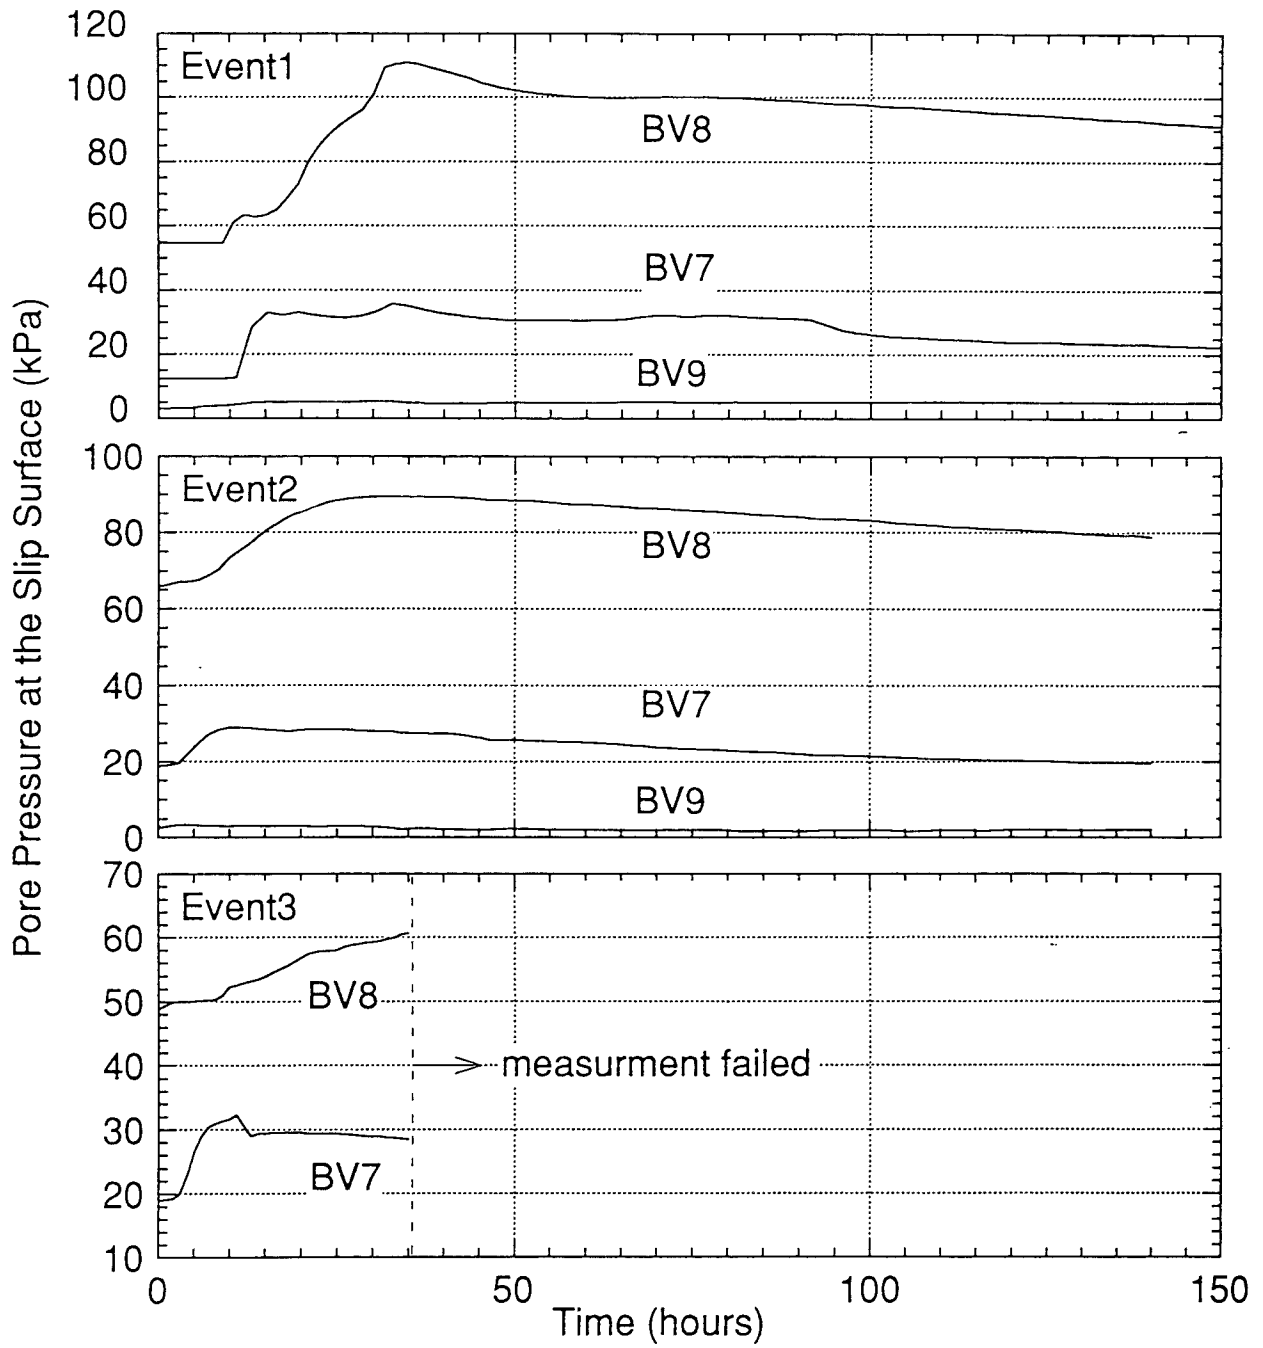
Fig. 46. Pore pressures at the slip surface observed during three events.

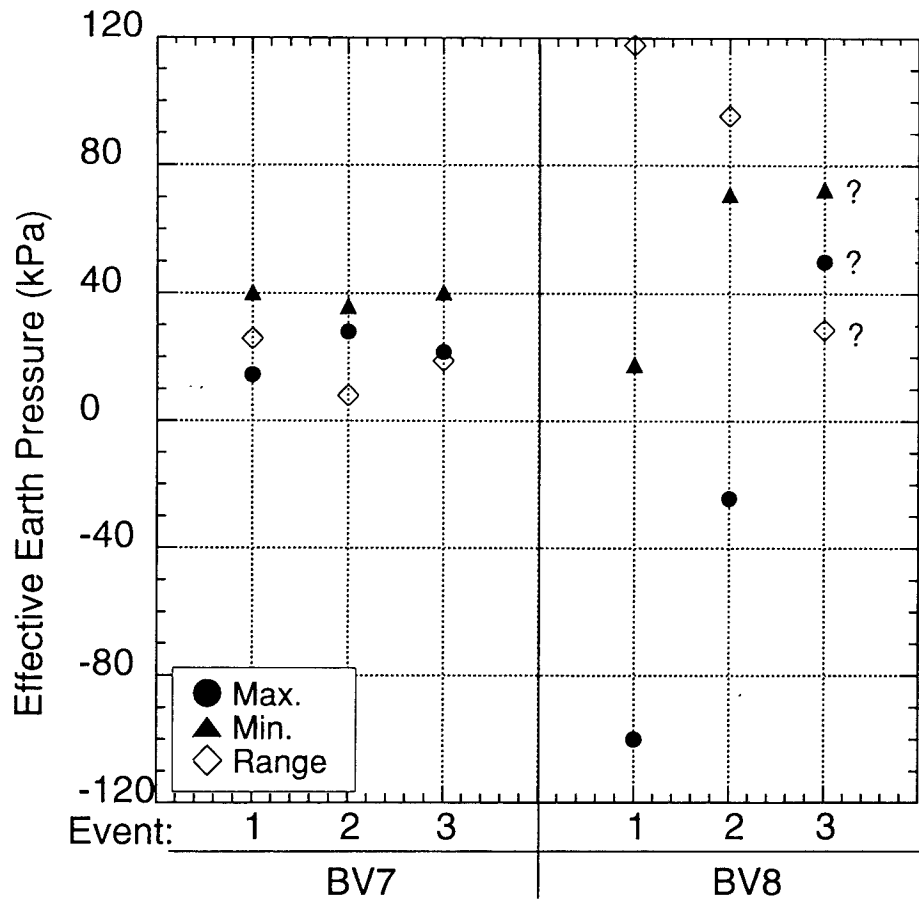
Fig. 47. The maximum and minimum values and the range of variation (the maximum - the minimum value) in the effective earth pressure in BV 7 and 8 for three events. Pore pressure measurement partially failed in BV 8 during Event 3 (see Fig. 46). Values plotted with "?" were obtained for period when pore pressure was measured (0 to 35 (hrs)).

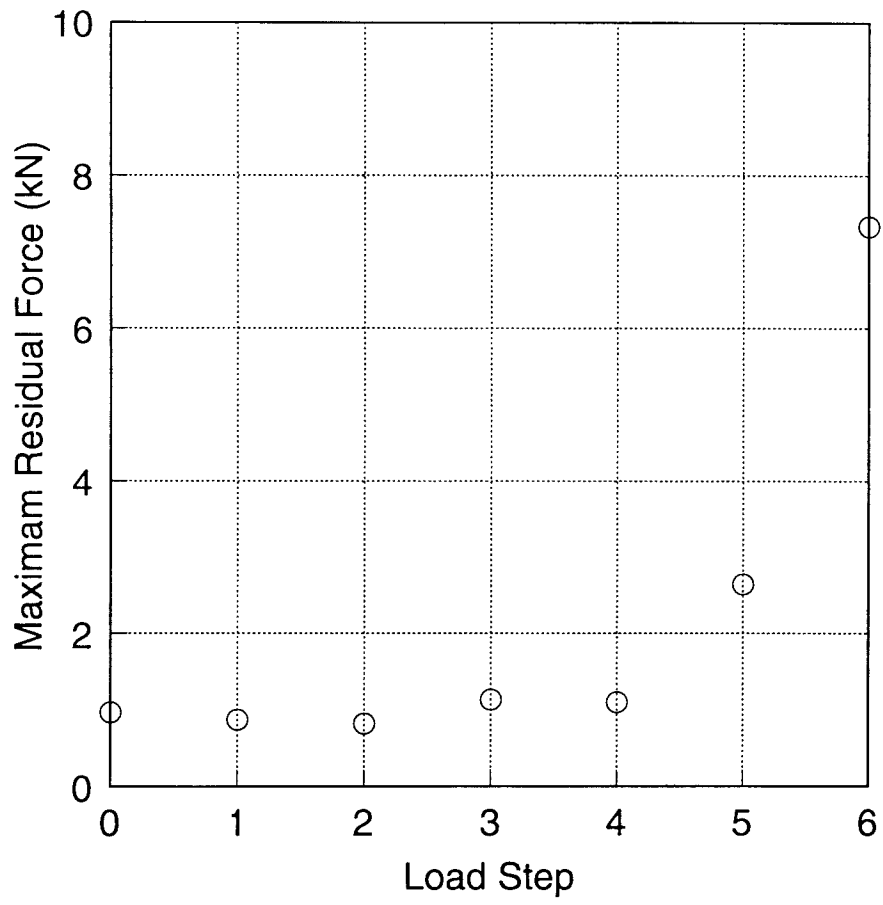
Fig. 48. Increase of the maximum residual force with load step.

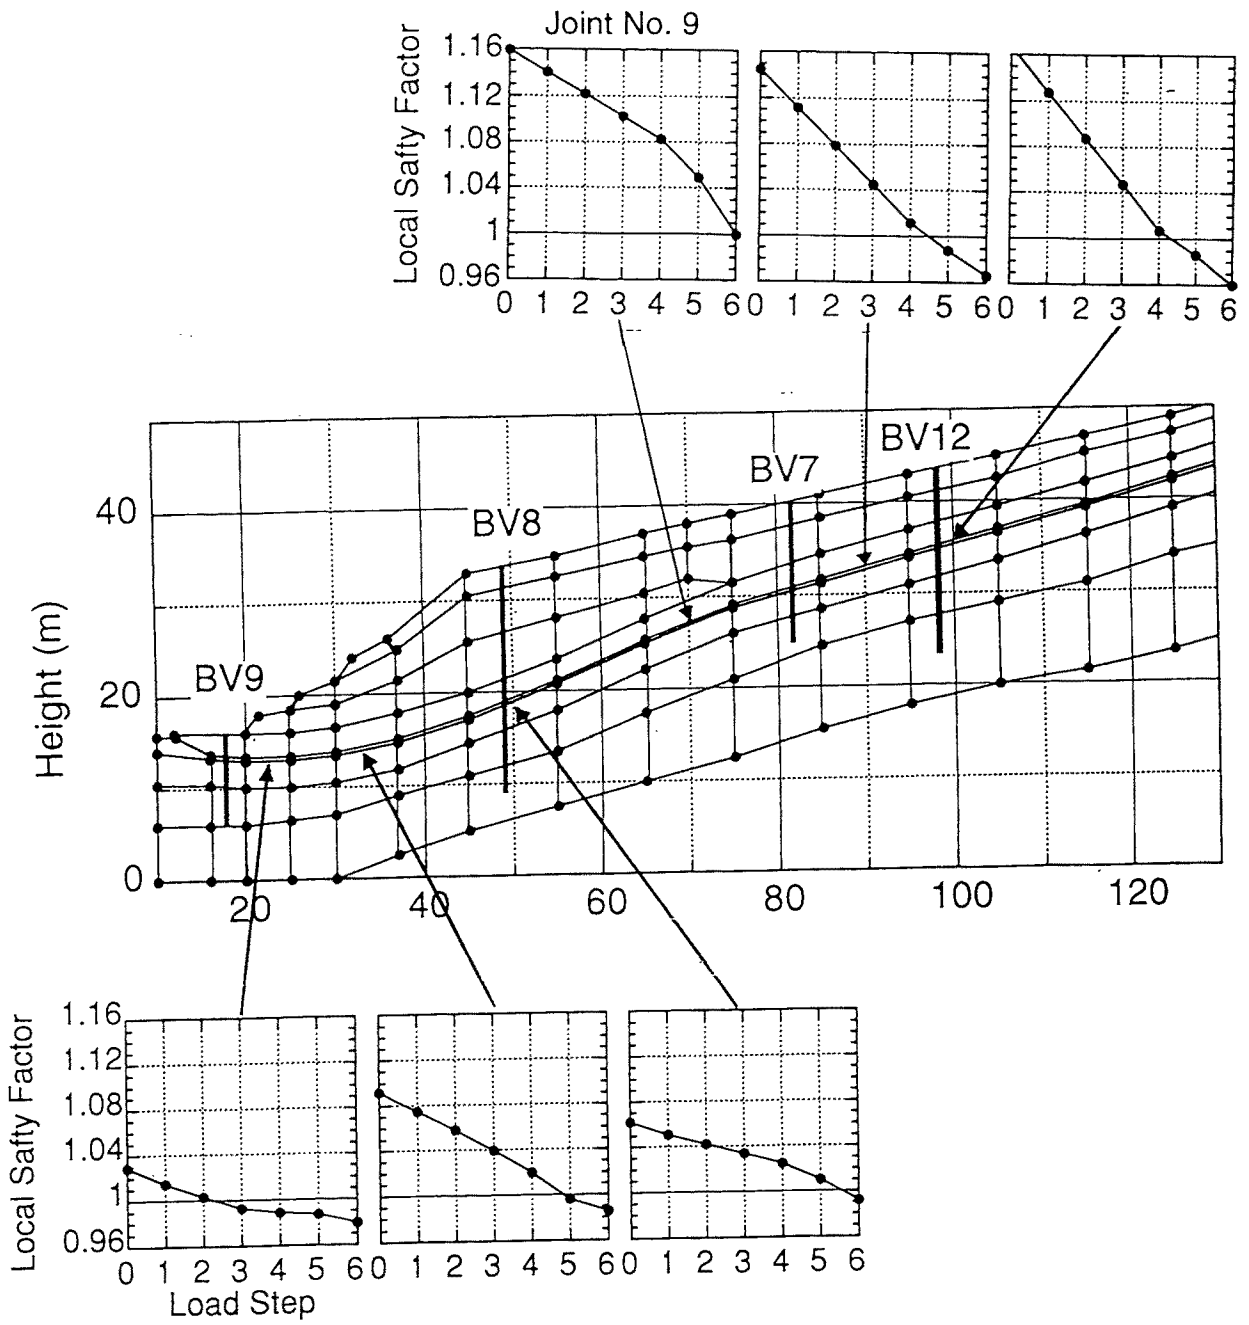
Fig. 49. Distribution of LSF and its variation with load step.

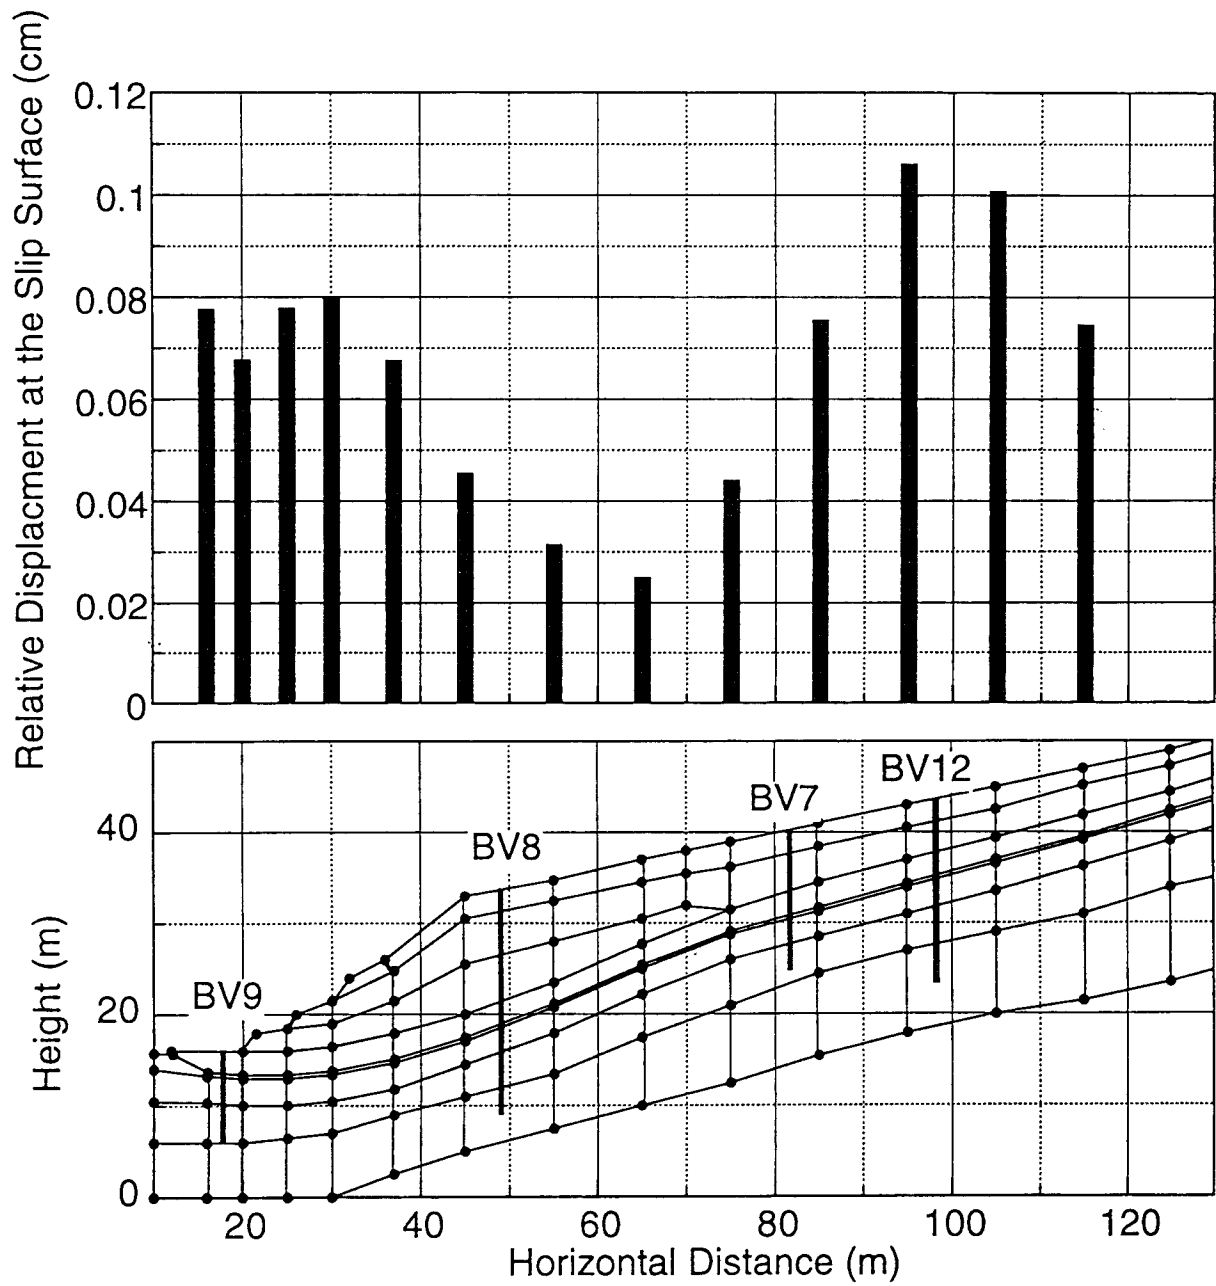
Fig. 50. Distribution of relative displacement at joint elements.

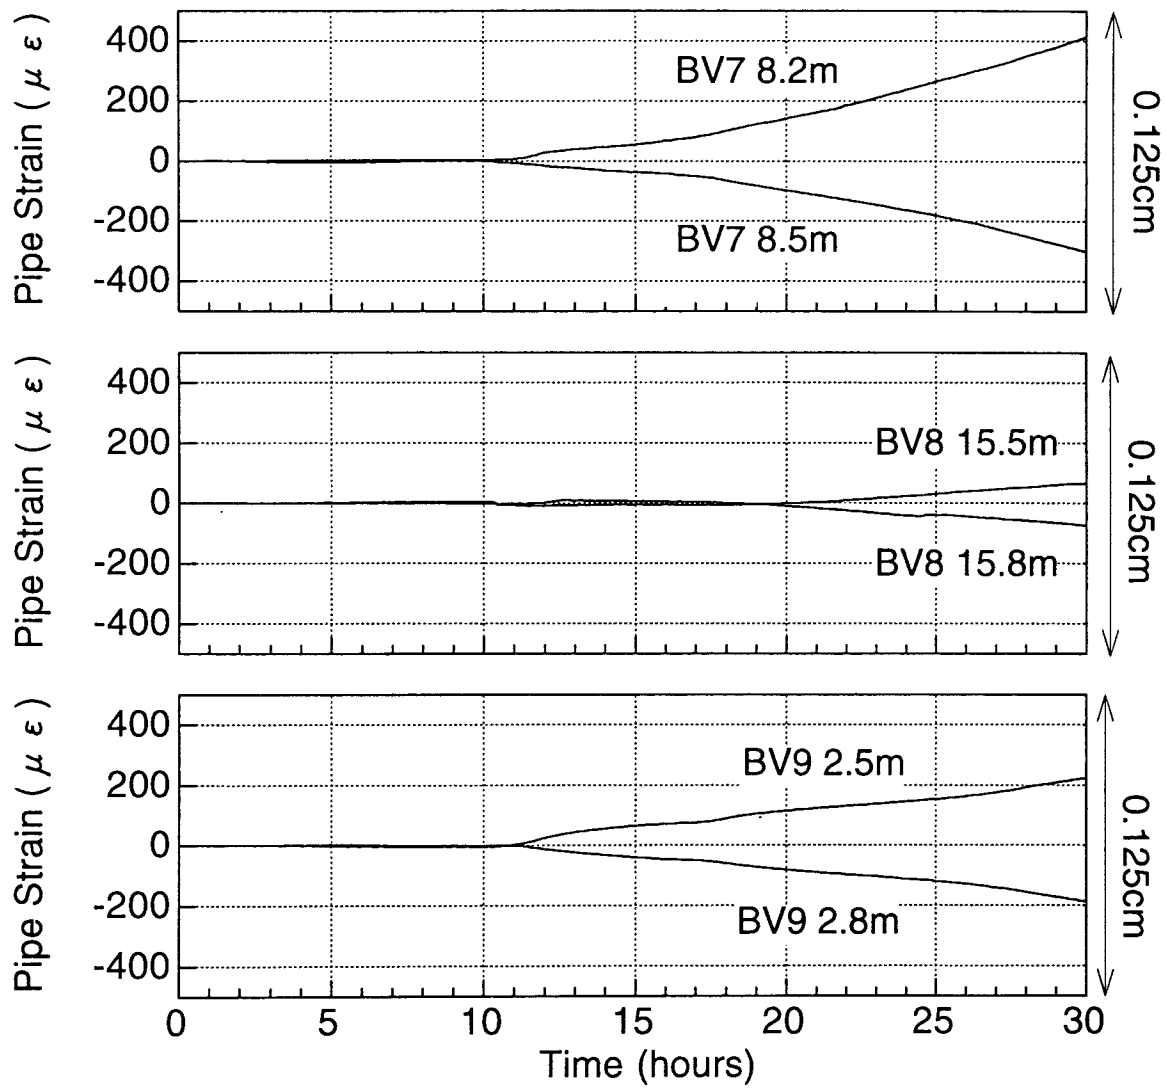
Fig. 51. Pipe strain just above and below the slip surface in BV 7 to 9 during the initial period of Event 1.

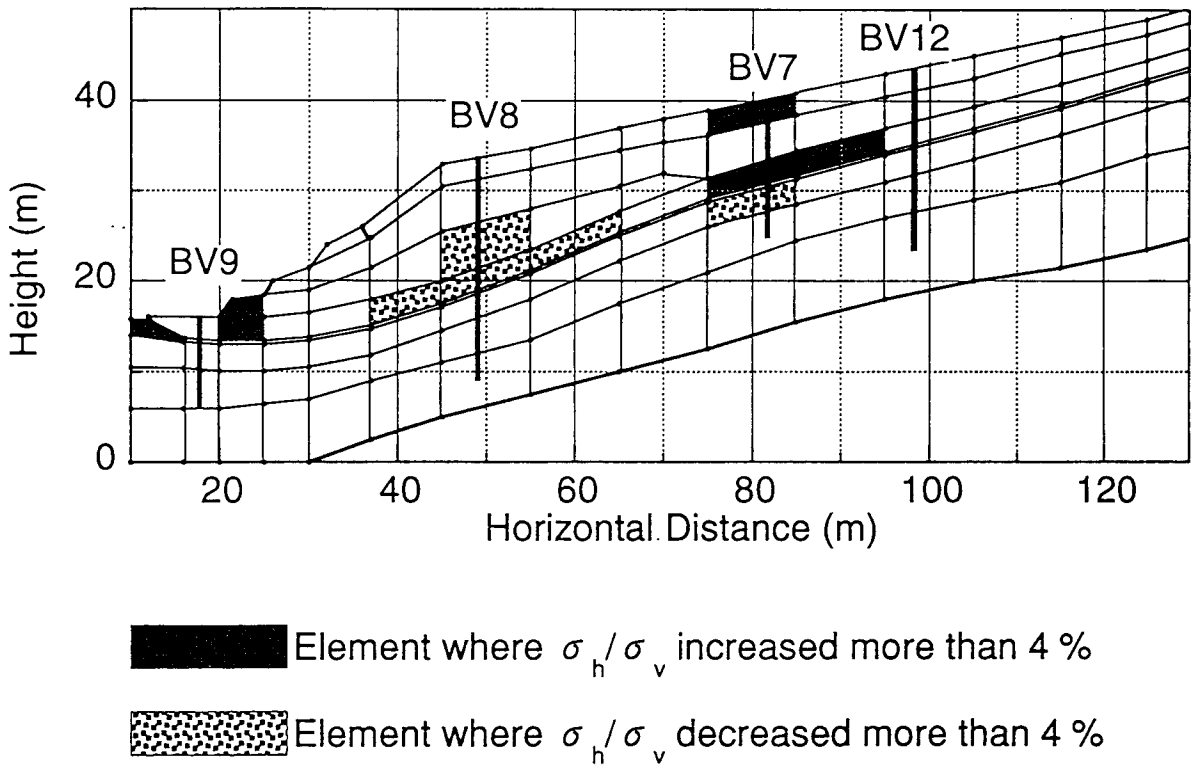
Fig. 52. Distribution of difference in the earth pressure coefficients between at the initial condition and at the end of analysis.

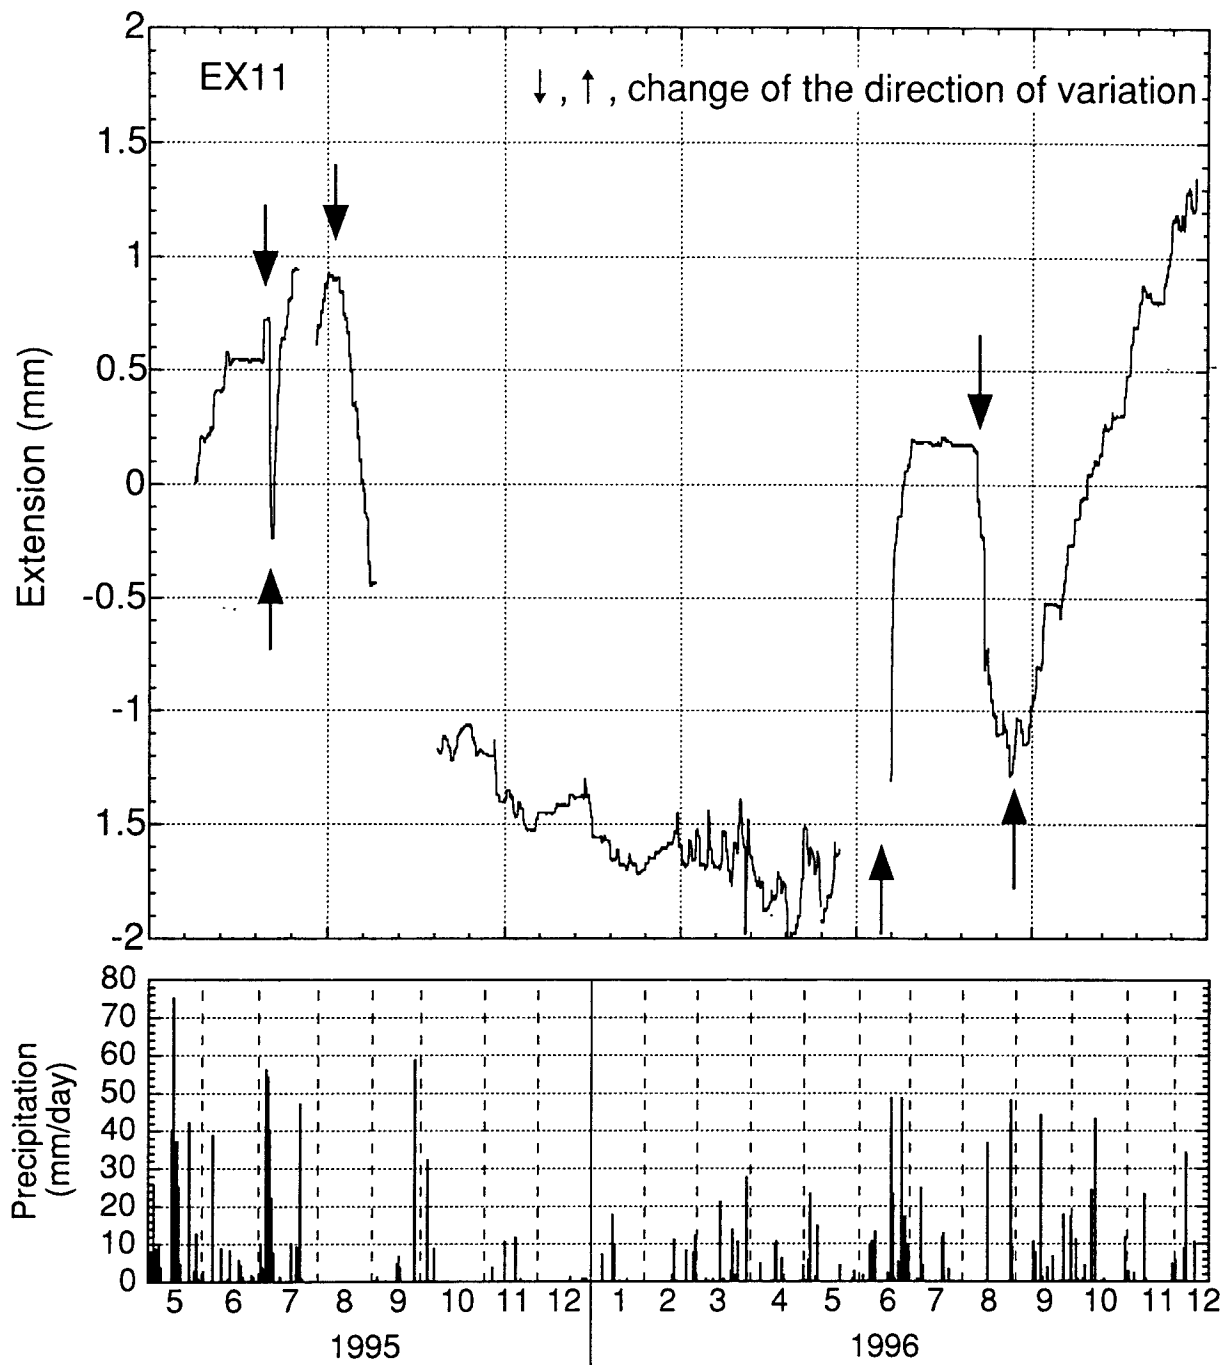
Fig. 54. Change of the direction of variation in EX 11 in the Todoroki landslide.

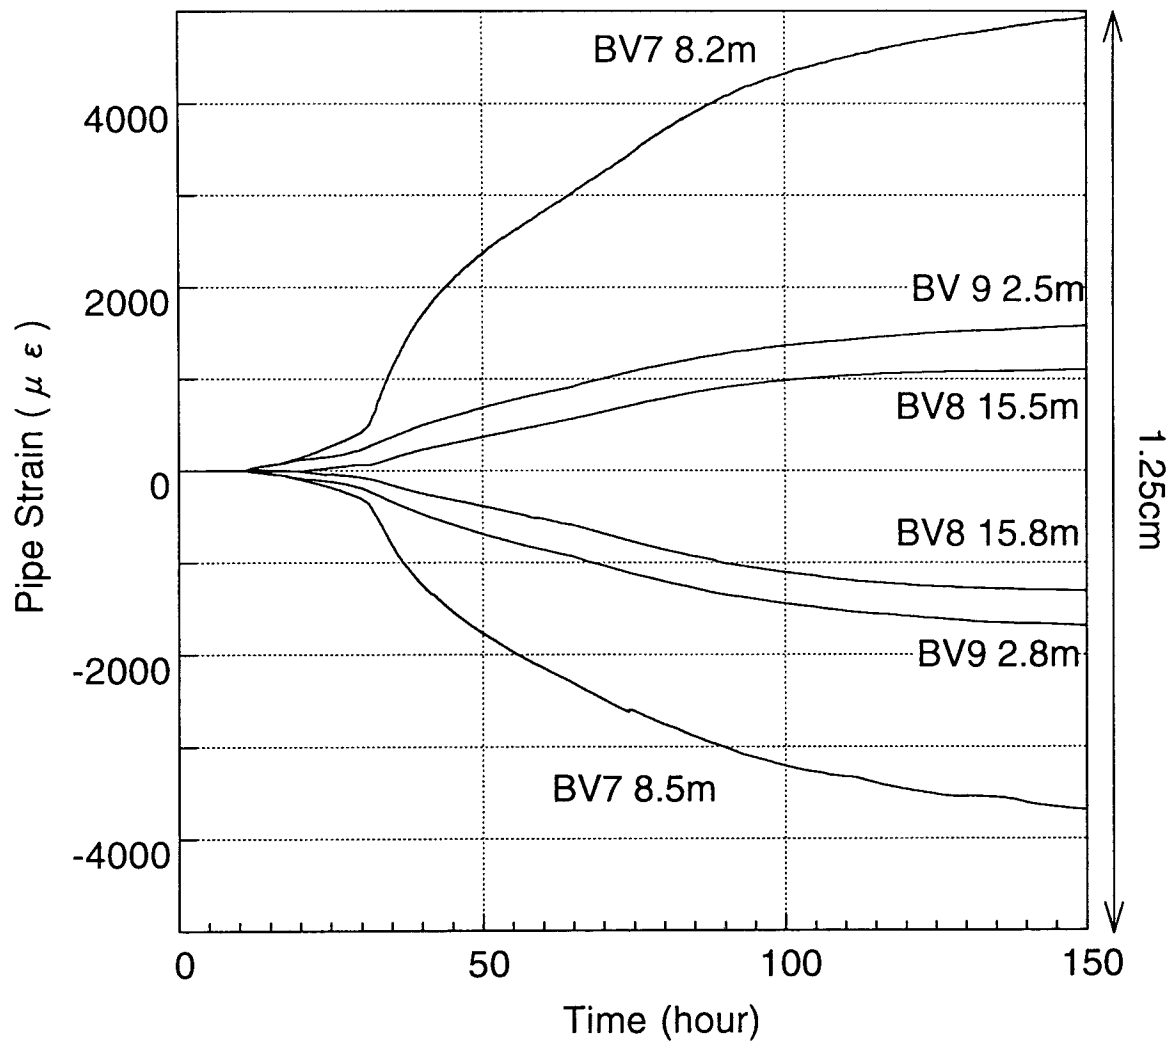
Fig. 55. Pipe strain at the slip surface observed during Event 1.

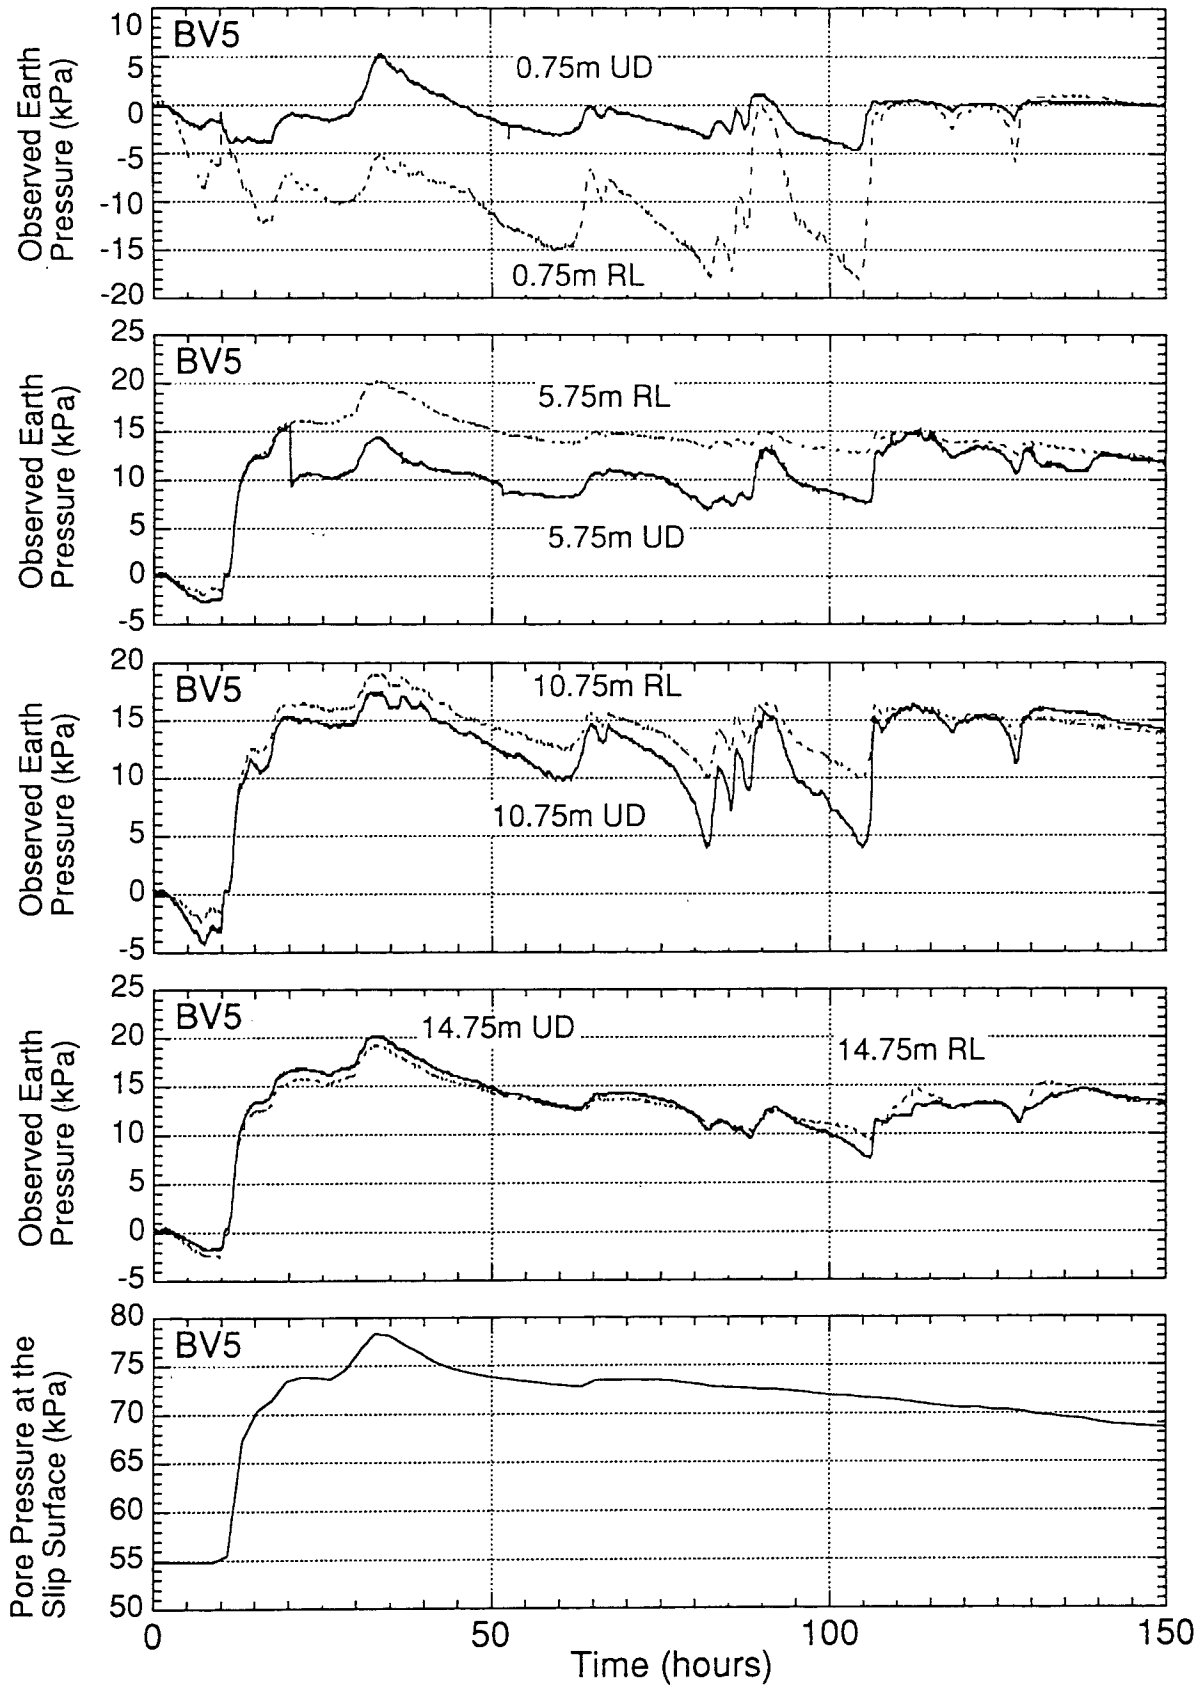
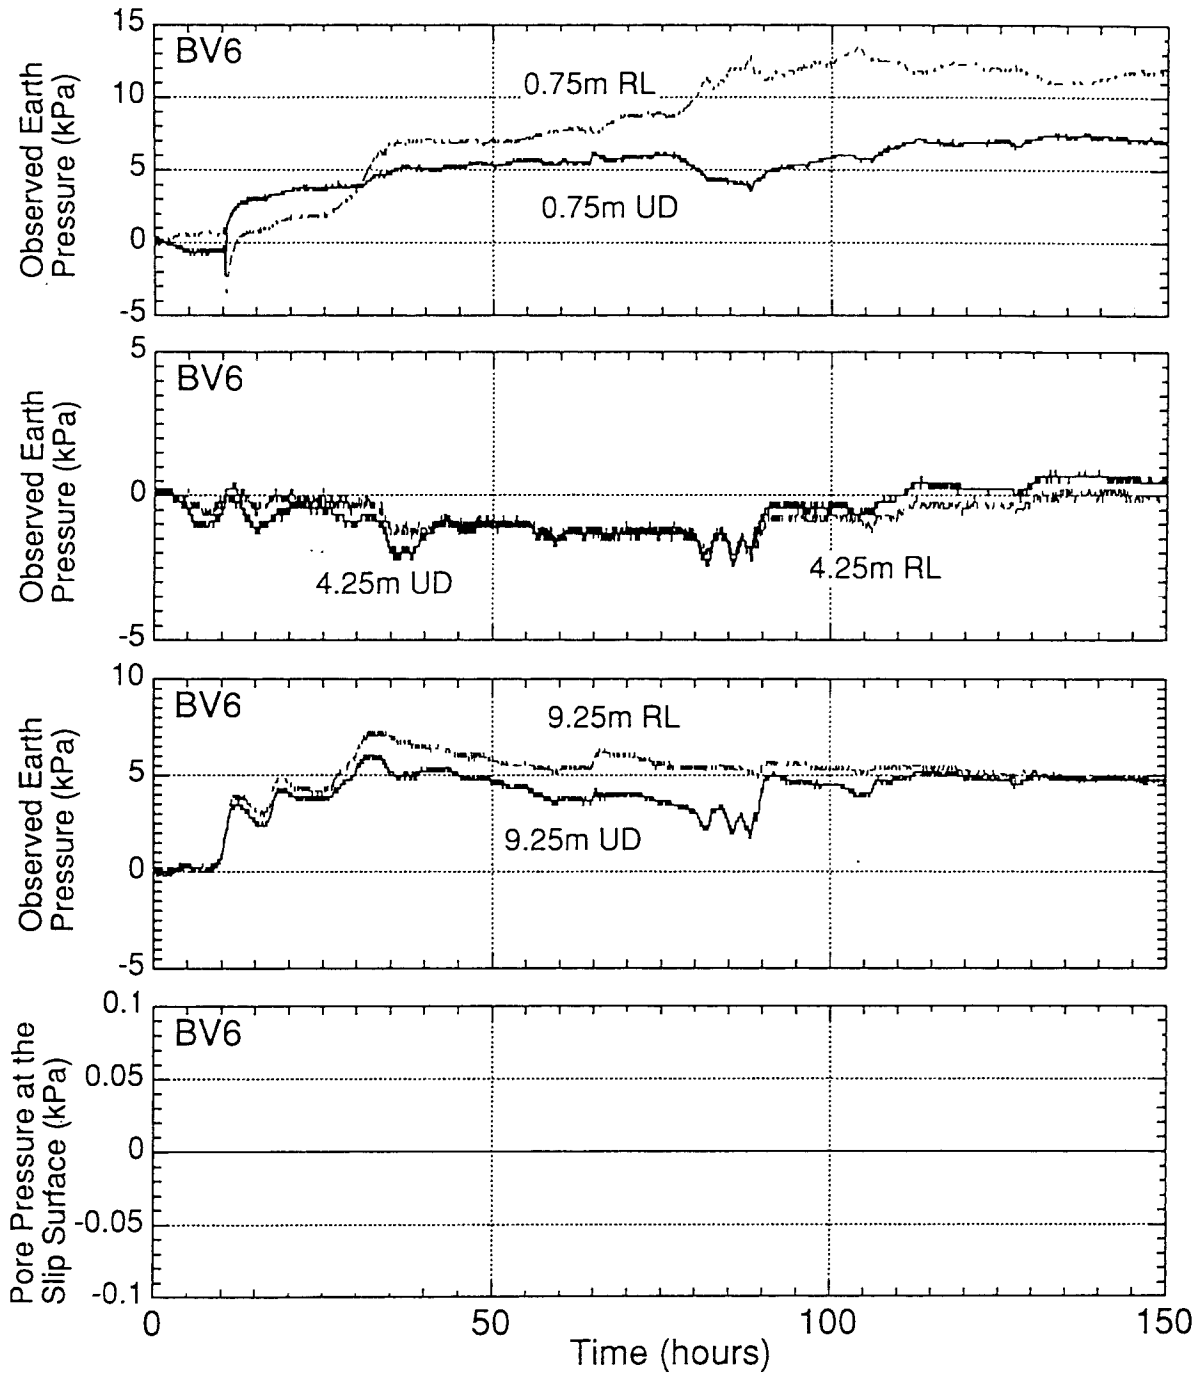
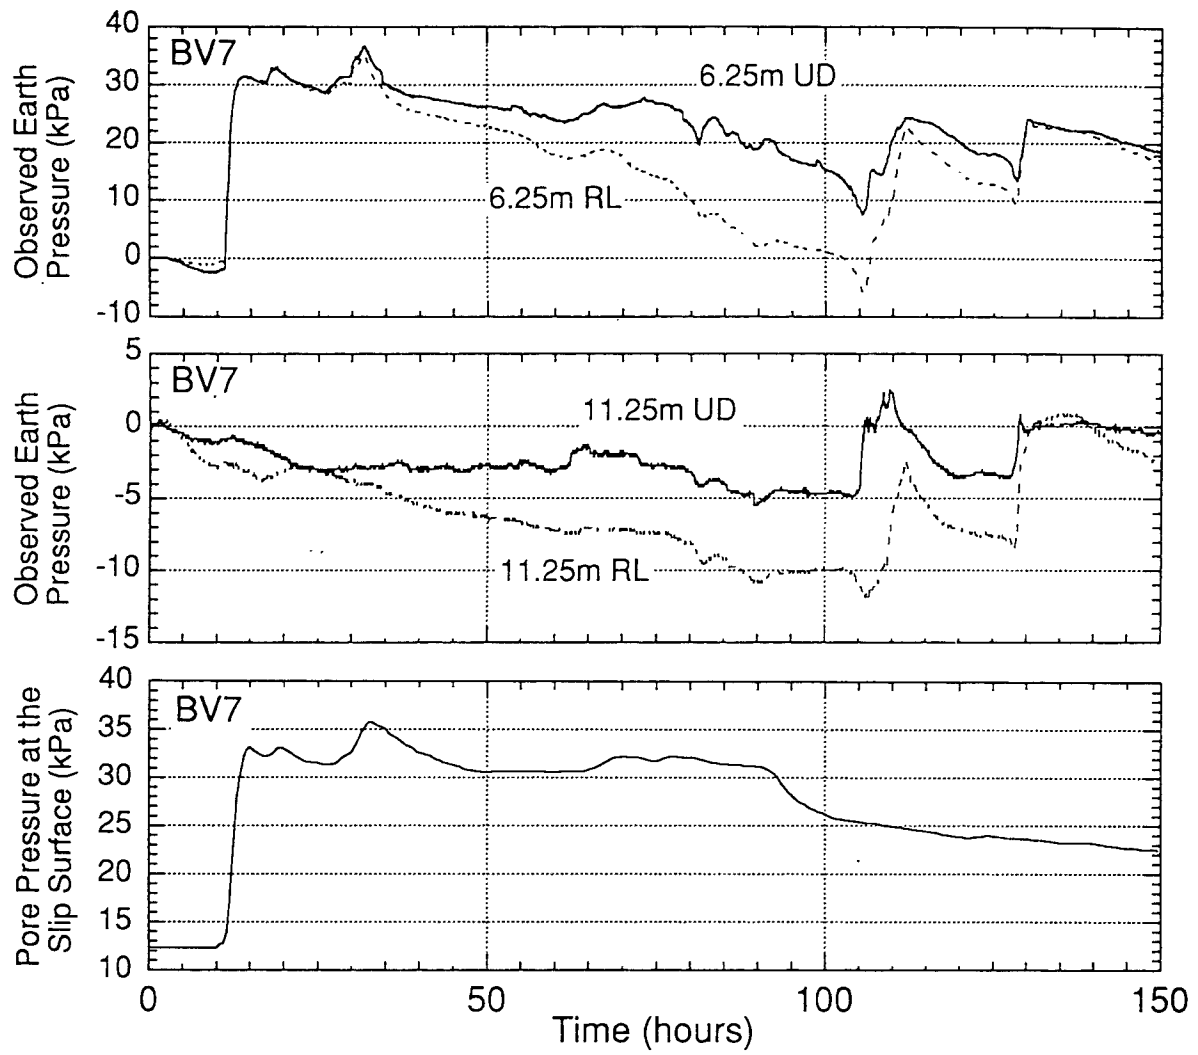
Appendix 1 (four pages): Observed earth pressures for BV 5 to 9 in Event 1 and pore pressure at the slip surface (those for BV 4 are shown in Fig. 34).

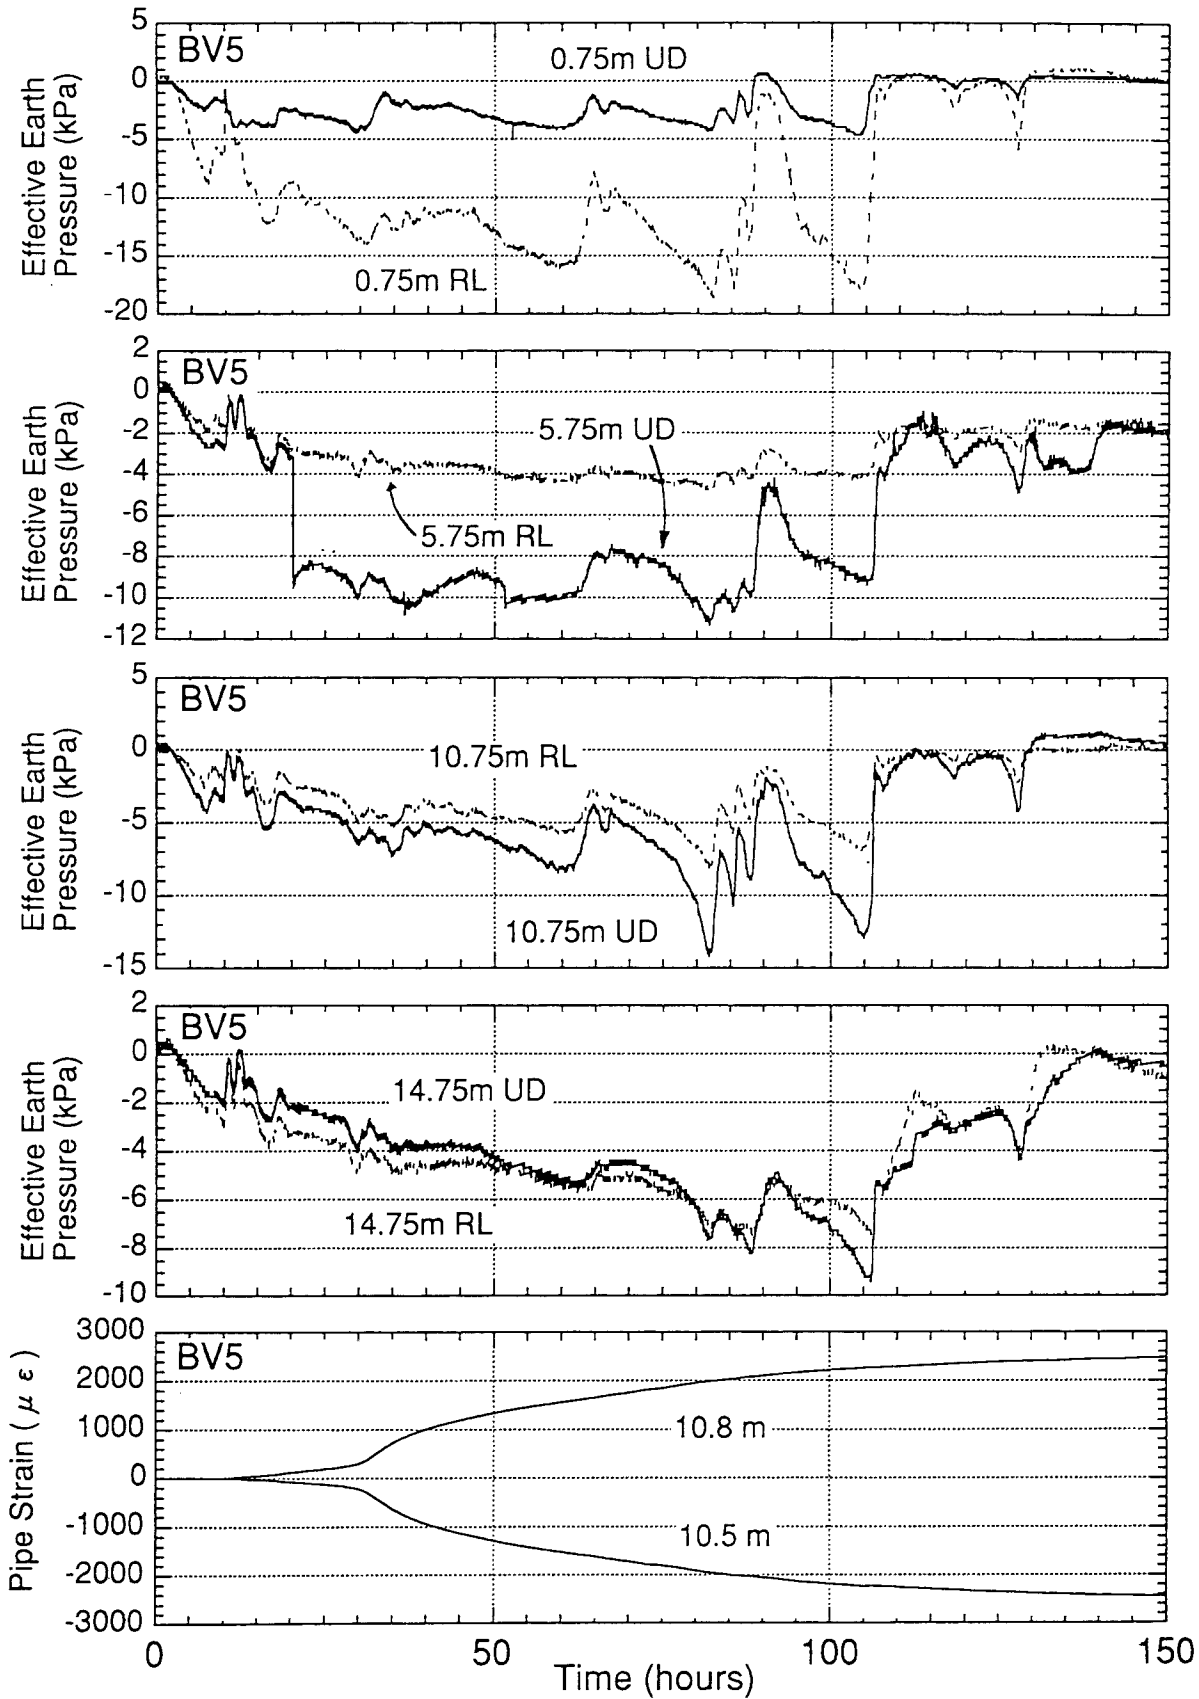
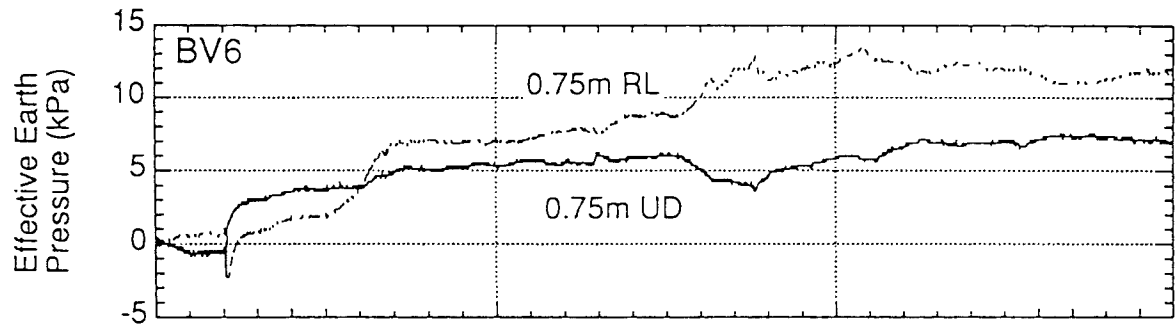
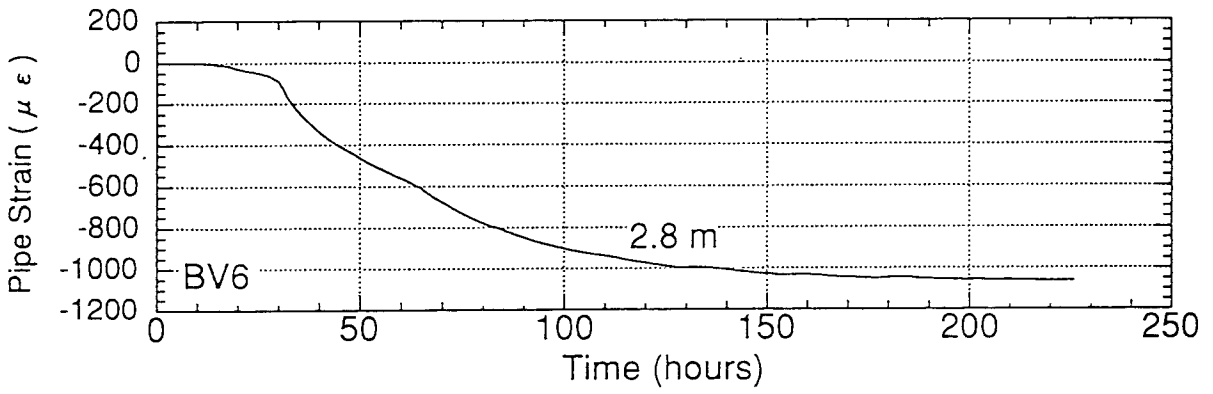
Appendix 2 (four pages): Calculated effective earth pressures for BV 5 to 9 in Event 1 and pipe strains at the slip surface (those for BV 4 are shown in Fig. 34).
