## Application of large scale ring shear tests to the analysis of tsunamigenic landslides at Stromboli

Daniela Boldini<sup>1</sup>, Fawu Wang<sup>2\*</sup>, Kyoji Sassa<sup>3</sup>, Paolo Tommasi<sup>4</sup>

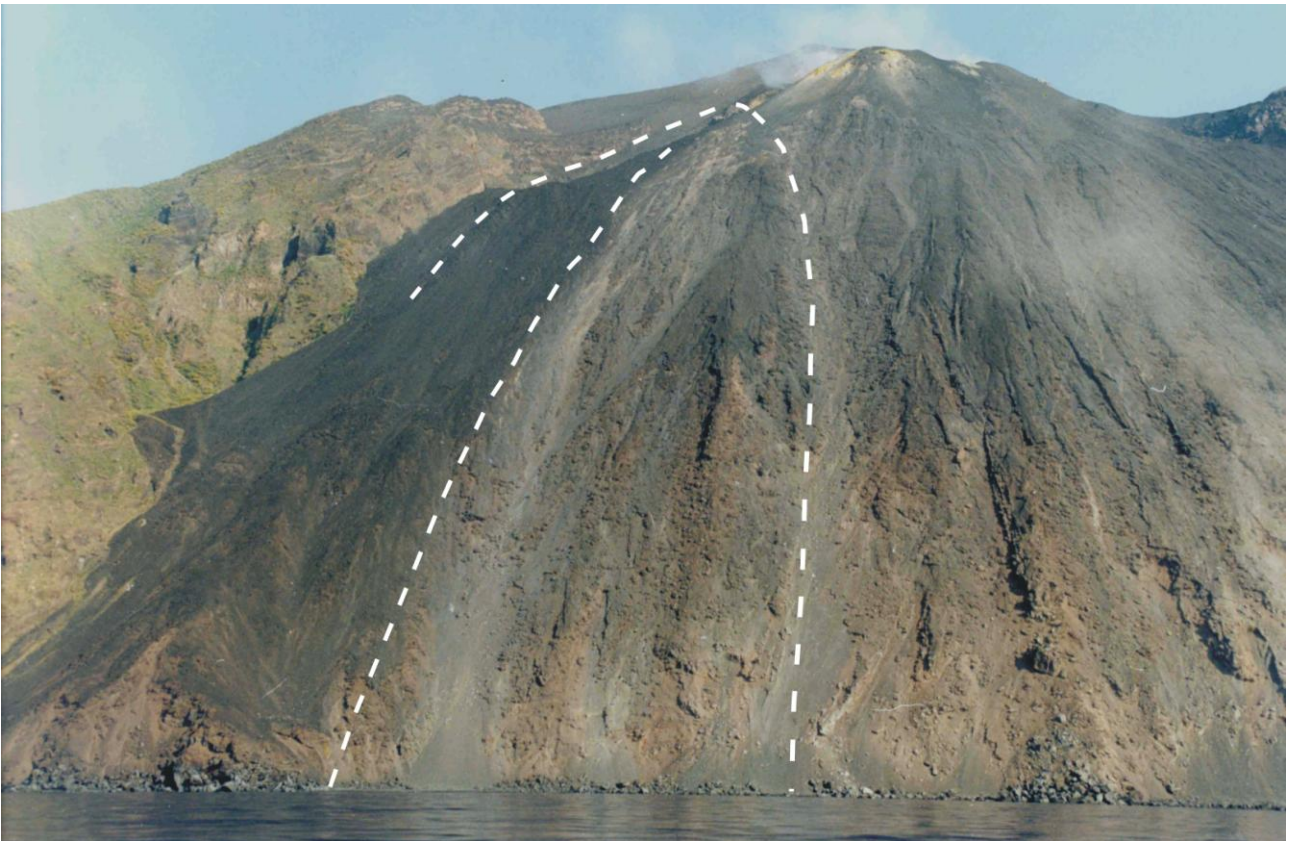
Figure 1

5 Fig. 1: Map of Stromboli island.

5 The Stromboli volcano, located on the homonymous island (North of Sicily, Italy), spreads products  
6 over its NW flank, called Sciara del Fuoco (hereafter indicated as the Sciara). Populated areas of the  
7 island (S. Vincenzo) mostly extend along the NE and E sides, very close to the coast (Fig. 1).  
8  
9 Another village, Ginostra, lies on top of a small natural terrace behind the southern limit of the  
10 Sciara. From spring to early autumn, and other vacation periods, the population rises sharply due to  
11 the influx of tourists, particularly along the coastal areas. Hazard assessment directly or indirectly  
12 linked to the activity of the volcano and the slope instability is important in terms of population  
13 risk.  
14

42  
43 The material was sampled in April 2004 on outcrops of volcanoclastic sequences, corresponding  
44  
45 to the lateral scarp of a small slide located at the foot of the slope (Figs. 1 and 3). In the sampling  
46  
47 area the volcanoclastic sequences mainly consist of gravelly and sandy layers (box in Fig. 3),  
48  
49 composed of angular to subangular clasts with high surface roughness and low sphericity.  
50  
51

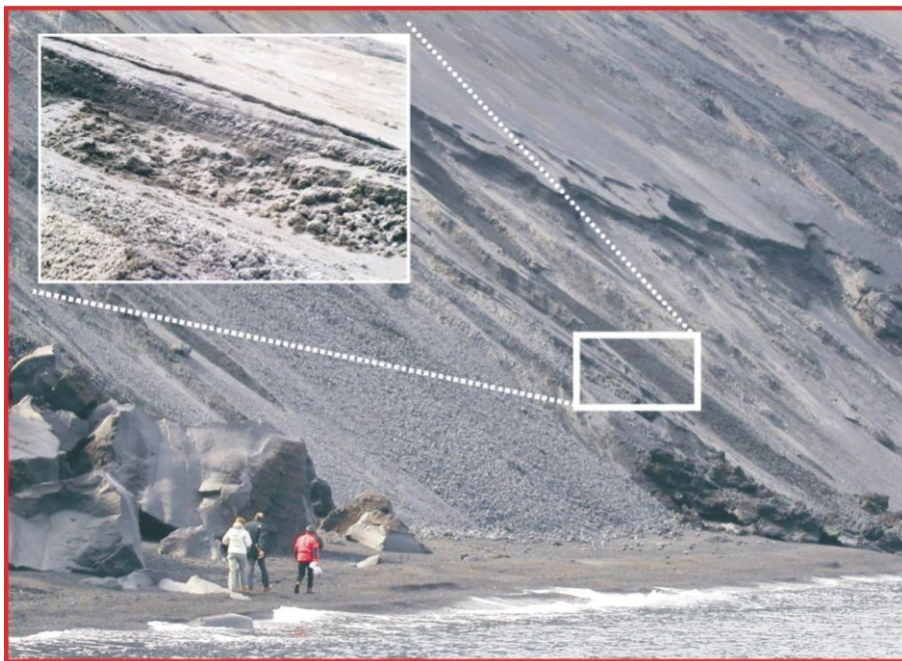
Figure 3

16 Volcaniclastic layers are the most abundant and weakest component of the Sciara deposit and  
17 extend continuously over extremely large areas (up to some  $10^5 \text{ m}^2$ ) (Fig. 3).  
18  
19  
20

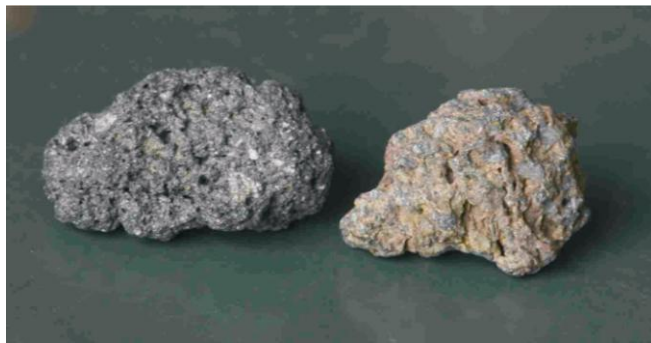
Figure 7

52  
53 Physical and mechanical properties of grains were determined by Tommasi et al. (2005b and  
54  
55 2007). Scanning electron microscope showed grains that appeared to be formed by small lumps,  
56  
57 ranging from a few tenths to a few millimetres in size, welded together so as to form a continuous  
58  
59  
60  
61

1  
2  
3 frame (Figs. 7 and 8). Pores are extremely diffuse and generally do not exceed a few tenths of a  
4  
5 millimetre in size, even though larger pores (up to 2-3 mm) are observed (Figs. 7 and 8). Most  
6  
7 grains result from the disruption of the lava flow fronts during the cooling and advancing on the  
8  
9 steep Sciara slope (autoclastic breccia); spatters from slides of the cinder cones are also present.  
10  
11 Fragments of low-porosity aphanitic lava, coming from the core of the lava flows, are less frequent.  
12  
13  
14 The mean value of the density of the entire sample set, measured with a mercurium pycnometer, is  
15  
16 2.34 Mg/m<sup>3</sup>, with a standard deviation of 0.04 Mg/m<sup>3</sup> (43 determinations). Solid matrix density,  
17  
18 determined with a helium pycnometer on powders (<0.074 mm,) is on average 2.90 Mg/m<sup>3</sup>,  
19  
20 yielding a mean value of the total porosity of the grains of 19.2%, that is almost completely

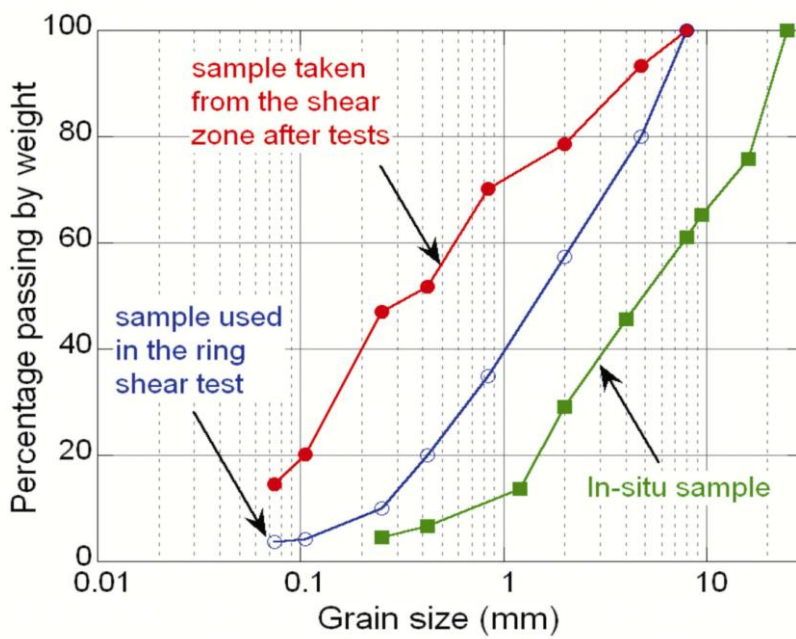
Figure 9

50  
51 The grain size distribution of a typical layer of the volcanoclastic deposit is shown in Fig. 9. To  
52  
53 ensure a convenient ratio between maximum grain and specimen sizes, tests were performed on the  
54  
55 fractions passing the 8 mm sieve. The grain size distribution curve (Fig.9) was shifted parallel to the  
56  
57 grain size axis, according to Fumagalli (1969), obtaining a sand with gravel, with a coefficient of  
58  
59 uniformity of 9.6.  
60  
61

33 Grains from the Stromboli volcanoclastic deposit were highly crushable under the investigated  
34 test conditions. Crushing, induced by shearing, is apparent both at a visual analysis of the shear  
35 zone (Fig. 13) and from the comparison of grain size distributions, determined before and after the  
36 test (Fig. 9).  
37  
38

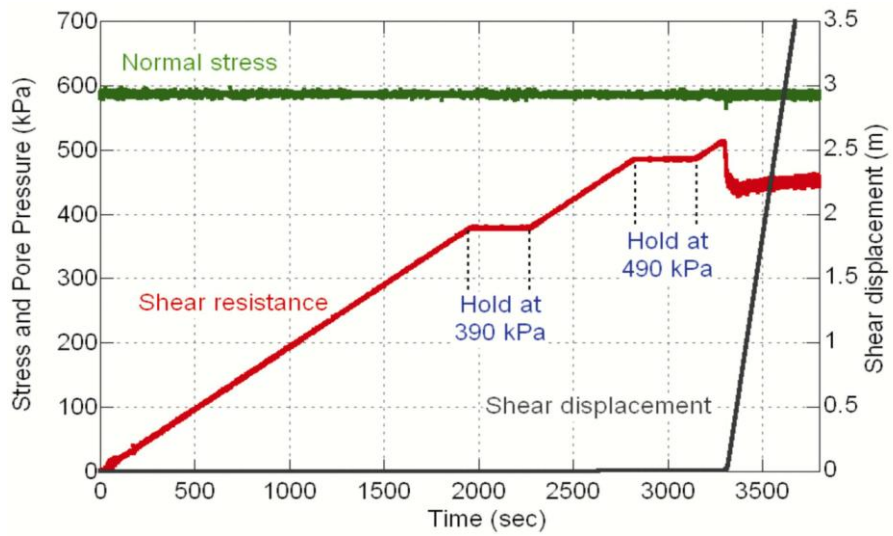
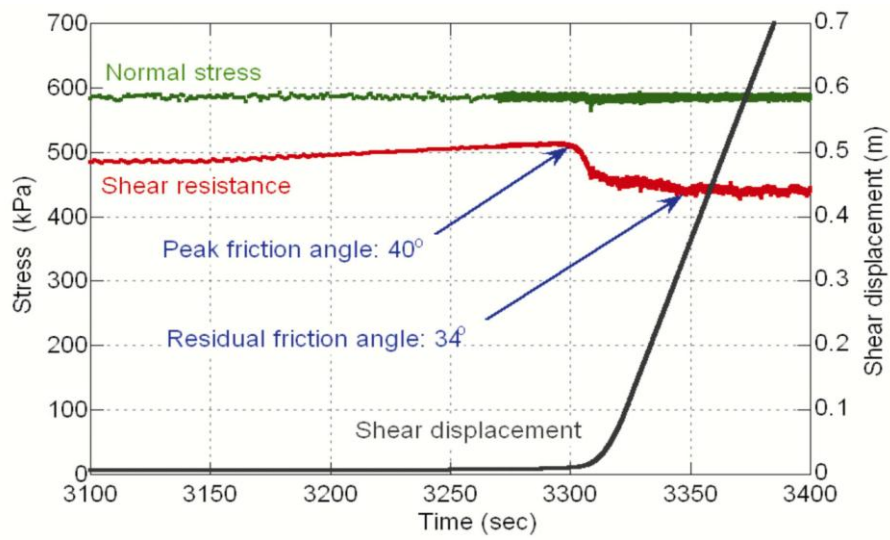
Figures 10a and 10b

5 Time-histories of normal stress and shear resistance are plotted in Fig. 10a and 10b. Shear  
6 resistance increased linearly, according to the linear increase of the applied torque, up to a peak  
7 value corresponding to an instantaneous friction angle of  $40^\circ$  (with two short hold-ups). After peak,  
8 the shear strength decreased to a value corresponding to an instantaneous friction angle of  $34^\circ$ ,  
9 which remained constant for the rest of the test. Due to the torque-controlled procedure, the drop of  
10 shear resistance after peak was accompanied by a sudden increase of the shear displacement rate.  
11  
12  
13  
14  
15  
16  
17

37  
38 Fig. 10: Time histories of total normal stress, shear resistance and shear displacements recorded  
39 during a dry ring-shear test: a) data of the whole test; b) detail of the near-failure stage.  
40  
41

18 These results are comparable to those obtained by Tommasi et al. (2007) through DS tests.  
19 The higher instantaneous peak friction angle ( $42^\circ$ ) is probably due to the much lower displacement  
20 rate.  
21  
22  
23  
24

25 The peak friction angle is higher than the average dip of both the subaerial slope ( $35^\circ$ - $36^\circ$ ) and  
26 the  $\alpha$  slip surface ( $33^\circ$ ). The latter is also lower than the residual friction angle of the volcanoclastic  
27 material. This is indirect evidence that without a magmatic intrusion the subaerial slope would not  
28 likely have failed with the slope geometry existing in December 2002.  
29  
30  
31  
32  
33  
34  
35  
36

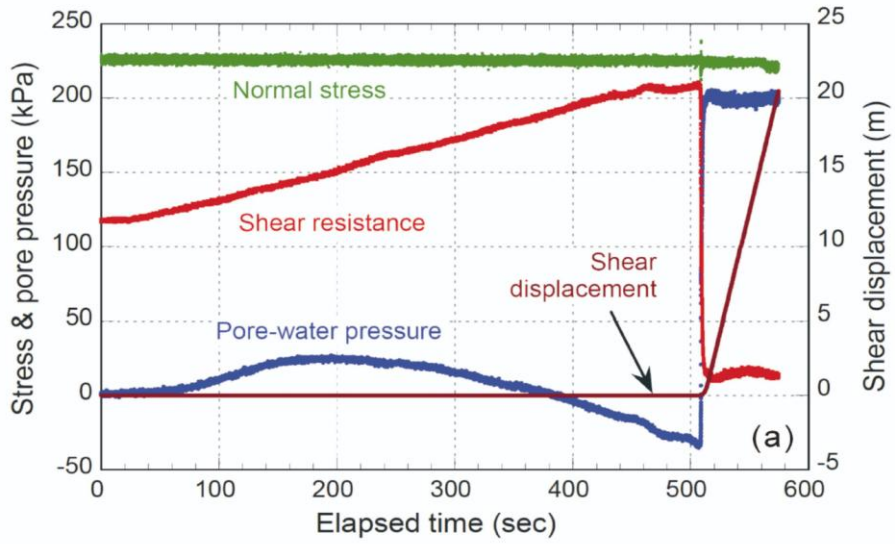
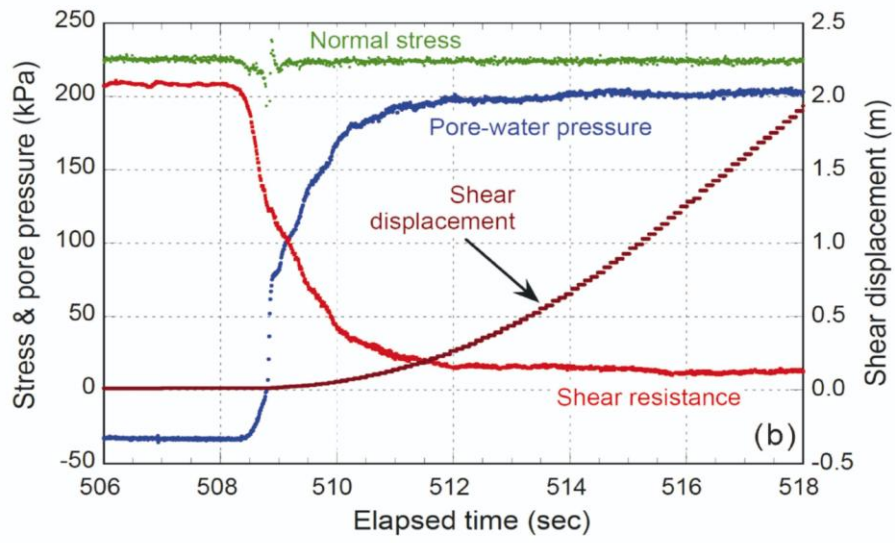
Figures 11a and 11b

41 Figures 11 reports time-histories of total normal stress, shear resistance, pore pressure and shear  
42 displacement. Data are shown both for the whole test (Fig. 11a) and in detail for the near-failure  
43 stage (Fig. 11b). Effective and total stress paths are plotted in Figure 12.  
44  
45  
46  
47

42  
43 Fig. 11: Time-histories of total normal stress, shear resistance, pore pressure and shear  
44 displacement recorded during the undrained ring-shear test: a) data of the whole test; b) detail of  
45 the near-failure stage.  
46  
47

48 During the first stage of the test, excess pore pressure generated as shear stress increased,  
49 producing a decrease in the effective normal stress (Fig. 12). This behaviour inverted when pore  
50 pressure reached about 25 kPa; from this point material dilation induced a progressive decrease in  
51 pore pressure down to negative values, producing a progressive increase in the effective normal  
52 stresses (Fig. 11a). When pore pressure reached about -37 kPa, the volcanoclastic material  
53 experienced liquefaction: pore pressure rose to values higher than 200 kPa, shear resistance abruptly  
54  
55  
56  
57  
58  
59  
60  
61  
62  
63  
64  
65

1  
2 decreased to a few kilopascals and, correspondingly, the shear displacement rate increased  
3 significantly (Fig. 11b).  
4

5  
6  
7 The apparent friction angle at the final stage (given by the arctangent of the ratio between the  
8 mobilised shear resistance and the total normal stress) is about  $3^\circ$ , showing a high mobility of the  
9 material under undrained shearing in the liquefied state.  
10  
11

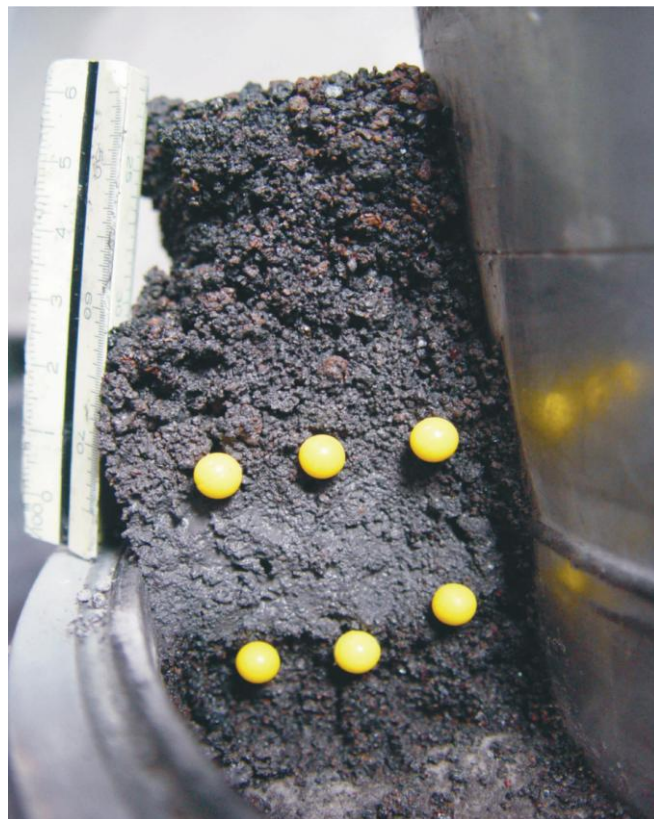
Figure 13

51  
52 Fig. 13: View of the shear zone after the test. The occurrence of grain crushing is visible.  
53

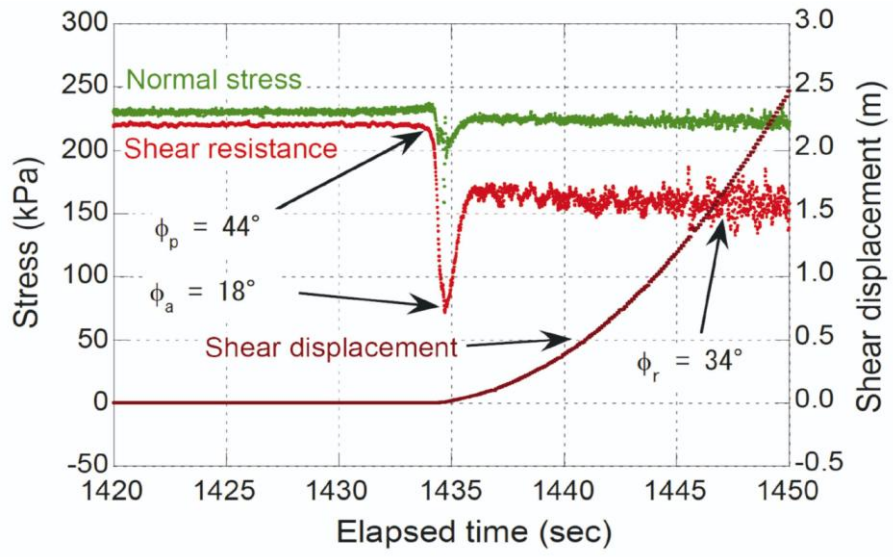
Figure 14

1  
2  
3 Initially the shear resistance increased gradually up to a maximum value, corresponding to a peak  
4 friction angle of about 44°. The linear increase of shear indicates that shearing is likely to occur  
5 under drained conditions. After peak, the shear resistance temporarily dropped to a value  
6  
7 corresponding to an apparent instantaneous friction angle of 18° and thereafter increased up to a  
8  
9 stable value, yielding a friction angle at large displacements of roughly 34°.  
10  
11  
12

13  
14 The drop in shear resistance is probably a consequence of the local development of excess pore  
15 pressures within the shear zone, which can build up due to the high crushability of the Stromboli  
16 volcanoclastic material. Since the rate of grain crushing and, in turn, the rate of pore pressure  
17 generation, possibly decreased as shear displacement proceeded, excess pore pressure soon decayed  
18 and the shear resistance was recovered up to a value corresponding to a friction angle of about 34°  
19 (Fig. 14).  
20  
21  
22  
23  
24  
25  
26

54  
55 Fig. 14: Time-histories of total normal stress, shear resistance and shear displacement recorded  
56 during the ring-shear test with open drainage.  
57  
58

27  
28 The peak friction angle measured in this test (44°) was higher than that determined in dry  
29 conditions (40°). This difference is due to the fact that the strength envelope of the Stromboli  
30 volcanoclastic aggregate is non-linear (Tommasi et al. 2007); indeed a higher normal stress was  
31 applied in the test on the dry material. Non linearity of the strength envelope is typical of coarse  
32 grained materials (Marsal 1973; Indraratna et al. 1993) and particularly of those with crushable  
33 grains (Miura et al., 2003).  
34  
35  
36  
37  
38  
39  
40

46  
47 The open drainage test performed , however, provides experimental evidence that a significant  
48  
49 drop in shear resistance, which would have been sufficient to lead the slope to failure, can be  
50  
51 expected even when excess pore pressure dissipation is not completely prevented. In this test, too,  
52  
53 the increase in pore pressure occurs after the material has experienced relatively large displacements  
54  
55 (almost three times greater than those reached in the undrained test).  
56
