## Studies of High-resolution Morphodynamics with Special Reference to River Bank Erosion

### Synopsis

**Keywords:** river bank erosion, high-resolution geomorphometry, sedimentary environments

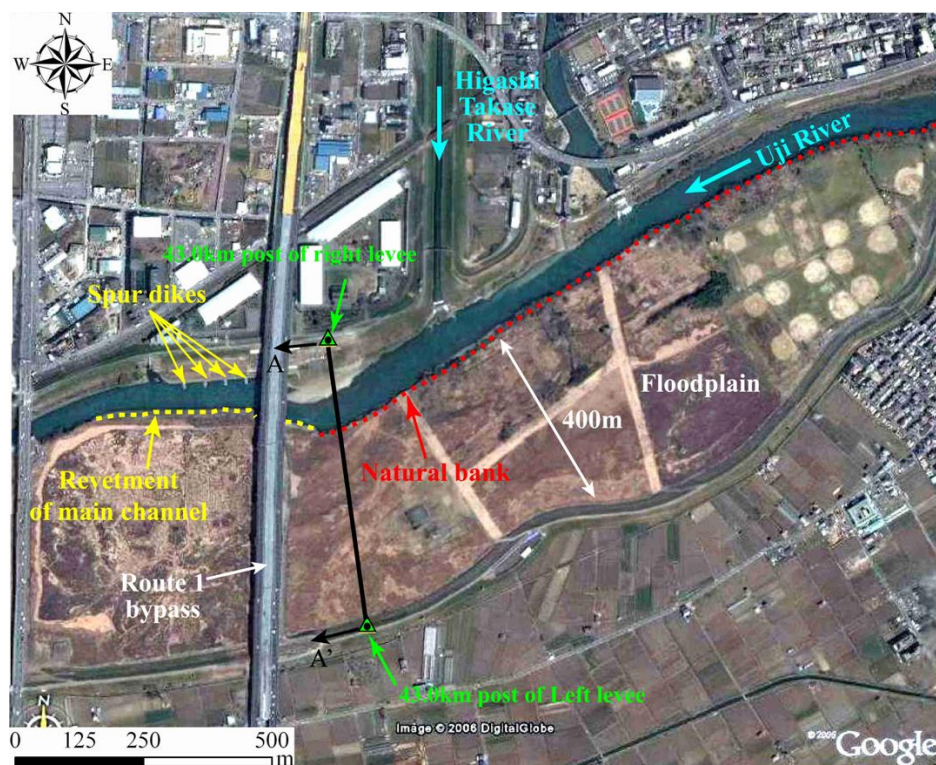
Fig. 2 Satellite image of study area (adapted from Google earth)

A satellite image adapted from Google earth is shown in Fig. 2, with a few geographical features for reference. In the downstream section from 43.0km post, revetment was constructed at the left bank of main channel in order to protect the bridge pier at the time of construction of the Route 1 bypass because Uji River has a gentle bend at this site. Spur dykes on the right bank was installed at the same time as above construction. Note that a natural river bank extends from immediately upstream the 43.0km post. A view of the natural river bank slightly upstream of 43.0km post is presented in Photo 1. In order to protect the bridge pier of the Route No. 1 bypass road, the revetment works were performed from 43.0km to the downstream section (Photo 1 (A)). The bank without revetment works was eroded and the outcrop was formed (Photo 1 (B)). Note that erosion has

indicated in Figs. 1 and 2. Note that the study area is a part of low-lying area that develops upstream of the confluence point of the three major rivers (Katsura, Uji and Kizu Rivers). The Ogura pond shown in Fig. 1 located to the south of this study area was reclaimed in 1941.

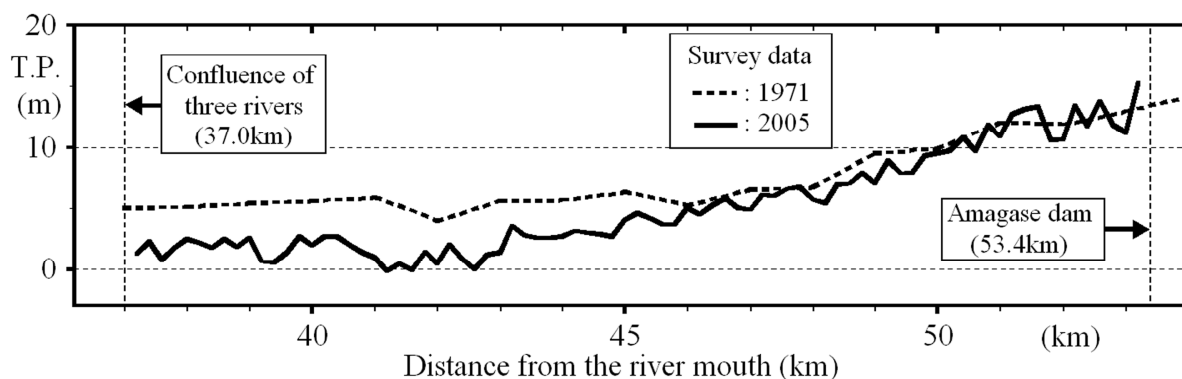
Fig. 3 Longitudinal profile of the deepest channel bottom in Uji River (adapted from survey results of Yodogawa River office, MLIT)

Fig. 3 shows the longitudinal profile of deepest point in the channel bottom of Uji River in which survey data in 1971 and 2005 were adapted from Yodogawa River office, MLIT. What has to be noticed is that degradation of channel bottom is significant in the section from 46.0km to 41.0km. The study area falls into this hot section regarding erosion.

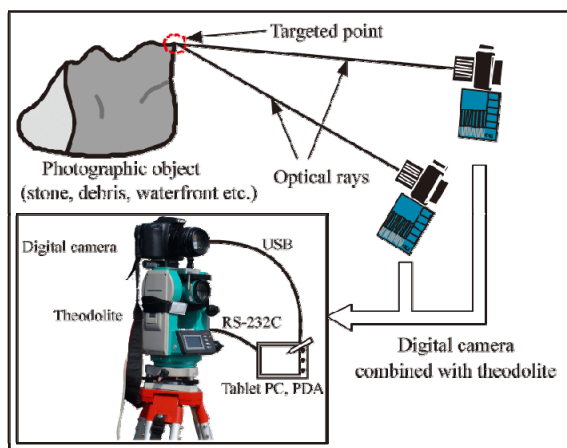
Fig. 4 Illustration of the digital photo-theodolite system used, together with principle of determination of a targeted material point of three-dimensional coordinates

The digital photo-theodolite consisted of a digital camera that was mounted on a theodolite (Fig. 4). The

digital camera used (Canon EOS 20D) had 8.2 million pixels ( $3504 \times 2336$ ), allowing a high spatial resolution. The theodolite facilitated the measurement of two angles of orientation on vertical and horizontal planes at every photographing position. The three-dimensional coordinates of a targeted object may be determined based on the method of spatial intersection (Ono and Hattori, 2002; Ono *et al.*, 2004). In essence, a pair of two photographs of the targeted point from two different positions permits its three-dimensional coordinates to be determined (Fig. 4).

In the case of analyzing process, a key for the identification of survey points was to seek objects with sharp corners (Fig.4). For this purpose, the boundary line of sedimentary facies, pebbles, debris and waterfront became a good target. Identified points in Survey 1 are summarized in Table 1 and a total of 5307 points were able to be identified. It follows from what has been discussed thus far that high-resolution and high-accuracy topographical data can be measured by digital-photo theodolite survey, compared with the normal survey.

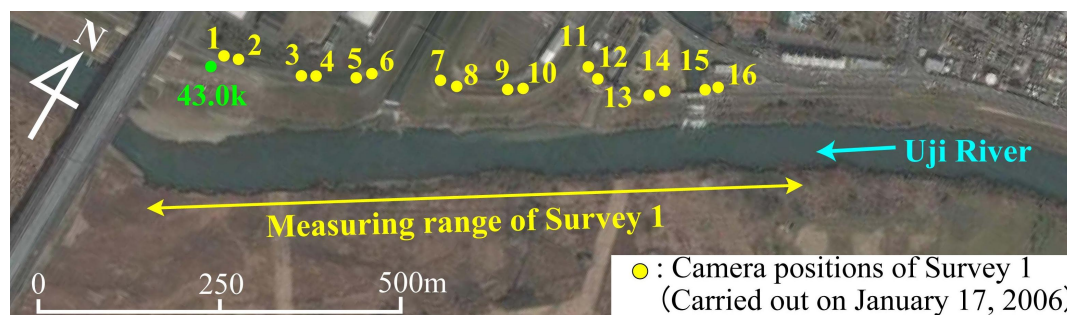
Fig.5 Camera positions and measurement range of Survey 1 performed on January 17, 2006

First topographical measurement of river bank using the digital photo-theodolite survey was carried out over a section approximately 1000m long on January 17, 2006 (Fig.5). This is hereinafter referred to as Survey 1. In Survey 1, we selected 8 pairs (16 positions) of

photographing on the crown of the right-hand levee. The interval between cameras was set at 20m and the interval of pairs of camera was set at 100m. In the distance to the river bank on which the camera focused, resolution was evaluated from the image corresponded to approximately 1cm per 1 pixel. When the calibration was performed in the analysis process, there was no error larger than 1 pixel. Thus it can be concluded that the measurement accuracy of survey 1 is of the order of millimeter.

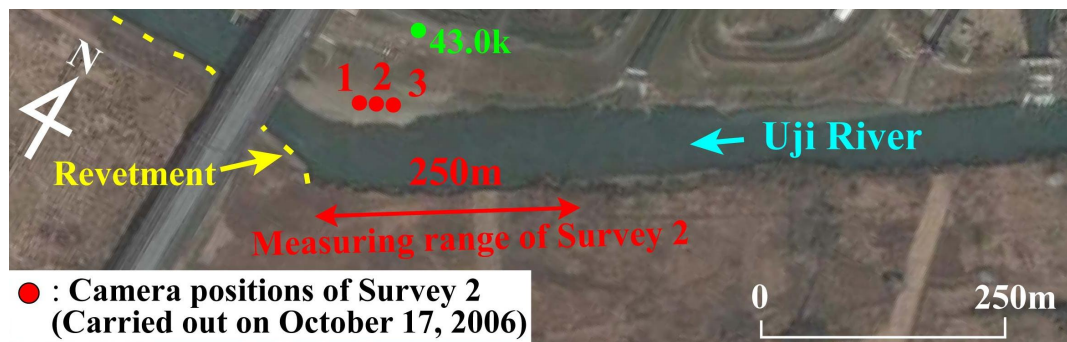
Fig.6 Camera positions and measurement range of Survey 2 performed on October 17, 2006

The second topographical measurement (hereinafter referred to as Survey 2) was carried out on October 17, 2006. Survey 2 focused on the 250m-long section of the left bank where erosion was particularly significant. The three camera positions were selected on the gravel bar that extended on the right bank of the main channel (Fig.6).

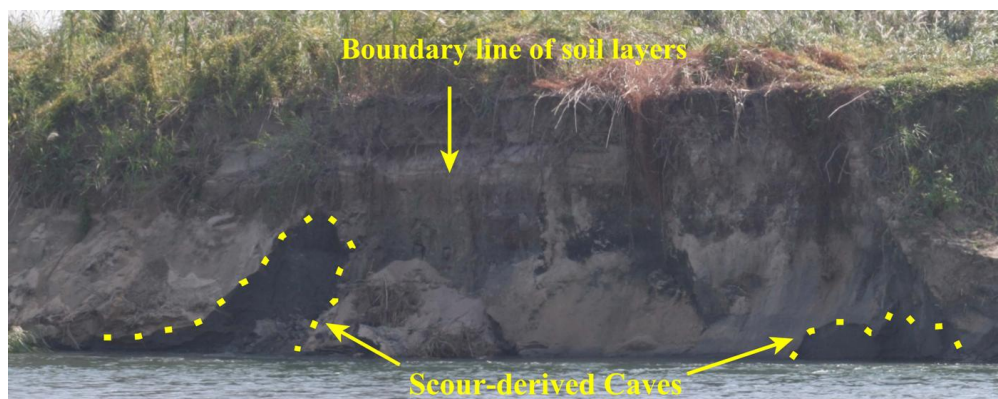
Photo 2 Topographical features of the left bank face as of October 17, 2006

The appearance of the face of the left bank is typified in Photo 2. One can notice caves standing just above the waterfront. They were an evidence of scouring due to stream power, leading to instability of the overlying soil mass. This interesting aspect of erosion will be discussed later in this paper in more detail. It would suffice at this point to mention that such caves were formed in a clayey soil layer and stood over a prolonged period of weeks or so.

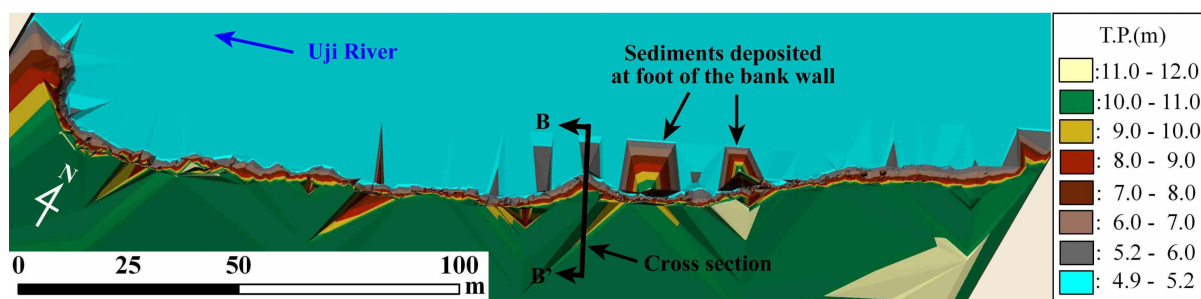
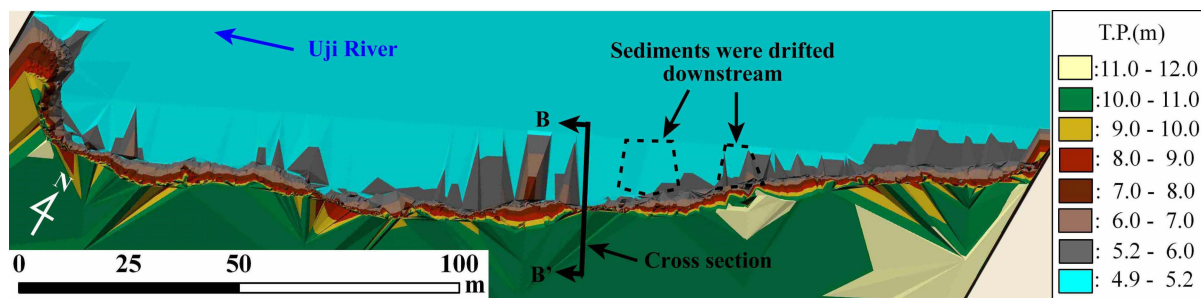
Fig. 7 Contour maps showing the three-dimensional topographical data based on TIN representation

shown in Fig. 7 in terms of contour maps.

Comparison of Figs. 7(A) and (B) presents of bank erosion that occurred in the 9-month period between surveys 1 and 2. For instance, one may note that the sediment taluses at the foot of the river bank were gone by erosion. Also, one may note significant changes that occurred to cross-sectional profiles B-B' (Fig. 8). The retreat of the bank amounted to approximately 6m.

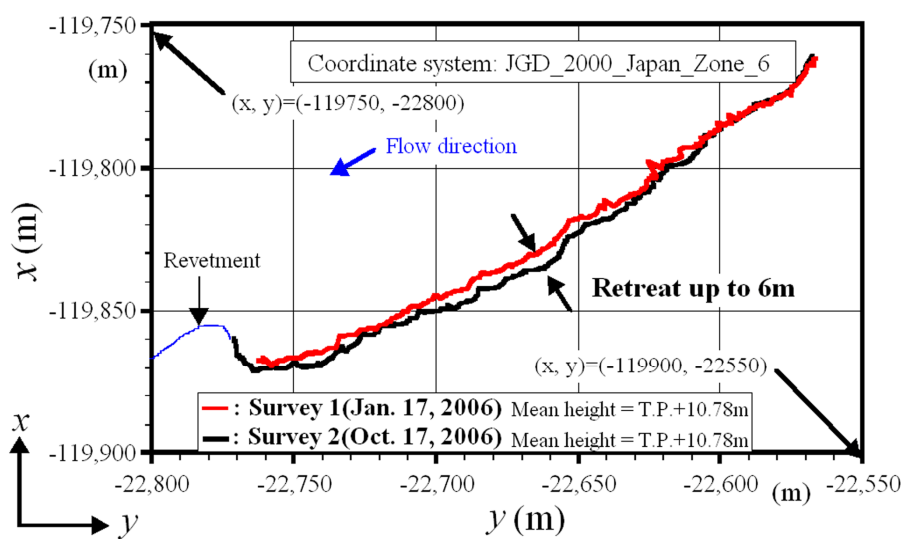
Fig. 9 Lines of bank crown plotted on the  $x$ - $y$  coordinate system indicated

In order to make apparent the recession distance, the edge lines of bank crown in Surveys 1 and 2 are plotted on to a horizontal plane with elevation of T.P. +10.78m as indicated in Fig. 9. Clearly, the bank underwent erosion at the most significant rates in the middle of the surveyed segment.

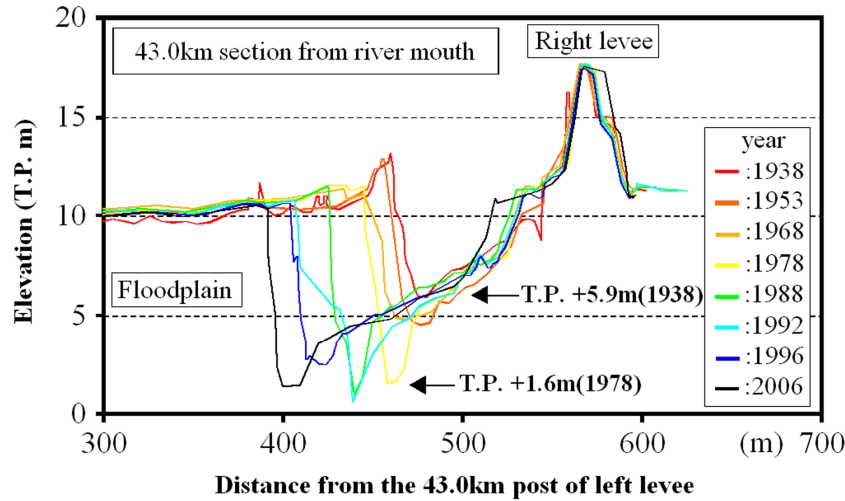
Fig. 10 Evolution of cross-section profiles of channel bottom (43.0km post, adapted from survey results of Yodogawa River office, MLIT)

took up the 43.0km section and compiled the survey results available from 1938 to 2006, as shown in Fig. 10. Those survey results were provided by Yodogawa River Office as paper-based data. In addition, the deepest point of channel bottom is presented in Fig. 11 in order to examine the evolution of channel bottom degradation. It is noted in Fig. 11 that the channel bottom in 1938 was relatively high with an elevation of T.P. +5.9m. Significant river bed degradation took place in the period between the late 1960s and early 1970s. After that the river bed elevation on the 43.0km section stayed at the averaged elevation of T.P. +1.6m. However, this observation does not mean the cease of erosion at the particular river section. Degradation stopped since 1978, instead, the bank retreat to the lateral direction has started and is progressing still now.

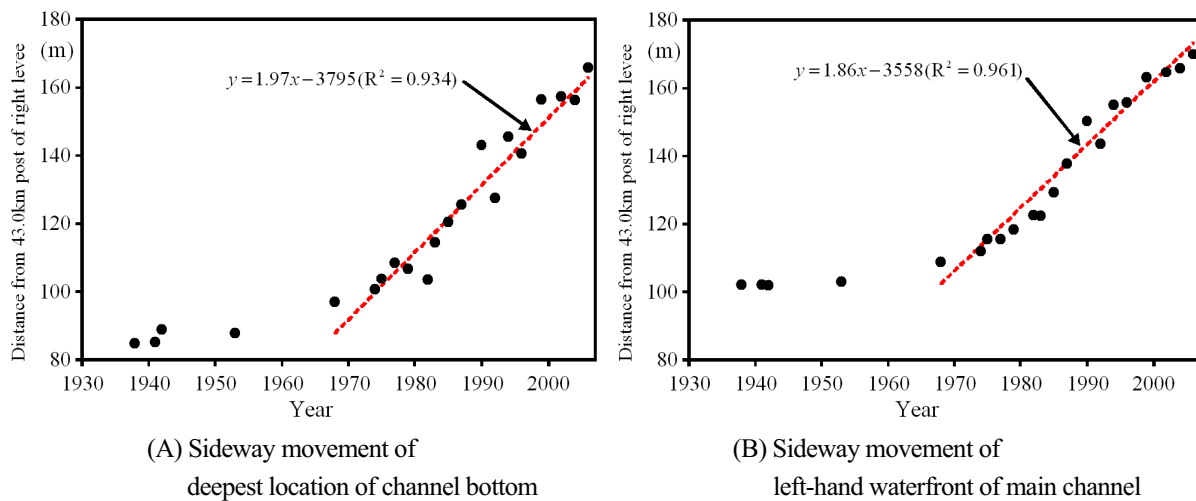
Fig. 12 Time-series data showing evolution of bank erosion

In order to investigate evolution of the river bank retreat, we referred both the deepest location of the channel bottom and left-hand waterfront of the main channel to the 43.0km post on right-hand levee. The results are shown in Figs. 12 (A) and (B). It is evident from these two figures that the bank erosion became significant in the late 1960s and thereafter has progressed at an approximately constant rate, i.e. nearly 2m recession annually.

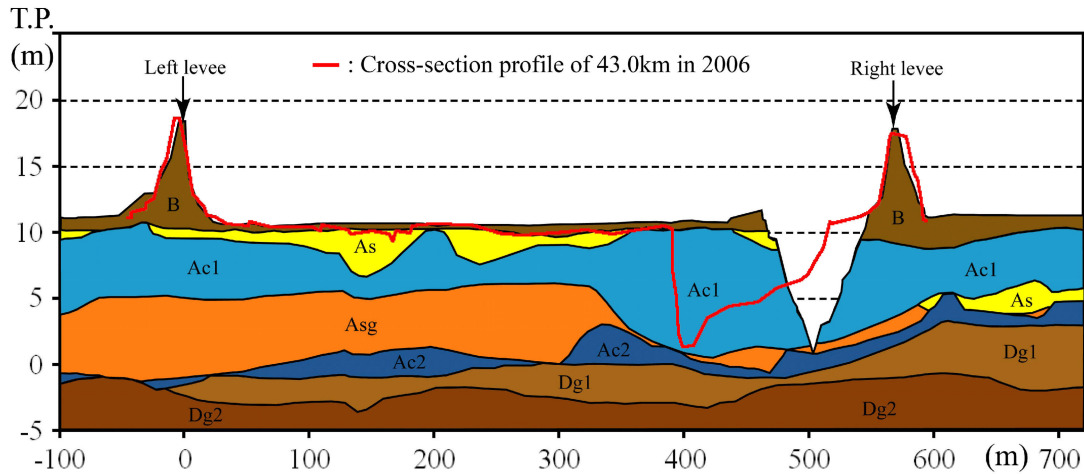
Fig. 13 Cross-section profiles through 43.0km post line is overlain onto a geological profile along Route No.1 bypass (adapted from Kyoto office, MLIT, 1991)

The question now arises as to what factors controlled the erosion progressing laterally while the river bed elevation stayed nearly constant. We consider that a sort of rock control may be an important factor. In order to make this statement more specific, let us look at Fig.13 in which the cross-sectional profile through 43.0km post

in 2006 and the geological profile along Route No.1 bypass (adapted from Kyoto office, MLIT, 1991) are superimposed. From Fig. 13, the following observations can be made, namely; 1) The Uji River incised the clay layer (Ac1). 2) After arriving at the lower end of the clay layer (Ac1), no further degradation occurred. Then, evolution has developed sideways.

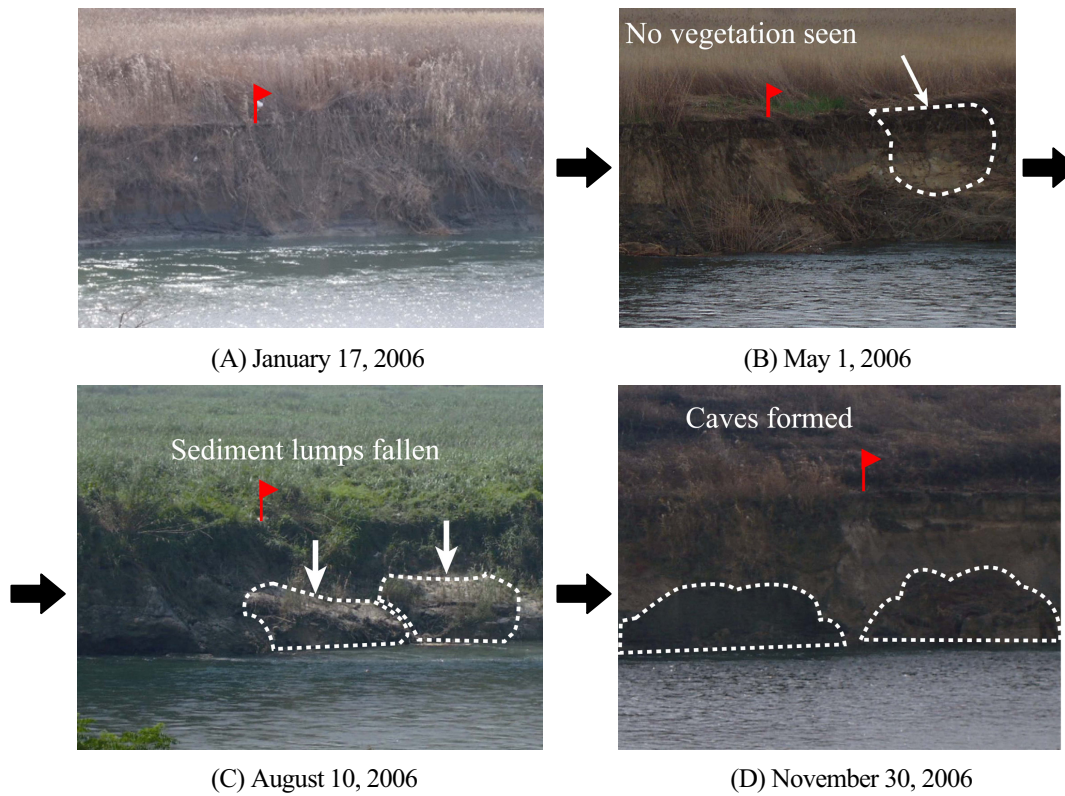
Photo 3 Snapshots showing development of a bank erosion process

A set of snapshots showing temporal development of bank erosion are presented in photo 3. The corresponding time series data of the water level of Uji River observed by the Mukaijima observatory (44.8km + 66.8m) is shown in Fig. 14.

The following observations may be made from Photo 3, with reference to Fig. 14 as well. First, vegetation on the bank face visible in Photo 3(A) was gone in Photo 3(B). It is inferred that the flood lasting for four days from April 11, 2006 was responsible for the erosion of the vegetation. However, it should be noted that no discernible topographical changes took place by the April 2006 flooding event.

Second, sediment lumps were visible in Photo 3(C), at the foot of the bank wall. The photograph was taken 15 days after 18 July flooding, the annual maximum flood.

Third, in Photo 3 (D), the fallen sediment lumps were gone, and caves stood immediately above the waterline. Note herein that such significant bank erosion took place under relatively mild stream conditions that lasted for a

The bank erosion process based on our field observations may be summarized as follows: 1) A granular soil layer is scoured by stream flows, forming caves; 2) The overlying clayey sediment then collapses in blocks; 3) The fallen clay blocks stay for some time as a kind of talus at the foot of the bank wall; 4) Stream flows may drift such natural protections downstream over a period of time. Then process 1) resumes, allowing the river bank to retreat by an amount.
