## Deformation Monitoring and Exploration on Shuping Landslide Induced by Impoundment of the Three Gorges Reservoir, China

The Three Gorges Dam construction on the Yangtze River in China is the largest hydro-electricity project in the world. After the first impoundment in June 2003, many landslides occurred or reactivated. Shuping landslide is one of the most active landslides among them. In this paper, the deformation of the Shuping landslide monitored by GPS, extensometers, and crack measurements are summarized. Also, for the investigation of the groundwater situation, 1m-depth ground temperature measurement was conducted, and the groundwater veins were estimated. Based on the monitoring data and exploration results, a deformation model of the landslide caused by impoundment of reservoir was proposed.

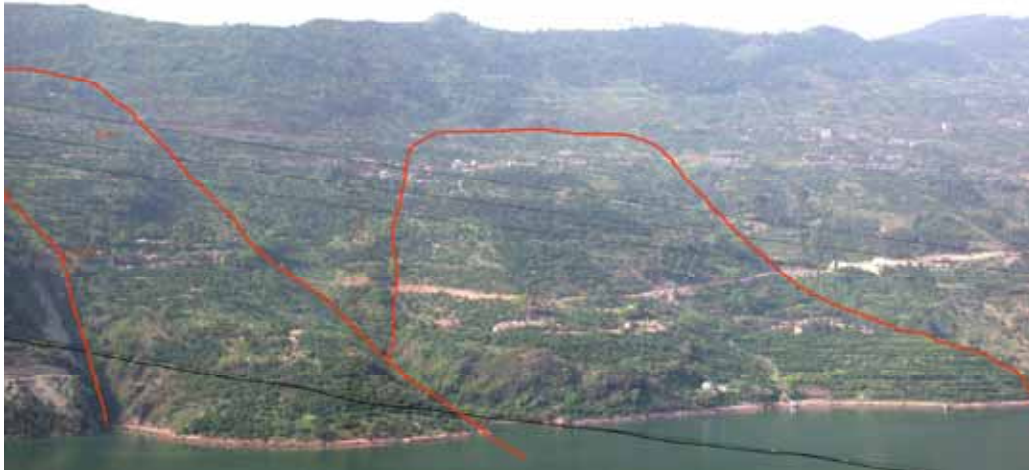
Fig. 2 Shuping landslide consisting of two blocks at the main stream of the Three Gorges Water Reservoir

For these reasons and aiming to study the influence of impoundment on landslide deformation, we selected Shuping landslide, which is located at the main stream of the Yangtze River (Fig. 1) in Shazhenxi Town, just about 3.5 km from the Qianjiangping landslide, as our research and monitoring field. Figure 2 is an oblique photograph of the Shuping landslide, and Figure 3 is the plane of the landslide. The landslide ranged its elevation from 65 m to 500 m. Its width was about 650 m, the estimated thickness of the sliding mass was 40 m to 70 m according to the bore hole data, and the total volume was estimated as  $2.0 \times 10^7 \text{ m}^3$ . The toe part of the landslide was under the water level of the Yangtze River. The slope is gentle at the upper part and steep at the lower part with a slope angle of 22 degrees and 35 degrees respectively..

The Shuping landslide is an old landslide which consists of two blocks. This can be confirmed in the photograph (Fig. 2). After the first impoundment of the Three Gorges water reservoir ended on June 15, 2003, obvious deformation phenomenon appeared at the slope, and it became intense from February 8, 2004. Also, the two blocks shows different deformation rate at slope surface. The serious deformation situation made 580 inhabitants and 163 houses in danger directly, and all of the inhabitants were asked to live in the disaster prevention tents which were provided by the central government. Until May 2004, most inhabitants moved their houses out of the landslide area.

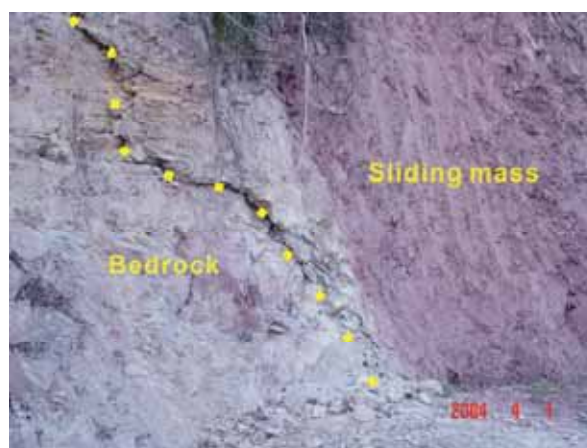
Figure 4 shows a crack at the right boundary of Block-I outcropped at a local road. The right-hand side is the sliding mass consisting of red muddy debris of old landslide, and the left hand side is bedrock of sandy mudstone, muddy siltstone of Badong formation of Triassic period (T3b).

Figure 4 Deformation situation at the right boundary of Block-I outcropped at a roadside

Figure 8 shows the extensometer installed in Shuping landslide. The positions of all of the thirteen extensometers were shown in Figure 3 as “SP1-x”. Among them, SP1-1 and SP1-2 were set across the main scarp; from SP1-3 to SP1-6 were set below the Shahuang road which has a high traffic. SP1-7 and SP1-8 were set almost parallel with SP1-5 and SP1-6. SP1-9 was set at the low part. Then, SP1-10, SP1-11, and SP1-12 were set near the Yangtze River at the toe part of the landslide. SP1-13 was set at the right boundary of Block-1 shown in Figure 4, because the crack extension is obvious.

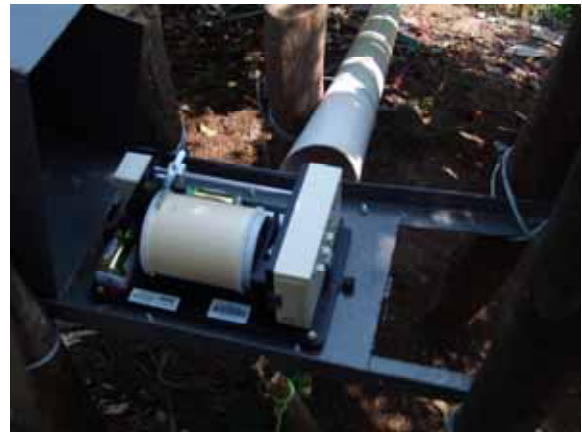
Figure 8 Extensometer installed in Shuping landslide  
The deformation is recorded on the rolled paper (left) and also saved in a memory (right box)
