# Applicability of non-contact inspection using laser ablation-induced vibration in a reinforced concrete tunnel lining

This paper considers the applicability of remote laser sensing to reinforced concrete tunnel linings with suspected corrosion of the reinforced steel. As an alternative to the hammering test, this approach represents a non-contact inspection method that provides quantitative evaluation. Remote laser sensing uses two types of lasers: an impact laser to induce vibrations in the measurement target by laser ablation and a detection laser to measure these induced vibrations. The validity of the method is verified by comparison with the results of a hammering test. It is shown that remote laser sensing can be successfully applied to a reinforced concrete tunnel lining, although the induced vibrations decay faster and the noise level are higher in the field than in the laboratory. Changes in natural frequency are occasionally observed; these are believed to be a results of changes in temperature and nonlinear vibrations. Based on the results of on-site laser measurements, the estimated

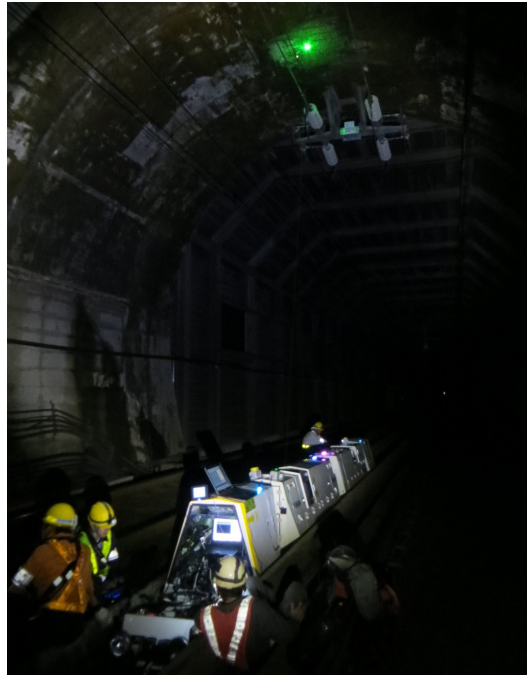
Figure 2: Experimental environment.

A carrier for the laser devices that can move along the central passage of the Shinkansen tunnel was developed, as shown in Fig. 2. The train-type carrier consisted of four cars. The system was powered from batteries installed in every car, so that the carrier was able to travel via the central passage and perform the inspection for several hours. The first and last cars were towing vehicles, and the laser systems were placed in the two middle cars. One car contained the impact laser and the laser Doppler vibrometer (LDV),

while the other car contained the photorefractive interferometer. Each car also had a laser range finder to measure the distance to the tunnel lining surface and focus the laser. On top of each car, there was a window for laser irradiation and a mirror for reflecting the laser to the intended irradiation point. Because the impact laser and the LDV were coaxial, they were not able to determine the irradiation point independently.
