## Geo-disaster Prediction and Geo-hazard Mapping in Urban and Surrounding Areas Progress Report in FY 2004

Masahiro CHIGIRA, Susumu IAI, Roy C. SIDLE, Toshitaka KAMAI,  
Mamoru MIMURA, Hiroshi SUWA, Takashi SAITO,  
and Tetsuo TOBITA

### Synopsis

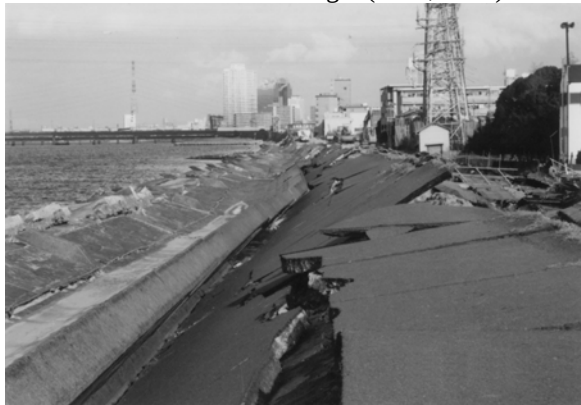
Fig. 1 Typical damage to river embankments (Yodo river embankment during 1995 Hyogoken Nambu earthquake) (after Ozutsumi et al, 2002)

The embankments were located within 40 km from the epicenter. The peak ground acceleration at the site of the embankments was about 0.2g as recorded at a nearby strong motion site (Matsuo et al, 2000). Typical damage to the embankments is shown in Fig. 1. The settlement of this embankment was 2.7 m. The other embankment located nearby settled only 0.3 m. These embankments were made of a core of soil materials covered with a concrete and asphalt as erosion protection and a parapet wall 8.1 m above the sea level.

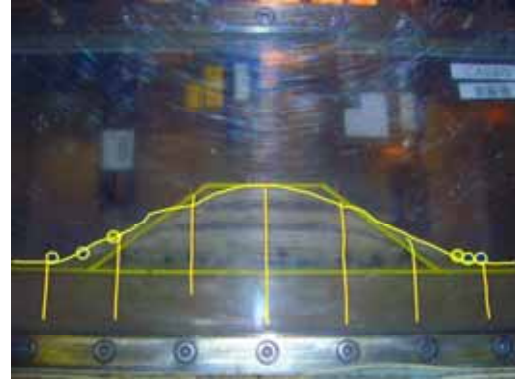
Fig. 5 Measured deformation of embankment on dense foundation ground after shaking (Case6)

The deformation shown in Fig. 5 is for dense foundation ground subject to a peak acceleration of 574 Gal (Case6). Failure mode of embankment in this case is represented by slide of embankment soil along the surface of embankment. Settlement of the crest is induced by this slide type of failure. There was no significant deformation in the dense foundation ground.

The computed deformation shown in Fig. 8 is for dense foundation ground. The agreement with the measured deformation shown in Fig. 5 is apparently not very good, especially the analysis was not successful in simulating the sliding of embankment slopes as shown in Fig. 5. This discrepancy is presumed to be due to the fact that, in the analysis, the nodes at both ends of the slopes share the same displacements as those of the foundation ground, whereas, in model tests, the soil of the embankment is free to slide over the foundation ground. If much finer meshes or other improvements in the analysis are adopted, the agreement would be improved. Within the scope of the present study, the results of analyses and model tests agreed in that deformation of embankment is confined within the embankment itself, without significant deformation in the dense foundation ground.
