# Studies of the Third Miyakojima Typhoon

-Its Characteristics and the Damage to Structures-

By Hatsuo ISHIZAKI, Ryozauro YAMAMOTO, Yasushi MITSUTA,  
Tatsuo MUROTA and Toshihiko MAITANI

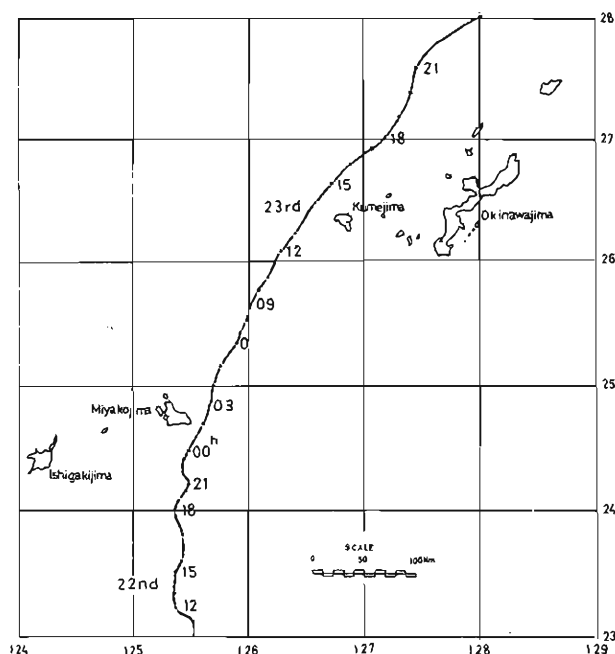
Fig. 2 The detailed track of the Third Miyakojima Typhoon near the Ryukyu Islands.

in this figure, a part of Miyakojima Isl. was within the typhoon eye around 0200JST. Kumejima Isl. was also in the typhoon eye for one or two hours in the afternoon of 23rd.

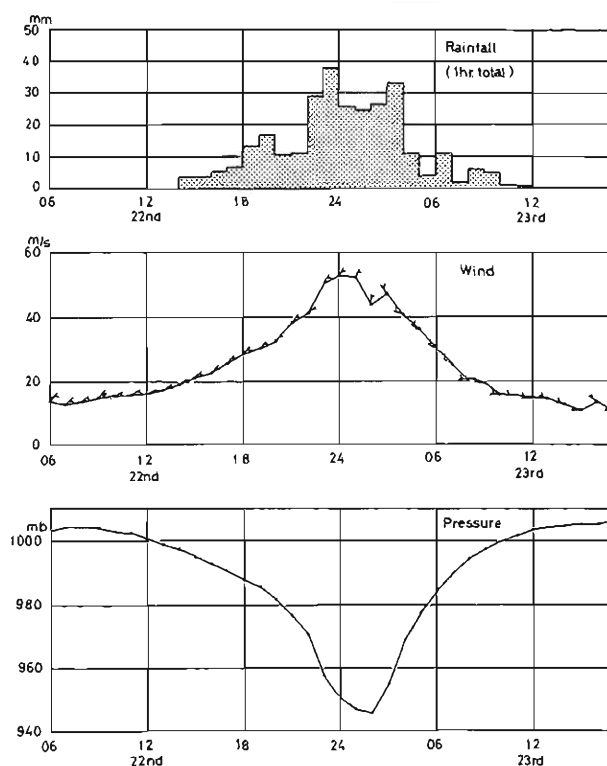
Fig. 3 Hourly changes of rainfall, wind and surface pressure at the Miyako Weather Station during the passage of the typhoon.

Fig. 3 shows the time changes of hourly rainfall, wind speed and atmospheric pressure at the Miyako Weather Station on 22nd and 23rd. The barogram and the anemogram are reproduced in Appendix A. Wind speed exceeded 20m/sec at 1400JST of 22nd, when the typhoon was located at a distance of about 150km to

the south of Miyakojima Isl. From 2000JST of that day, when the front part of the maximum wind zone passed the island, the rainfall became so severe that an intensity of 32mm/hr was recorded during the period from 2300 to 2400JST. The maximum wind speed of 54.3m/sec (NE) was observed at 0006JST of 23rd. The typhoon center was at its nearest position from the weather station during the period from 0100 to 0200JST, meanwhile the minimum atmospheric pressure of 942.5 mb was observed at 0138JST of 23rd. During this period wind and rainfall were relatively weak. The second peak of wind and rainfall were seen for 2 hours from 0200JST, when the rear part of the maximum wind zone passed over.

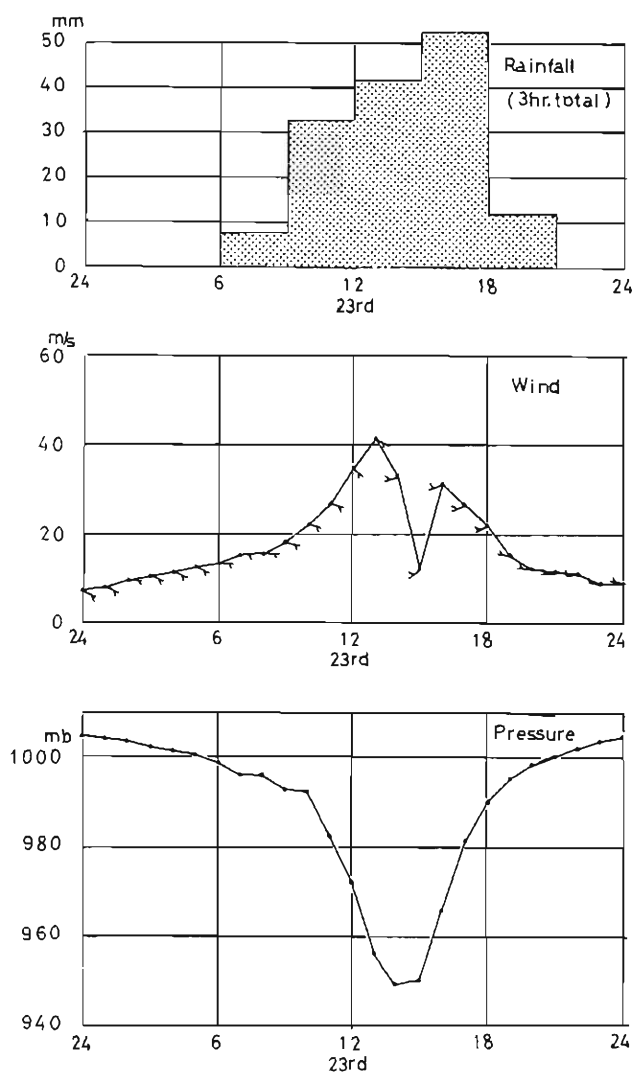
Fig. 5 Hourly changes of rainfall, wind and surface pressure at the Kumejima Weather Station.

Fig. 5 shows the time change of three-hourly rainfalls, wind speed and atmospheric pressure at the Kumejima Weather Station on 23rd. Here, a maximum wind speed of 43.7m/sec (SE) and a maximum peak gust of 62.4m/sec (SE) were observed about 1300JST of 23rd. The typhoon was nearest to the Kumejima Weather Station when it was about 40km to the northwest at 1400 to 1500 JST, and a minimum atmospheric pressure of 947.9 mb was observed at 1435JST of 23rd. Around this time the whole island was within the eye of the typhoon and eye phenomena were seen all over the island, as seen in the results of the field expedition shown in Fig. 6 and Appendix B. The central pressure of the typhoon was not so filled

as at the time of passage near Miyakojima Isl., but the wind over Kumejima Isl. was not so strong as over Miyakojima Isl. This might be caused by the difference in the ground topography of the two islands, i.e. the former is mountainous and the latter is flat all over the island. However, there exists another possible explanation of this maximum wind speed difference, which is that the difference was caused by the variation in the diameter of the eye, i.e. the diameter became larger near Kumejima Isl. as shown in the next paragraph. If the total circulation is conserved in the eye, the maximum wind speed at the edge of the eye is inversely proportional to the diameter.

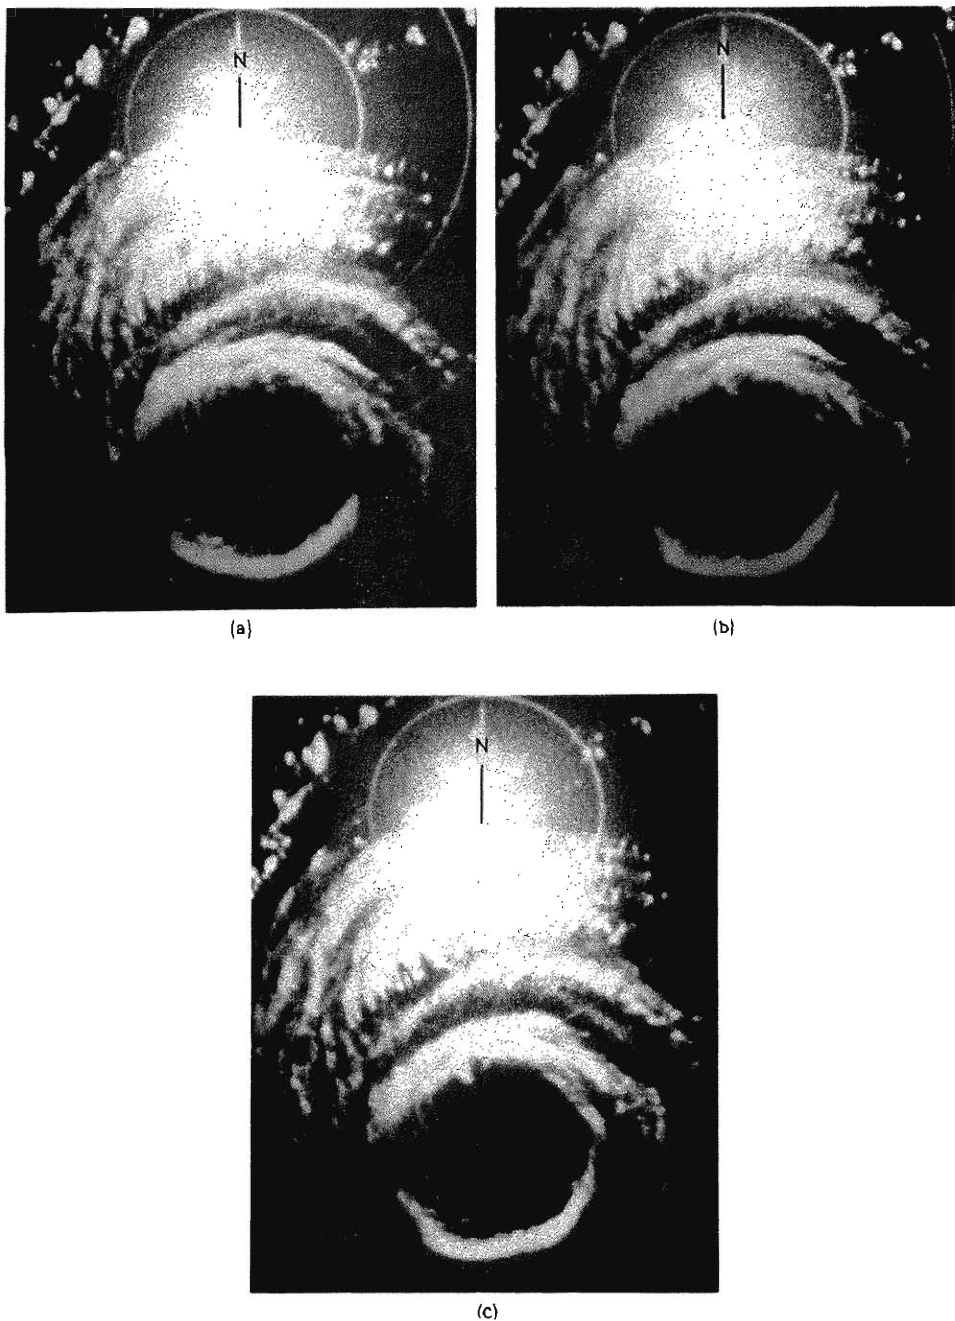
Photo. 1 The feature of typhoon eye seen on the radar scope of the Miyako Weather Station around 1400JST of 22nd. Every 2-minute change from (a) to (c).

Photo. 1 shows the features of the typhoon eye at 1400JST of 22nd, when the center of typhoon was at a distance of 150km to the south of Miyakojima Isl. It can be seen that some line echoes extend from the eye wall inwards. These line echoes have a certain angle to the eye wall, and move in an anticlockwise direction. These line structures of the eye wall can well be seen in the next photograph (Photo. 2). The southwestern part of the eye consists of lump echoes on lines whose ends extend inside from the eye wall into the eye as shown in Photo 1.

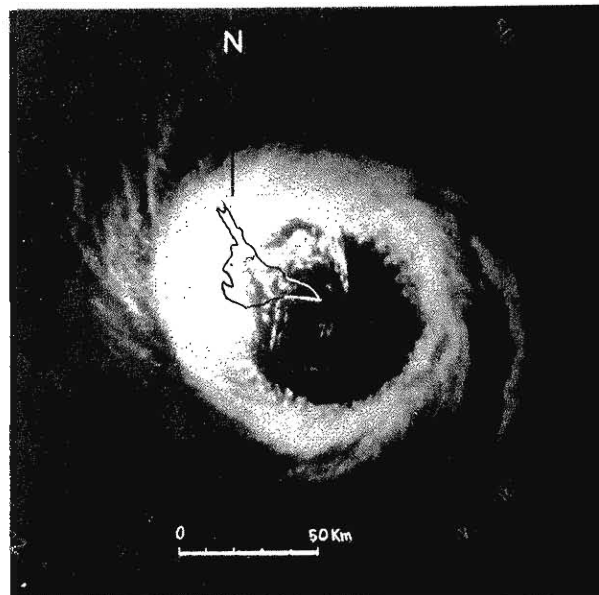
Photo. 3 The feature of typhoon eye around 0100JST of 23rd.

Photo. 3 is the radar picture at 0100JST on 23rd, when the typhoon was at its nearest point to Miyakojima Isl. The existence of distinct cloud echoes within the eye is supported by the fact that rainfall was reported within the eye as shown in Appendix A and B. A remarkable radar echo like swirl can be found within the eye. These characteristics of the typhoon eye will be discussed in

Radar observation shows that the eastern part of Miyakojima Isl. entered the typhoon eye (Photo. 3). This can well explain the meteorological situation obtained by field expedition within Miyakojima Isl. (Fig. 4). The detailed results of the field expedition are shown in Appendix B. As is clear from these data the western edge of the typhoon eye has passed the western part of the island, where no significance of eye phenomena was observed.

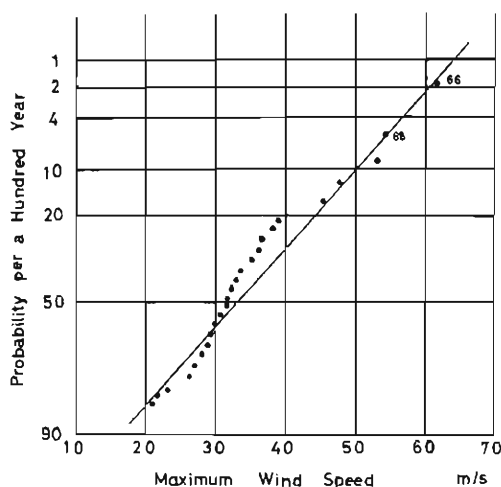
Fig. 7 Occurrence probability of annual maximum wind speed at Miyakojima Isl.

The number of typhoons, which came within a range of 300km from Miyakojima Isl., amounted to 132 in the period from 1938 to 1964, which means 4.8 typhoons per year on the average. The occurrence probability of annual maximum wind speed at Miyakojima Isl. is estimated from the wind records during the past 30 years. The result is shown in Fig 7.

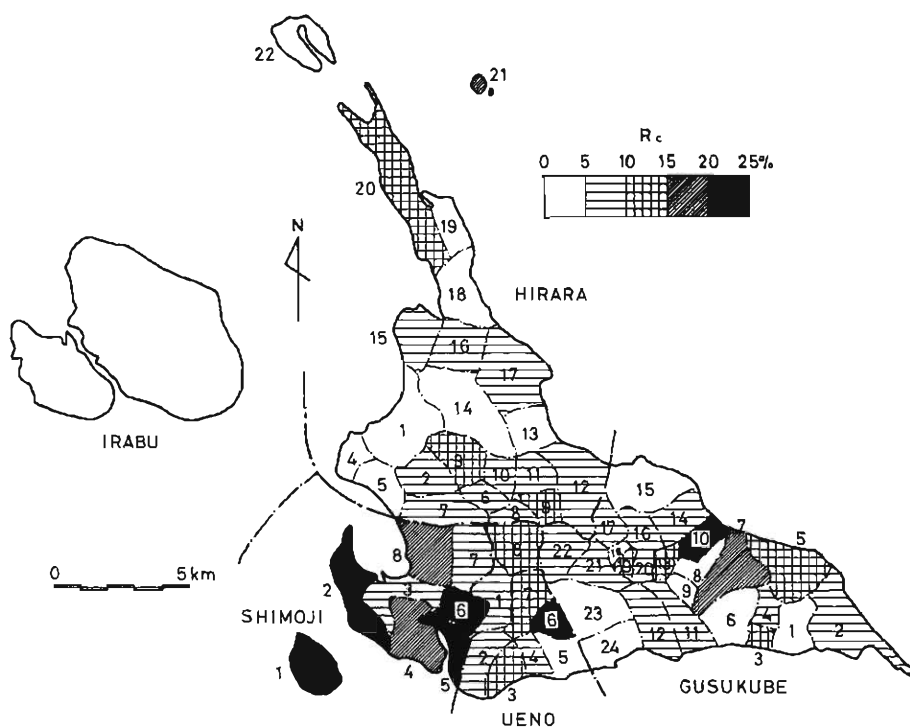
Fig. 9 The distribution of completely destroyed houses in Miyakojima Isl.

Fig. 9 illustrates the distribution of completely destroyed houses in Miyakojima Isl. It will be seen from this figure that the distribution pattern is complicated. The characteristic features of damage in this island can be summarized as follows in comparison with the case of the Second Miyakojima Typhoon.

Shimoji-cho : This is the region of the severest damage in Miyakojima Isl. The direction of the severest wind in this region was NNW. This wind comes

from the sea and the flat feature of this county weakens the intensity of the wind very slightly because of small ground roughness.

In the case of the Second Miyakojima Typhoon, damage in this county was not so severe as in others. This is because the severe wind came from the east and the east wind has a long overground fetch.

Ueno-mura : This region suffered severe damage by both the Second and Third Miyakojima Typhoons. The severest winds caused by these two typhoons were from E or S and NNW, respectively. But this county is generally flat and located at the highest spot of Miyakojima Isl., which causes severe wind in all directions.

Gusukube-cho : This is a rugged county having many ups and downs of 20 m or so. These ups and downs appear to affect the wind speed distribution delicately and correspondingly the damage done by the Second and Third Miyakojima Typhoon.

Hirara city : Various types of topography are contained in this region, and the extent of damage seems to be affected correspondingly by these different types. The southern part of this region near Ueno-mura is a part of the highest area of Miyakojima Isl. and the damage is as severe as in Ueno-mura. In the north peninsula the damage is also severe, which is considered to be caused from its good seaward exposure and the modifying effect of the topography as shown in the next section. The city area of Hirara is closely settled but the damage was very minor compared to that in other regions, for which the detailed descriptions will be given in the next section.

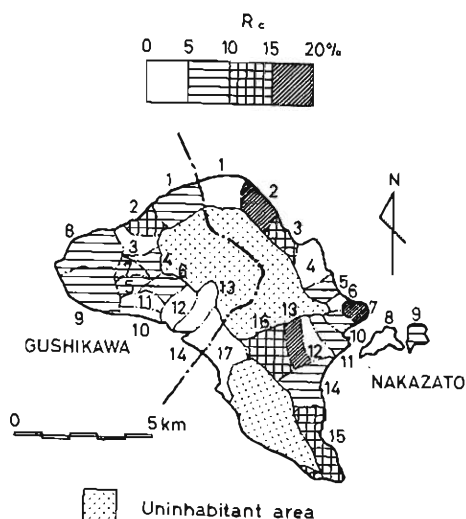
Fig. 10 The distribution of completely destroyed houses in Kumejima Isl.

Fig. 10 is a similar damage distribution map of Kumejima Isl., in which the

ties. The severest wind in these counties came from the direction parallel to the coast and it is considered that the mountains near the coast increased the wind speed over the region. The counties in the western area of Nakazato also appear to suffer the damage in a similar situation.

Magari (13) and Yamashiro (16) are located in or near the mountain gap between the northern and the southern mountains. These counties were seriously damaged by the force of the wind which blew through this mountain gap from east to west.

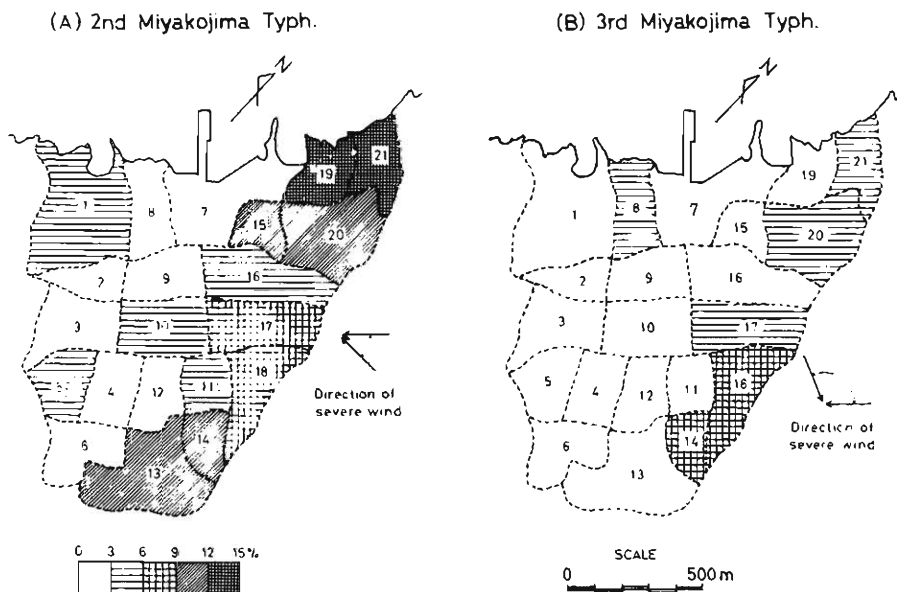
Fig. 11 Distribution of completely destroyed houses in Hirara City. Severe wind directions in the figure correspond to winds more than 40m/s.

Fig. 11 shows the distribution of completely damaged houses in Hirara City. The directions of the severest wind observed at the Miyako Weather Station, which is in the suburbs of Hirara City, were E and NE for the Second and Third Miyakojima Typhoon, respectively. Examining the relations between the wind direction and damage distribution, it will be found that the damage is less

severe in the central and leeward parts of the city and more serious in the windward parts of the city area. This is because the extent of wind speed decrement is smaller over the windward outskirts than the leeward.

This example of Hirara City is considered to be a typical damage pattern in highly populated cities, and shows that the damage in large cities can be decreased down to the extent of that in the central part of Hirara City by changing the environmental conditions in the outskirts. Appropriate arrangements of trees appeared to be satisfactory for this purpose in Maja or Janado, Kumejima, where the damage rate (5% or so) was smaller than in nearby areas. But it will take a long time until the trees grow into effective wind-shelter belts, so the half-way method must be adopted for the time being to make artificial wind shades or wind breaks.

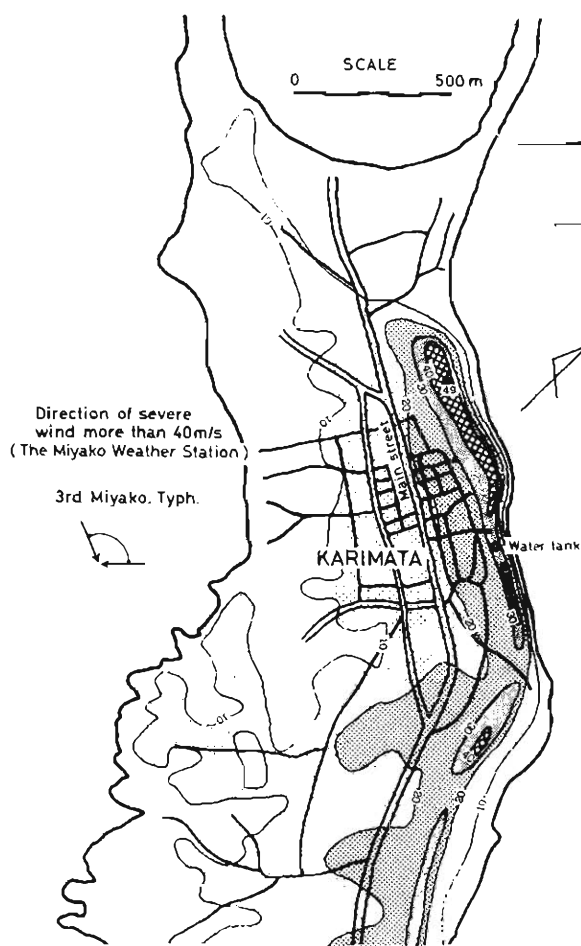
Fig. 12 Topography of Karimata.

Fig. 12 shows the topography of Karimata, which is located at the tip of the north peninsula of Miyakojima. An east-west section of this area is also shown

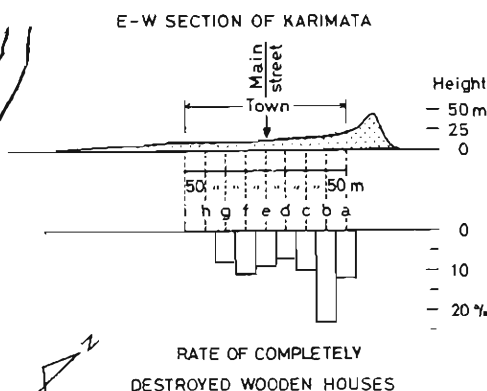
Fig. 13 East-west section of Karimata and the rate of completely destroyed wooden houses. Rates in the figure are calculated as follows: (1) towns are divided into 9 strips (a-i) of 50m wide parallel to the main street as shown in Fig. 14, (2) completely destroyed houses in a strip are divided by the total number of wooden houses in the strip, because the completely destroyed houses were all wooden and reinforced concrete houses suffered fairly slight damage.

in Fig. 13. There is a sharp narrow range of about 50m high running from north to south at the eastern end of the county. In the case of the Third Miyako-jima Typhoon the most serious

Fig. 14 shows the locations of completely destroyed wooden houses in Karimata. From reports, received from local residents, wind was severer in the east part of the main street. This seems to be supported by the distribution of completely destroyed houses as seen in Fig. 13. This will be explained by the fact that the wind speed was increased at the east end of the main street by the effect of the range where stream lines concentrated to the sideway of the range. The damage rates are shown in Fig. 13 in relation to the terrain section.

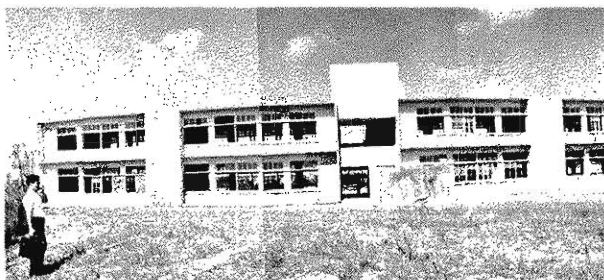
Photo. 4 Damage to a wooden school building :  
removal of wooden sashes from windows.

Photo. 4 shows the damage to a wooden school building. Wooden window sashes were completely removed from the windward side of the reinforced concrete wall. This is because of the weak connection between the sashes and the

walls. Similar damage was often seen to have occurred to reinforced masonry houses as shown in Photo. 5. This damage can be prevented by careful construction work.

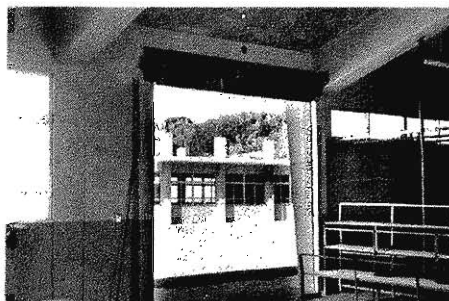
Photo. 6 Damage to light-gauge steel shutter : complete removal of shutter from the opening.

Photo. 6 shows the damage to an opening of a school building. This damage was inspected in detail by the Construction Section of the Government of the Ryukyus.

According to the inspection, the causes of damage were found to be as follows:—

- i) Lack of adequate connection between walls or beams and shutters
- ii) Deficiency in the strength of several parts of the shutter against wind.

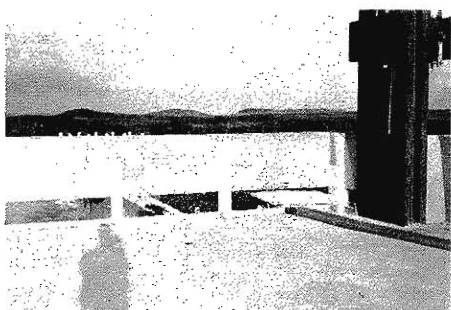
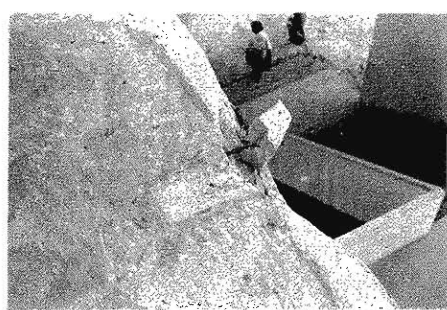
Photo. 7 The same parapet of reinforced concrete as shown here (a) was blown off to the ground because of weak anchorage to the roof (b).

Photo. 7 is a parapet of a new building completed five days before the occurrence of the Third Miyakojima Typhoon. A part of the parapet was blown

off from the roof to the ground because of the weak anchorage of the parapet to the roof.

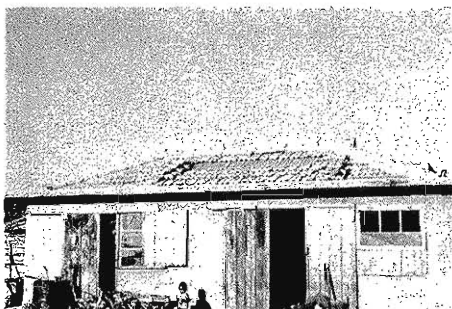
Photo. 8 Damage to a cement-tile roofing : tiles were removed extensively from the roof (damaged part are repaired by sheet-zincs).

The features of the roof damage to wooden houses appeared to differ seriously according to the type of roofings. In the case of clay-tile roofings which generally have bed boards, the removal of roof tiles from eaves, ridges verges or corners is observed, but it is not so crucial for the total collapse of the houses. On the other hand, in the case of cement-tile roofings without bed boards the damage is extensive over the roof and often it leads the houses to total collapse (Photo. 8).

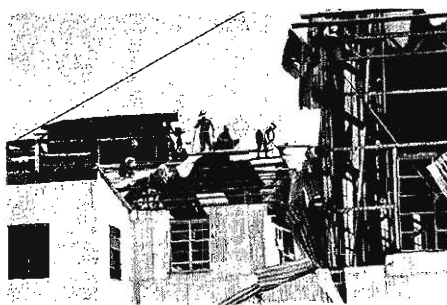
Photo. 9 Damage to sugar factories : removal of sheet-zincs.

Damage to steel structures occurred to sugar factories and a paraboloid reflector antenna for radio communication in Miyakojima Isl. In sugar factories, sheet zinc was removed from walls and roofs (Photo. 9) and the latter antenna was transformed in the plane of the reflector to the leeward by the

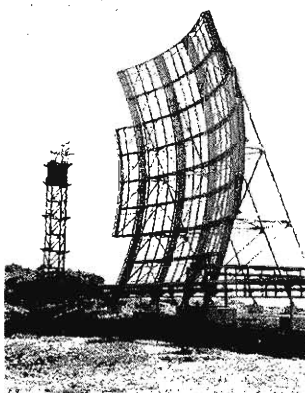
Photo. 10

A paraboloid reflector antenna (16m×16m) transformed slightly in the plane of the reflector.

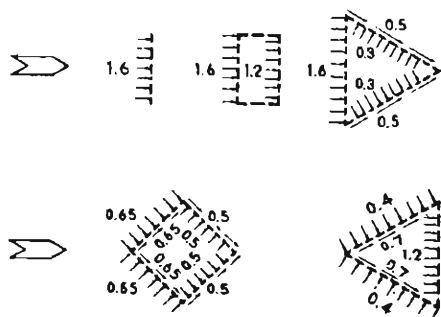
These figures show the cross-section of the lattice beam or column. The exposed area subjected to the wind pressure shall be the total area of the lattices projected to the plane perpendicular to the latticed plane.

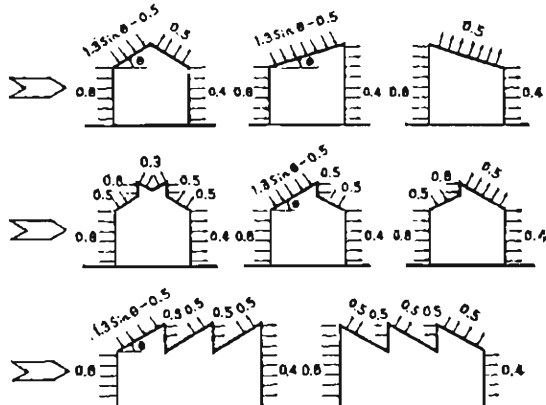
The wind pressure segments of curved roofs shall be divided into four equals.
