# 地上設置型合成開口レーダー(GBSAR) を用いた観測事例と今後の課題

平成27年度 京都大学防災研究所 一般研究集会(課題番号:27K-08)  
新世代SARがもたらす災害・環境モニタリングの進展

日本工営株式会社  
倉岡 千郎 中島裕一

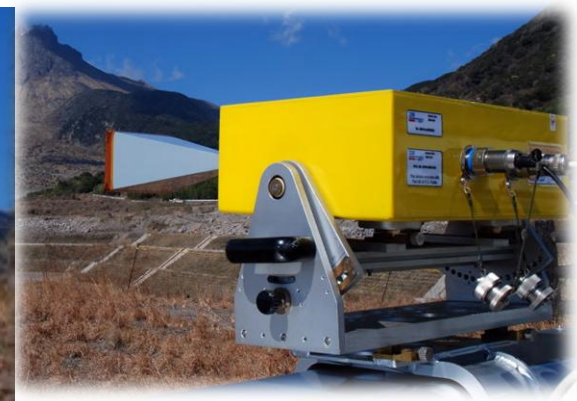
2mのレール上をアンテナが移動→合成開口

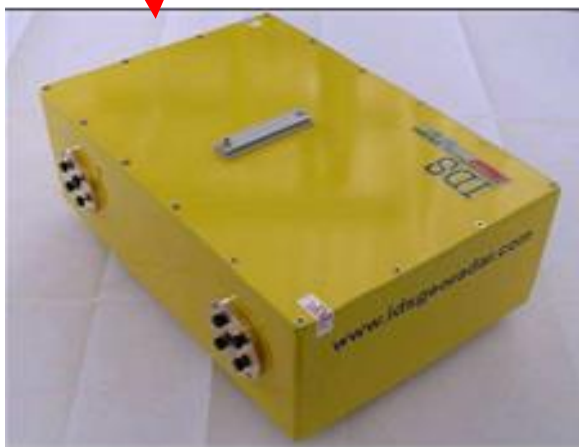
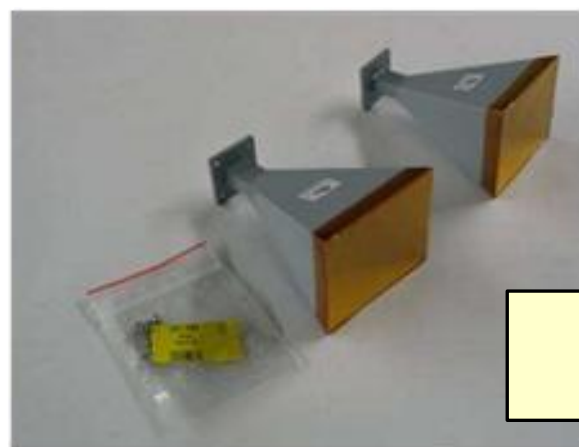
ホーン型  
アンテナ

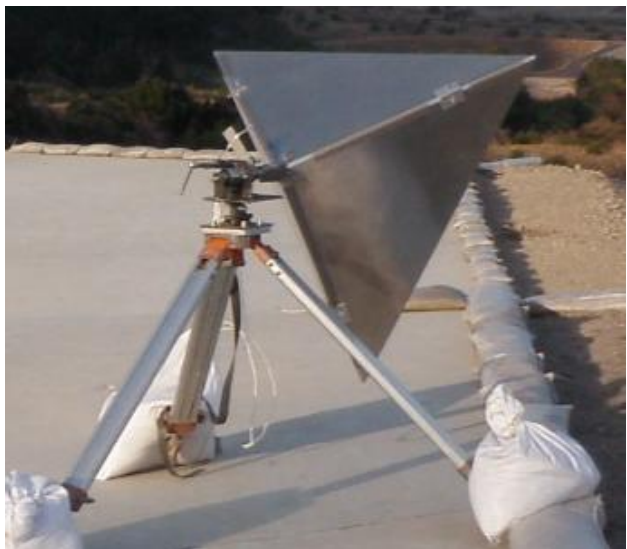
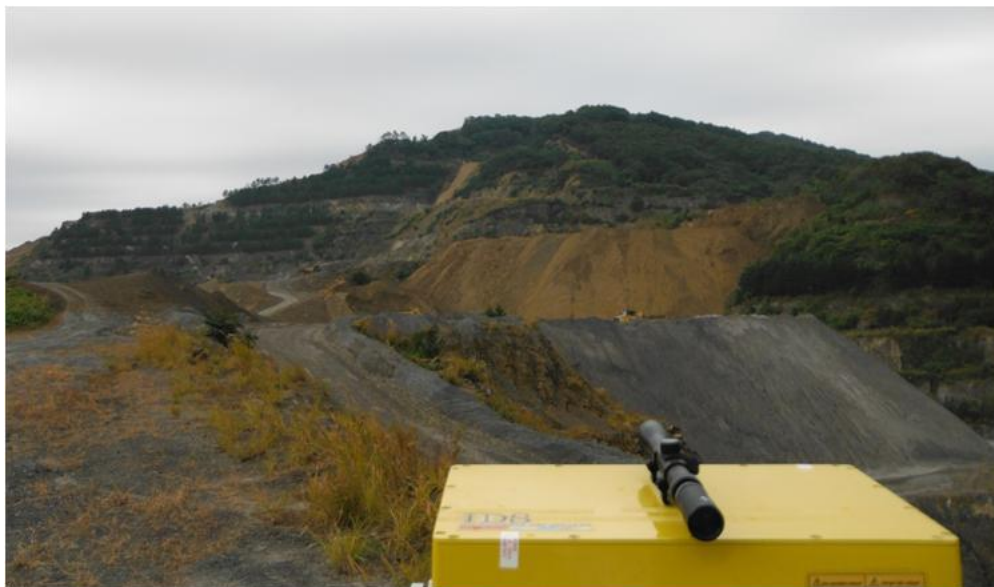
反射板(CR: Corner reflector)

辺の大きさの異なる3つのCRを用いた: 70 cm、45 cm、30 cm
