DISASTER PREVENTION RESEARCH INSTITUTE  
BULLETIN No. 24

ON THE CHARACTER OF SEEPAGE WATER  
AND THEIR EFFECT ON THE STABILITY  
OF EARTH EMBANKMENTS

KŌICHI AKAI

KYOTO UNIVERSITY, KYOTO, JAPAN

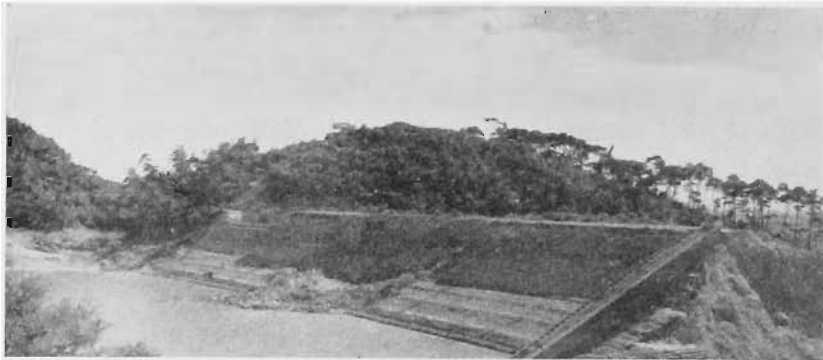
Photo. 5 Failed Aiai-ike Dam (left: spillway, right: drain holes with sluice gates).

maximum amount of water storage was about 350,000 m<sup>3</sup>, and the maximum discharge flowing out from the spillway, whose length was 20 m and overflowing depth was 0.7 m, was designed as 20.8 m<sup>3</sup>/sec so as to drain the rainfall of 58 mm in an hour. The free-board under the crest of earth dam to that of spillway was about 2 m, and three drain holes were set with sluice gates along the upstream slope near the center of dam length for irrigation (Photo. 5).

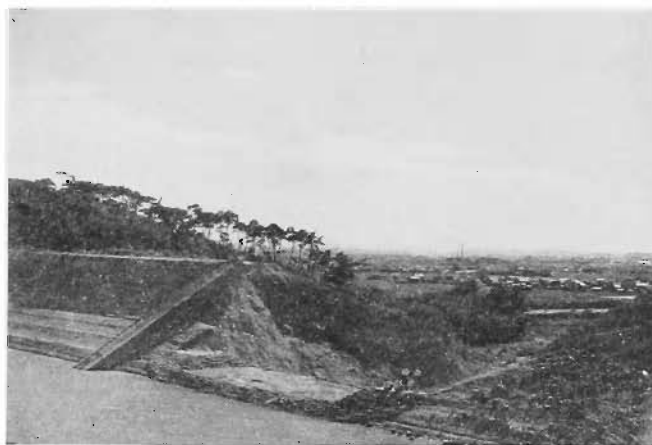
Photo. 6 Primary failure of downstream slope due to full reservoir.

In the early morning of July 18, 1957, the amount of rainfall reached about 50 mm for a few hour at the dam site. Three sluice gates along the upstream slope, however, were not opened considering the capacity of the spillway. As the result the water level at the upstream slope was raised, until water flowed out over the crest of spillway, showing the depth of 15~20 cm, which was the first chance since the beginning of dam operation. But soon after the full reservoir, the upper portion of the downstream slope was washed back over the length of 48 m near the dam center, which caused a complete failure of the dam (Photo. 6).

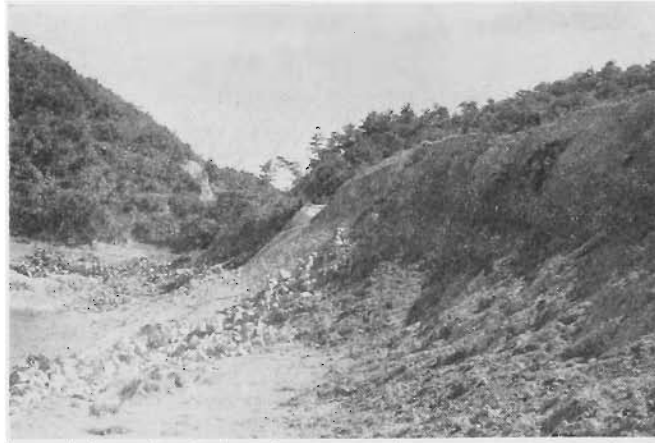
Photo. 7 Secondary failure of upstream slope due to rapid-drawdown.

As soon as the decrease of the storage level accompanied with the failure initially occurred, the upstream slope sloughed away into the pond, leaving the width of crest of 2 m wide, over the length of 37 m in the left side of dam length (Photo. 7.). In this article the author mainly treats the analysis of this latter failure caused by the rapid-drawdown of the reservoir, though more brief discussion will be given additionally to the former due to the full
