## Performance of Levee System at Flood Stage

### Synopsis

## 2. The October 2004 flood disaster in Maruyama River basin

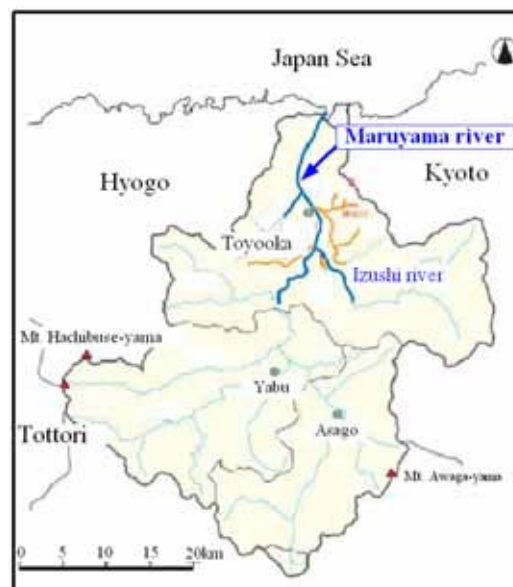
Fig. 1 A map showing the Maruyama River course

The Maruyama River runs through a northern part of Hyogo Prefecture via the low-lying Toyooka Basin and drains into Japan Sea (Fig. 1). Typhoon 0423 made landfall in Osaka at 18:00 on 20 October 2004. It brought about precipitation as much as 278mm in the Toyooka area over a two-day period (20-21 October 2004). The associated hydrograph obtained at the Tachino Observatory (Toyooka Office, 2005a) is shown in Fig. 2. It is seen that the water level started rising from around 14:00 on October 20 and rapidly increased thereafter, exceeding the design high-water level (T.P. +8.16m) at around 21:00. Eventually, the maximum water level rose as high as T.P. +8.29m.

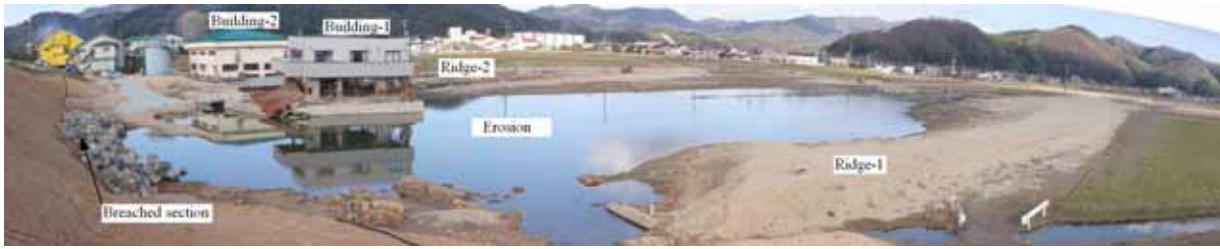
Photo. 1 Panoramic view showing consequences of levee breaching at Tachino, as of December 22, 2004

Visits to the breaching-affected area made us notice a range of marked sedimentary features such as shown in Photo. 1 (Azuma *et al.*, 2005). In this photograph one may note the central water body (erosional feature) and two distinct piles of particulate matter (depositional feature; ridges 1 and 2). In order to precisely evaluate these and other related topographical changes, we selected and used the method of digital photo-theodolite surveying (Ono and Hattori, 2002; Ono *et al.*, 2004). The features of the method will be described below.

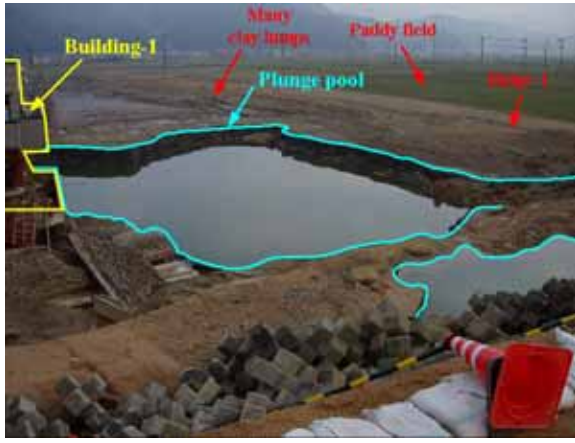
Let us first look at Photo. 3 that captures the sedimentary features of the plunge pool and adjacent areas. The periphery of the plunge pool had nearly vertical faces. This feature is compatible with the observation that the plunge pool was formed by scouring of the clayey subsoil in the paddy field. Also, a close look at Photo. 3 beyond the plunge pool shows the

presence of a number of clay lumps that were produced by scouring, transported and finally left on the affected flood plain. The size of the clay lumps has a practical implication and will be referred to later in this paper.

Photo. 3 A view of plunge pool and adjacent areas (photograph taken on November 25, 2004)

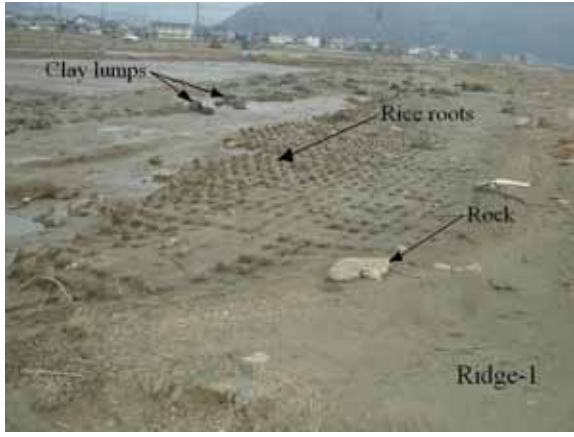
As mentioned earlier, we noted the presence of a number of clay lumps in the flood plain beyond the plunge pool (Photo. 4). The clay lumps were evidently outsized, compared with the deposited sandy materials. The size of the large clay lumps were 50cm or so in diameter (Azuma *et al.*, 2005). The question now arises as to how such clay lumps were formed. Our idea about this is schematically shown in Fig. 13. The stream power due to the overflow may be the principal agent for scouring the clayey subsoil in the paddy field, producing clay lumps. Indeed, if the clayey soil had a significant tensile strength, it could then fail in the form of blocks under the action of water jet or stream power; this failure mode should be contrasting with that of cohesionless sandy sediments.

Photo. 4 Clay lumps left on the severely eroded surface in the clayey subsoil

pool. A view of such an area after the event is presented in Photo. 4. Many clay lumps can be seen left on the severely eroded surface of the clayey subsoil. The surface conditions were markedly different from the adjacent zone where the rice roots remained. It will thus be worth exploring the stream power that can completely erode such rice roots.
