## Structural Damages Caused by Tatsumaki

By Hatsuo ISHIZAKI and Yoshihito TANIKE

### Abstract

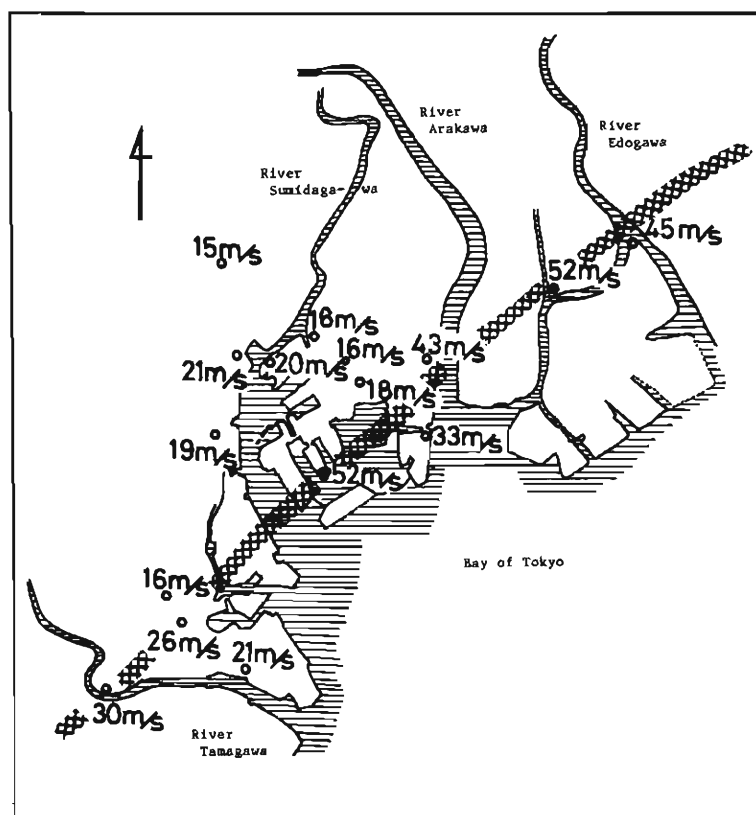
Fig. 1. The distribution of the maximum peak gusts due to the Tatsumaki observed at meteorological stations.

The maximum peak gust observed by anemometers was 52 m/sec. This value was obtained at two locations on the severely damaged belt, both of which are indicated by black points in **Fig. 1**. The recorded maximum peak gust hyperbolically decreased as the distance of the observation point from the center line of the damaged area increased. The true maximum peak gust was not measured because the center of the damaged area does not necessarily mean the path of the center of the Tatsumaki and the center of the damaged area was somewhat uncertain in some areas.

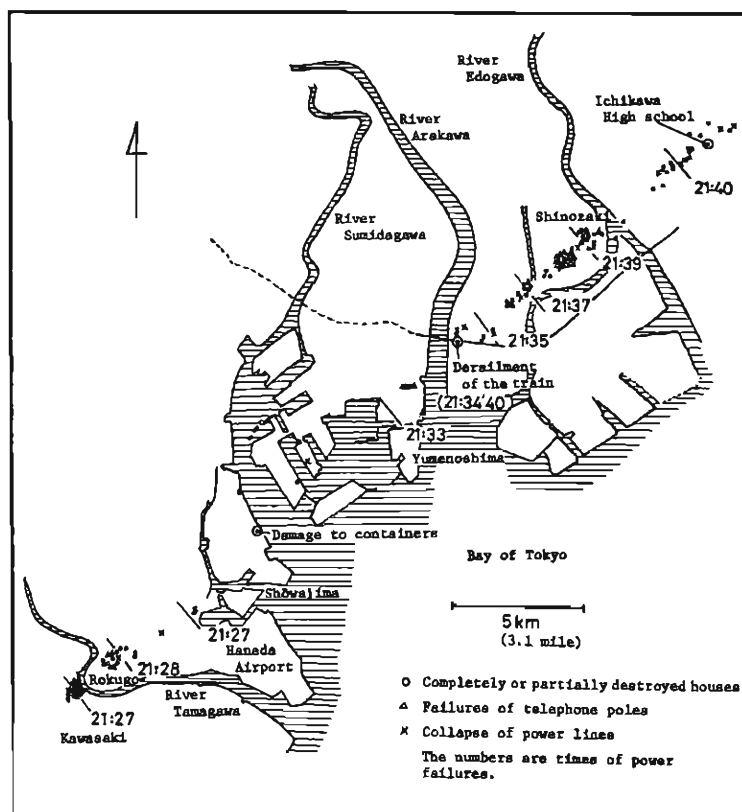
Fig. 2. The distribution of damage to houses (○), electric facilities (×) and other remarkable damages (⊙). The numbers are the hours of the power failures and the hour of the train derailment.

The Tatsumaki hit the southeastern part of Tokyo and severe damage was caused along a line from the coast of Tokyo Bay near Haneda Airport running northeastward. The total amount of damage is indicated in **Table 1**. These statistics indicate that this Tatsumaki was not an extraordinarily severe one compared to the average Tatsumaki. The distribution of the damage to houses (including completely, partially and slightly damaged houses), the damage to the electric facilities (electric poles and power transmission lines) and some other remarkable damage are indicated in **Fig. 2**.

As the hours on the strip charts were not sufficiently accurate, the hours at which the strong gusts appeared on the charts do not always match the hours of the power failures recorded at the switching stations. The most reliable determination of the hour of the damage occurrence or Tatsumaki passage can be done by the hours of the power failure, which are recorded with an accuracy of one minute and the hour of the train accident, which is probably accurate within an order of ten seconds. The hours of the damage occurrence thus determined are indicated in **Fig. 2**.

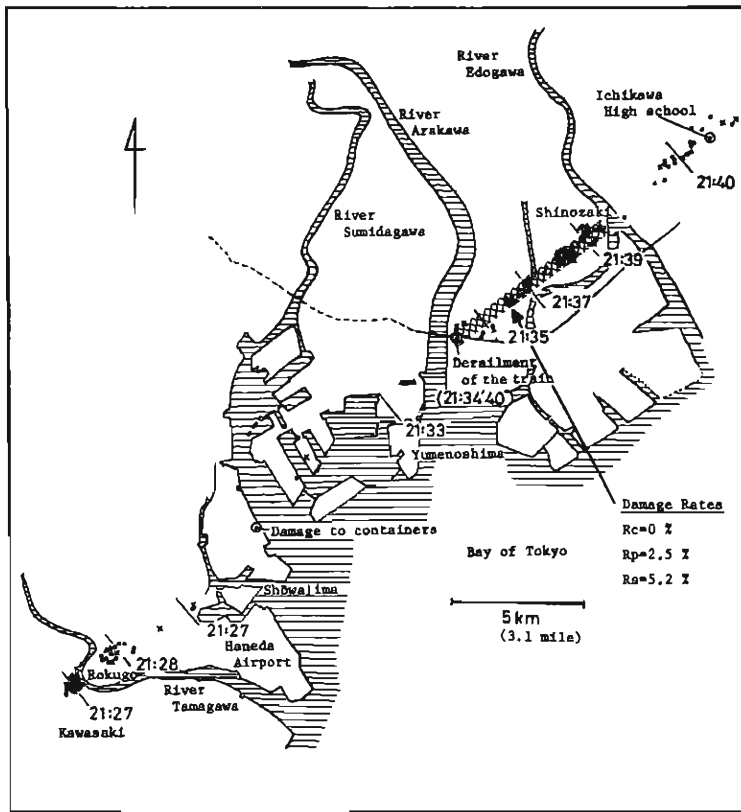
Fig. 3. The damaged zone caused by the Tatsumaki in a mature state.

While the damage rates of the present Tatsumaki in the Edogawa District which is between the Arakawa River and the Edogawa River, where the Tatsumaki was in a mature state, the damage rates within the damaged zone of the Tatsumaki were  $R_c=0\%$ ,  $R_p=2.5\%$  and  $R_s=5.2\%$  respectively (see **Fig. 3**). These rates were obtained by dividing the number of damaged houses by the total number of houses in the area inflicted by the Tatsumaki, that is the area with a width of 0.4 km and a length of 5.7 km along the contour line of the damaged zone which is indicated by oblique lines in **Fig. 3**. The recorded maximum peak gust of the Tatsumaki was 52 m/sec at two observation points. The observation points were a short distance away from the center of the path and the true maximum peak gust is likely somewhat higher than this value. If the wind exceeds 52 m/sec in a typhoon, the damage rates of  $R_c$ ,  $R_p$ , and  $R_s$  will be above 5%, 20% and 50% respectively as shown in **Table 2**. The present Tatsumaki damage is far less than those of typhoons of the same wind speed. The difference of the damage rates between Tatsumaki and typhoons is due to the short duration of the maximum peak gust. A high wind of a typhoon continues for several hours whereas in the case of a Tatsumaki it continues only for a few seconds. Furthermore, the area afflicted by the peak gusts in a typhoon is 10–15 km wide, while it is only about a hundred meters in the case of a Tatsumaki. With respect to the structural aspects, horizontal forces are mainly dominant in typhoon winds, whereas up lift forces are as strong as horizontal forces in Tatsumaki winds.

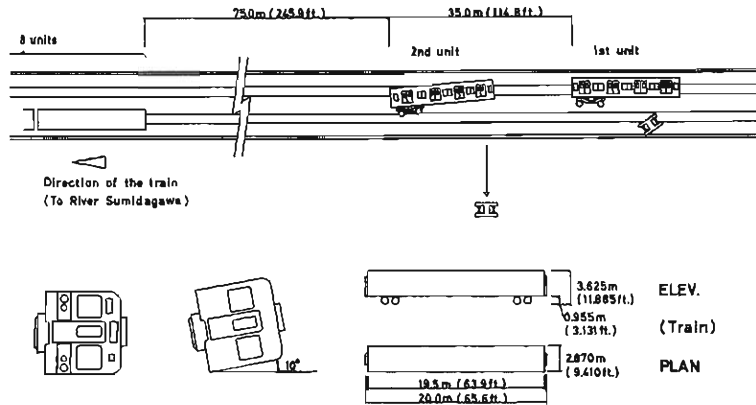
Fig. 4. The derailment of a train on a bridge over the Arakawa River.

The two last cars of a 10 car train travelling to Nakano at the speed of 78 km/hr were turned over on the rails of the other lane near the bridge entrance over the Arakawa River at 21:34'40" by a strong wind blowing off from south (see **Fig. 4** and **Photo. 1** offered by Tokyo Express). The height of the bridge was about 15 m above the water level and the external form is indicated in **Photo. 2**. Weights of the last and second last cars were 27.5 tons and 36 tons respectively. Fortunately only 21 people were injured because there were not many passengers on the train. The driver in the lead car was not aware of anything unusual and did not slow the train down until he felt the train derail and lean to the right. He found the cars in the rear had turned over after the train stopped completely. Although the two derailed cars had a total of 8 wheels, only one trace of the wheel crossing on the rail was found in the subsequent investigation. Two cars are assumed to have been

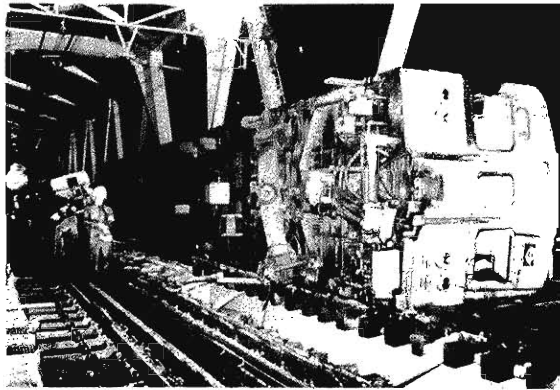
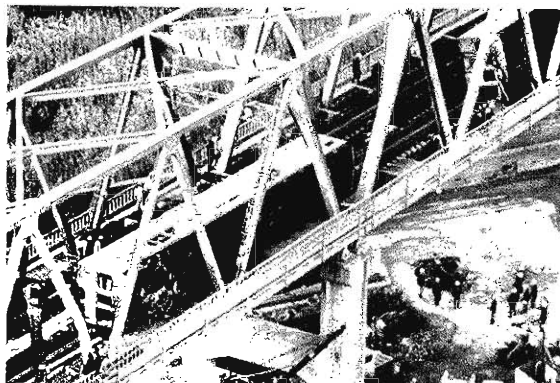
Photo. 1. The derailment of a train (offered by Tokyo Express).

first lifted up and then turned over by the wind.

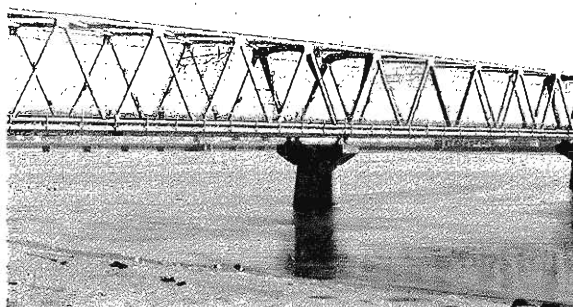
Photo. 2. The external form of the bridge.

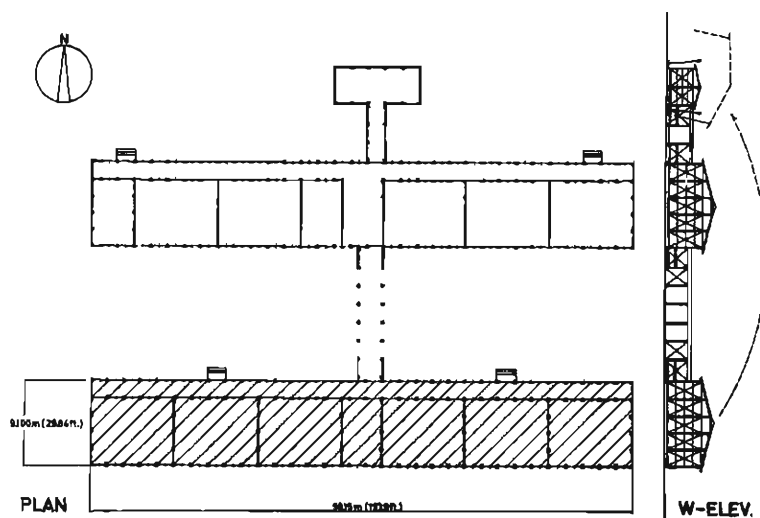
Fig. 5. The damage of a prefabricated school building caused by strong up-draft.

a neighbouring building which was 4.8 m in height (see **Photo. 3** and **Fig. 5**). The school building had 7 rooms and a floor area of  $9.1 \text{ m} \times 59.2 \text{ m}$ . The distance between the two buildings was 37 m. The floor boards of the school building remained intact and the desks in the rooms also remained as they were. The weight of the uplifted building including the side walls and roofs was about  $82 \text{ kg} \cdot \text{w}/\text{m}^2$ . It was found that the side walls were not sufficiently fixed to the floor boards or to the foundation of the building, therefore the building could be lifted up only by an up-lift force equivalent to the weight of the building.

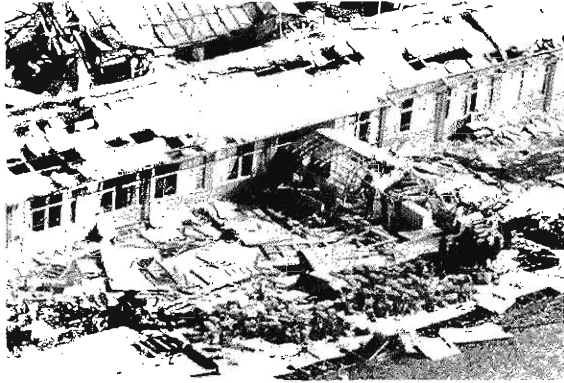
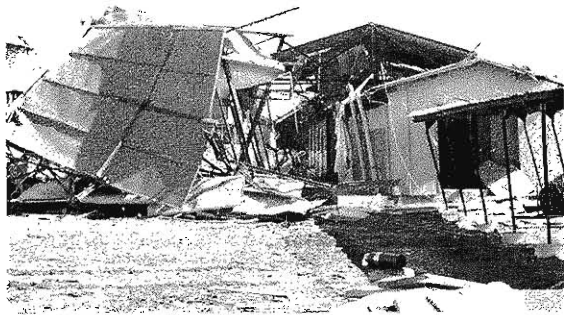
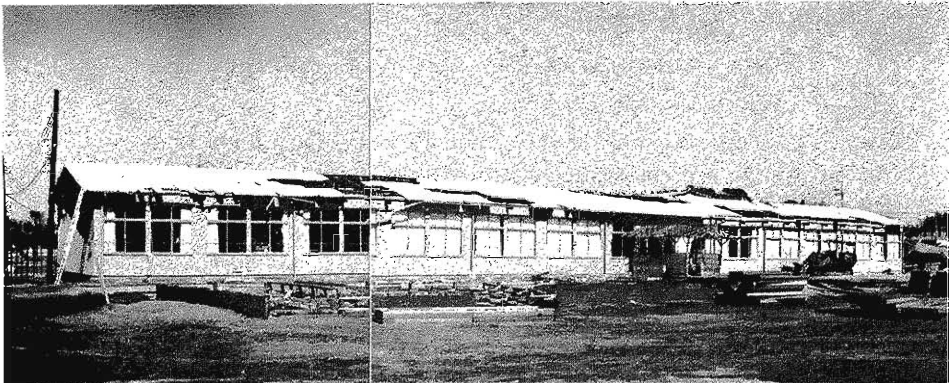
Photo. 3. The damage to a prefabricated school building.

A prefabricated one-story school building situated the north of Ichikawa City was lifted up approximately 5 m, flown over and crashed down on the other side of

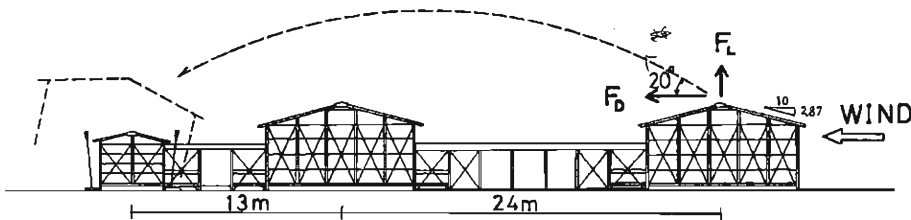
Fig. 7. The orbit of the building which flew.

The damage to the prefabricated school building (see **Fig. 7**); If the maximum peak gust is assumed to be 75 m/sec, the up-lift force per square meter is given as follows.

The drag force per square meter is also calculated to be  $450 \text{ kg}\cdot\text{w}/\text{m}^2$  by DIN. The total force acting on the school building is  $477 \text{ kg}\cdot\text{w}/\text{m}^2$  obtained by the vectorial summation of the drag force and the up-lift force. The rising angle to the horizontal is considered to be about 20 degrees. If the total force  $F_t$  of  $477 \text{ kg}\cdot\text{w}/\text{m}^2$  acting on the building with the rising angle of 20 degrees continues for only a half second, the initial velocity  $V_0$  is given as follows;

The distance flown over by the building is roughly calculated to be about 53 m in the case where the building was carried over with an initial velocity of 29 m/sec and a rising angle of 20 degrees. The distance flown over measured on the spot was about 40 m, which is almost the same as the calculated value of 53 m. Furthermore, the height of the orbit above the next building that was 24 m distance from the building which flew is also calculated to be about 5 m, which slightly exceeds the next building of 4.8 m in height.
