## Portable Ring Shear Apparatus and its Application on Croatian Landslides

### Synopsis

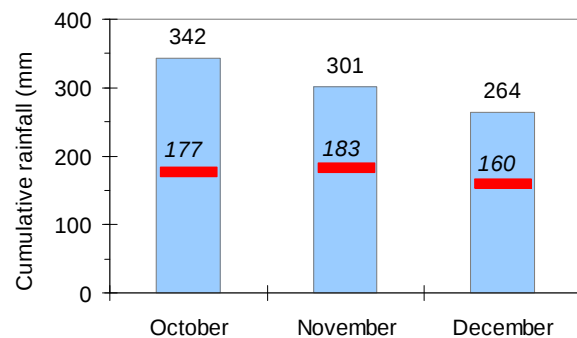
Fig. 2 Cumulative rainfall at the Rijeka rain gauge for October, November, and December 1996.

Red lines and italic numbers show long-term (1948–2009) monthly averages.

Figure 2 shows the cumulative rainfall measured in October, November, and December, 1996, at the Rijeka rain gauge. In the considered period, the monthly rainfall was from 94% (October) to 64 % (November) higher than the average monthly values in the period from 1948 to 2009 (red lines in Fig. 2) (Ostric et al. 2011).

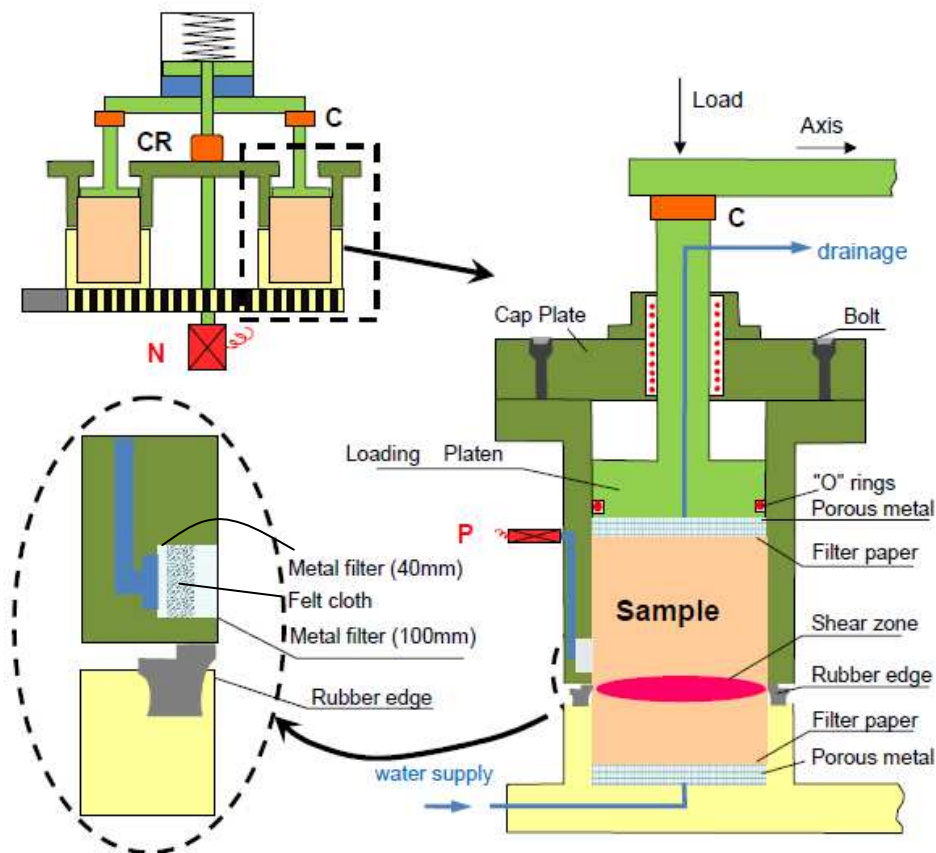
Fig. 3 A half cross-section of the shear box and the close-up diagram of the edges (CR - Connection Ring, C - Connection , N - Load cell for Normal Stress; P - Pore pressure transducer)

The most essential part of the ring shear apparatus is the construction of the undrained shear box (SB). Design of the shear box is illustrated in

Figure 3 with enlarged diagram of the right half of the cross section of the SB and its surroundings, including the water pressure measurement system

The sample in the ring-shear box is laterally confined between pairs of upper and lower confining rings, forming the shape of two

doughnuts. .During the test, the sample is loaded normally through an annular loading plate connected to an oil piston. The lower half of the shear box rotates while the upper half of the shear box is retained by two shear resistance cells that measure shear resistance.

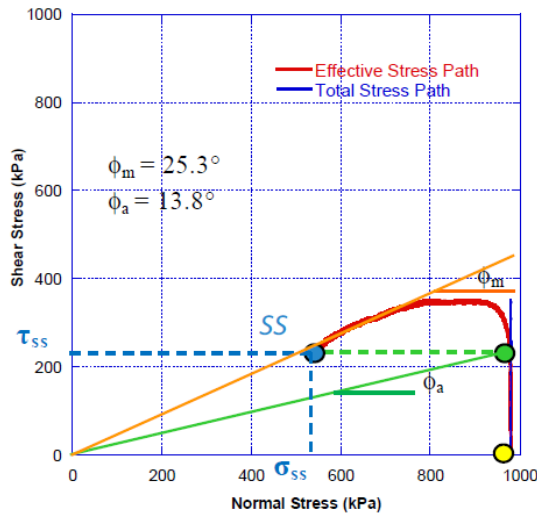
Fig.4 Stress path of Undrained Speed Control Test on saturated marl sample from Kostanjek landslide ( $B_D=0.95$ ; initial dry density:  $1.48 \text{ g/cm}^3$ , specific gravity,  $G_s=2.70$ ).

Figure 4 shows stress path that reached the failure line and moved down along the failure line. In this test, the peak failure line was not observed. The straight line fitting the stress path gave values of the friction angle during motion as well as peak

friction angle of  $25.3^\circ$  and apparent friction angle,  $\phi_a=13.8^\circ$ . We assumed cohesion is zero.

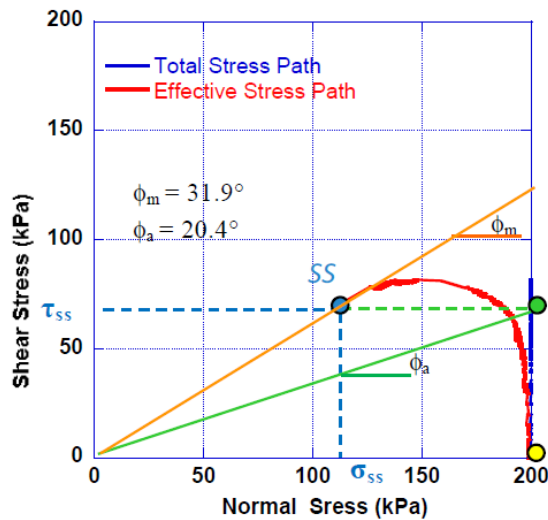
Fig. 5 Stress path of Undrained Speed Control Test on saturated clayey sample from Grohovo landslide ( $B_D=0.95$ ; initial dry density:  $1.51 \text{ g/cm}^3$ , specific gravity,  $G_s=2.664$ ).

Figure 5 shows stress path that reached the failure line and moved down along the failure line and like in the previous test, the peak failure line was not observed. The straight line fitting the stress path gave values of the friction angle during motion and also at peak as  $\phi_p = \phi_m = 31.9^\circ$  and apparent friction angle,  $\phi_a=20.4^\circ$ . We assumed cohesion is zero.

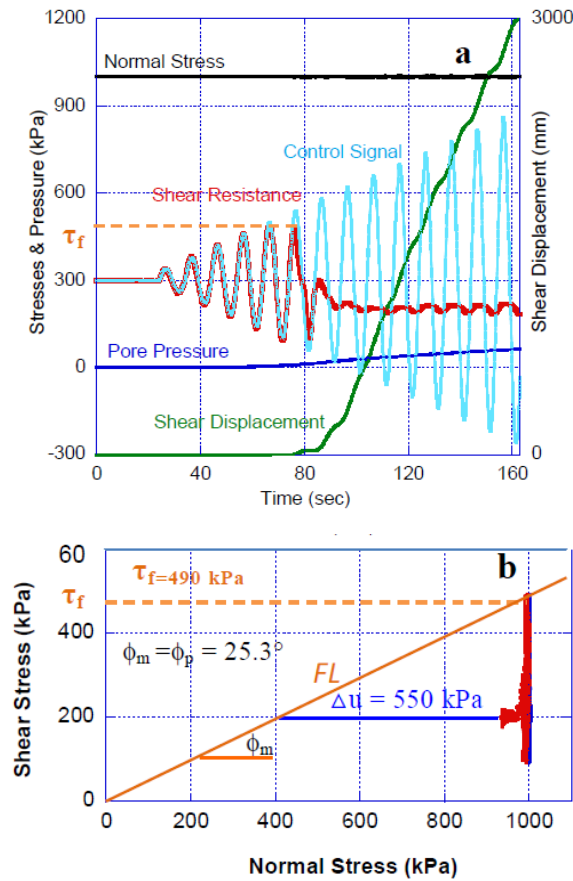
Fig. 6 Undrained cyclic loading test on saturated marl sample from Kostanjek landslide ( $B_D=0.96$ ; initial dry density:  $1.48 \text{ g/cm}^3$ , specific gravity,  $G_S=2.70$ ). a) Time series data for stress, pressure and shear displacement and b) Stress Path.

After consolidation of the sample, cyclic shear stress loading was applied in the undrained condition. The results of cyclic tests are presented in Figures 6 and 7. Figures 6a and 7a are showing time series data of cyclic tests, where the black line shows normal stress, the light blue line shows the control signal for shear stress which was given to the servo-stress control motor. The red line shows the shear resistance mobilized on the sliding surface, the dark blue line shows the monitored pore pressure and the green line shows the shear displacement. Figures 6b and 7b are showing stress path, with red line showing effective stress path and blue line showing total stress path.

Figure 6 shows time series data and the stress path of cyclic test conducted on the Kostanjek marl sample. For this sample, initial normal stress of 1000 kPa and initial shear stress of 300 kPa was applied before cyclic (sine wave) shear stress was loaded at 0.1 Hz and stepping up shear stress by 40 kPa/ cycle.

Although pore pressure must have been generated in the shear zone, it could not be well monitored as it can be estimated on Figure 6b. During the post failure movement after 80 sec in Figure 6a, the effective stress should be on the failure line. So the horizontal difference between the failure line and the monitored effective stress (550 kPa) is excess pore water pressure value which was not monitored by the pore water pressure sensor shown in Figure 6a. This is due to the slow response resulting from the lower permeability of the material tested.

The accelerated motion was produced after failure, as it is shown on Figure 6a. Although, initially both lines of the control signal for shear stress and the mobilized shear resistance are the same, they differ after failure. Shear resistance decreased from the maximum value of 490 kPa to the steady state although control signal is continued to be increased. The difference of stress is used for acceleration of shear motion.

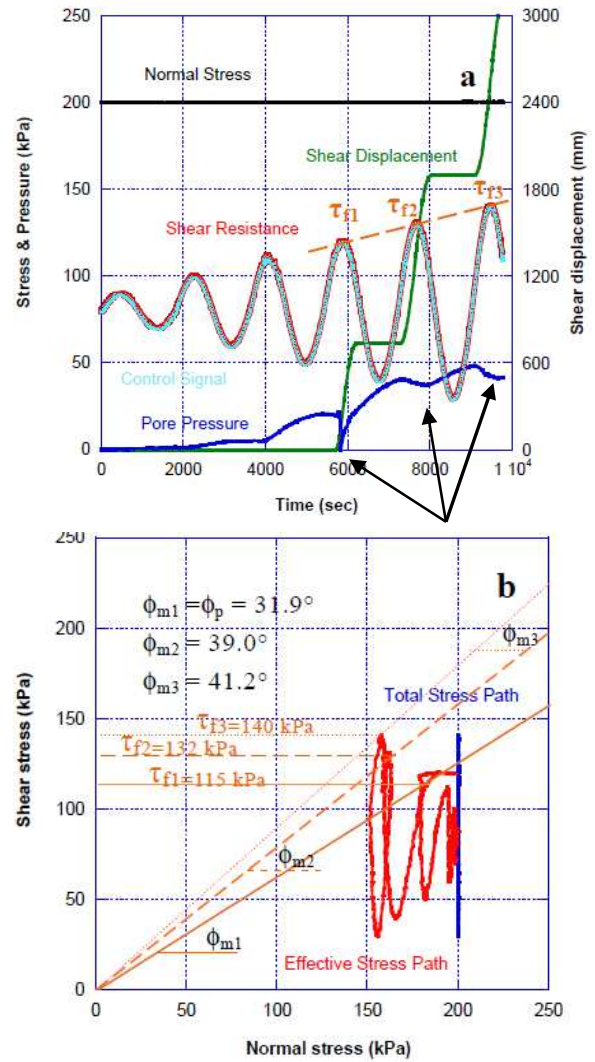
Fig. 7 undrained cyclic loading test on saturated clayey flysch sample from Grohovo landslide ( $B_D=0.96$ ; initial dry density:  $1.51 \text{ g/cm}^3$ , specific gravity,  $G_S=2.66$ ). a) Time series data for stress, pressure and shear displacement and b) Stress Path.

Figure 7 shows the time series data and stress path of cyclic test conducted on the Grohovo clayey flysch surface sample. Due to the low permeability of this sample, we chose much slower cycle shearing of 2 cycles/ hour.

For Grohovo sample, initial normal stress of 200 kPa and initial shear stress of 80 kPa was applied before cyclic shear stress was loaded with the amplification increment of 10 kPa/ cycle at 0.1 Hz. The sample failed, but without rapid failure motion. Figure 7a shows that displacement of 700 mm occurred after 6, 000 sec and pore pressure of app. 20 kPa was generated. Unlike the previous case (Kostanjek sample), both lines of the control signal for shear stress and the mobilized shear resistance are the same during the test.

Shear displacement occurred in a different mode then for Kostanjek sample. Each time shear stress given by control signal reached value of shear resistance, shear displacement occurred.

When shear stress decreased, displacement stopped and shear resistance moved down with loaded shear stress lower than failure line. Sample showed dilative behavior, which is indicated by black arrows on the graph, showing negative pore pressure generation at each displacement step. Consequently, the peak friction angle increased as well, from the initial value of  $31.9^\circ$  to  $39.0^\circ$  and  $41.2^\circ$ . The sample showed strength-hardening behavior.
