# Existing Performance and Effect of Retrofit of High-Rise Steel Buildings Subjected to Long-Period Ground Motions

March 2010

Yulin CHUNG

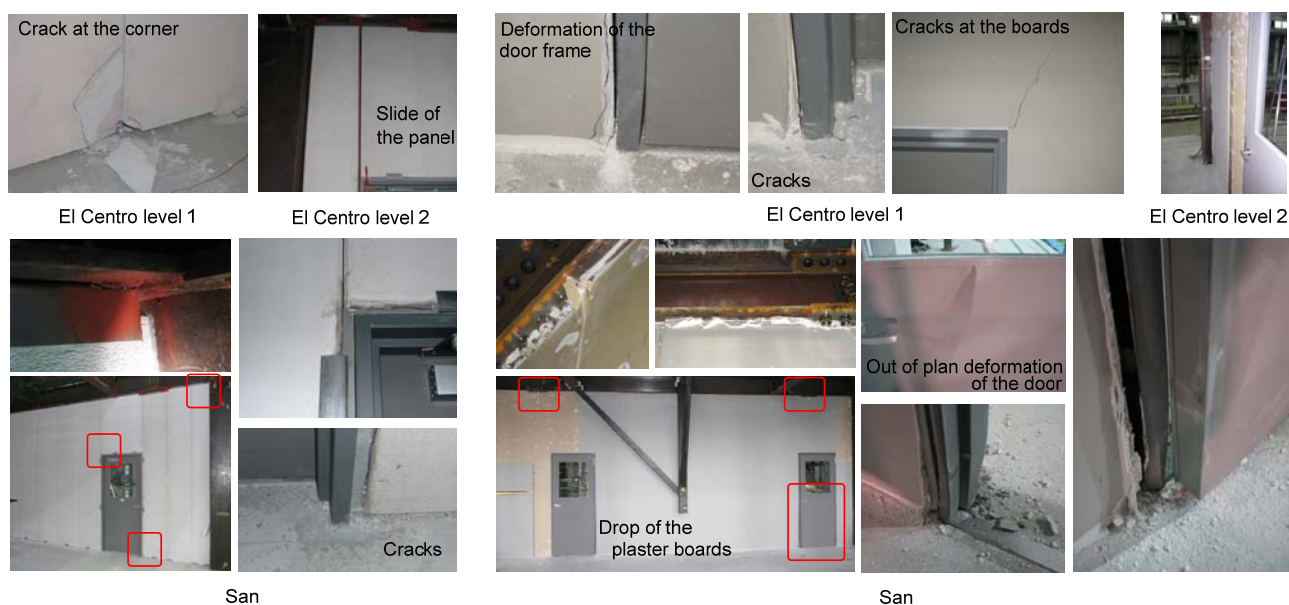
Figure 3.15 Damage to various nonstructural components

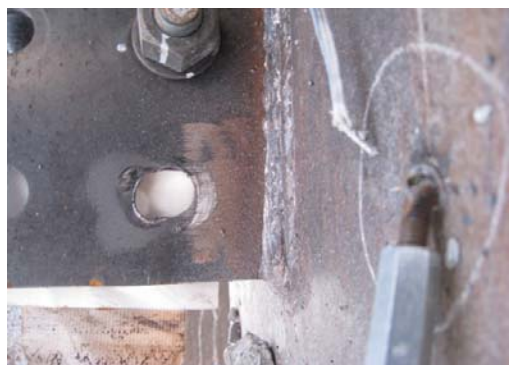
Figure 4.8 Deformation of bolt hole

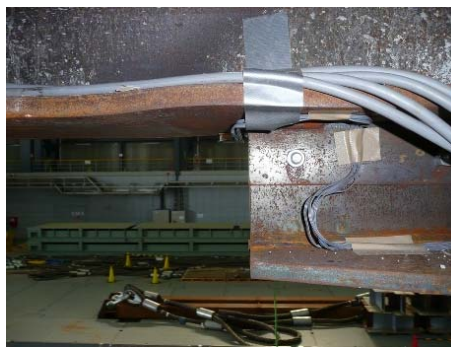
Figure 6.19 Fracture situation of connections (SL)
