# **Characterization and Management of Disaster Waste: Case of Gorkha Earthquake Nepal**

Raju Poudel

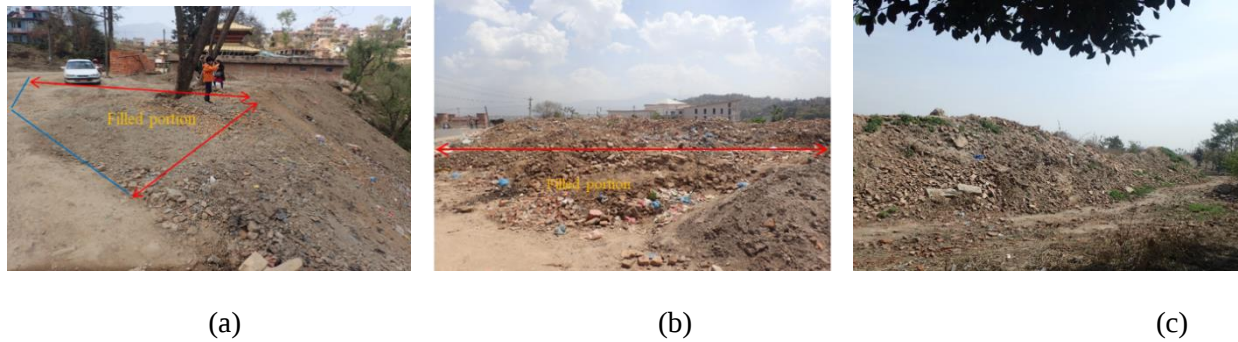
Figure 3-4: (a) Debris fill on a cliff slope, Bhajangal Kirtipur, (b) debris collection in a playground, Kirtipur, and (c) debris from archaeological sites in Tundikhel, Kathmandu

From the results, it is clear that building debris generated within the core city area of Kathmandu Valley was disposed of using various methods that did not include disposal to the government designated area.

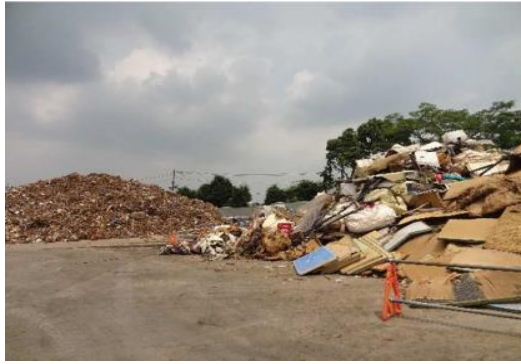
Figure 4-4: Disaster Waste Treated

Kumamoto prefecture used about 9.8 hectares of land for secondary temporary waste storage site in order to help disaster waste treatment at primary waste storage sites run by seven cities/ municipalities. The volume of disaster waste treated at the secondary temporary storage site was around 0.2 million tons in total: 0.008 million tons of waste concrete, 0.028 million tons of roof tiles, 0.06 million tons of wood debris, 0.103 million tons of mixed waste, and 0.002 million tons of tatami and futon (Figure 4-4). Separation, crushing, and compression facilities were adopted for the disaster wastes in order to recycle them as much as possible and also reduce the volume of waste that goes to landfills (Figure 4-5). Waste concrete and tiles were reused mainly for building and civil engineering materials after removal of impurity materials. Wood debris were roughly crushed to reuse for cement raw materials making and for biomass power generation, and finely crushed to make raw materials for paper making. Mixed wastes generated from dismantled debris were classified by using equipment such as trommel to be used as fuel for cement raw materials and for incineration power generation. Inorganic materials and residues were disposed of at landfill sites. Waste tatamis and futons were treated by shredding and compression process for incineration energy recovery.

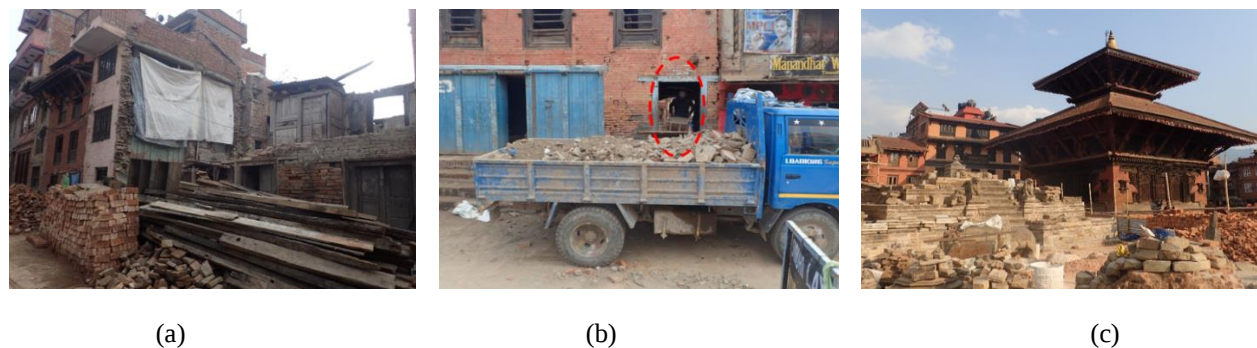
It was observed that more than 50% of damaged buildings in Sakhu had yet to be demolished and cleared. Similarly, in Lubhu, only 3% of building debris had been cleared and reconstructed; 25% of the buildings were only debris-cleared; 62% of buildings had vulnerable parts removed but the debris was not cleared; and 10% of buildings still had vulnerable parts. Building debris from historical and archeological monuments was managed by the Department of Archaeology, Nepal. According to DUDBC, damage to high-rise buildings was observed but no high-rise buildings needed to be demolished in Kathmandu Valley.

Figure 3: (a) Damaged buildings and materials in Khokana, (b) debris removal from a house in Bhaktapur, and (c) damaged monument reconstruction in Bhaktapur
