Submitted to *Engineering Geology*

The internal structure of a rockslide dam induced by the 2008 Wenchuan ( $M_w$ 7.9) earthquake, China

Authors: Gonghui Wang, Runqiu Huang, Toshitaka Kamai, Fanyu Zhang

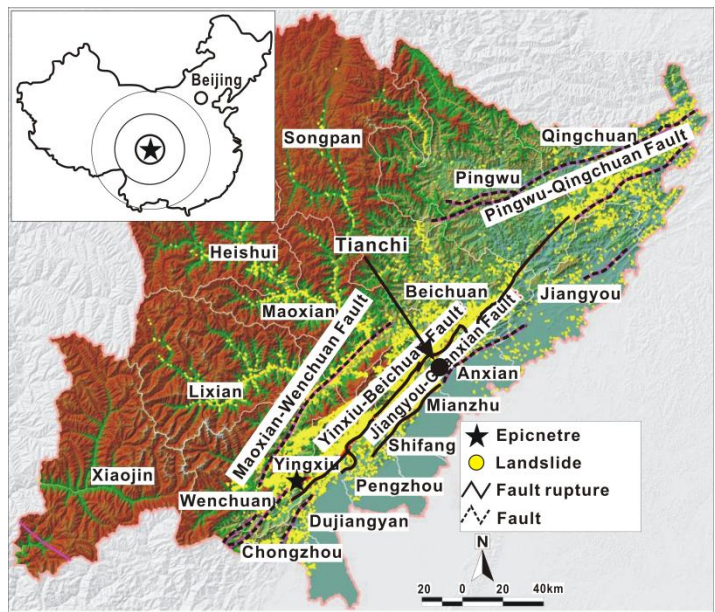
Fig. 1 Epicenter of Sichuan earthquake, distribution of landslides, and location of Tianchi landslide dam (after Huang and Li (2009)).

To assist in assessing the risk of outburst flooding due to landslide dam failure, we carried out detailed field surveys of some of the big landslide dams formed during the 2008 Wenchuan earthquake, investigating the geological and topographical characteristics of the landslides, their processes of formation and the internal structure of the landslide dams. In this paper, through study of the landslide dam formed in Tianchi Town, Mianzhu City, we examine the formation of a landslide dam resulting from a long-travel rockslide occurring in a carbonate rock area. We surveyed the internal structure of the dam site by means of a multiple-channel surface-wave technique, and also analyzed the grain size distribution at the dam site. Based on the survey results, we discuss the dam's formation and stability. Fig. 1 shows the epicenter the 2008 Wenchuan earthquake, the

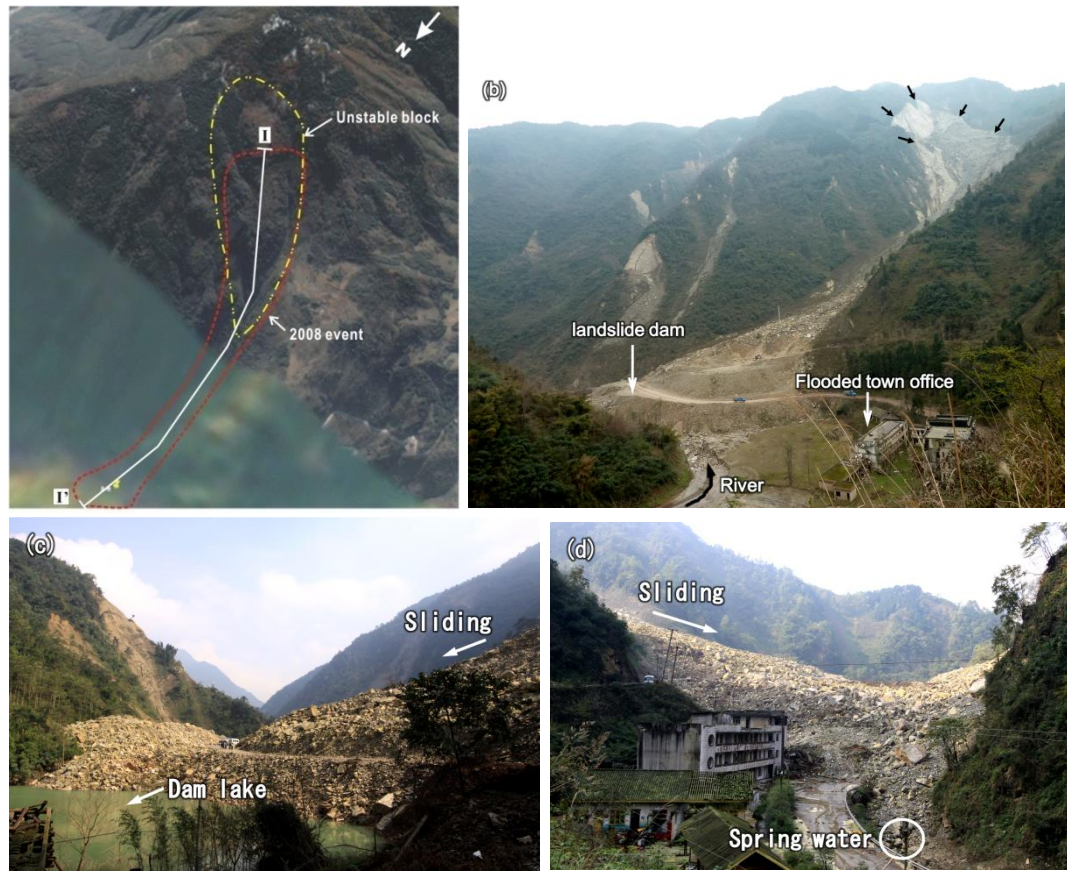
Fig. 2 Landslide dam in Tianchi area. (a) aerial photo of landslide area before the quake; (b) View of the landslide from the upper stream of the river after all construction has been finished (Taken on March 19, 2011); (c) Landslide dam and lake (Courtesy of F. Cai, taken on November 7, 2008 by F. Cai) viewing from upstream; (d):Landslide dam viewing from downstream (Courtesy of F. Cai, taken on November 7, 2008)

The landslide dam in Tianchi town (hereinafter called the Tianchi landslide dam) (Fig. 2), about 100 km north of Chengdu, resulted from a rock avalanche occurring on the right slope of a tributary of the Mianyuan River in Mianzhu City. Fig. 2a shows a satellite image of the landslide area taken before the earthquake. Figs. 2b and 2c present an oblique view of the whole dam site and a view from upstream. Fig. 2d shows a view of the dam from downstream, in which the piping is marked by a circle. From the Google Earth image and field investigation, we inferred that there was an unstable rock at the source area before the earthquake (marked as 'Unstable block' in Fig. 2a). The geological setting of the Tianchi area is presented in Fig. 3. The landslide area consists of Devonian clastics and carbonate (dolomite or dolomitic limestone). Bedding planes and joints of the bed rock in the source area were surveyed and are shown in Fig. 4, and they can be mainly divided into 5 groups. The bedrock of the source area was fractured by these bedding planes and joints, and a big unstable wedge was formed on the bedrock near the mountain ridge (Fig.4a). This unstable wedge failed during the earthquake, and traveled downslope rapidly (~28.5 m/s, Wang et al., 2011), burying the river channel, and climbing the slope of the opposite bank. A landslide dam was formed, with a dam height of 34–41 m, a length (along the river channel) of 158 m, and a width (across the river channel) of 70–102 m. The city hall, elementary school, and some houses on the upstream side were flooded by the impounded water. Fig. 5 shows the cross section along line I-I' shown

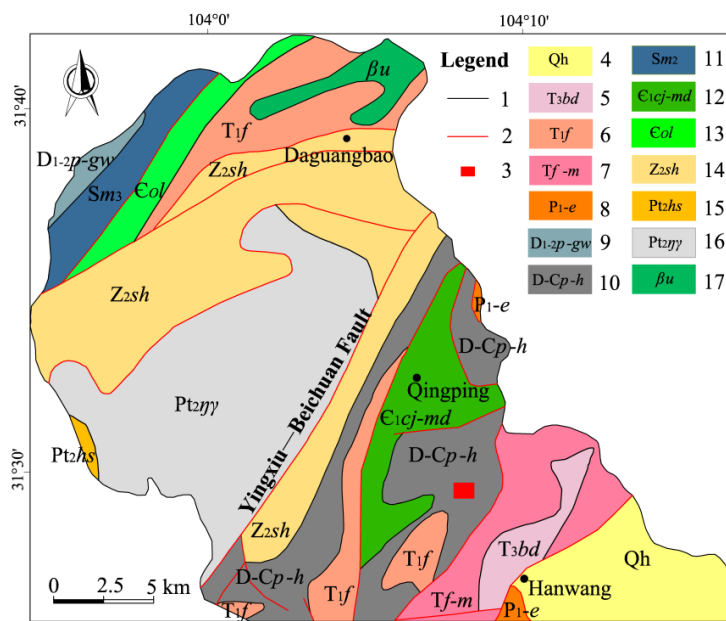
Fig. 3 Geological settings of Tianchi area (1: Stratum boundary; 2: Fault; 3: Tianchi landslide area; 4: Quaternary alluvial and diluvial deposit; 5: Triassic Sand, conglomerate, siltstone and mudstone; 6: Triassic shale; 7: Triassic clastic rock and carbonate rock; 8: Permian shale, limestone and basalt; 9: Devonian sandstone and conglomerate with carbonate rock; 10: Devonian clastic rock and carbonate rock; 11: Silurian slate; 12: Cambrian shale, siltstone, mudstone and sandstone; 13: Cambrian dolomite; 14: Sinian dolomite and marble; 15: Proterozoic acid volcanic, clastic rock and carbonate rock; 16: Proterozoic granite; 17: Diabase dike)(after Ma, 2002)

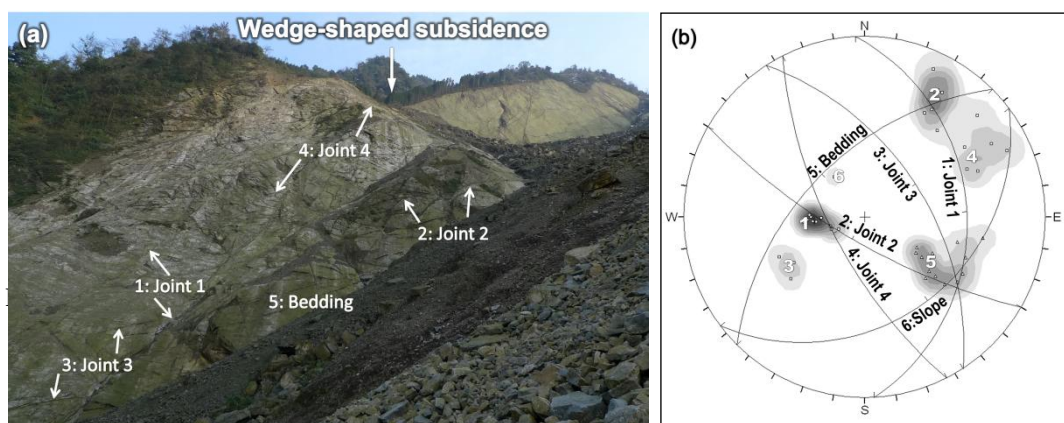
Fig. 4 (a): Source area of the landslide, (b): Stereonet graph of the discontinuities of rocks on the source area

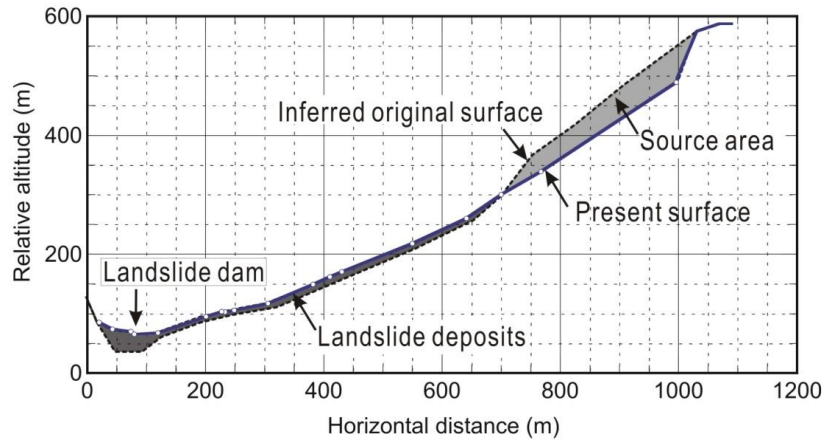
Fig. 5 Longitudinal section along line I-I' in Photo 2a

in Fig. 2a. For the cross section in Fig. 5, the topography after the quake was measured by a laser measuring technique (Trupulse360), while the topography before the quake was inferred from maps and field investigation.

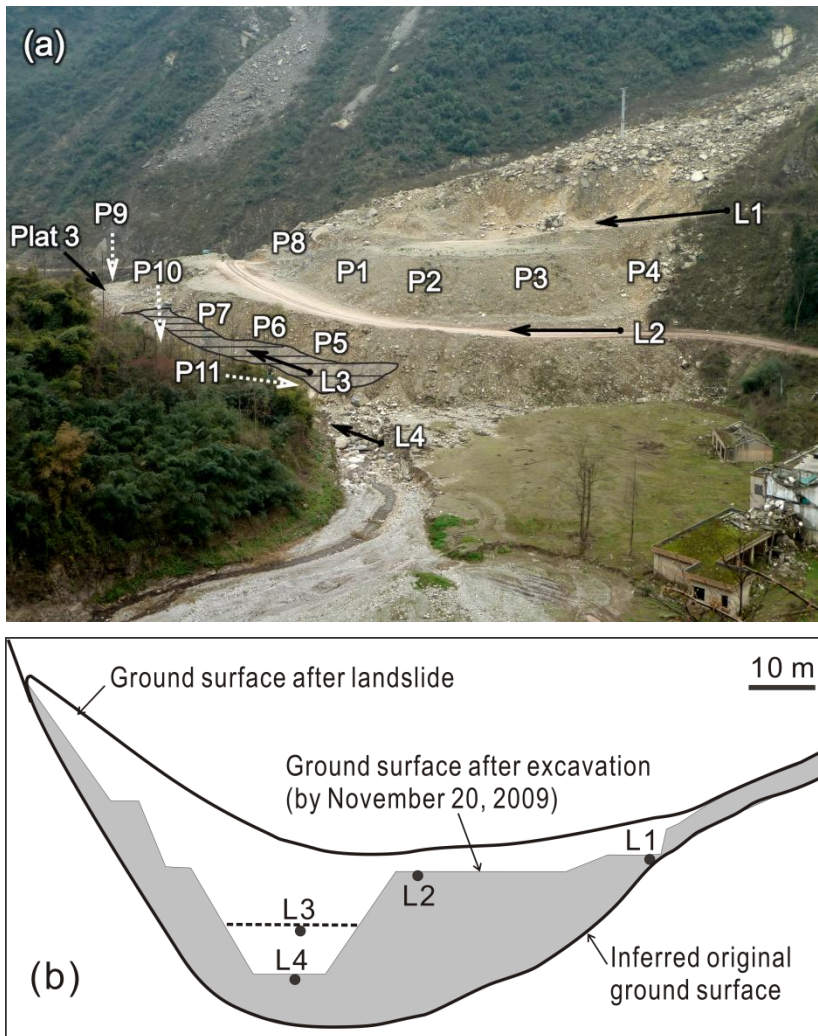
Fig. 6 (a) Photo of landslide dam after excavation with locations of S-wave survey lines and grain size analysis points (P1~P11); (b) Cross section of the landslide dam during differing surveying times. L3, L4: spillway levels on November 20, 2009, and June 16, 2010, respectively.

We sampled 11 locations for the distribution of grain size in the Tianchi landslide dam (Fig. 6a). Samples P1 – P8 were taken on November 2009, and P9 – P11 on June 2012. P1 – P4 and P8 are located on the upper steps along the road, P5 – P7 are on the side slope of the excavation at level L3. P9 – P11 are located at the bottom of the excavation (about 2 m above the outcropping former river bed). P9 is near the downstream margin of the landslide dam, while P10 is below P7, and P11 is below P5. Fig. 7 presents the grain-size distributions. Because very large boulders were located only in the surficial layer, there were no grains  $> 50\text{cm}$  in Fig. 7. From the grain size distribution of P1 – P4, and P8 (Fig. 7a), we saw that the grains tended to become coarser closer to the lateral margins (say, P8 and P9). This tendency is normal in the deposits of large-scale rock avalanches (Schulz et al., 2008; Crosta et al., 2011; Davis and McSaveney, 2011; Dunning and Armitage 2011), due to the segregation of grains during movement. Nevertheless, a similar tendency was missing in the grain-size distribution of P5 – P7 (Fig. 7b). This may result from the facts that P5 – P7 were located in the deeper soil

Survey line L2 was along the newly built road. Due to the construction of the road, a 3–5m thick soil layer had been excavated (Fig. 6b). In L2, the whole surficial layer (about 6 m deep) and all soil layers (from the

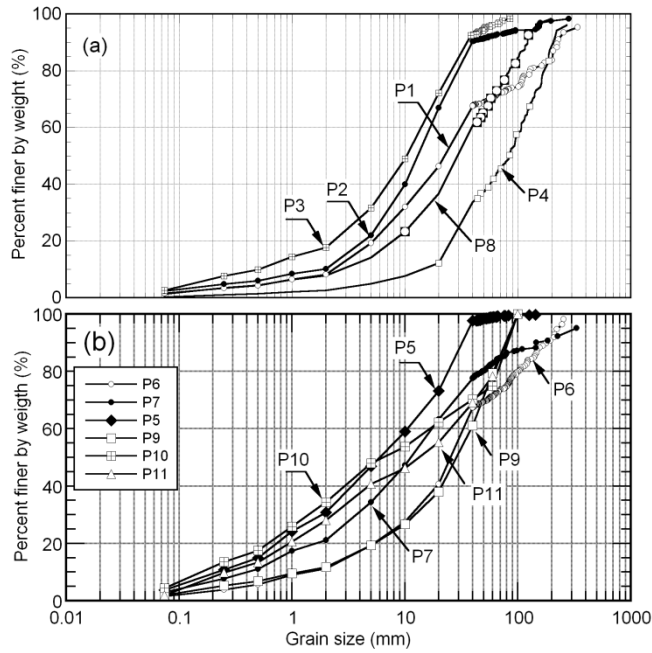
Fig. 7 Grain size distributions of materials from dam body. (a): samples on the same altitude level. (b): Samples at different depth of the dam body

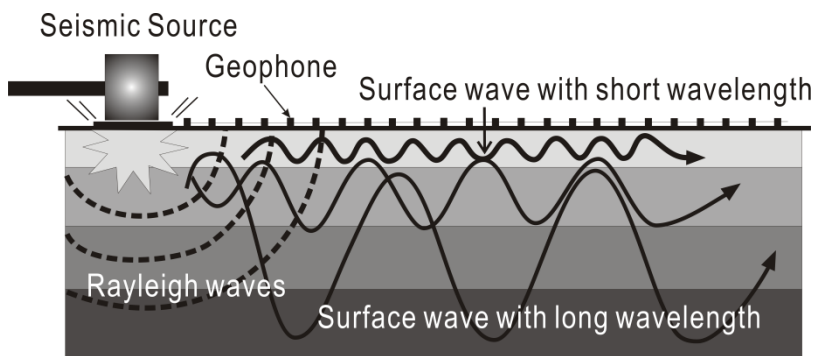
Fig. 8 Measurement principle of multichannel analysis of surface waves (MASW).

To investigate the internal structure of the landslide dam, we used a surface-wave method known as multichannel analysis of surface waves (MASW) (Park et al., 1999; Hayashi and Suzuki, 2004) to measure the shear-wave velocity profile of the landslide-dam site. The survey principle of MASW and the layout of equipment (Seismograph: Model McSEIS-SXW, OYO Corporation, Tokyo, Japan; Geophones: Model GS-11D, OYO Geospace Corporation, Houston, Texas, USA) are outlined in Fig. 8. In the survey, 24 geophones were spaced at 2 m intervals along a line. A wooden hammer (about 8 kg) was used as the seismic motion exciter. The hammer points were outside of both ends of the survey line and also intermediate between the geophones. We carried out our first survey in November 2009, when the landslide dam had been excavated with the shape shown in Fig. 6b. The landslide dam excavation had three steps (L1, L2 and L3), with the most upper one (L1) along the original road before the earthquake and exposed during the excavation. Step L3 (shown by dashed line) was flat at the time of our survey, although it was later dug deeper as excavation progressed. In June of 2010, we surveyed this area again, when the excavation had been finished, and the bottom of the excavation had reached almost to the original river bed level (L4). Hereinafter, we call these survey lines L1, L2, L3, and L4, respectively. Fig. 9 show the shear-wave velocity profile along survey line L1, and Fig.10 along survey lines L2 to L4. As mentioned above, L1 is along the original road. The shear-wave velocity values obtained along this line thus represent those of the slope before the earthquake. As shown in Fig. 9, most of the field has shear-wave velocity values ranging from 400–480 m/s. However, around 30 m from the beginning point and at a depth of 9 m, shear-wave velocity values are smaller (ranging from 350–400m/s). This field of smaller shear-wave velocity values might reflect the former channel of the stream, i.e., landslide debris buried the stream path, with the soil layer deposited being looser than the surrounding original mountain slope.

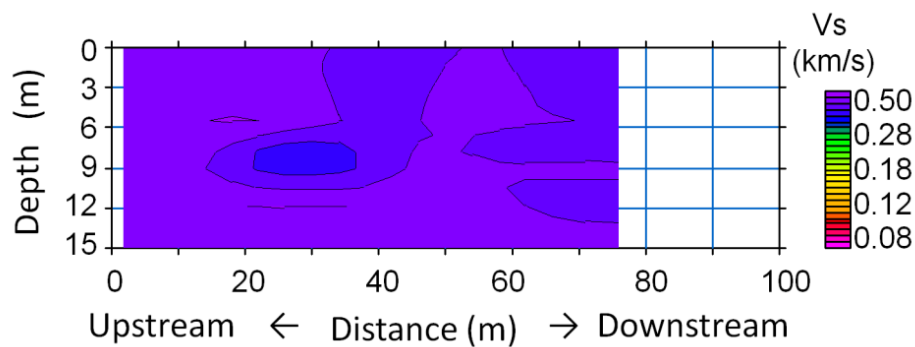
Fig. 9 Shear-wave velocity ( $V_s$ ) profile along traverse line L1

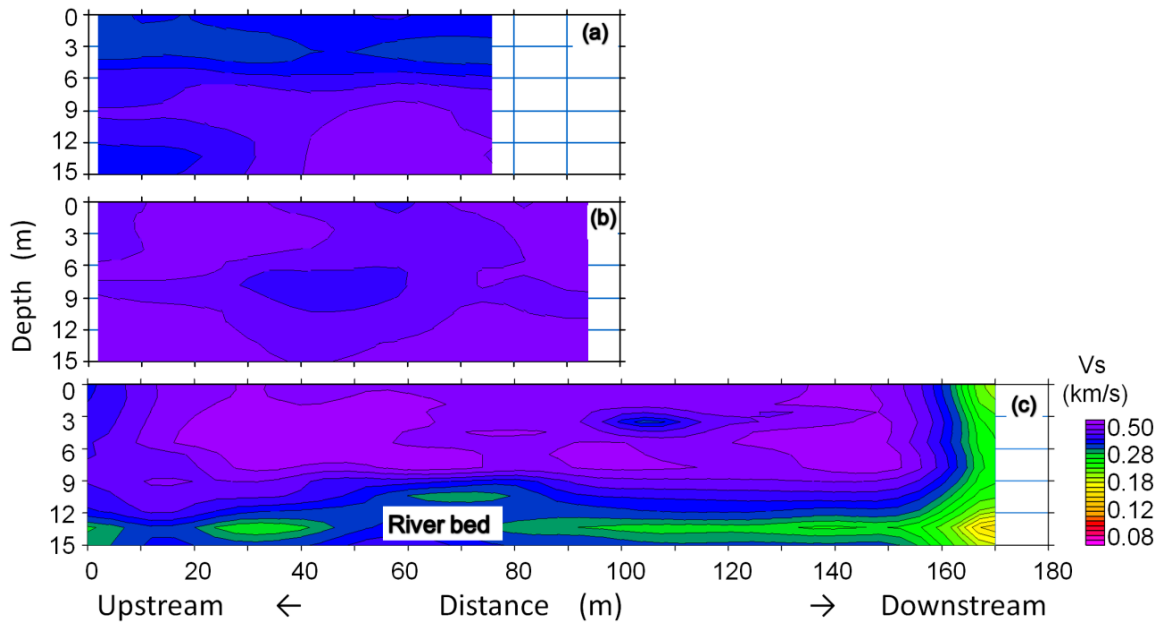
Fig. 10 Shear-wave velocity ( $V_s$ ) profile of the dam body. (a), (b), (c): results for traverse line L2, L3 and L4, respectively

surface to the bottom) 0–30 m from the upstream end of the line had relatively smaller shear-wave velocity values (330–390 m/s) (Fig. 10a). Most of the soil layer along L3 showed greater shear-wave velocity values (400 m/s–480 m/s) (Fig. 10b). However, the domain on the middle part of the survey line (30–60m) and 7–10m deep had relatively smaller shear-wave velocity values (330m/s–400m/s). Although the grain size of the soil layer near this area was not measured, from the grain size distribution of the surficial soil layers in L3 (P5–P7 in Fig. 7b), we can infer that the effective grain size ( $D_{10}$ ) tended to become smaller. If it is assumed that the soil density is everywhere constant, the rigidity modulus becomes smaller with decrease of gravel content. Because the shear-wave velocity  $V_s = \sqrt{\frac{G}{\rho}}$  ( $G$ : Rigidity modulus;  $\rho$ : mass of soil layer), the smaller the rigidity modulus is, the smaller the shear-wave velocity becomes. Therefore, we infer that the area with smaller shear-wave velocity (shown in the ellipsoidal area) might result from a segregation phenomenon as shown in Fig. 7. Due to the segregation process during movement, finer debris accumulated in this area, forming soil layers that are relatively weaker than the surrounding domain. The soil layer below line L4 showed high shear-wave velocity values (400 m/s–480 m/s) in general, with a small area with relative low shear-wave velocities (330–390 m/s). However, the soil layer near the bottom (the original river bed) showed lower shear-wave velocities (250–300m/s). This may partially result from the original fluvial river-channel deposits and also the entrained substrate mixed with rockslide debris.

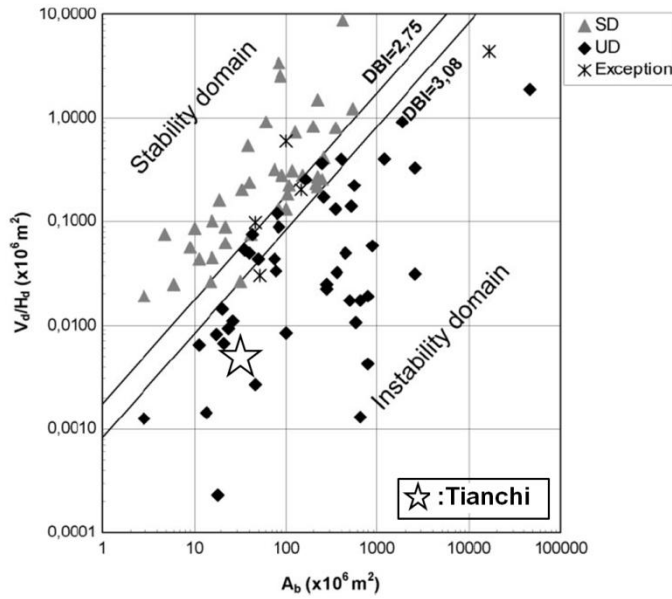
Fig.11 Stability analysis using Dimensionless Blockage Index (after Ermini and Casagli (2003))  $\blacktriangle$  : intact landslide dams;  $\blacklozenge$  : collapsed landslide dams

where  $A_b$  is area of the catchment ( $\text{km}^2$ );  $H_d$  is height of the landslide dam (m) ;  $V_d$  is volume of the landslide dam ( $\times 10^6 \text{ m}^3$ ). Based on the analysis of many recorded landslide dams all over the world, Ermini and Casagli (2003) recognized three “stability domains” for the dimensionless blockage index (1) when  $DBI < 2.75$ , the landslide dam lies in the stability domain; (2) when  $2.75 < DBI < 3.08$ , the landslide dam is in the uncertain domain; and (3) when  $DBI > 3.08$ , the landslide dam is in the instability domain.

For Tianchi landslide dam, its length is about 158 m, width 70–102 m, and height 34–41 m, the upstream catchment area is about  $30.83 \text{ km}^2$ . Equation 1 indicated a *Dimensionless Blockage Index* value of 3.72. Hence, Tianchi landslide dam could be regarded to lie in the instability domain. However, no breaching occurred before the channel was excavated. This suggested that the landslide dam itself was stable. It is noted that during the channel excavation on some other large landslide dams formed in the same earthquake in Sichuan, such as Tangjiashan, Xiaojiaqiao, and Xiaogangjian, etc, abrupt dam breaching occurred, resulting in catastrophic flooding downstream. In Fig. 11, we superimposed the plot of catchment area against  $V_d / H_d$  together with those obtained by Ermini & Casagli (2003), where SD means the stability domain, UD instability domain. The risk of abrupt breaching of some large landslide dams formed in the 2008 Wenchuan earthquake is correctly indicated by the Dimensionless Blockage Index, with the exception of the Tianchi landslide dam. This may be due to the fact that the Dimensionless Blockage Index is based on topographic features of the landslide dam and the upstream catchment area, without consideration of the dam’s geotechnical properties. Such anomalous behavior has also been reported by Strom (2010), who suggests that additional quantitative parameters characterizing landslide dams and dammed lakes should be used in the stability analysis of landslide dams. However, although
