## Historical Development and Some Experiences of Energy Dissipator at Multiple-Purpose Projects in Japan

By Yoshiaki IWASA and Hiroji NAKAGAWA

### Synopsis

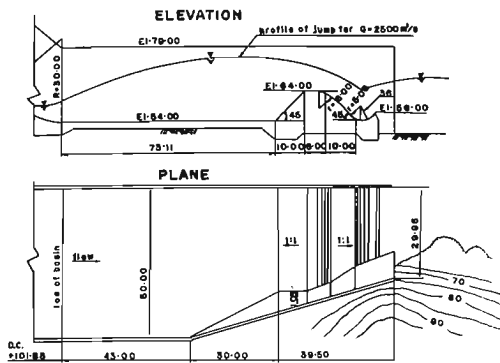
Fig. 8. Tsuruta Dam stilling basin works.

test, it has been indicated that the contraction of the apron toward downstream had an effect on shooting the flow along the curved river channel in emergency operation and on reducing the weir height to 10 m due to increase of efficiency of back-water<sup>6)</sup>. The final design of the stilling basin and the spraying flow condition in emergency operation observed in model test are shown in Figs. 8 and 9, respectively.

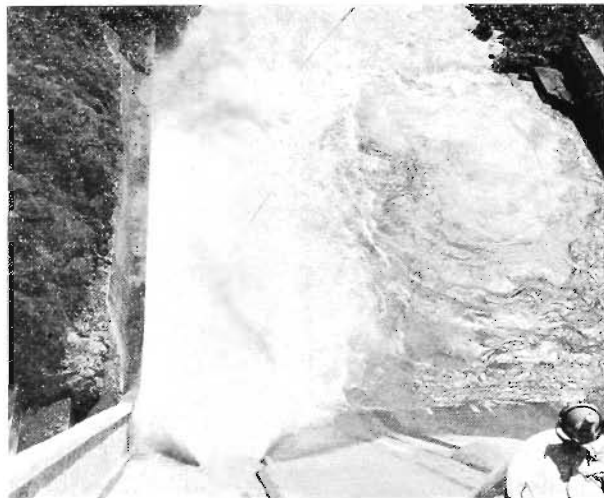
Fig. 14. Laterally back current at Tase Dam during one outlet operation.

the concrete floor by dragged debris, shown in Fig. 14. Moreover, the coffer-dam left just downstream of the apron checked the development of the bed

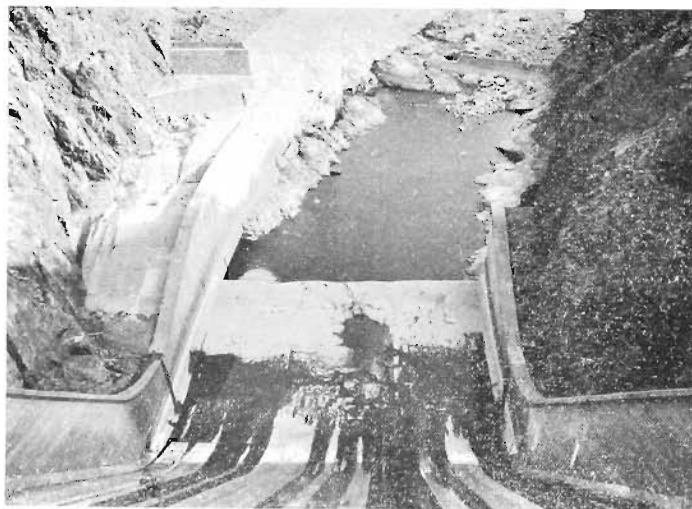
Fig. 15. Erosion at Nagayasuguchi Dam.

The first operation of the spillway was made during the flood in September, 1956, after completion of the project in 1955. Six floods of which the maximum released discharges ranged from 1,000 m<sup>3</sup>/sec. and the average period of operation was 300 hours passed over the spillway during the year of 1956 to 1957. An extensive damage was noticed at the central part of the apron and on the top of the end sill, when the basin was dewatered for inspection in January, 1958, as shown in Fig. 15. The maximum depth of erosion on the concrete floor was about 2 m and the face of guide wall on the left side was roughened by abrasion. The severe erosion on the top of the end sill would result from the cavitation, where the reinforcing steel was bent toward upstream by bed rollers.

Causes of erosion and failure were thought to be the following: In design, though the front of jump is secured in the basin for discharges less than 1,500 m<sup>3</sup>/sec., the length of the apron is so short the bed erosion between the apron and the cofferdam is severe, and that the lateral eddy current which occurs due to the uneven distribution of the incoming flow and curvature of the exit channel draws the scoured debris into the basin, with results of severe abrasion of the concrete floor. For discharges over than 1,500 m<sup>3</sup>/sec., the tailwater depth held by the cofferdam is so insufficient to form a hydraulic jump that the flow deflected by the end sill causes a deep erosion of the channel bank. As to construction, the erosion patterns of the apron which are different between three blocks may be verified by the fact that the placing period, the quality and strength of concrete were varied each other. Cavitation damages on the sill may be accelerated by a rough concrete surface placed at the curved section. As to actual operation, when all spillway gates are operated at uniform opening, the flow concentrating to the central part of the basin will occur and result in reduction of the stilling action. For the topographical condition, the abrupt bend of the exit channel will cause a lateral back roller at the upstream portion of the cofferdam.

In 1962, the eroded parts of the apron and protection-wall were repaired by replacing the concrete, and the damaged river bank was protected by derrick stones, which have indicated a satisfactory performance against flood releases thereafter.
