## Assessment of Landslide Risk during Earthquake/Rainfall on Urban Areas

Kyoji SASSA, Gonghui WANG, Hiroshi FUKUOKA

### Synopsis

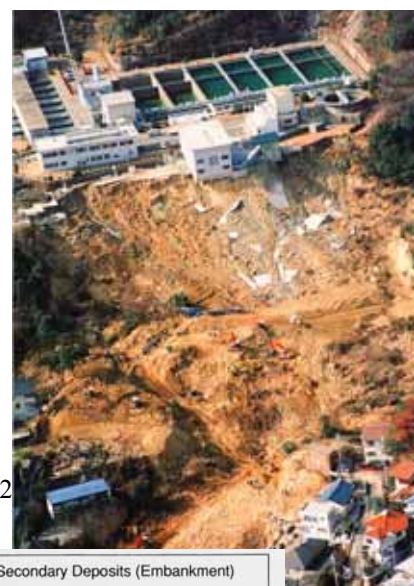
Fig. 2 Aerial view of the landslide area

At the Hyogoken-Nanbu earthquake, many landslides were triggered in the metropolitan areas between Kobe and Osaka. Among them the largest landslide disaster was the Nikawa landslide, which killed all 34 residents sleeping in 11 houses below the slope. The volume of this landslide was 110,000 ~120,000 m<sup>3</sup>, and the moving distance was about 175 m (Sassa et al. 1996). No recorded data concerning the sliding speed was available. However, it is believed that it was a rapid landslide, since no one evacuated from the destroyed houses and all 34 residents were killed. The locations of Nikawa and other two landslides introduced in this paper are presented in Fig. 1. Fig. 2 is a photograph showing

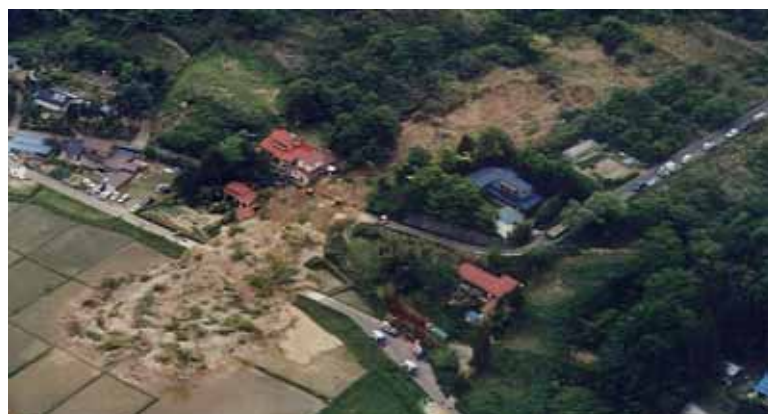
Fig. 9 Oblique side view of the landslide (Photo courtesy of Kokusai Kogyo Co., Ltd).

Fig. 9 shows an oblique side view (taken by Kokusai Kogyo Co. Ltd). From this photo, it is seen that the road on the right side is almost parallel to the landslide, indicating the nature of gentle slope. It is also noticed that almost all of the displaced landslide mass slide out of the source area and deposited on a horizontal rice paddy. Fig. 10 is the view from the toe of the landslide, which was taken four days after the event (at our survey time). The source area was covered by blue sheet for the prevention of possible second disaster during rainfall. The bamboos on the source area originally were transported with the landslide mass; however, most of them were standing almost vertically on the rice paddy with very thin landslide mass below them.
