2004年スマトラ島沖地震津波災害の全体像の解明  
Comprehensive analysis of the damage and its impact on coastal zones  
by the 2004 Indian Ocean tsunami disaster

平成 16 年度科学研究費補助金  
(特別研究促進費) 研究成果報告書  
Grant-in-Aid for Special Purposes  
Research Report

研究代表者  
京都大学防災研究所  
河田 恵昭

## Chapter 2 Earthquake, Tsunami and Damage at Banda Aceh and the Environs in Northern Sumatra (Matsutomi, H.)

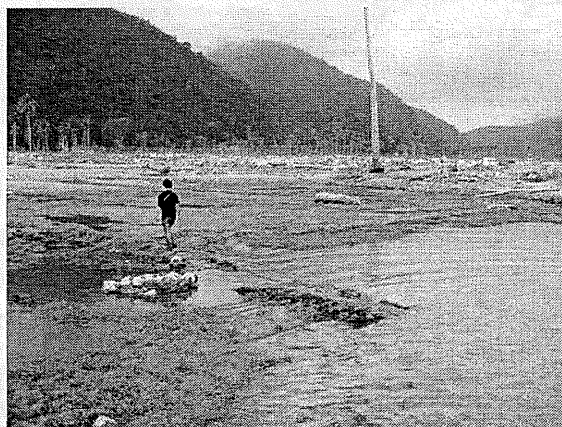
Photo 2. 1 The rice field was submerged near the coast at Peukan Bada.

At Peukan Bada located at the west of the Banda Aceh city, the rice field near the coast is submerged after the earthquake as shown in Photo 2. 1. Because the rice field was originally above a high tide level, we measured the ground level of the rice field from the high tide level. It suggests that the subsidence of more than 20cm occurred due to the earthquake.

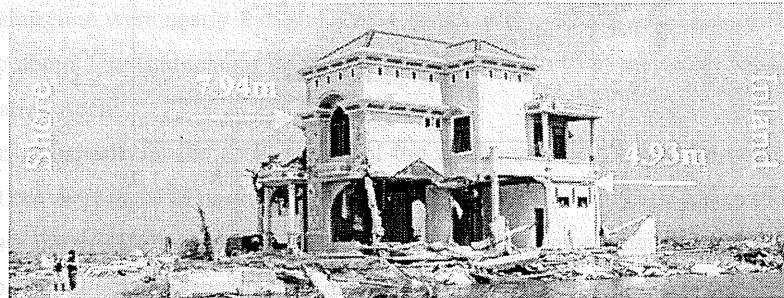
Photo 4 Partially damaged family house located at a distance of about 0.9 km inland from the shoreline in Banda Aceh. Left side is shore and right side inland. Numerals indicate inundation depths.

The tsunami advanced about 4 km inland in Banda Aceh. Within 2-3 km from the shoreline, houses except for strongly-built reinforced concrete ones with brick walls (Photo 4), which seemed to be partially damaged by the earthquake before the tsunami attack, were completely swept away or destroyed by the tsunami. Inundation depth (Photo 4) and estimated current velocity at a distance of about 0.9 km inland from the shoreline were nearly 5 m and 8 m/s, respectively. The tsunami height reduced from 12 m at Ulee Lheue to about 5 m (inundation depth is 1.6 m. See Photo 9) at the Great Mosque located in the central part of Banda Aceh.

Photos 4-6 show examples of variation of the inundation depth, current velocity and so on due to the distance from shoreline. The judgments of degree of damage to houses are based on the criterion of destruction defined by Matsutomi and Shuto (1994).

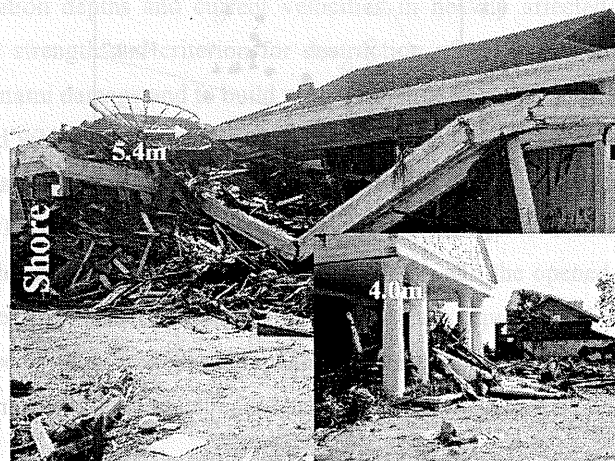
Photo 5 Partially damaged family house located at a distance of about 1.3 km inland from the shoreline in Banda Aceh. Left side is shore and right side inland. Numerals indicate inundation depths.

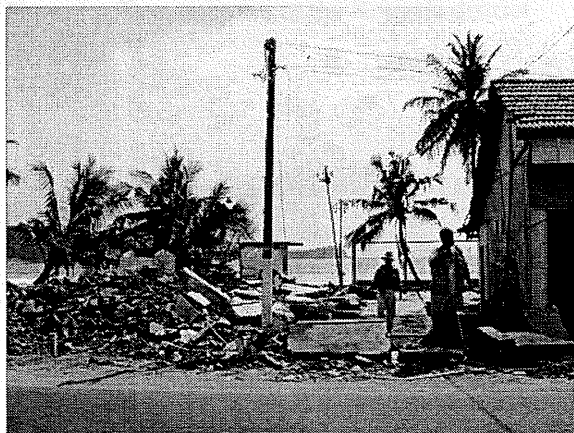
Photo 3 Tsunami inundation level(upper) and destroyed beachfront house (lower)

In the Galle Fort surrounded by the wall of 5-6 m high and constructed 400 years ago, the inundation area is small, where the buildings were not damaged. Tsunami flood power was reduced by the seawalls. By contrast, a new central area in Galle is located 2-3 m above the sea level at the behind of the Fort. This is reported that the tsunami separated at the Fort could meet at the central area and inundated inland.

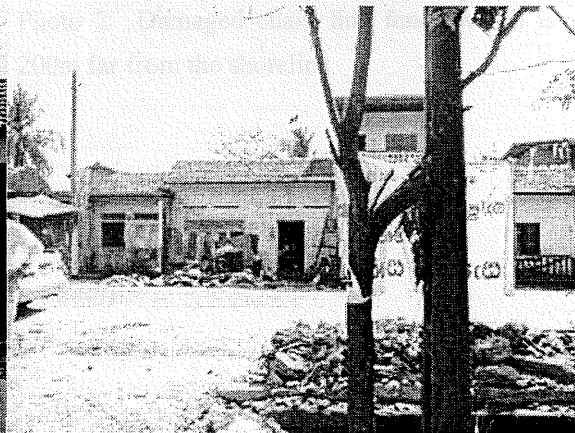
Photo 4 Tsunami inundation level(upper) and barely damaged beachfront house (lower)

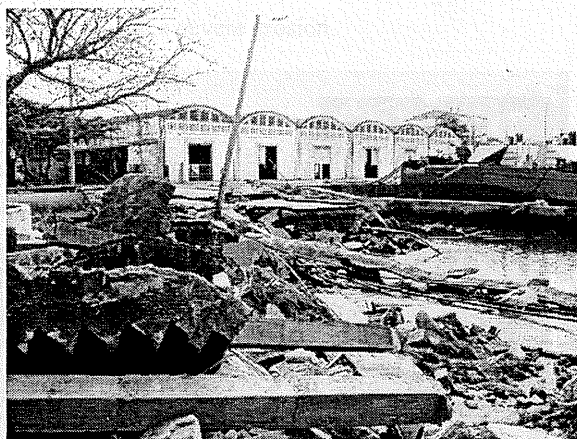
Photo 5 Damage of the quay at the Galle Port

The tsunami traces were found on the wall of the storage shed and of the office building that are located at the entrance of the inland. The trace height from the mean sea level was 5m and 6m respectively. Though big destruction was not seen on the breakwater, the quay was destroyed as shown in Photo 5 and the services at the port was not available when we visited after the tsunami attack. The huge dredger ship was moved on the quay as shown in Photo 6.

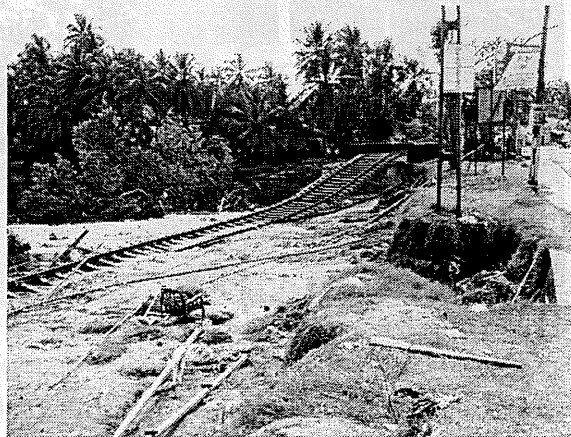
Photo 10 Scouring damage on the foundation of railway at Ambalangoda

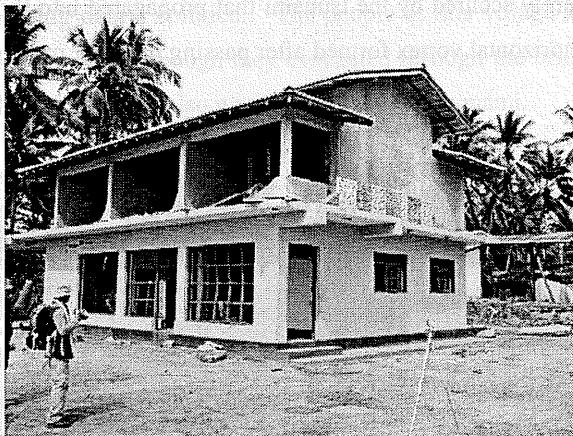
In Paiyagala which is 48km in north of Kahawa, there is a tsunami trace which is about 6m above the mean sea level, it is 4.2m far from the shore in the inundation level. Only a part of house such as windows and doors in the houses made of concrete were damaged as shown in Photo 13.

Photo 13 Barley damaged building made of concrete

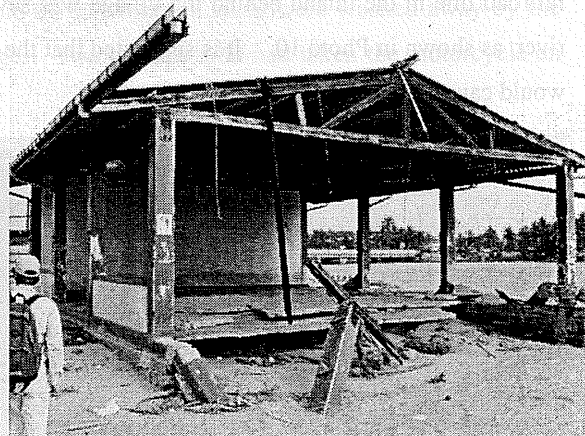
Photo 14 Damaged concrete floor by the tsunami lift force

The Panadura district 25km in south of Colombo is located between the river and the sea. It is indicated that the damage was caused by both of the tsunami running up the river and the overtopped tsunami from the coast. The impact of tsunami, especially lift force, was able to destroy the concrete floor and roof as shown in Photo 14.

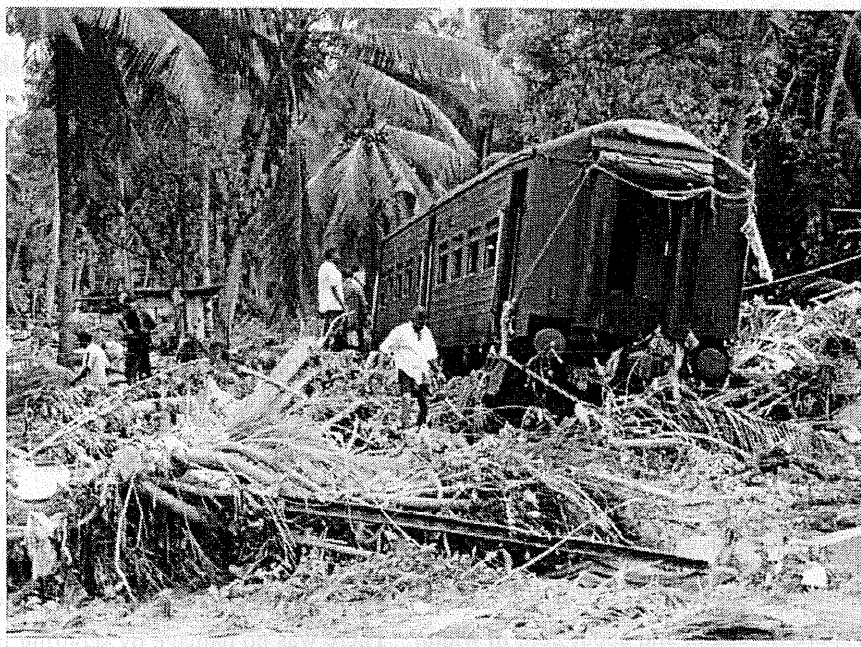
The residents of the district saw the disaster and began to flee inland. Some of them escaped into the stopped train. Generally railway cars are stronger and higher than automobiles etc., the residents probably thought they were safe. This would be why not only passengers but also residents were died in the train cars. But the second wave that struck 30 to 40 minutes later, about 15 minutes according to other witnesses, engulfed the train shown in Photo 15.

Photo 15. View of the Overturned Railway Train
