## Failure mechanism of anchored retaining wall due to the anchor head itself being broken

**ABSTRACT:** In this research, a case history of temporary earth support collapse is first illustrated briefly and the mechanisms of accident occurrences are introduced, with the results showing that the shallow penetration of piles mainly caused the sequences of collapse. In order to understand these failure characteristics and mechanisms, centrifuge model tests using an in-flight excavator were carried out. The failure mechanism of the retaining wall in this labour accident was firstly demonstrated using centrifuge model tests by Toyosawa et al. (1998). In this paper, we added some viewpoints regarding the mechanism of the retaining wall and it was thus clarified that the active and passive earth pressures in the retaining wall increased during excavation and then the anchor head exceeded the capacity with respect to tensile stress. As a result, the retaining wall and ground behind the wall collapsed suddenly.

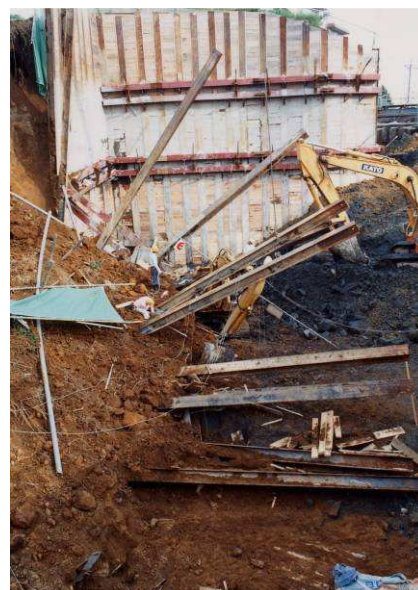
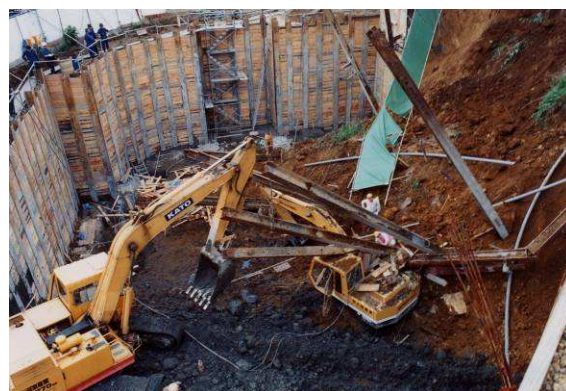
Fig. 3 The scene of the collapse accident

At around 1:15 p.m., with a loud noise, the central 15 m of the temporary earth support structure on the east side collapsed suddenly with the ground behind the support. The ground slid into the excavation area with a soil volume of approximately 200 m<sup>3</sup> and a maximum thickness of approximately 4 m.

(a) The scene of the collapse accident (from south side)

(b) The scene of the collapse accident (from north side)

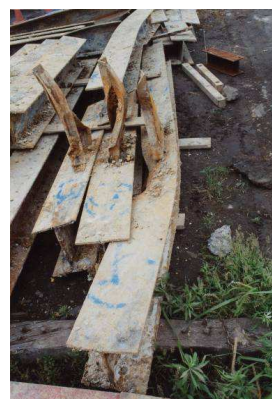
(c) Damaged H- steel for anchor head

- 1) Remedial work was being performed on the excavation bottom despite insufficient penetration of the main piles. It is assumed that, due to insufficient penetration, the earth pressure caused the displacement of the main piles.
- 2) The main piles were supported by the ground anchors installed at an angle of 45 degrees from the horizontal plane. Downward force provided from the anchor's tensile force made the connection between the wale which supported the anchor heads and the anchor heads ineffective.
- 3) Finally, the unstable earth support structure led to a huge-volume soil collapse.

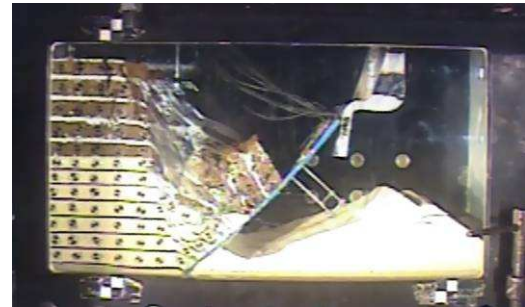
Fig. 11 Profile of models after failure

Figure 11 shows the profile of each model after failure. Figure 11(a) shows the model with sand layer after failure. During the excavation process, the penetration depth of the wall decreased step by step as excavation proceeded. Failure occurred when the penetration depth of the wall reached about 35 mm and continuous failure with a small displacement emerged with each excavation step. Figure 12 shows the ground displacement field behind the model sheet pile at the final excavation step using PIV (Particle Image Velocimetry, Kikkawa et al. 2006). The failure line angle was about 65 degrees.

The model consisting of Kanto loam and sand layers is shown after collapse in Fig. 11(b). The failure happened suddenly when the penetration depth reached about 60mm. The failure line's angle in the sand was about 65 degree.

(a) Sand layer

(b) Kanto loam and sand layer
