## **Flood triggered oil spills: Lessons from the Natech accident in Saga prefecture in August 2019.**

### **Synopsis**

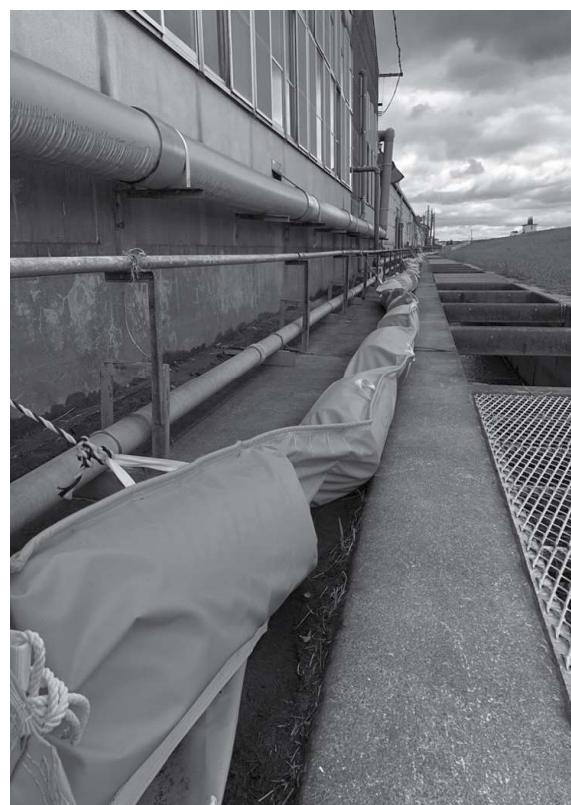
Figure 5. Permanent oil boom implemented in the south side of plant premises, in the closest area to Rokkaku river embankment.

In the months after the event, the company took additional measures to reduce the possibility that events of this magnitude could re-occur. Indeed, an oil fence approximately 90cm high has been installed inside the heat treatment plant surrounding the oil tanks. Moreover, permanent oil booms with a total length of about 600 meters have been installed along the east and south sides of the plant premises since these are the closest areas to the Rokkaku river (Nishinippon Shimbun, 2019). A part of the barrier is shown in Figure 5.
