## Rethink of failure of underground construction- lessons learned from Taiwan

**ABSTRACT:** Underground construction is widely adopted in urban area but sometimes the construction might cause severely failure. In this paper, successful interpretation of instrument data is addressed and several examples are demonstrated since geotechnical monitoring is thought to be an effective tool to avoid failure. Further, the failure may also be caused by misinterpretation of responsibilities of parties relating underground construction so responsibilities distribution in site investigation, design, construction and geotechnical monitoring are discussed. It is recommended that adequate data of site investigation shall be provided by the client and shall not leave all responsibilities to the contractor. Well- experienced experts shall be invited to evaluate the quantity and quality of data of site investigation before the project goes to tender.

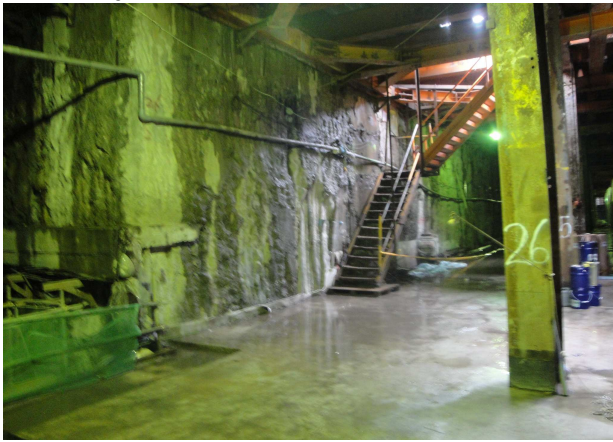
Fig. 3 Quality of diaphragm wall

Wall deflections were measured at an excavation located in eastern Taipei. The maximum excavation depth of the site is 22.85 m and it was retained by a 43 m deep, 1.2 m thick diaphragm wall. Eight- level internal bracing were adopted to provide additional horizontal supports. It is also noted that depth of bedrock on site was various, from 28 m to 40 m below surface level. It was found that a large wall displacement (up to 115 to 135 mm) was measured and Figure 3 presents a comparatively poor quality of wall constructed on the site. It was constructed using hydraulic- grab type machine and it was reported by the contractor that appearance of rock affects the quality of the wall. Observations here did reflect the quality of wall

and this might not be pointed out during the design stage.

Further, as shown in Figure 3, the quality of wall could not be predicted before commence of the design but could possibly be detected after wall installation. The design of the excavation should thus be revised after wall installation because of the quality of wall. Moreover, conducting independent check could increase the reliability of the design and it cost less for design change before commence of construction of an underground project. It is thus recommended that independent checks shall be delivered and revision of design should be concerned from time to time in order to reduce the risk. The employer might not be capable to carry out tasks stated above and it is suggested
