## Disasters Caused by Severe Local Storms in Japan

By Hatsuo ISHIZAKI, Yasushi MITSUTA, Tatsuo MUROTA,  
YUZO YOSHIKAWA and In Whan SUNG

### Abstract

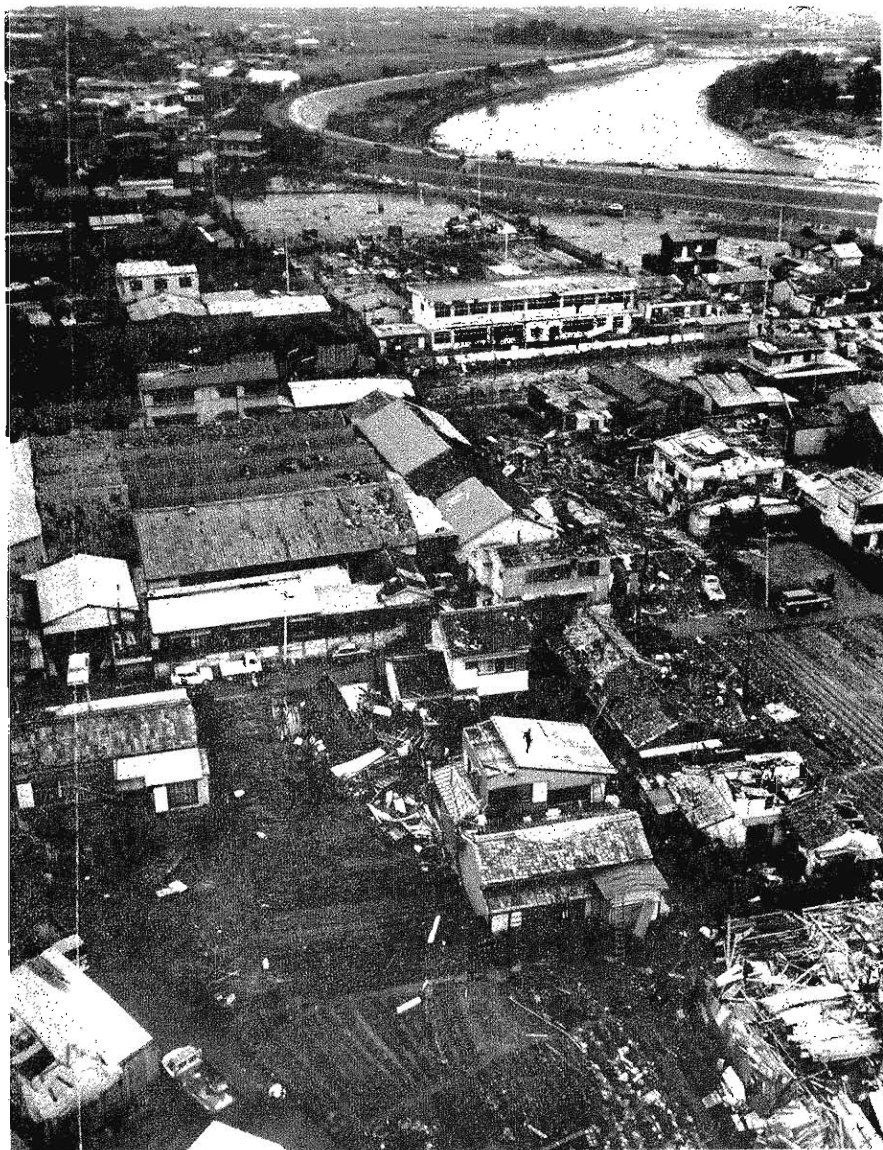
Photo. 1. Aerial view of the damage in the Shimoji-cho area after the Tatsumaki.  
(by courtesy of the Chunichi Newspapers)

In Area (C), more than 80 buildings were totally destroyed or badly damaged. There, the width of the damaged area became about 200 m at maximum. The aerial view of this area after the Tatsumaki is shown in Photo. 1.

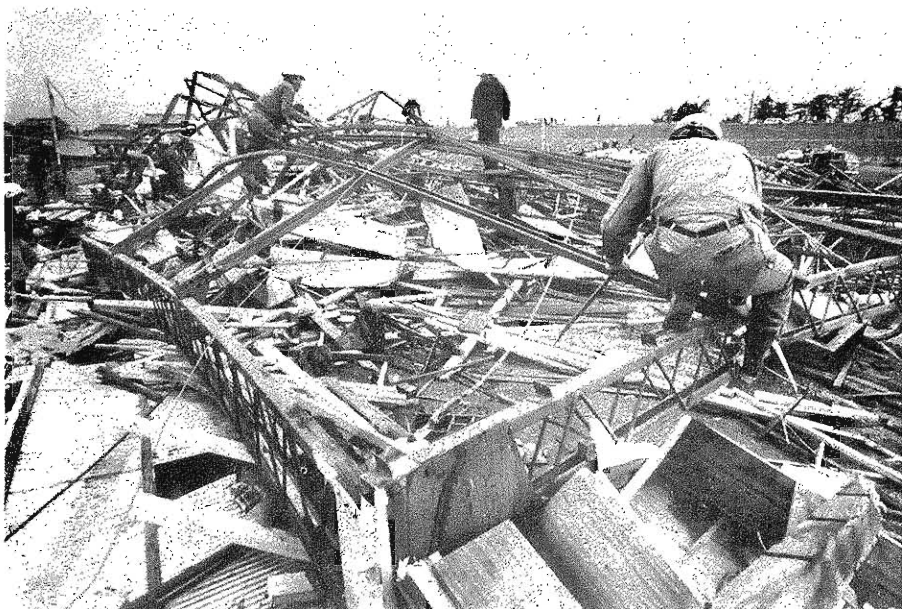
Photo. 3. Wreckage of a light-gauge-steel structure. Bodily removal of the structure from its foundations. (by courtesy of the Mainichi Newspapers)

Wooden or steel structures were more seriously damaged (Photos 2, 3 and 4). Reinforced-concrete buildings suffered damage only at openings. The general features of the damage were similar to those caused by the strong winds of typhoons, but severe local damage caused by heavy debris, as shown in Photo. 5 was often observed.

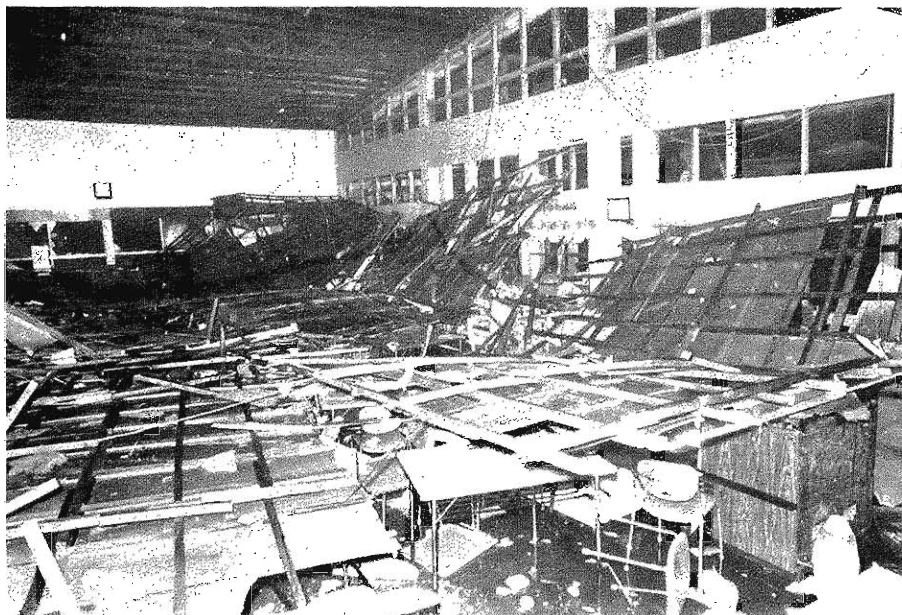
Photo. 4. Damage to a steel structure. Complete removal of the roof and collapse of the ceiling. (by courtesy of the Chunichi Newspapers)

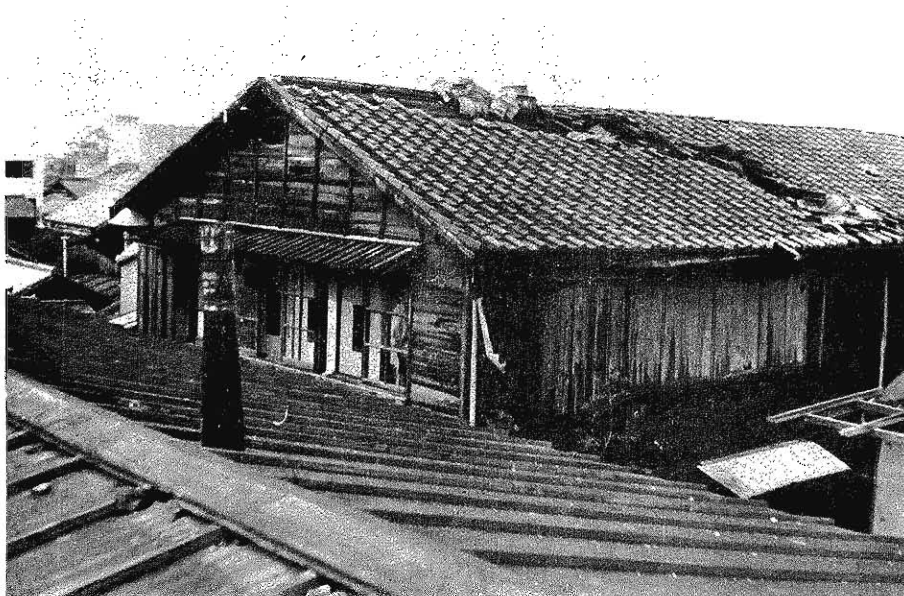
Photo. 5. Local damage to a tiled roof caused by heavy debris. (by courtesy of Mr. K. Chikada)

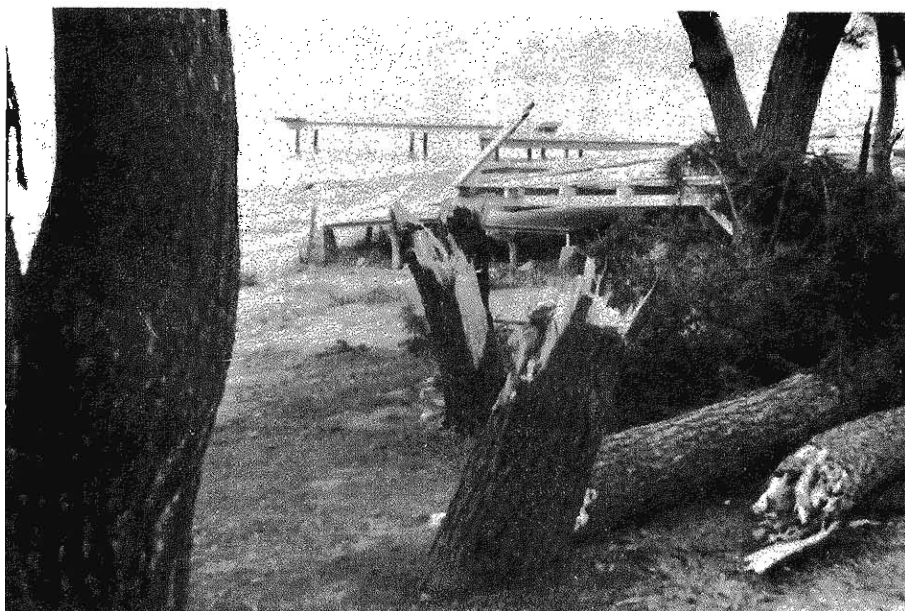
Photo. 7. 30 cm diameter pine trees broken off at the roots.

The damage caused by this storm was surveyed by the present authors just after the disaster and the detailed description of the meteorological situation and the damage is reported in another paper (Ishizaki et al.<sup>11)</sup>). The distribution of the damage is summarized in the map shown in Fig. 5. The shaded area is the severely damaged area, but fortunately there were only a small number of houses in it. Some of the pictures of the damage are shown in Photos 6 and 7.
