## Landslide Disasters Triggered by the 2004 Mid-Niigata Prefecture Earthquake in Japan

Kyoji SASSA, Hiroshi FUKUOKA, Fawu WANG,  
Gonghui WANG, Kenji OKADA\*, Hideaki MARUI\*\*

### Synopsis

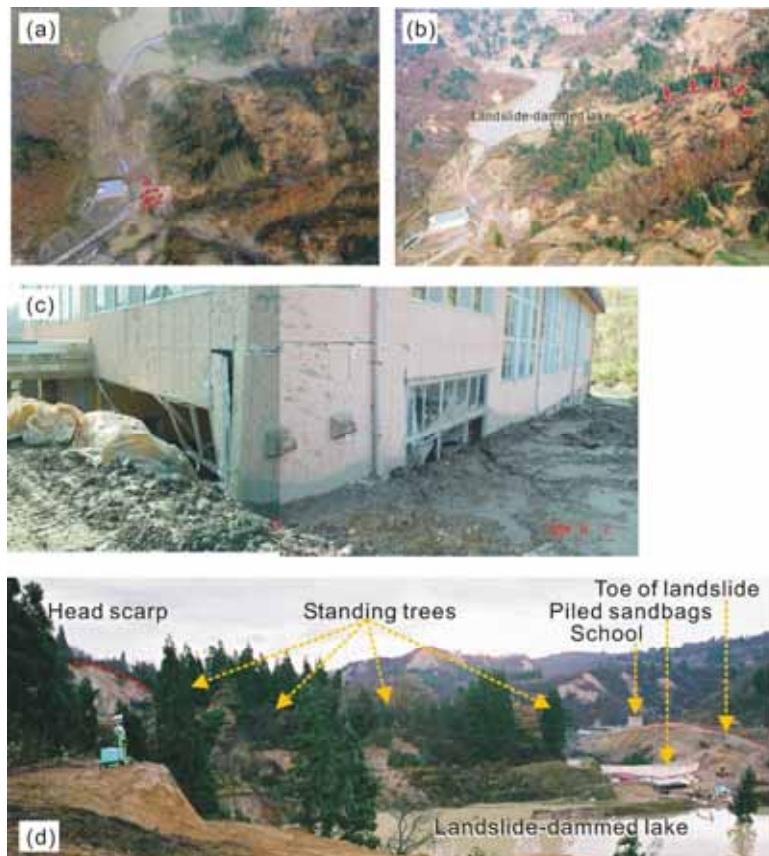
Fig. 2 General view of the Higashi Takezawa landslide. (a) Oblique airphoto taken by Marui on 3 November 2004, (b) Oblique airphoto taken by Sassa on 6 November 2004, (c) Debris intruded into a school building from the landslide mass, d) Side view of the Higashi Takezawa landslide taken on 16 November 2004.

The landslide that posed the greatest threat to the area was the Higashi Takezawa landslide, which blocked the Imokawa River, forming a landslide dam. Fig. 2a, b show the general view of this landslide taken from a chartered helicopter. Photo a) was taken on 3 November, and photo b) was taken on 6 November. The road bridge that can be seen in photo a) was submerged in the landslide-dammed lake in photo b).

Both photos clearly showed that the landslide mass was not disturbed through its approximately 100 m distance of rapid movement. As can be seen in photo b), trees on the landslide generally remained straight. However, the forest showed backward rotation at the toe of the landslide (photo a), because the landslide mass filled the Imokawa River and moved upward along the slope of the opposite bank. The building in Fig. 2a was an elementary school. Fig. 2c shows debris that flowed into the entrance and a window of the school building, and mud that scattered onto the building wall. The phenomenon suggested the rapid movement of this landslide. The debris and scattered mud at the school building probably came from a small landslide (“A” in Fig. 2a) at the toe of large displaced landslide mass. This part of the mass did not include the forest, but probably was soils from/around the Imokawa River that was scraped and carried by the displaced landslide mass. Fig. 2d shows a side view of this landslide from which high mobility can be hypothesized based on the angle from the head scarp to the toe of the landslide. The mobilized apparent friction angle was 7.5 degrees.

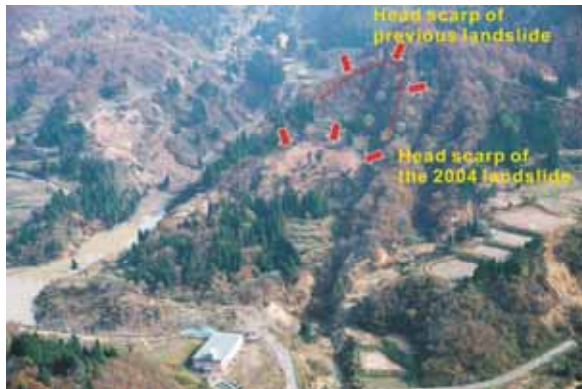
Fig. 3 Higashi Takezawa landslide and the head scarp of past landslides (Taken by Sassa)

Fig. 3 presents another view of the Higashi Takezawa landslide. The head scarp of the current landslide is shown on the figure by red arrows, and the head scarp of the previous landslide is shown by a curved line with red arrows. We investigated the head scarp of this landslide. A very straight, gently-dipping (around 20 degrees) stiff silt (stone) layer outcropped as shown in Fig.4. This layer seemed to be a part of sliding surface of this landslide. It is relatively impermeable and groundwater flowed over this stiff silt

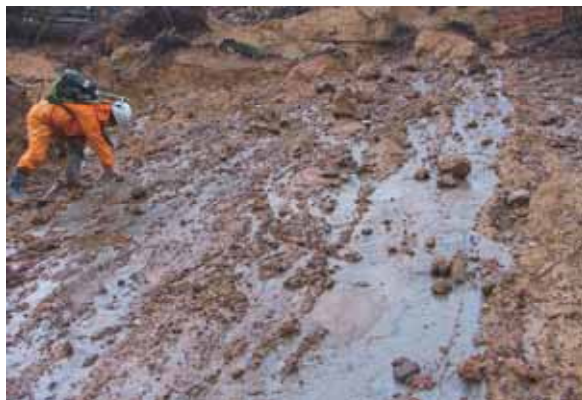
Fig. 4 Stiff silt (stone) layer outcropped in the head scarp (it inclined around 20 degrees to the landslide moving direction and groundwater flowed over the layer)

layer. The sand layer over this stiff silt layer was soft. It was probably a part of previously moved landslide mass. A sample (H2) was taken from this sand layer behind the current sliding surface as seen in Fig.5.

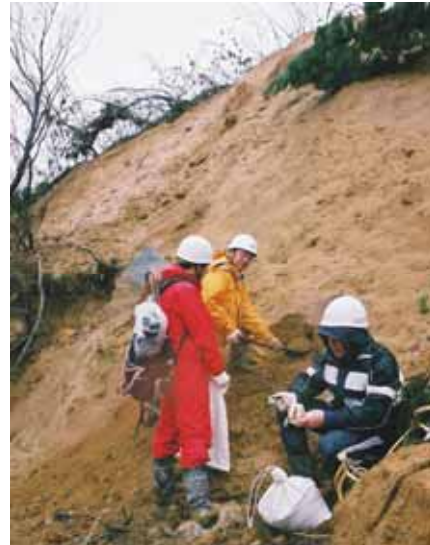
Fig. 5 Sampling from the sand layer behind the sliding surface and over the stiff silt (stone) layer

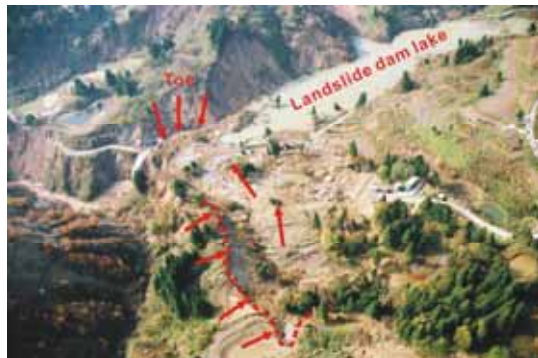
Fig. 8 Overview of the Terano landslide (Taken by Sassa on 6 November 2004)

Fig.8 presents the view from the head scarp to the toe of the Terano landslide. It created a large landslide dam and resulted lake. The landslide is a part of big repeatedly-moving type of landslide complex area, which is typical in the Tertiary mudstone landslide-prone area. Fig. 9a, b show the plan and the section of this landslide. This landslide was also

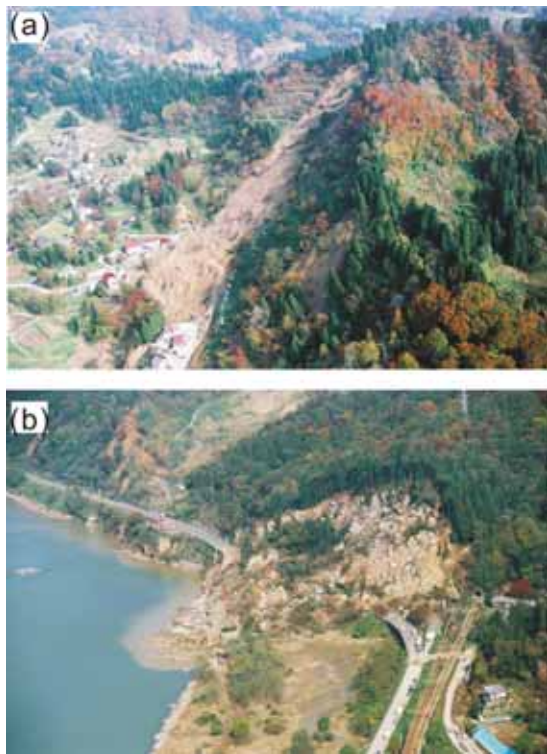
Fig. 12 Oblique airphoto of the Haguro landslide (a) and the Myoken landslide (b). Both photos were taken from a helicopter by Sassa on 6 November 2004.

The Higashi Takezawa, Terano and Dainichisan landslides were 25-50 m deep-seated landslides. The Haguro landslide (Figs. 1, 12a) was relatively shallow, and the landslide mass was very disturbed because of

the steep slope and its shallow depth. This landslide destroyed a road and many parked cars, but fortunately no one was killed. The relatively small rock slide in the Myoken area (Fig. 12b) covered a main road and buried a car occupied by a mother and two children. The rescue team noticed the car buried under the displaced landslide mass, and tried to rescue the occupants. However, the rescue operation took three days because of the very unstable landslide rock debris. The rescue activities were monitored and broadcasted every day by TV and other media. Finally a 2-year-old boy was safely extracted from the buried car. The Myoken landslide occurred on a convex slope. In addition, it was dry, which was one reason the boy could survive for 92 hours under the landslide mass.
