# The Application of Monitoring and Early Warning System of Rainfall-Triggered Debris Flow at Merapi Volcano, Central Java, Indonesia

Teuku Faisal Fathani and Djoko Legono

**Abstract** The 2010 Mt. Merapi eruption has produced approximately 140 million m<sup>3</sup> of pyroclastic deposit, in which more than 10 million m<sup>3</sup> deposits are potential to move downstream through Boyong/Code River towards Yogyakarta City. The flow behavior of Code River may be affected by the presence of accumulated sediment at the upstream of the river (namely Boyong River). By rainfall trigger, this potential source can cause debris flow disaster that may contribute damage to the settlement areas in Yogyakarta City. This paper presents the application of monitoring and early warning system to mitigate the impact of debris flow disaster along Boyong/Code River as revealed by most adaptive, low cost, and collaborative-based technology. The real-time monitoring equipment consists of automatic rainfall recorder, automatic water level recorder, debris sensor, and interval camera. The system was developed by considering the community aspiration in determining the types and placement of monitoring e

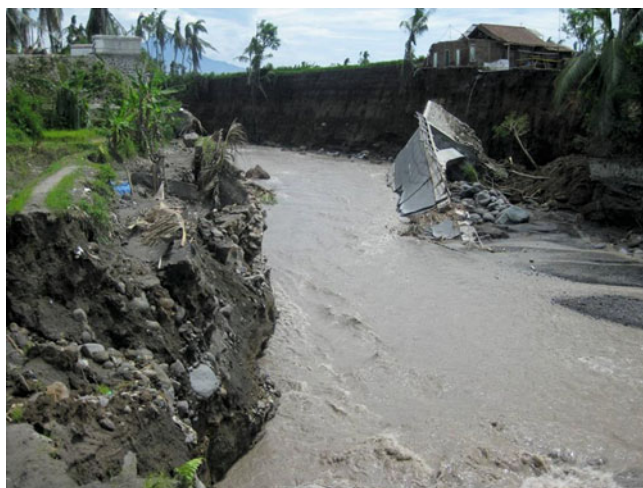
**Fig. 2** Collapsed bridge due to the destructive power of rainfall-induced debris flow

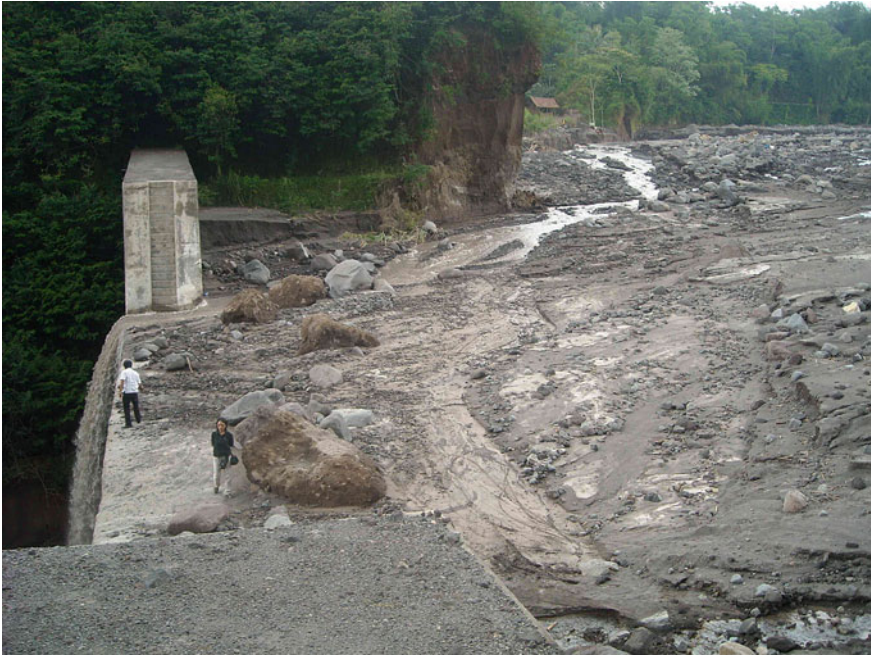
**Fig. 5** Upstream condition of Boyong River: Sabo dam BOD4 on 14 January 2011

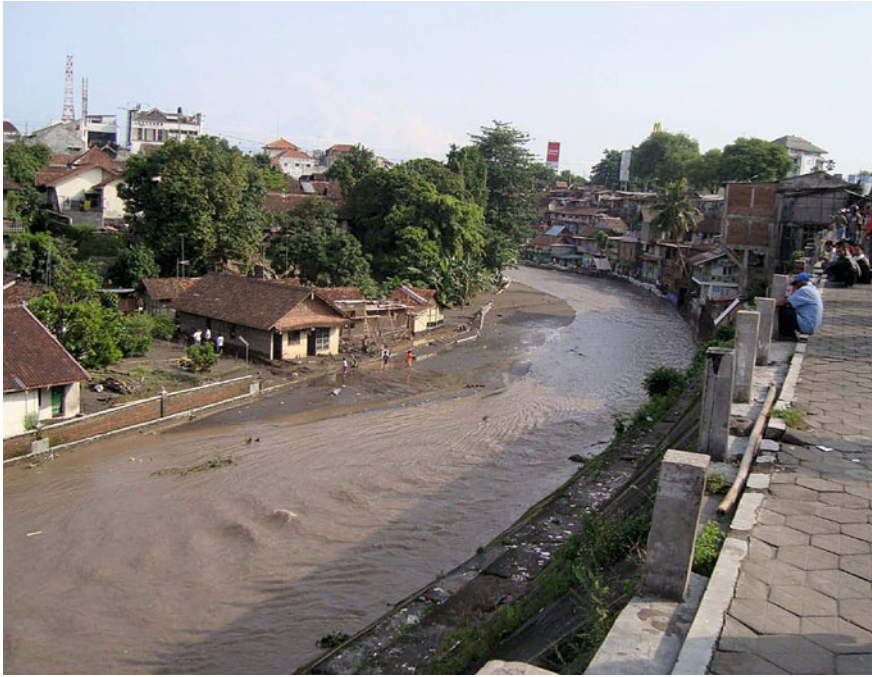
**Fig. 6** Downstream condition of Code River: Jogoyudan area in the Yogyakarta City on 30 November 2010

Apparently, during the days after 29 November 2010, increase in rainfall intensity occurred, triggering a more intensive debris flow that caused significant damages in several infrastructures at some rivers (Pabelan River and Putih River). Fortunately, no casualty was reported. However, the damage of important infrastructures such as roads, bridges, paddy fields, and settlements was very significant. A hyper-concentrated flow in Boyong/Code River occurred several times that made the local people evacuate themselves (Fig. 6).

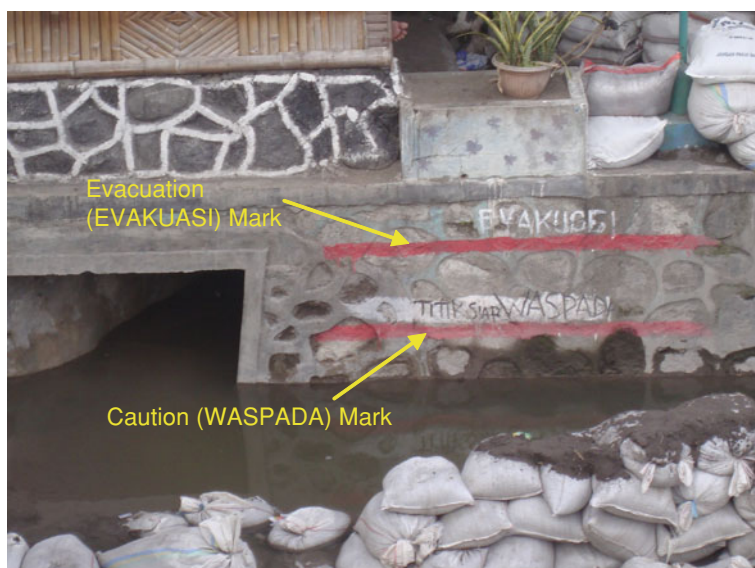
Figure 9 shows the current warning system pursued by the community at surrounding Code River. The community living near the river has tried to carry out debris flow monitoring with the simplest way. Based on the previous experience, “caution” and “evacuation” elevation are marked on the river slope protection; hence, they can decide the right time to evacuate. The presence of integrated debris flow early warning system indeed helps the community to increase their awareness and preparedness in facing the disaster.

**Fig. 9** Existing community warning alert in anticipating debris flow

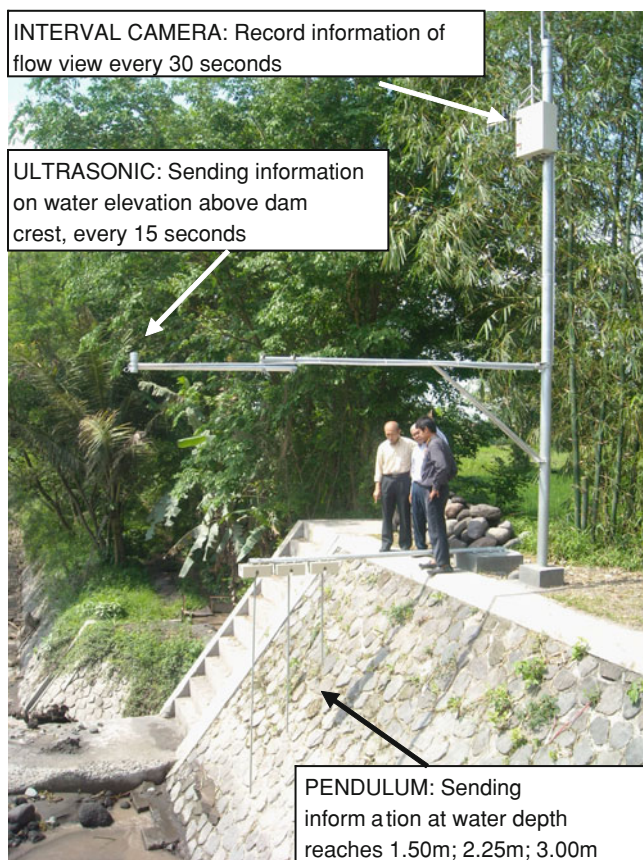
Figure 12 shows the cross-sectional monitoring system at Rejodani. Ultrasonic monitoring equipment, interval camera, and three different levels of pendulum are

**Fig. 12** Cross-sectional monitoring system at Rejodani

placed in one river cross-section. This system transfers the monitoring results regularly to the central station. The whole system was built by prioritizing most adaptive and least cost technology. Through this system, a debris flow monitoring system of Boyong/Code River for community at Yogyakarta City is implemented. This monitoring system is easy to replicate for rivers threatened by debris flow disaster at the surrounding of Mt. Merapi area.
