## On Heavy Rainfall Disaster in Tokai District in September 2000

Kazuya INOUE, Motoyuki USHIYAMA, Taisuke ISHIGAKI, Keiichi TODA  
and Kensaku KURIYAMA\*

### Synopsis

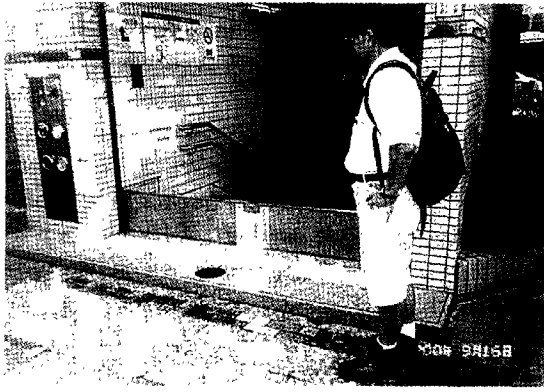
**Photo 4** Flash board of stair entrance at Nonami station

way railways. Flash boards of stair entrance were set at both stations. At Nonami station, the flash board of 40 cm height was set at each entrance (see Photo 4). However, as the surface inundation depth became higher than the flash board height, the inundation water invaded over the flash board. At Shiogamaguchi station, though wooden boards of 20 cm height were piled up, the inundation water could not be obstructed. And at Heiandori station, the new subway construction site adjacent to the station was submerged and the part of submerged water flowed into the subway railway from the drainage holes.

1. Setting of flash board of stair entrance is effective for inundation water protection, but the surface inundation depth is much influenced by the geographical condition around the station. Therefore, the review of past inundation records and the detailed check of geographical conditions around the station studied are very significant.
2. When the surface inundation extends suddenly, the inflow protection activities at plural entrances are expected to be very difficult. A sure preparation for controlling inundation water intrusion into subway station should be proceeded from ordinary times.
